Report No. 14537.R01
November 2007

ERRIGAL TRUAGH, MULLANACROSS, CO MONAGHAN

CONSERVATION MANAGEMENT STRATEGY

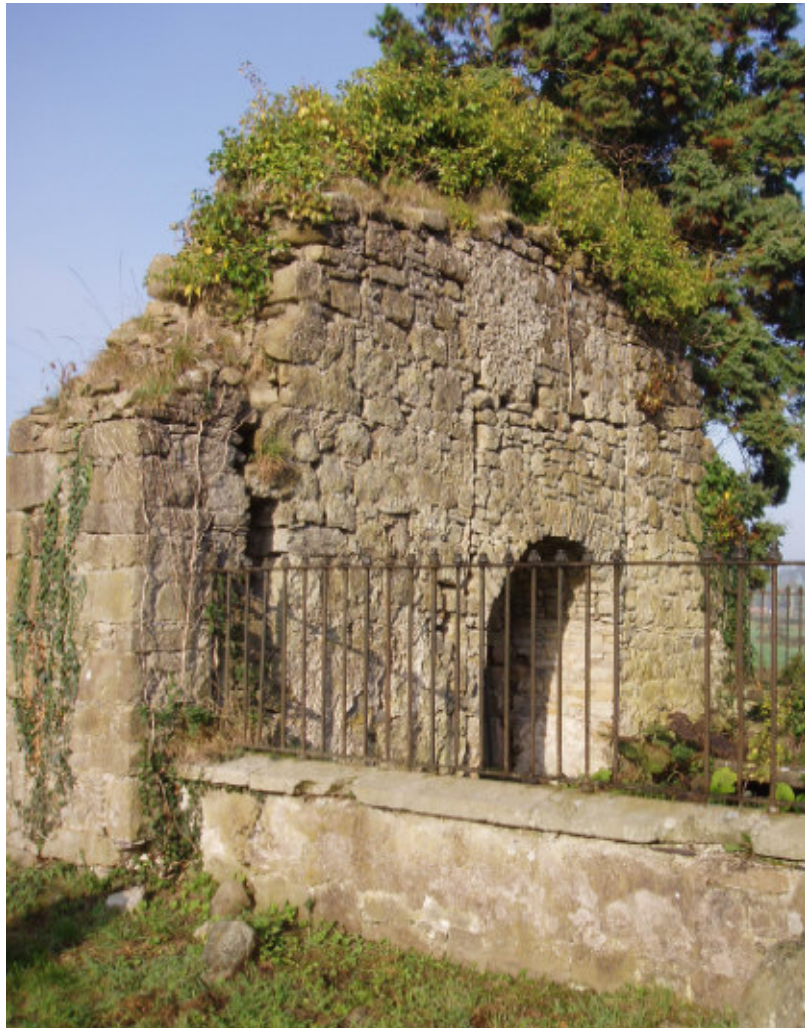
Fig. 8 The east-facing elevation of the west gable. The large crack in the foreground has resulted in the end of the wall becoming detached from the main panel of masonry. We would suggest that the end of the wall be pinned back to the main panel and the void infilled. The vegetative growth along the top of the wall requires removal and any loose capping stones discovered re-bedded.

- Action 9 Conservation work to the gable ridge-lines, to comprise localised replacement of missing stones, securing of others that are currently loose and repointing with a lime-based mortar. It should be noted that the aim here is not to effect a return the original pitch lines, but merely to provide consolidation of what remains.

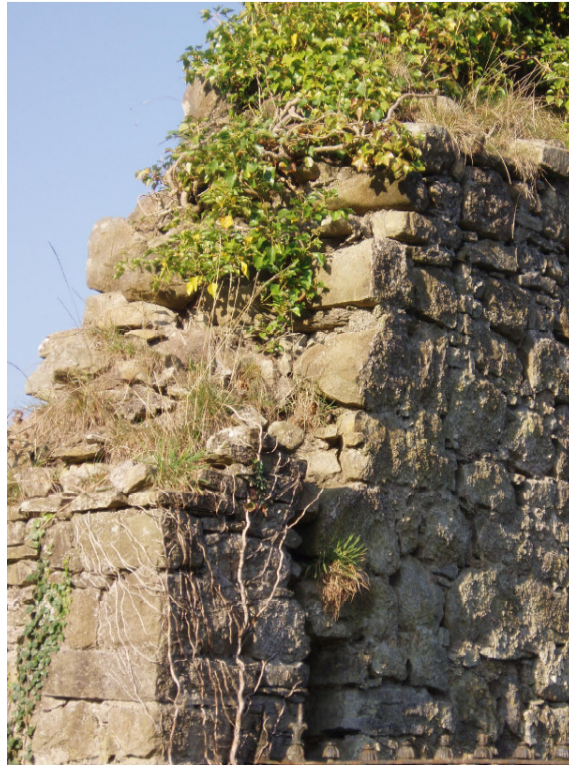
Fig. 9 Ivy and grass have become established on the top of the west gable wall. This should be removed and the masonry conserved

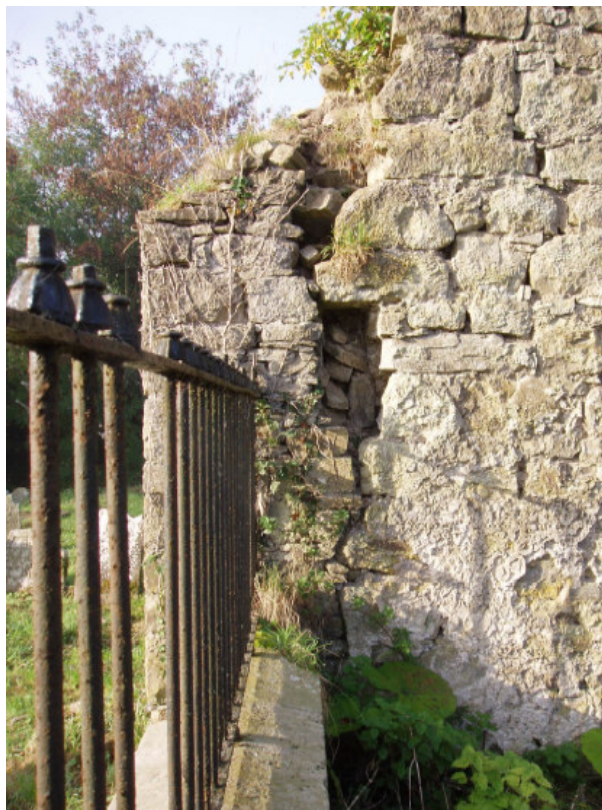
Fig. 10 Close-up of the severe crack in the east-facing elevation of the west gable of the church. The detached end of the wall needs to be pinned back to the main panel of masonry and the void infilled

- Action 10 Stabilising the large crack at the south end of the wall (**Fig. 10**) by pinning from the south side (using the CINTEC anchoring system or similar (www.cintec.com) before partially filling any gaps with stone (preferably the stone lying around the base of the wall) and a lime-based mortar.

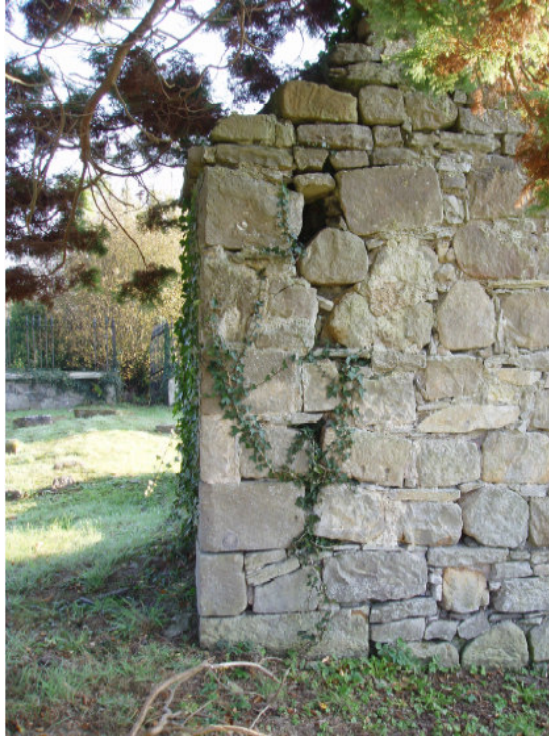
Fig. 11 A large crack and is also apparent at the north end of the west gable. This needs stabilising and conserving

- Action 11 Stabilising and conserving the quoinwork at the northern end of the wall, where there is movement (**Fig. 11**).
- Action 12 Rebuilding the northern jamb of the doorway (**Figs 12 and 13**). This has deflected, possibly because of the gate's instability. Sympathetic infilling of the large crack that has developed should also be undertaken (preferably with loose stone lying around the graveyard) and gaps repointed with a lime-based mortar.

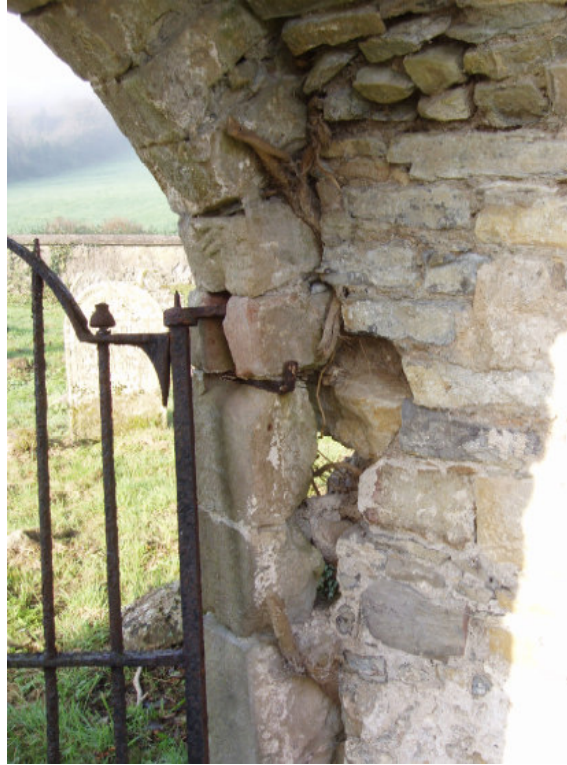
Fig. 12 Detail of the movement in the north jamb of the doorway in the west gable. The gate should be temporarily taken down to enable conservation works to the wall to take place. Once the wall has been consolidated the gate can then be re-hung

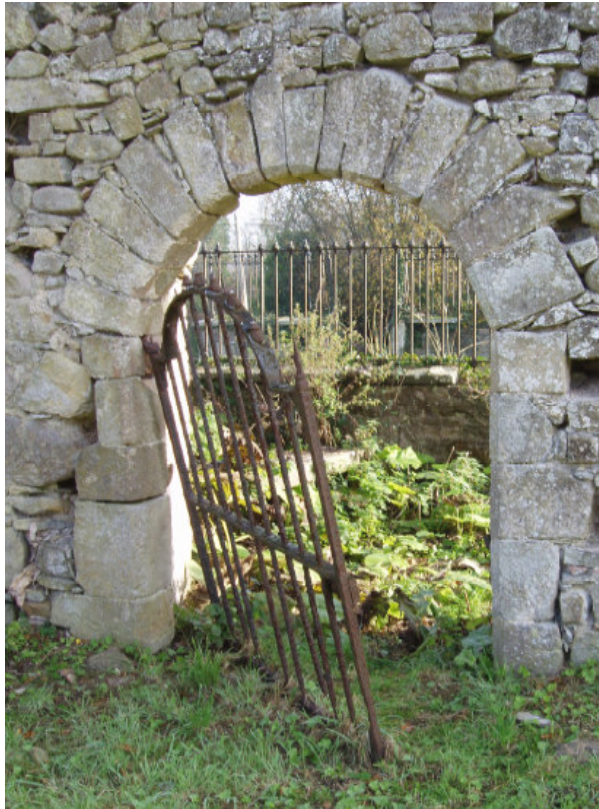
Fig. 13 Gate into the Anketell plot. This needs urgent removal and refurbishment

- Action 29 The gate into the Anketell enclosure (**Fig. 13**) needs urgent remedial attention. Its bottom hinge has separated from the jamb, and the weight of the gate on the sole remaining hinge may be causing structural movement to the jamb. Since the ironwork of the gate is in poor condition, it will need substantial restoration. In the short term, therefore, the gate needs to be removed and put into safe storage on or near the site.

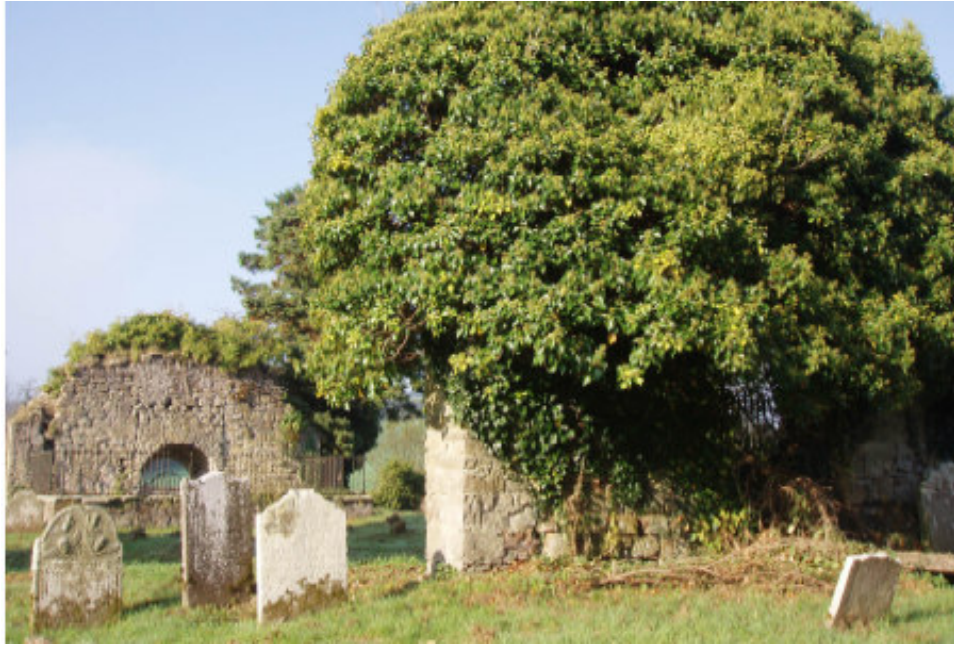
Fig. 16 The east gable of the church is heavily overgrown with ivy

Action 15 The ivy appears to be the most imminent problem (**Fig. 16**), especially since it is growing from the wall itself rather than the ground. However, as detailed in Action 20, no attempt should be made to address the problem until a programme of conservation works is in place. Heavy trimming of the ivy in the interim is not to be recommended as this will encourage new and more vigorous growth, although a very light trim might be beneficial. As with any maintenance or conservation works on the site the correct access equipment should be used and health and safety procedures followed. It is not advisable, for example, to prop ladders against the masonry, since this may be unsafe and may destabilise precarious fabric.

Action 21 Removal of the ivy from the gables of the church should only begin when funds and a timetable are in place to conserve the fabric that will be exposed. Once these are in place the roots should be cut at ground level and the plant allowed to die back (this process can be accelerated using suitable herbicides). Once dead, the ivy should be removed from the top downwards, and the fabric which is exposed conserved at the same time. Conservation should concentrate on sensitive and agreed re-pointing with a lime-based mortar, thus stabilising any loose masonry.

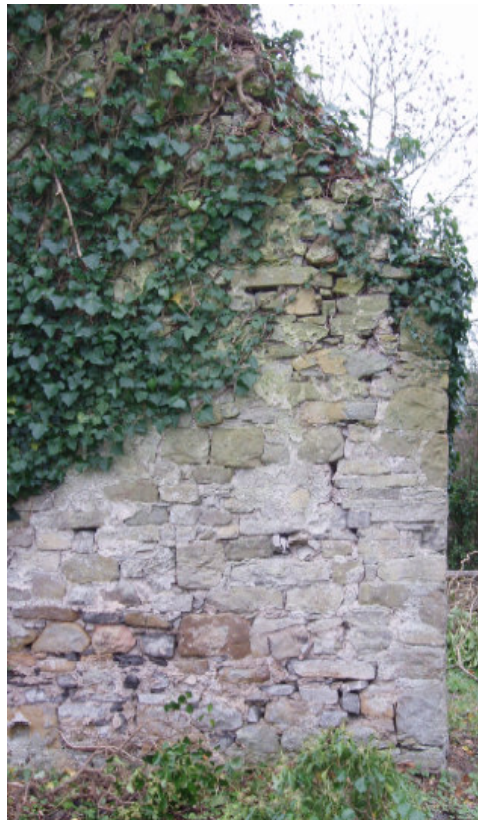
Fig. 17 The south gable end of the east gable also displays movement and needs remedial work

Action 17 The south gable end displays a similar crack to those visible in the west gable (**Fig. 17**), and should be treated in a similar manner.

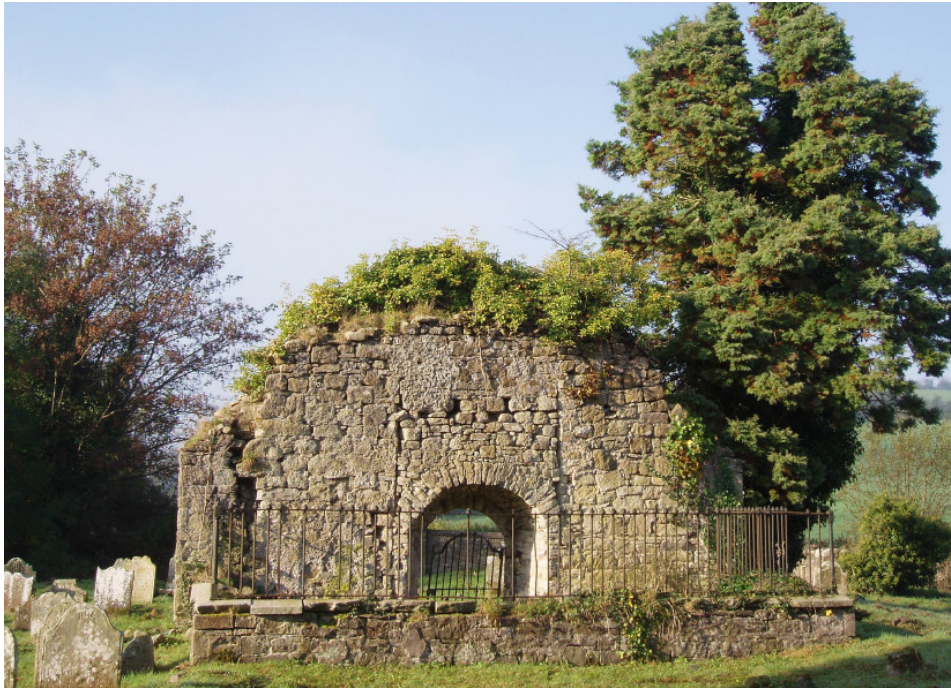
Fig. 18 The fir tree to the north of the church gable will eventually cause problems without regular pruning

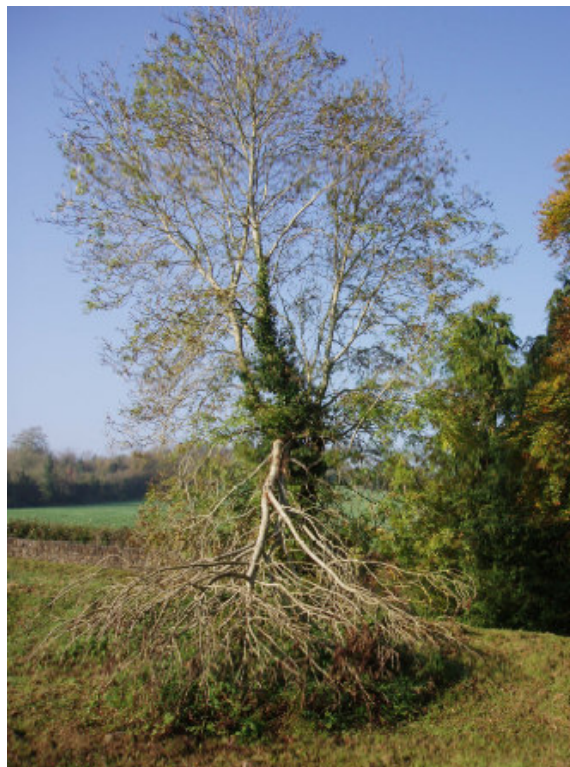
Fig. 19 A Rowan in the north-east corner of the graveyard requires attention

Action: monitor Falling branches and trees are a hazard to the public and monuments alike. Regular tree maintenance is therefore essential and work to the collection of trees in the north-eastern part of the graveyard, where a Rowan has partially fallen, is now required (**Fig. 19**). However, the retention of dead trees is beneficial to natural habitats, and a policy of clearance should be weighed against the potential for encouraging the quality and diversity of wildlife.

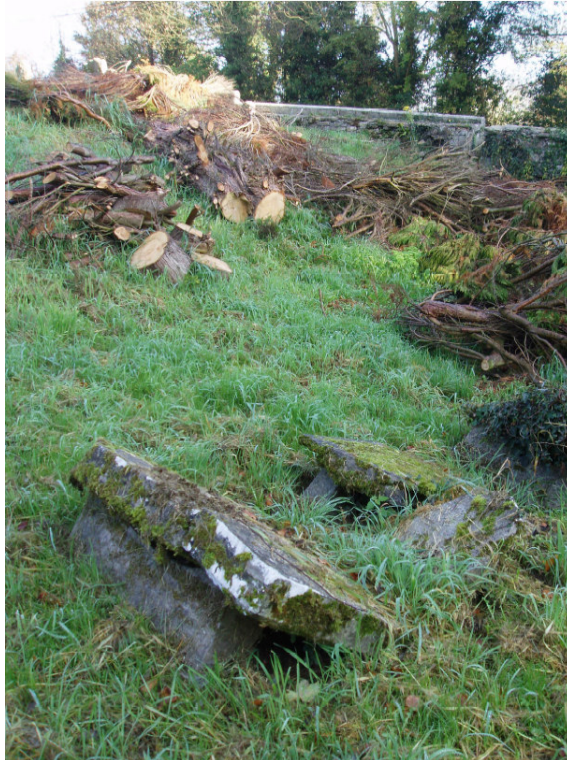
Fig. 20 Recently-felled tree in the south-eastern part of the graveyard. This needs careful clearance, although the stump should be left.

remnants require clearing away (**Fig. 20**). The stump should not however be removed, since this might cause damage to surrounding graves and grave-markers, and should instead be treated to accelerate the rotting process.

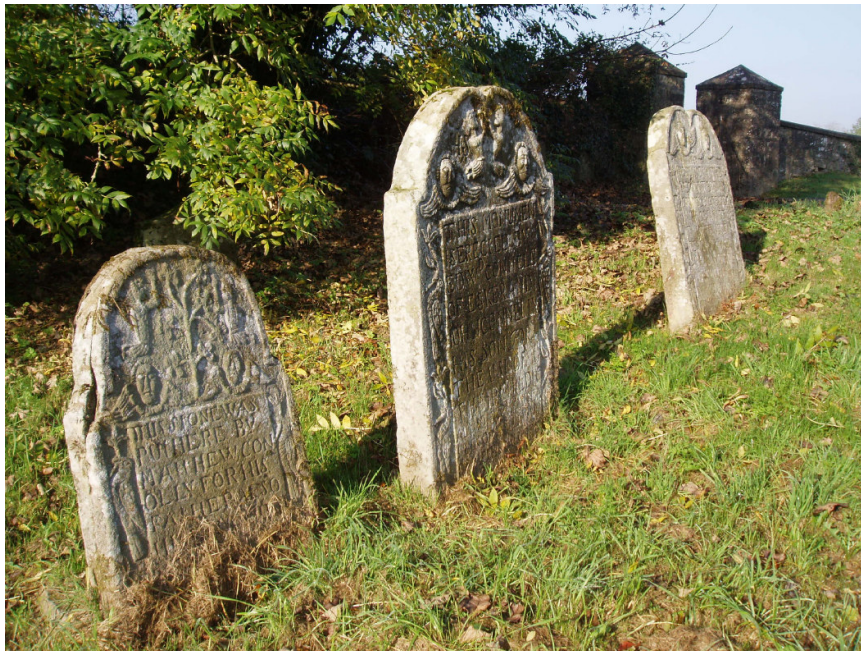
Fig. 23 Most gravestones are in good order

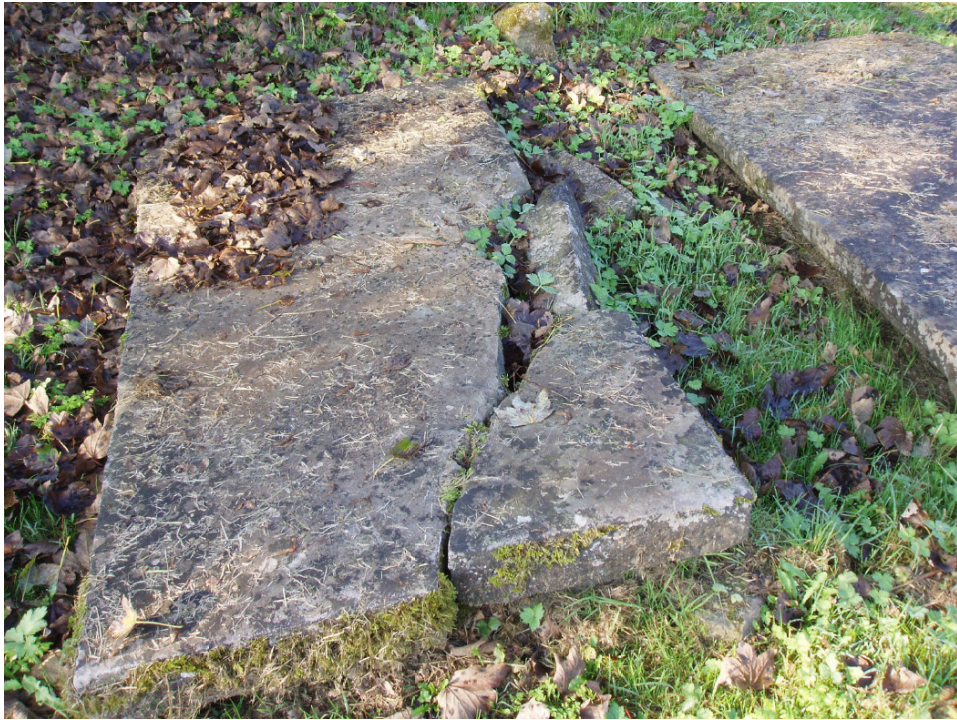
The majority of the gravestones appear to be in good repair and are easily accessible (**Fig. 23**). Some, however, have sustained damage in antiquity, and this is especially true of some of the grave slabs (**Fig. 24**). Whilst this damage is unfortunate, repairs would be expensive and they are consequently thought to be unnecessary at this time.

Fig. 24 Some of the grave slabs have been broken

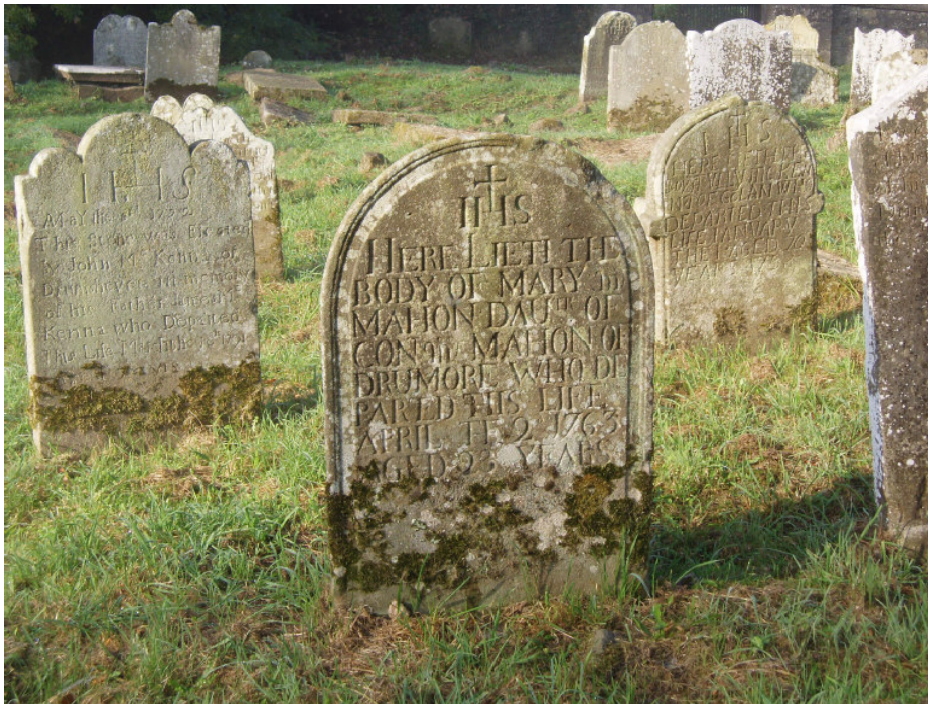
Despite the temptation, there appears to be no need to right any of the fallen grave-markers. The effects of time and weathering are a key characteristic of graveyards, and suit their character of gentle decay. Gravestones should not be raised or straightened, unless by doing so their structural integrity can be stabilised, and they should not be cleaned. Moss and lichen also add to the character of graveyards (**Fig. 25**), and here do not appear to be obscuring

Fig. 25 Moss and lichen cover some of the gravestones. Expert advice should be sought on whether this will eventually cause damage to the stonework

- Action: monitor inscriptions (possibly because they have already been removed to aid recording). Some lichens damage stonework, and it might be beneficial to consult a lichenologist to ascertain whether the Errigal lichens are benign or not. Mosses are generally sympathetic to gravestones and should only be removed if there is clear evidence that the growths are having a detrimental effect on the integrity of the stone.

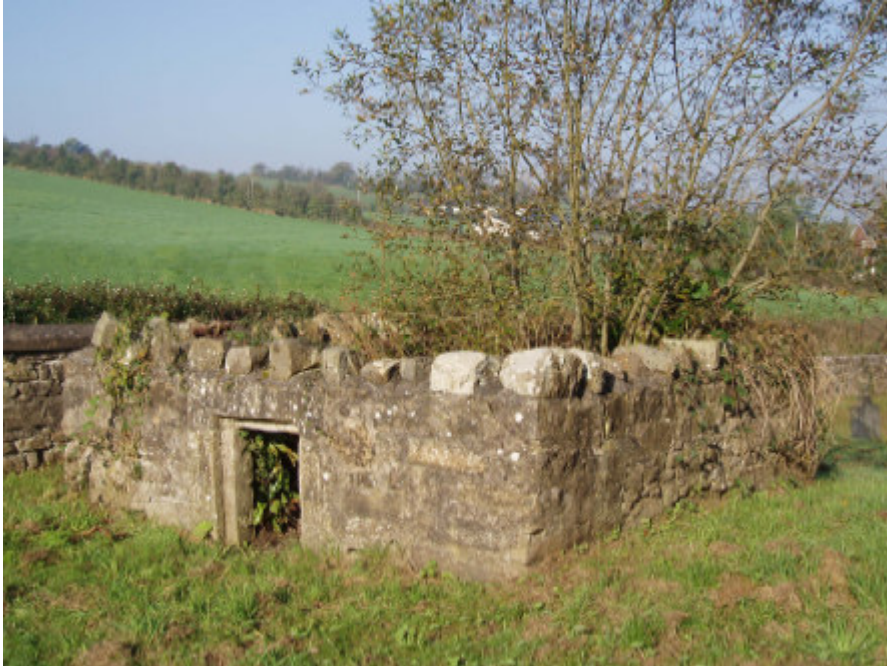
Fig. 26 The Sweeny enclosure. This has an inscribed doorway lintel which reads 'Arise ye dead and come to Judgement'. Rebuilt in 1980

- Action 26
 The Sweeny enclosure was rebuilt in 1980. It is not known whether its freestone crenellations were an original feature, although they appear out of character, and have been attached with an unsympathetic cement (**Fig. 26**). The 'small bush' noted in the 1996 Errigal Trough Development Plan is now sizeable, and needs careful removal immediately. The undergrowth within the enclosure (**Fig. 27**) also needs careful removal and, after careful inspection by an archaeologist, any loose and undecorated rubble removed for storage elsewhere.

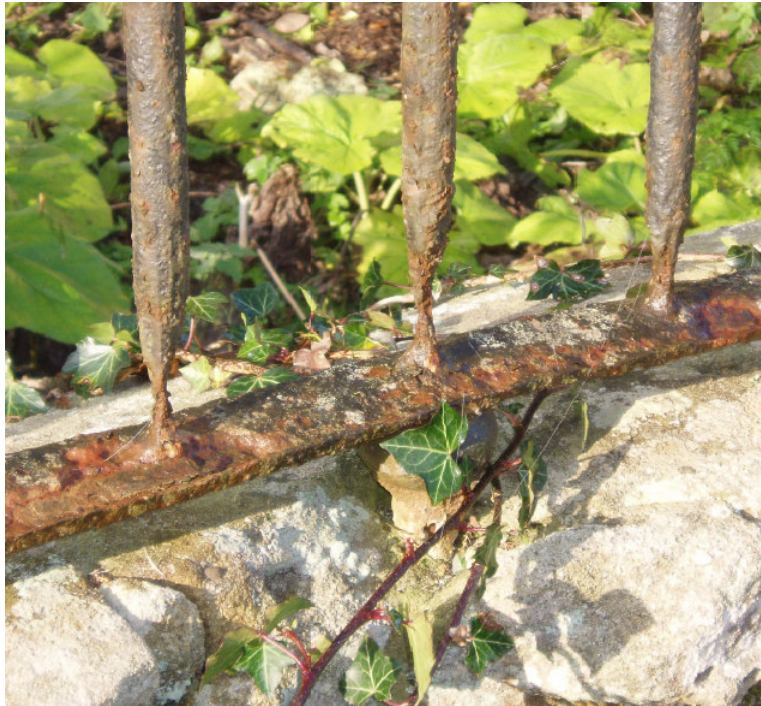
- The cast ironwork to the various family enclosures is an important part of their character. Unfortunately it is in the main in poor condition and now in need of urgent remedial work. Some of the railing uprights around the Anketell plot, and their finials, are damaged or missing. However, these omissions, although regrettable, do not overly detract from the sense of enclosure that the railings are designed to impart, and it is not necessary at this time to replace them.

Fig. 30 Detail showing the extent of corrosion to the railings around the Anketell plot

- Action 28 What is necessary is some urgent remedial conservation work, as follows;
- (i) Wire brush off flaking paint and surface rust and treat with proprietary rust-killer.

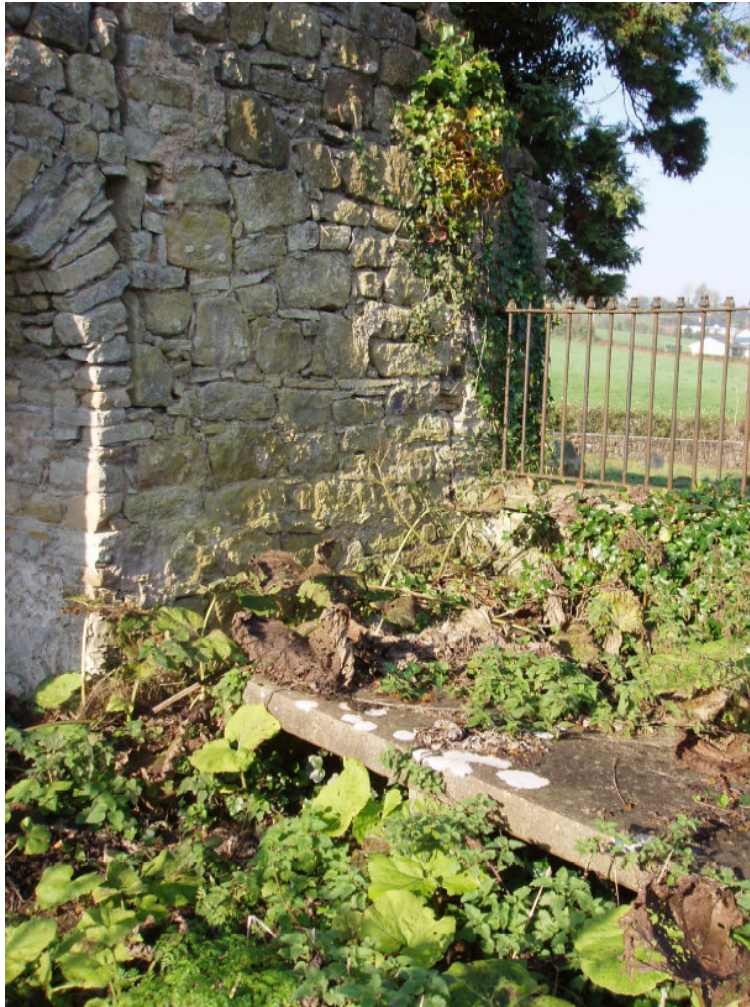
Fig. 31 The interior of the Anketell plot is overgrown and needs clearing

- Action 30 The interior of the plot is overgrown, and needs clearance (**Fig. 31**). During the clearance any stonework (such as missing copings) or architectural ironwork (such as the heads of the railing uprights) should be removed and carefully stored elsewhere on the site for later re-use.

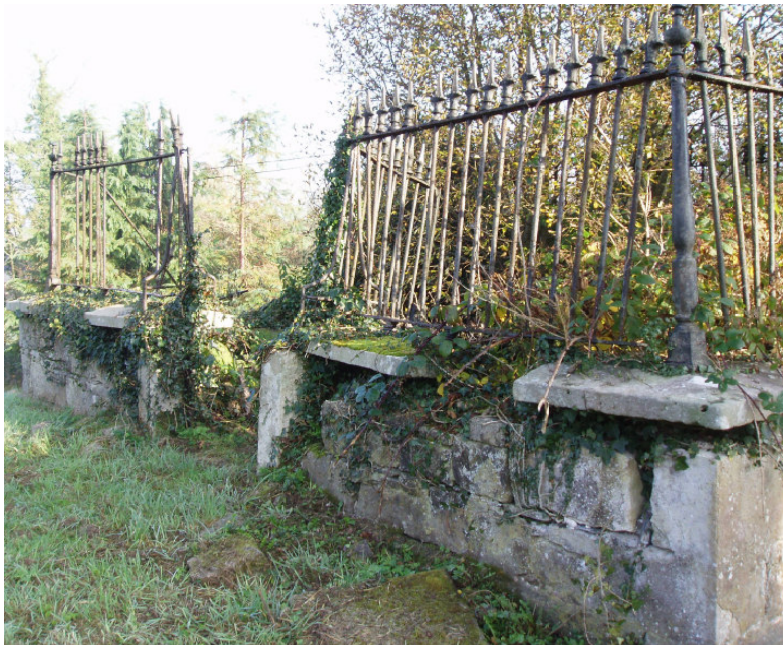
This free-standing plot is in a generally poor state of repair. The railings are in disarray, their supporting dwarf wall has collapsed in several places and the interior is overgrown (**Figs 33 and 34**).

Fig. 33 The Singleton plot

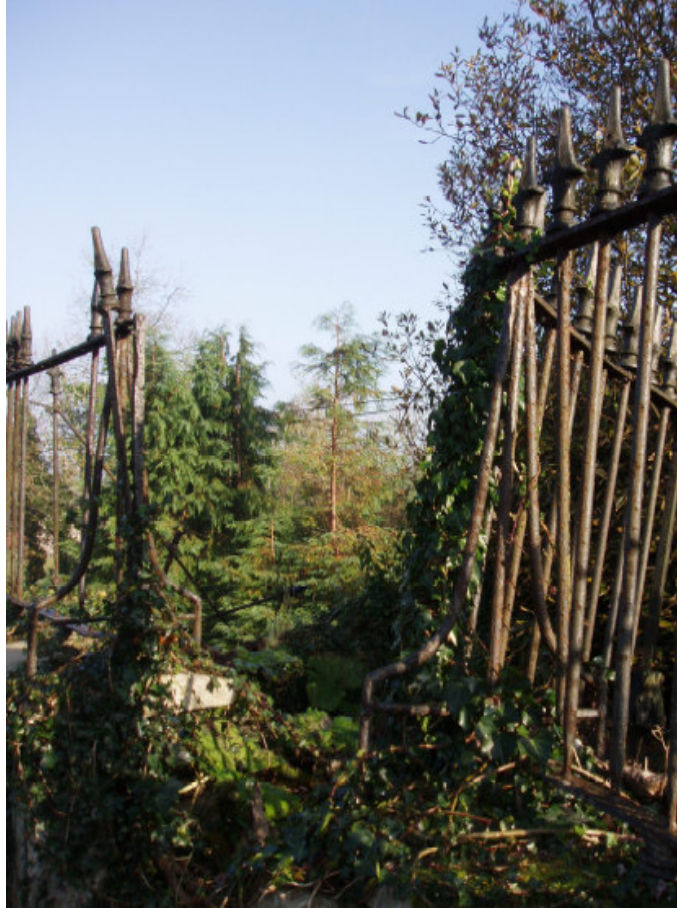
Fig. 34 The railings around the Singleton plot are in a state of disarray

- Action 39 The condition of the railings and gate is problematic. They need to be dismantled to effect proper repairs to their support wall, but also need substantial renovation work in their own right. Sections, especially on the north elevation, appear to be missing, although they may lie hidden in undergrowth. It will be expensive to replace the missing sections, which are in cast iron and have decorative elements to patterns which foundries may no longer hold. Equally, however, they do contribute to the character of the enclosure, and it is not advisable to remove them from the site unless there is a programme in

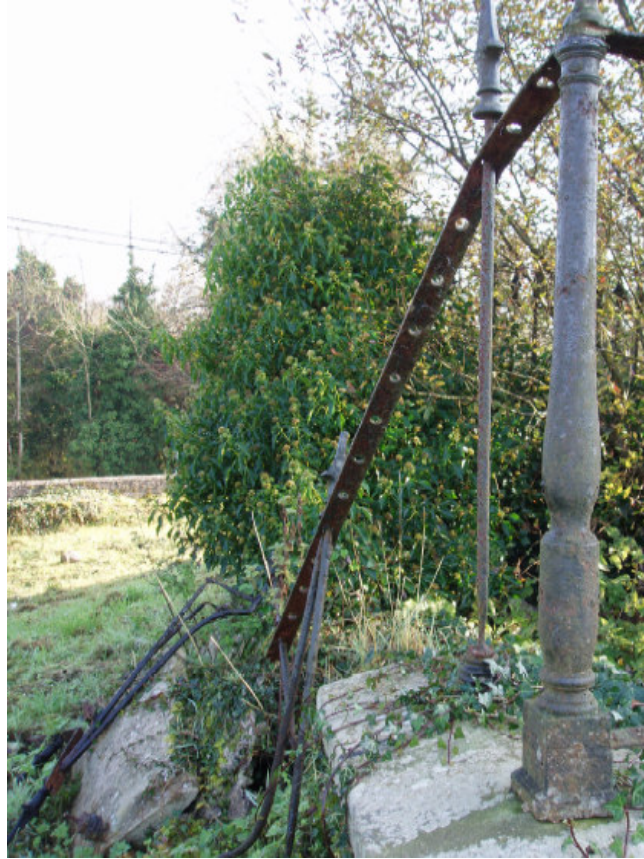
Fig. 35 The north wall of the Singleton plot has collapsed and needs urgent remedial attention

- Action 38 The north and west walls need partial or total rebuilding (**Fig. 35**). This should be undertaken by removing all loose stonework (the position of which should have been recorded by a professional before the work commences) and rebuilding it using the same mortar-type as the original. The copings, where available, should be reset. Initial undergrowth clearance may reveal some of the stonework which appears to be missing.

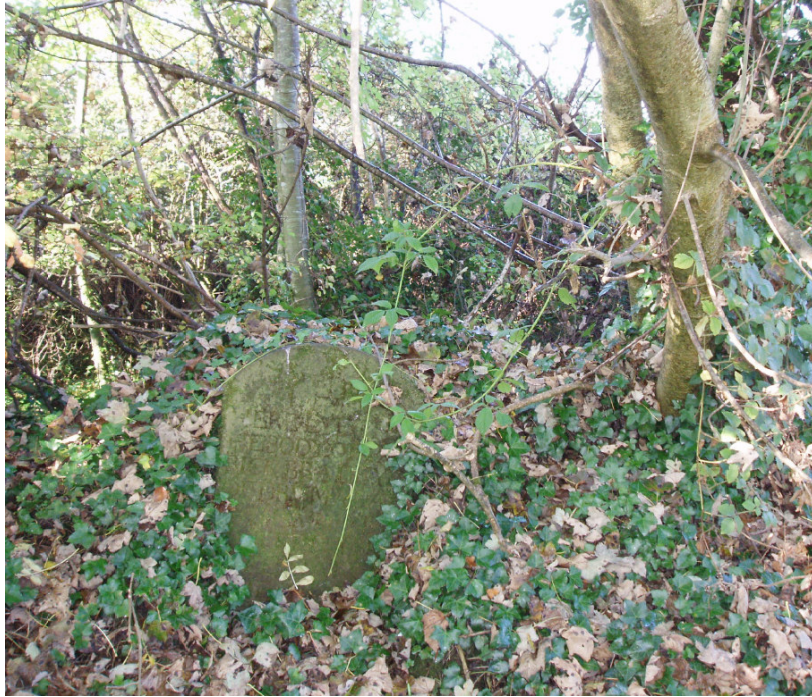
Fig. 36 The south-western boundary wall has collapsed

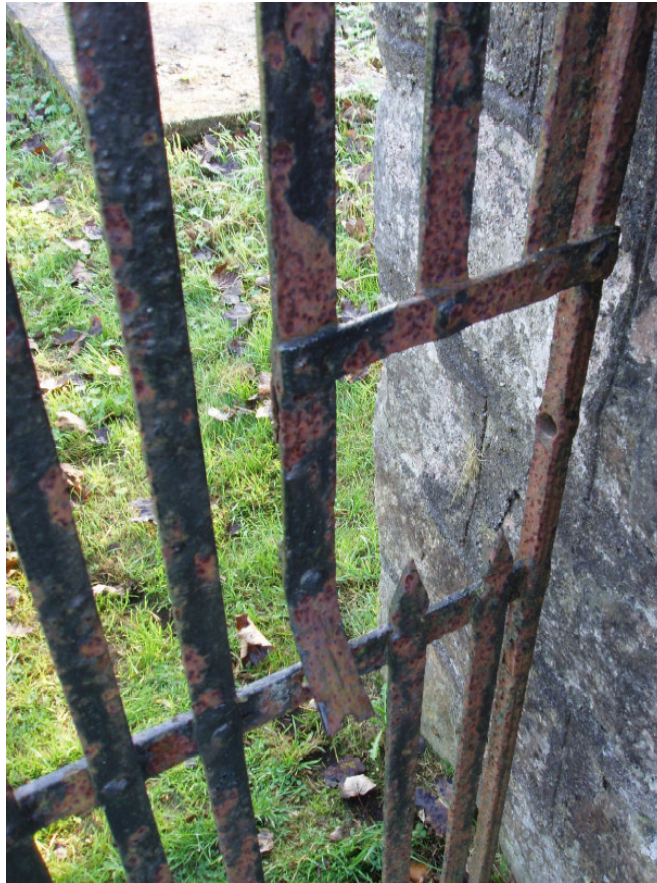
Fig. 37 The main gate into the graveyard needs refurbishing

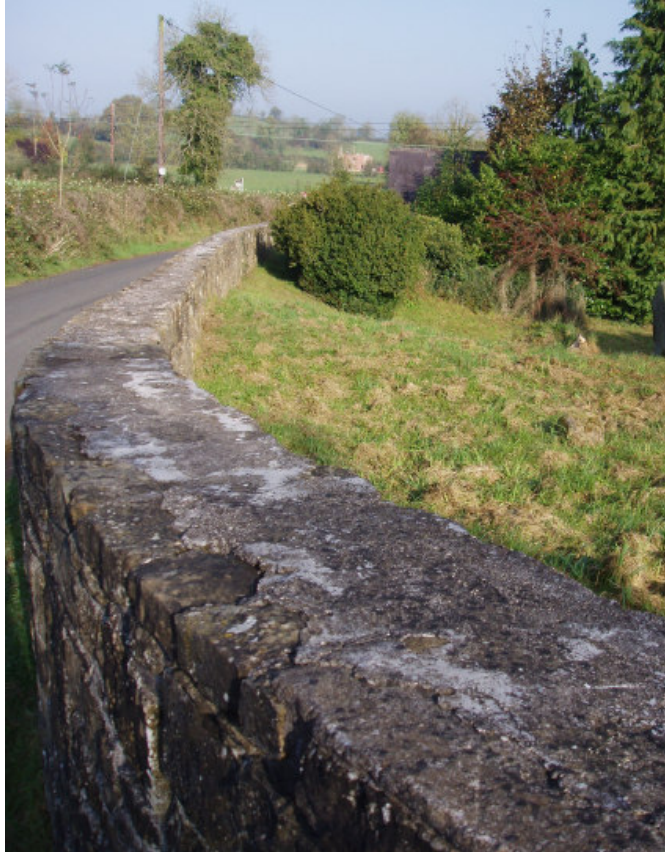
Fig. 39 The coping from the wall is missing and should be replaced

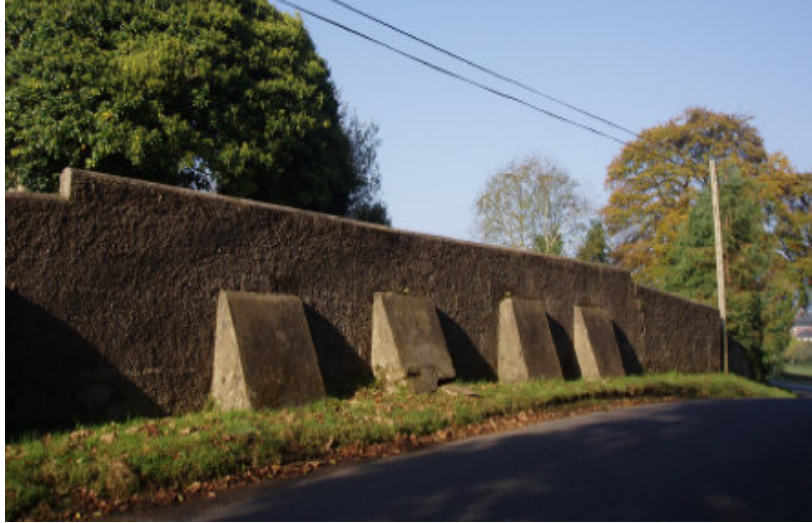
Fig. 41 The east wall of the graveyard has had buttresses added in an effort to retain the wall

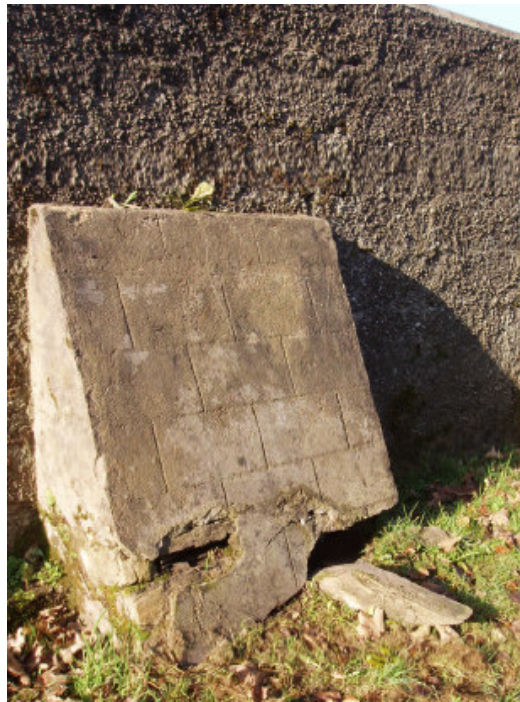
Fig. 42 Detail of the buttress which requires attention. An inspection of the existing walls foundations should be undertaken prior to specifying what actions regarding any future buttressing works to the wall are required

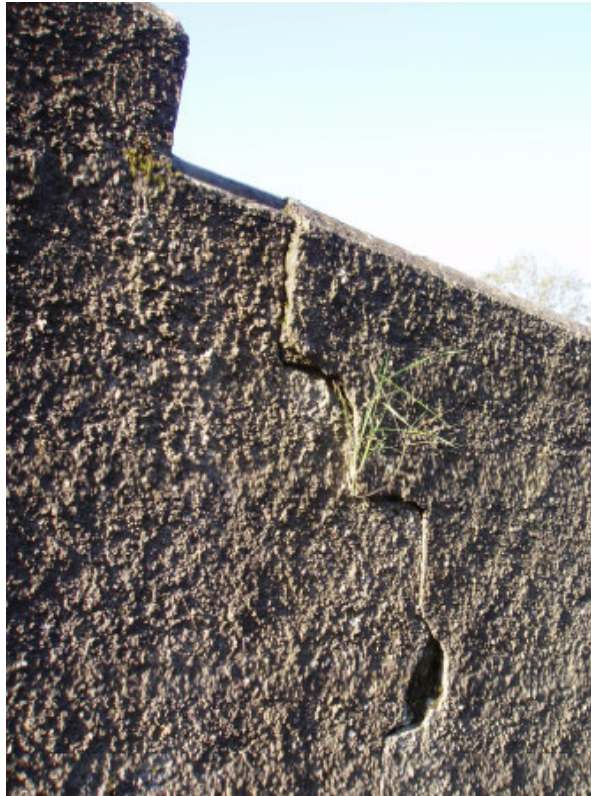
Fig. 43 There is movement in the east wall of the graveyard. The cause of the crack needs to be ascertained to confirm what measures need to be instigated in the future to prevent further damage to the wall. Structural Report on wall recommended

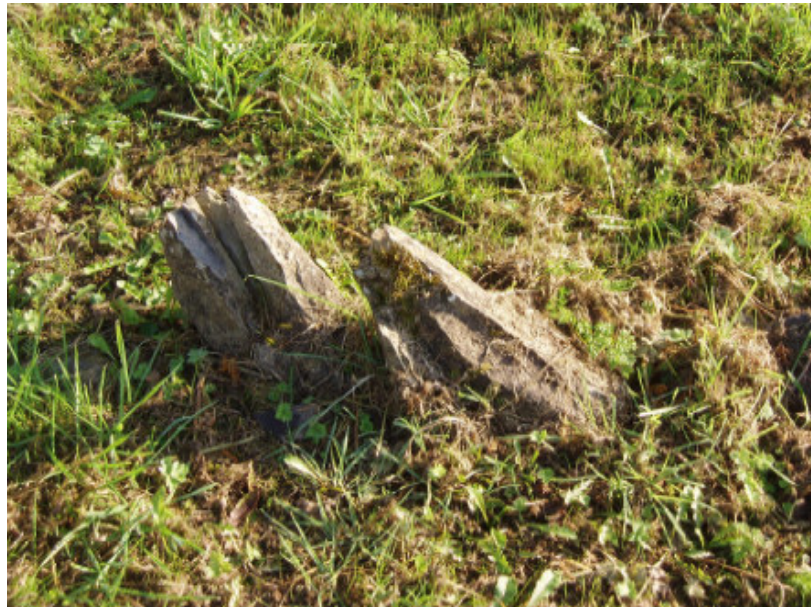
Fig. 44 Trip hazard. These stones, the base of damaged grave-markers, should be left *in situ*
