Report No. 14537.R02

November 2007

## MAGHEROSS, CARRICKMACROSS, CO MONAGHAN

### CONSERVATION MANAGEMENT STRATEGY

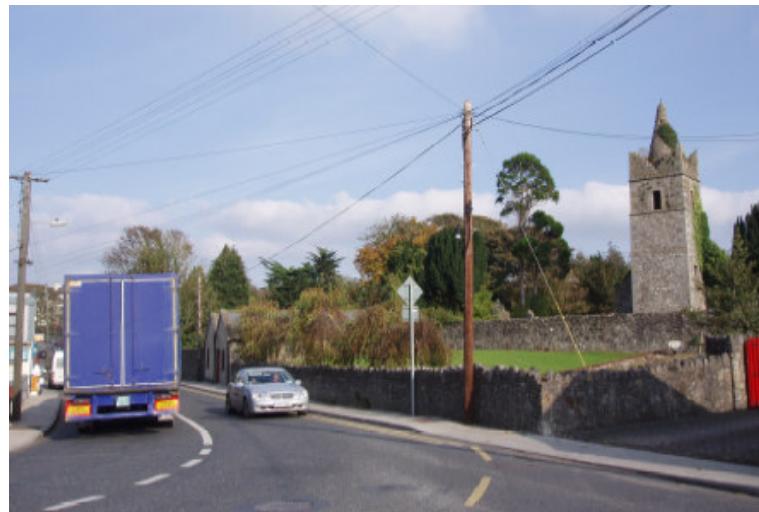
Fig. 7 The road outside the church is deceptively busy, and the setting of the church is marred by overhead telephone cables

- Action 3      The general setting of the church is marred by a profusion of overhead telephone wires (Fig. 7). If possible, the opportunity to replace these with underground cabling should be taken.

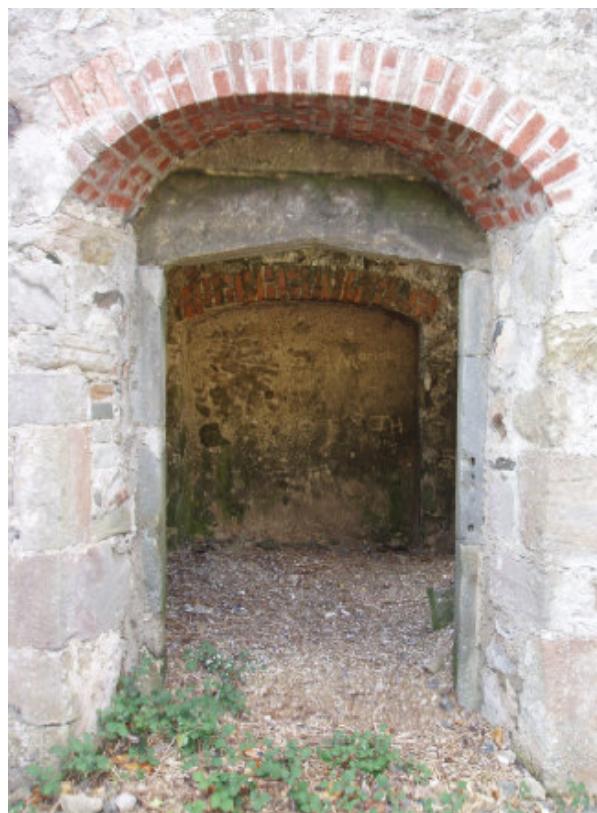
Fig. 10 The east door in the tower

- Action 10      The east door from the tower into the nave has been the subject of remediation works in the past (Fig. 10). Whilst this may have stabilised previously unstable masonry, the bricks are not in keeping with the historic fabric, and this type of repair is not recommended for any future works.

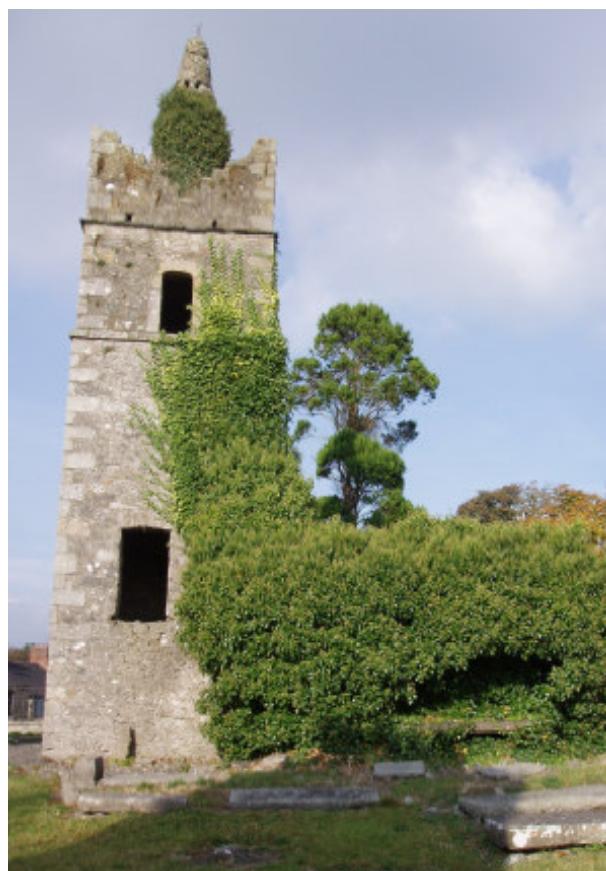
Fig. 12 Ivy covers the south wall of the church and is climbing the tower

Action 15 Removal of the ivy which covers the west part of the southern wall and is slowly covering the tower (Fig. 12). This should be removed under the same controlled conditions as detailed in Action 12.

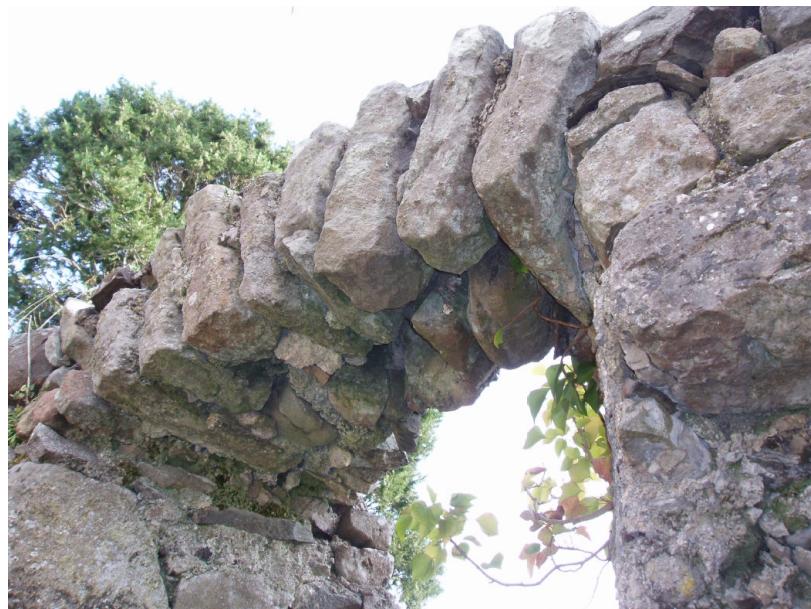
Fig. 14 Detail of the south-east window of the nave, showing the precarious nature of the lintel

Action 17 The window in the eastern end of the south wall (Figs 14 and 15) needs some urgent remediation work to stabilise large cracks in its jambs, and a potentially unsafe arch. The cracks should be stabilised by inserting three or more pins at 600mm centres, and repointing. The arch should have any gaps refilled with stone (preferably stone lying around the base of the wall) and repointed in a lime-based mortar. Once this is complete the top of the arch should be capped with mortar to prevent further weather incursion.

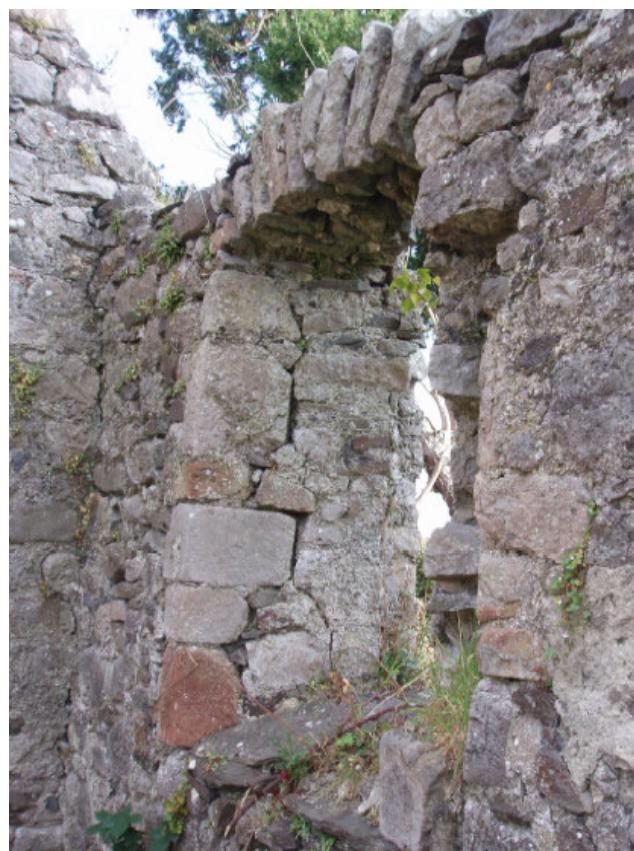
Fig. 15 The south-eastern window in the nave, showing the extent of cracking in the wall

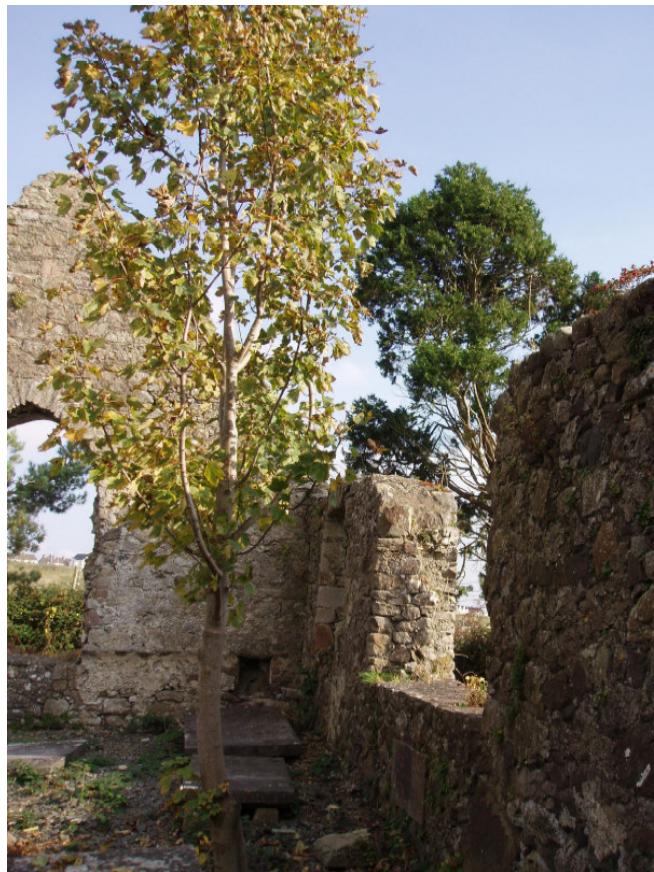
Fig. 16 A tree within the nave needs removal before its roots damage surrounding fabric and underlying archaeological deposits

Action 18 A tree is growing in the nave adjacent to the south wall (Fig. 16). This should be carefully removed by a tree surgeon because its roots will eventually damage the wall and underlying archaeological deposits.

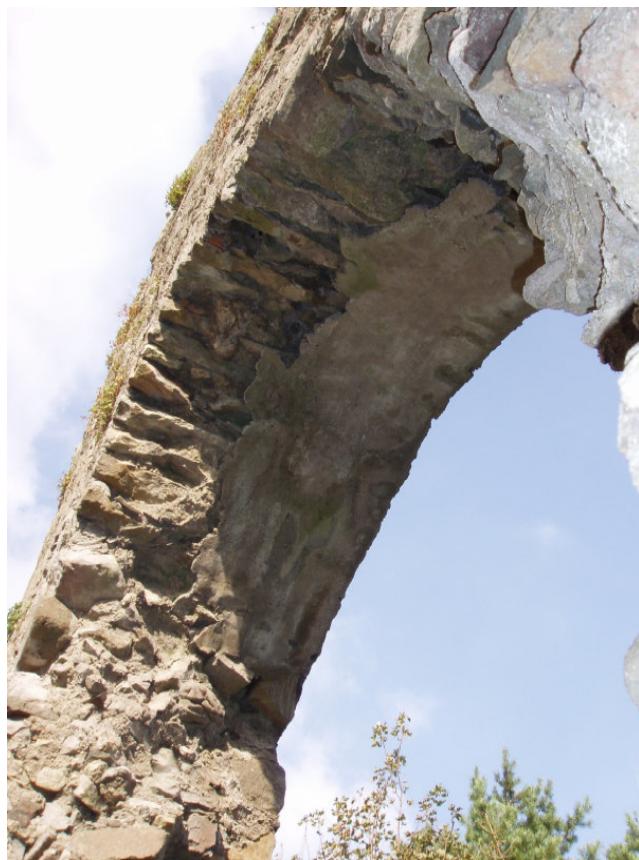
Fig. 17 The underside of the main nave window

Action 19 The window in the eastern gable has at sometime in the past been repaired using cementitious mortar (Fig. 17) which is now beginning to delaminate from the window opening. This action should be monitored and, when appropriate, it should be removed and the window surround repointed using lime mortar. This should be done sensitively, with the aim of consolidation rather than restoration. The wall-top requires weather-proofing with lime mortar (Fig. 18).

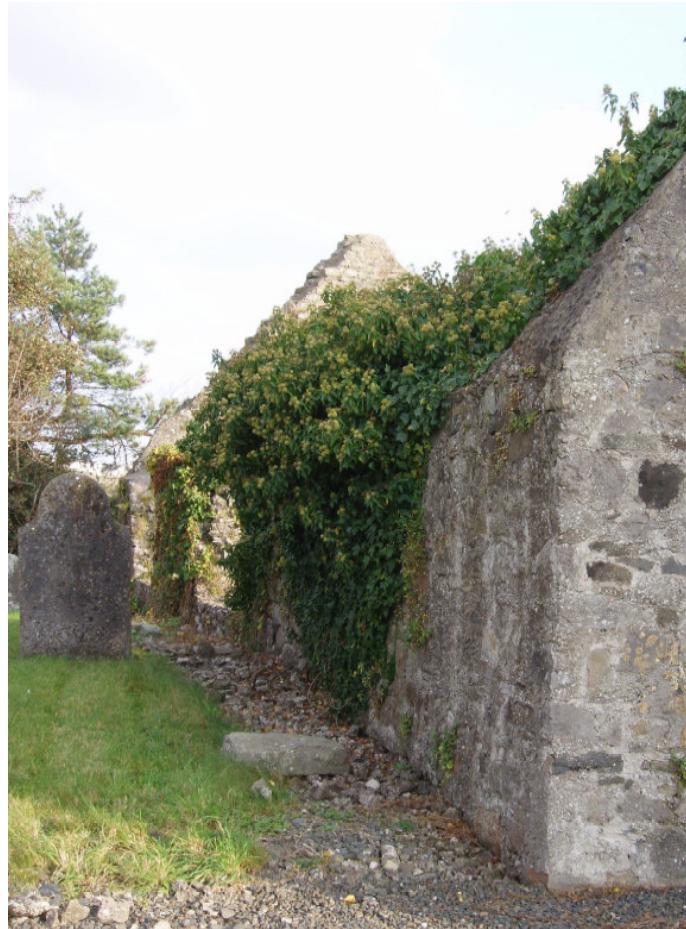
Fig. 19 The north wall of the nave needs its ivy removing

Removal of the ivy from the church walls should only begin when funds and a timetable are in place to conserve the fabric that will be exposed. Once these are in place the roots should be cut at ground level and the plant allowed to die back (this process can be accelerated using suitable herbicides). Once dead, the ivy should be removed from the top downwards, and the fabric which is exposed conserved at the same time. Conservation should concentrate on sensitive and agreed re-pointing with a lime-based mortar, thus stabilising any loose masonry.

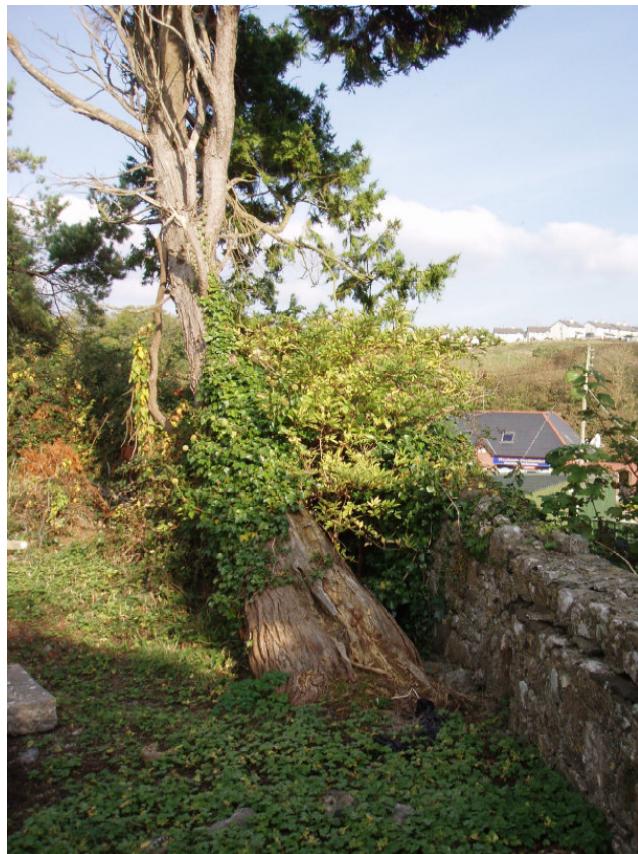
Fig. 22 This yew tree is damaged, and has the potential to destabilise the adjacent wall

Falling branches and trees are a hazard to the public and monuments alike. Furthermore, the trees along the north-eastern boundary wall are likely to eventually undermine and destabilise the boundary wall. A yew tree against the south-eastern boundary (Fig. 22), where the enclosure wall is also a substantial retaining wall, shows signs of distress and is a serious potential hazard. Its removal requires urgent consideration.

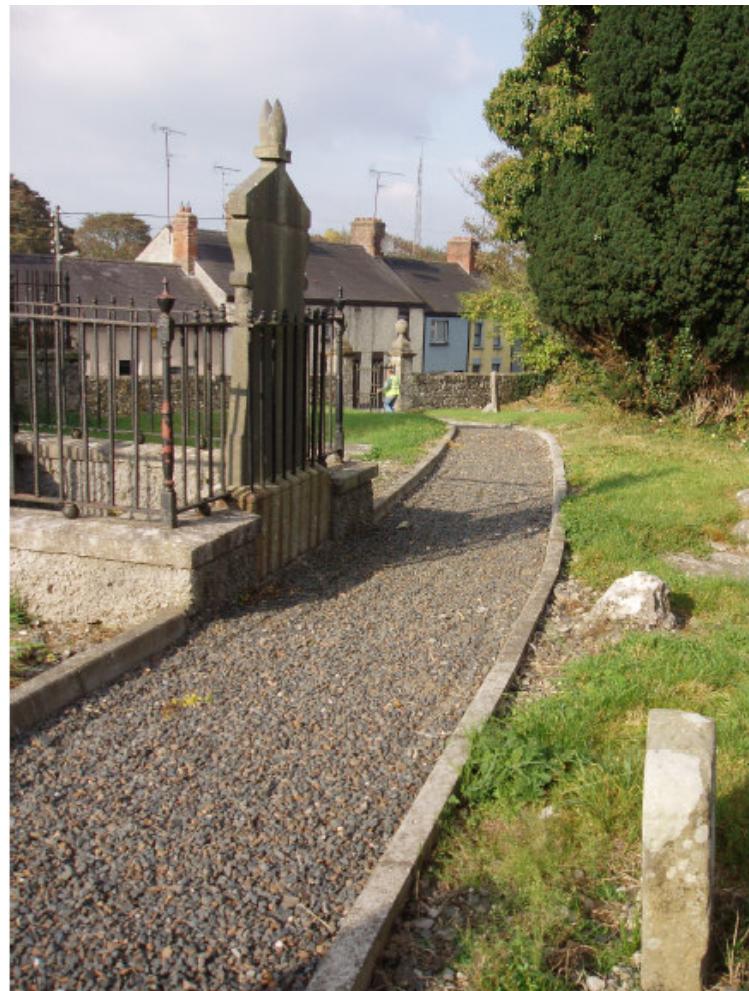
Fig. 23 Although a surfaced path is sympathetic to the church's urban setting, the concrete kerbstones are out of keeping

Access from the road to the church is via a graveled path which is in keeping with the urban setting of the church (Fig. 23). However, the use of concrete kerbing is at odds with the historic character of the site and should, when it is appropriate, be replaced with stone kerbing or removed altogether. Around the rest of the churchyard there is no need for paths, although if pedestrian traffic increases sufficiently, natural paths will in any case develop, and on routes that have found to be most suitable.

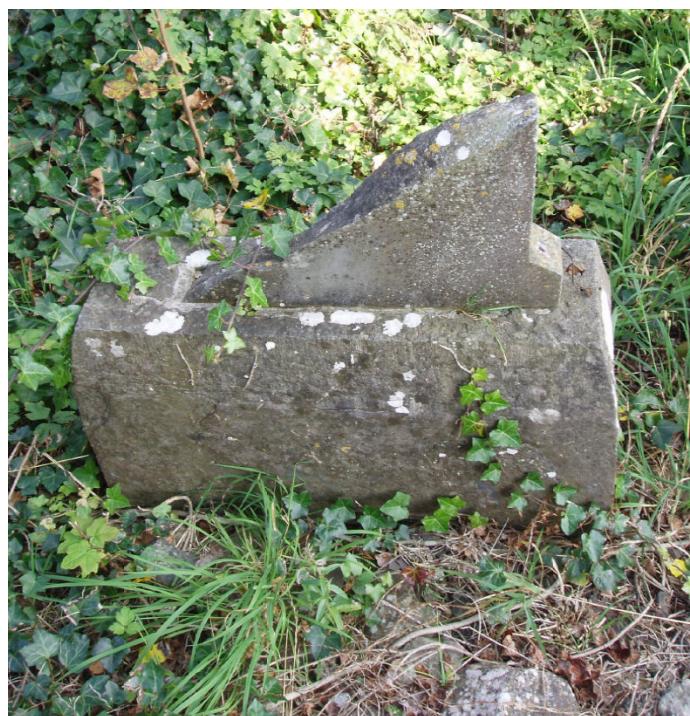
The majority of the gravestones appear to be in good repair and are easily accessible (Fig. 24). Some, however, have sustained damage in antiquity, and this is especially true of some of the grave slabs (Figs 25 and 26). Whilst this damage is unfortunate, repairs would be expensive and they are consequently thought to be unnecessary at this time.

Fig. 25 Some of the grave markers have sustained significant damage

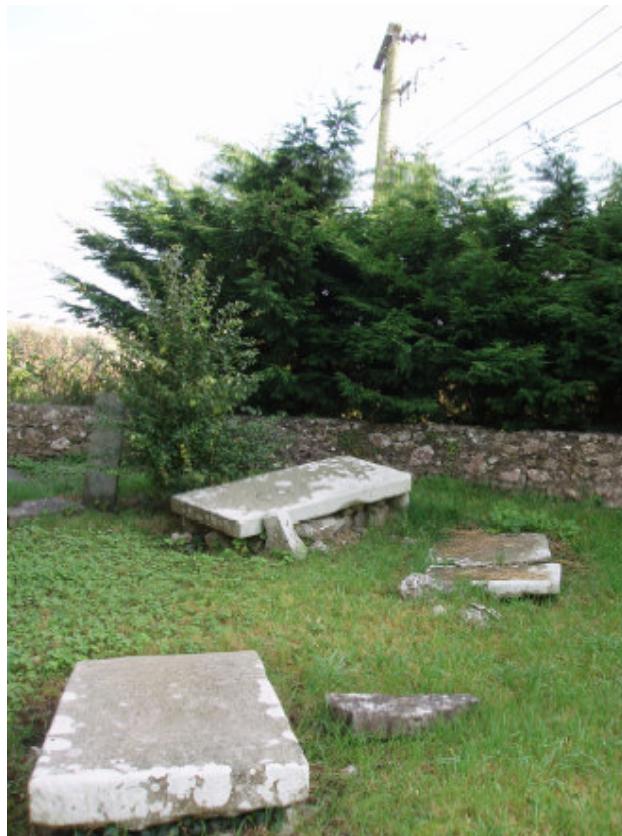
Fig. 26 Table-slabs in the south-eastern corner of the graveyard have sustained damage

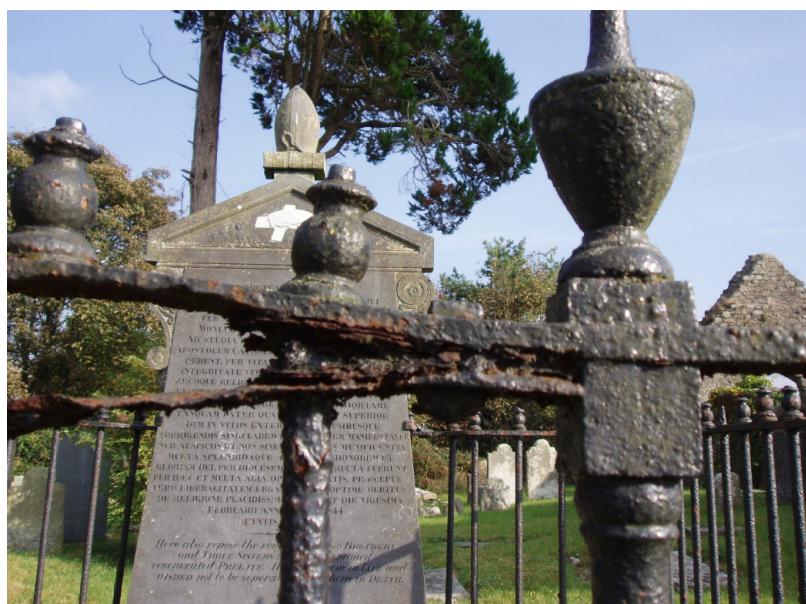
The ironwork to the various family enclosures is an important part of their character. Unfortunately it is in the main in poor condition, and in need of remedial work (Fig. 29), or is missing entirely (Fig. 30).
Action 29	<p>The condition of the railings and gate is problematic. They would need to be dismantled to effect proper repairs to their support walls, but also need substantial renovation work in their own right. It is important to note that sections which appear to be missing may be lie hidden in undergrowth. If not, it will be expensive to replace the missing sections, which are generally in cast or wrought iron and often have decorative elements to patterns which foundries may no longer hold. Equally, however, they do much to contribute to the character of the enclosure, and it is not advisable to remove them from the site unless there is a programme in place to return them quickly. (We do not recommend removal from the site of any fabric unless there is a clearly identified return date because of the potential for artefacts to become lost). It may also not be advisable to replace suitably renovated sections unless a complete circuit can be attained, because of structural integrity issues.</p> <p>The optimum solution is therefore to renovate and conserve the railings, and to replace their missing sections with newly-cast or fabricated sections to the original patterns, before restoring them to their original positions.</p> <p>However, since replacement would be a costly exercise it may have to be deferred. What is necessary at this time is some urgent remedial conservation work, as follows;</p> <ul style="list-style-type: none"> <li>• Wire brush off flaking paint and surface rust and treat with proprietary rust-killer.</li> <li>• Paint with a micaceous iron-oxide build coat</li> <li>• Finish with two coats of black gloss.</li> </ul> <p>It is unlikely that the railings were treated to decorative paintwork when they were installed, and the temptation to do so now should be resisted.</p> <p>Over time, the base of the uprights, which are in a much corroded condition, will rot out, and at this time the railings will need to be removed and renovated.</p>

Fig. 29 Much of the ironwork encircling the enclosures is in poor condition

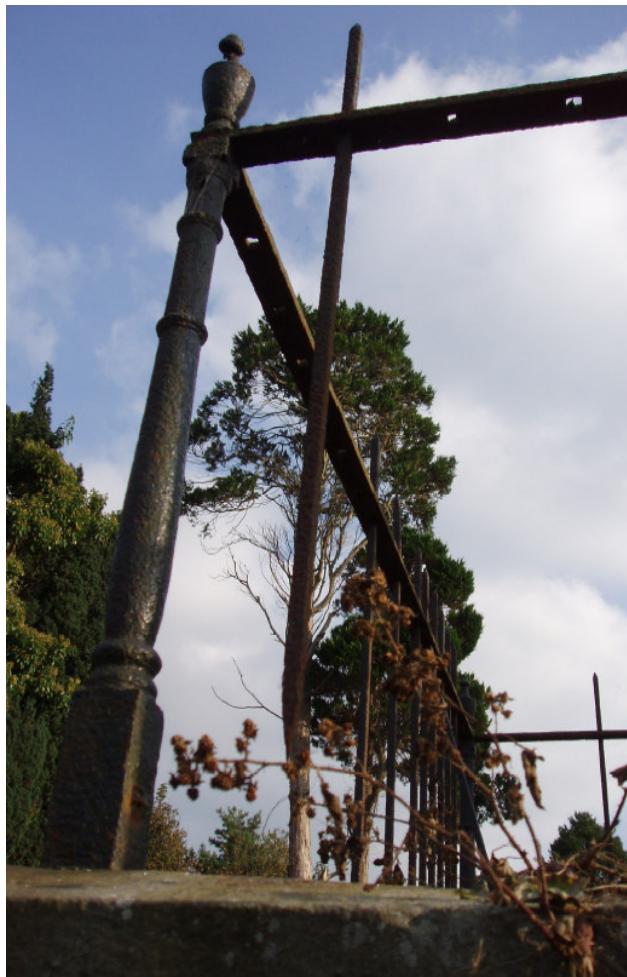
Fig. 30 Some of the railings around the enclosures are missing

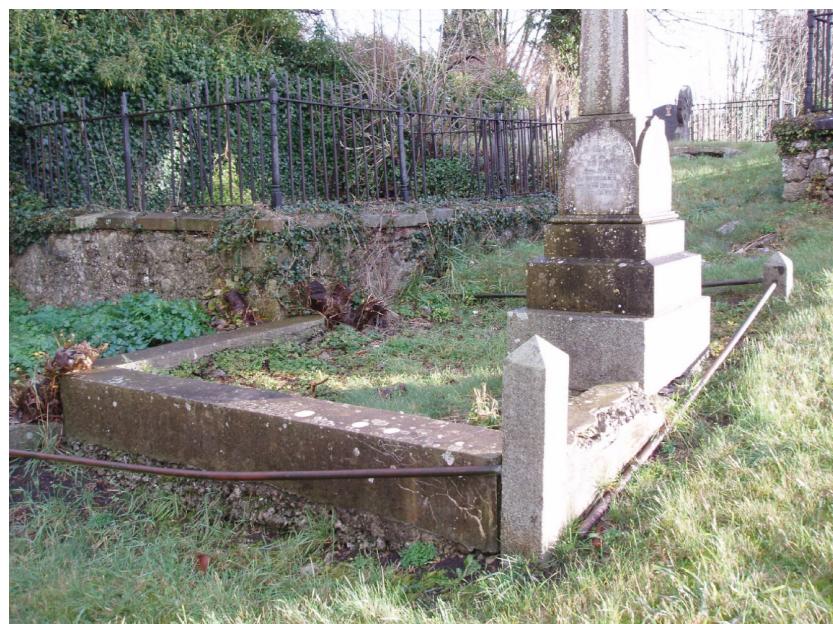
Fig. 31 Enclosure 1

This simple enclosure (Fig. 31) comprises a monument (in good repair) surrounded by a dwarf wall. Modern poles act as simple railings. These are in disrepair and could be removed from the site as they contribute little to the original design intent. One of the corner posts has been displaced by a tree trunk which has now been reduced to ground level (Fig. 32; this is one of two trees that have caused damage to the monument). The corner post should be replaced once the tree stump has been removed, although care is required if this is to be done sympathetically. Minor conservation repairs to the dwarf walls are also required.

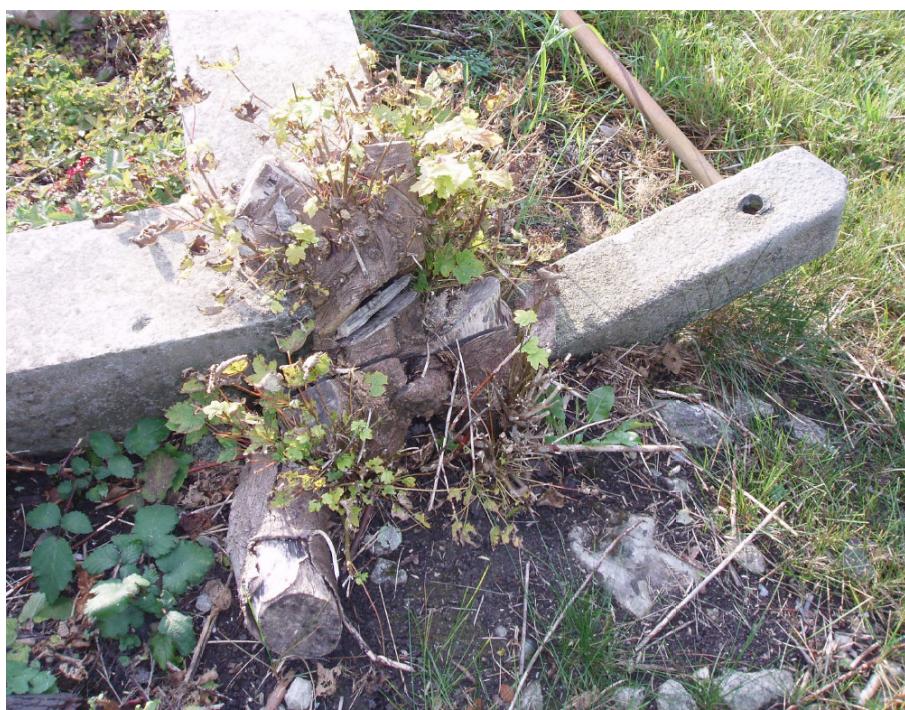
Fig. 32 Detail of the damaged corner post to Enclosure 1

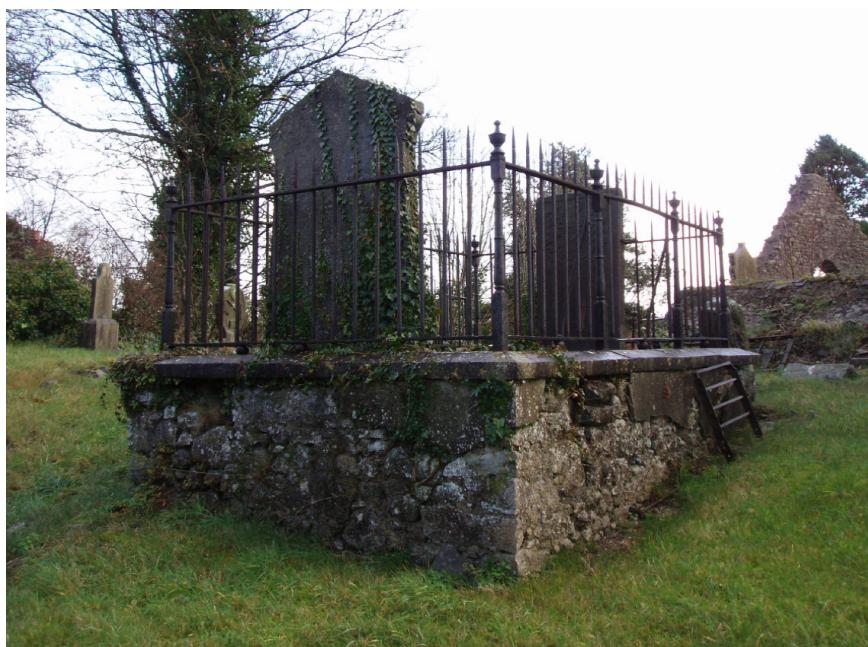
Fig. 34 Enclosure 3

This enclosure comprises a dwarf wall (in some areas rendered) topped by iron railings and containing three grave markers (Fig. 34). Its iron gate has become separated from the railings and now lies against the dwarf wall. This should be removed for safe-keeping. The remaining railings should be painted and conservation repairs conducted to some areas of the wall where stones have fallen away. As with all other repairs, the replacement stonework should be sourced from within the graveyard if possible, and should be set in a lime-based mortar. Otherwise, little conservation work is required, although the development of undergrowth within the enclosure should be kept in check and consideration should be given to removal of the remaining render, which is in poor condition.

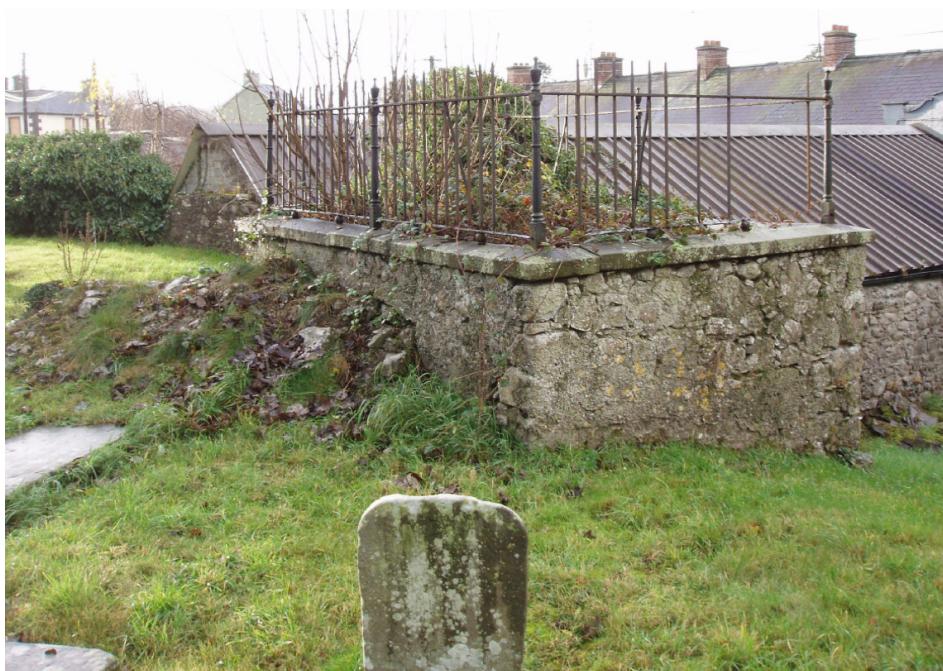
Enclosure 4 is situated against the corner of the workshop which lies to the west of the site. It is distinguished by its short, curved, corbelled access tunnel, the opening to which has been broken into in the recent past (Figs 35 and 36). This presents a public health and safety hazard and should be blocked off in a sensitive and appropriate manner, perhaps using masonry set in lime mortar.

Fig. 35 Enclosure 4, with its corbelled entrance to the underground vault situated to the left of the picture

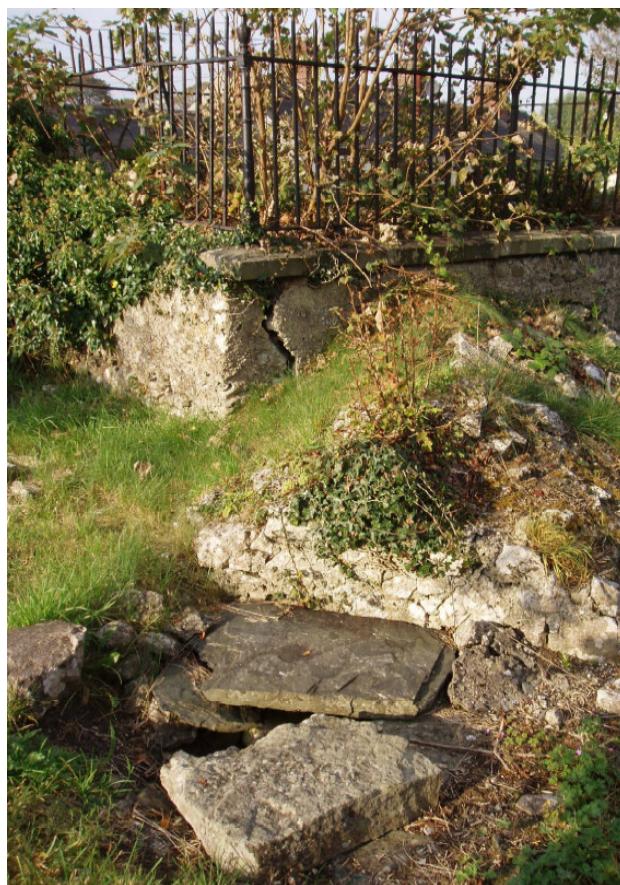
A crack has developed in the south-eastern corner of the dwarf wall of this enclosure (Fig. 36). This needs stabilising by resin-grouting ties into pre-cut slots, prior to repointing in the manner outlined above.

Fig. 36 The entrance to the crypt passage. In Enclosure 4

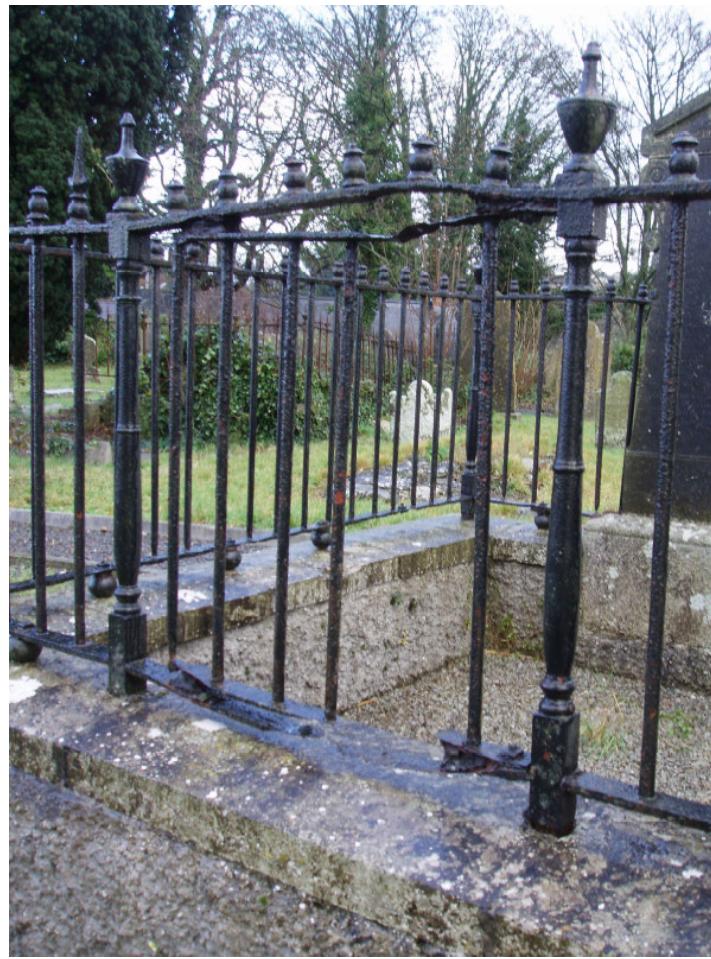
Enclosure 5 (Fig. 37) is generally in a state of good repair, possibly because it is the burial place of a Bishop of Clogher, Edward Kiernan. The need for immediate conservation work is limited to painting of the railings and very minor repairs to the dwarf walls that support them. In the longer term, attention will need to be paid to the gate into the enclosure, and its supporting ironwork, since these are in very poor condition (Fig. 38).

Fig. 38 The gate into Enclosure 5 is in very poor condition

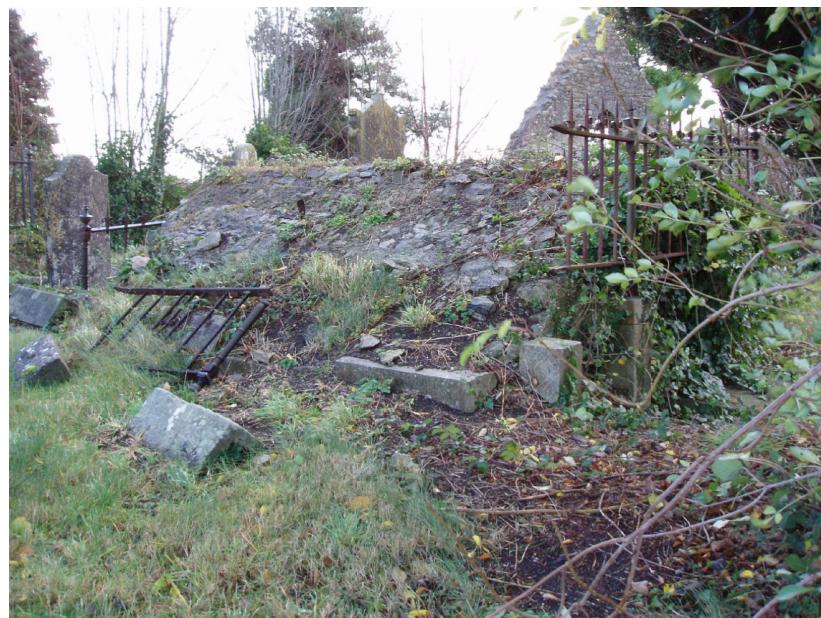
Fig. 39 Enclosure 6, looking south

Enclosure 6 is in a poor state of repair (Figs 39 and 40) which is unfortunate because it is the sole example of its type in the graveyard. The enclosure comprises a mortared stone tomb set in a double pitch and originally surrounded by railings set in a dwarf wall. These railings are now in such a poor state of repair (and, indeed, are missing along several stretches) that consideration should be given to their removal and safe storage elsewhere. The dwarf wall is in a similar state of disrepair, as is the entrance, which is set into the east-facing 'gable'. Conservation work to the dwarf wall and the entrance is an urgent requirement, as is removal of the undergrowth, the roots of which are destabilising the tomb roof.

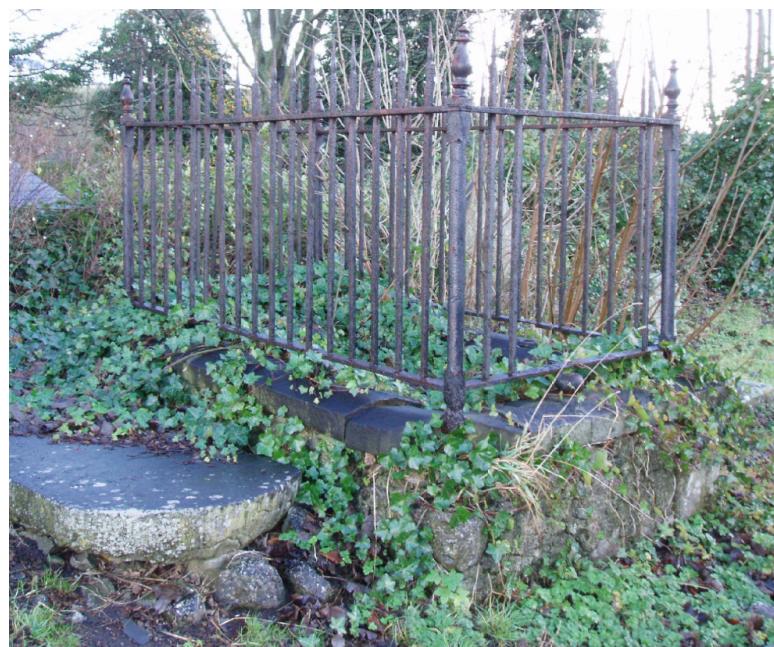
Fig. 41 Enclosure 7, looking south-east

This small enclosure is set against the east wall of the churchyard (Fig. 41). Although it is in generally good repair the gate through the railings which encircle it is missing, and the dwarf wall that supports the railings requires minor conservation works. Additionally, the interior, and the area surrounding the enclosure, needs its vegetation clearing. The railings needs cleaning and painting, and if the gate can be found and is in a good state of repair it should be remounted.

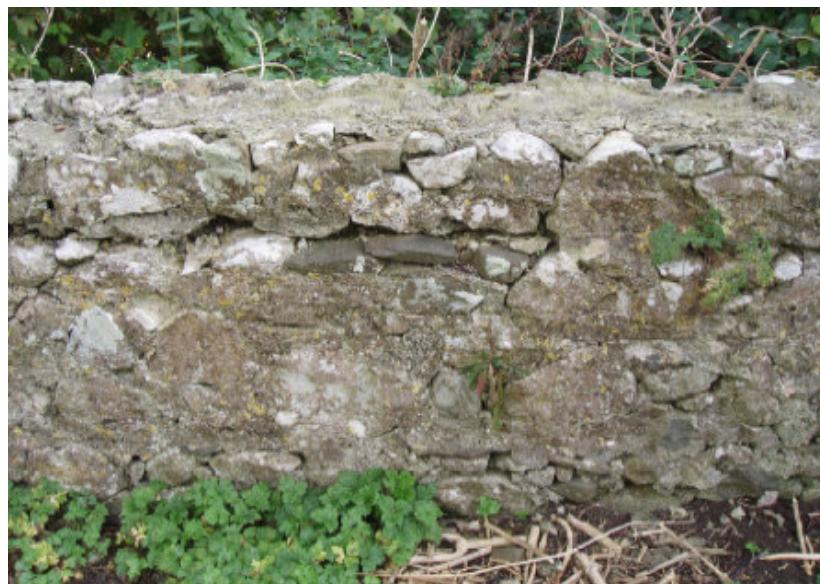
Fig. 44 Detail of the south wall

Few remedial works are necessary to this wall, which appears to be in generally good condition. However, some localised repointing in a lime-based mortar would be beneficial in areas where gaps have appeared (Fig. 44). Although the top of the wall has been capped with cement which should be left *in situ*, any

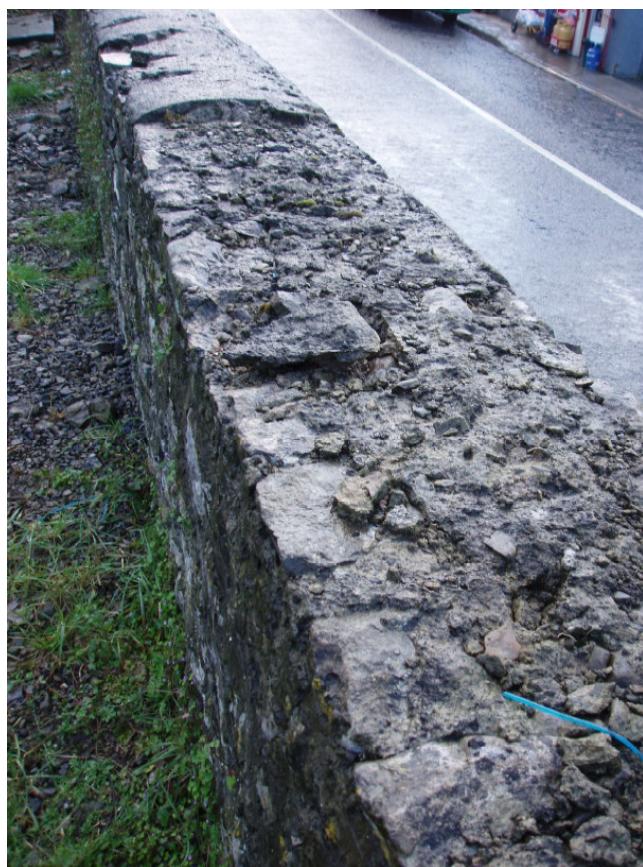
Fig. 45 Parts of the west wall of the graveyard need recapping with a lime-based mortar

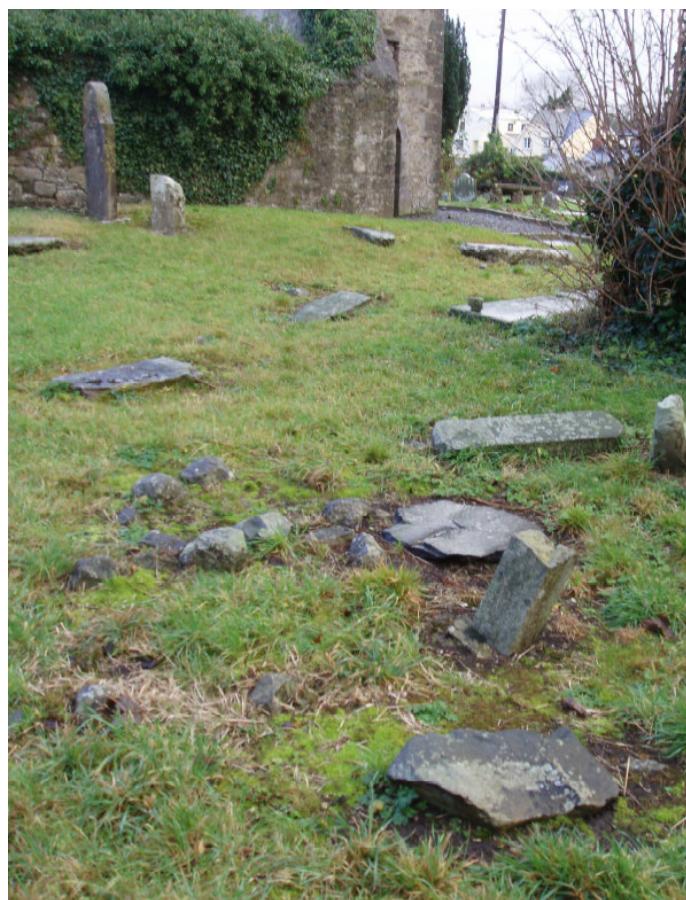
The masonry appears to be generally stable, but loose masonry on the ground might be cleared to prevent unnecessary trip hazards. Although most masonry is embedded in the ground (Fig. 48) and represents the bases of broken gravestones there are also quantities of loose stonework. The embedded stones should be left in place, but the loose stonework and rubble should be cleared away for re-use in the conservation work to the site's fabric.

Fig. 48 The graveyard is littered with loose and semi-embedded stones
