Temple Moyle, Lattonfasky, Co. Monaghan
Conservation Plan

Temple Moyle, Lattonfasky, Co. Monaghan Conservation Plan

Monuments: MO024-034001 Church & MO024-034002 Graveyard

Our Ref: 2021_53

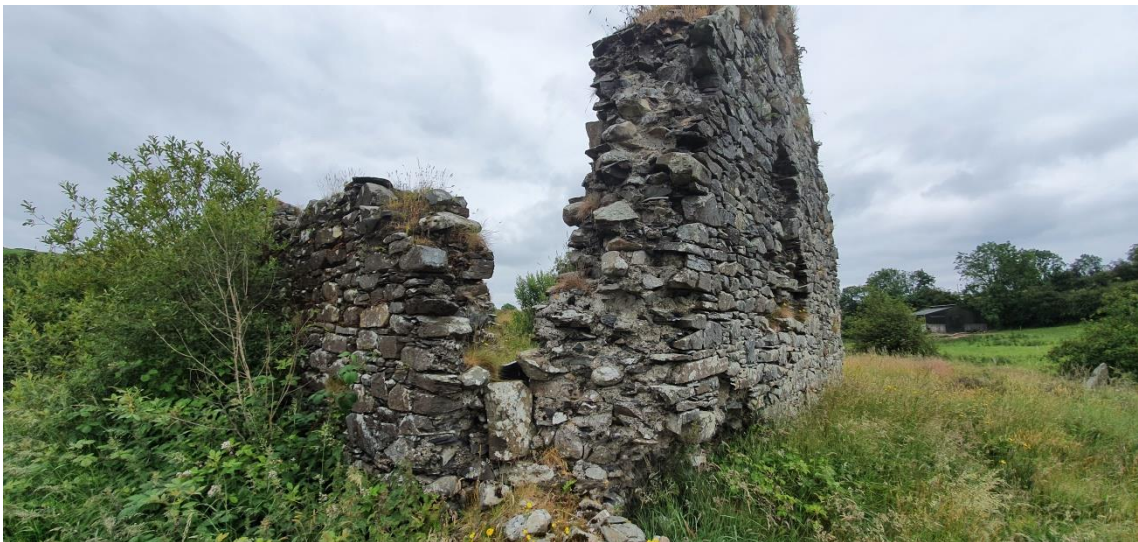
Plate 10: NW corner of Chapel, facing SE, showing collapse and brush overgrowth

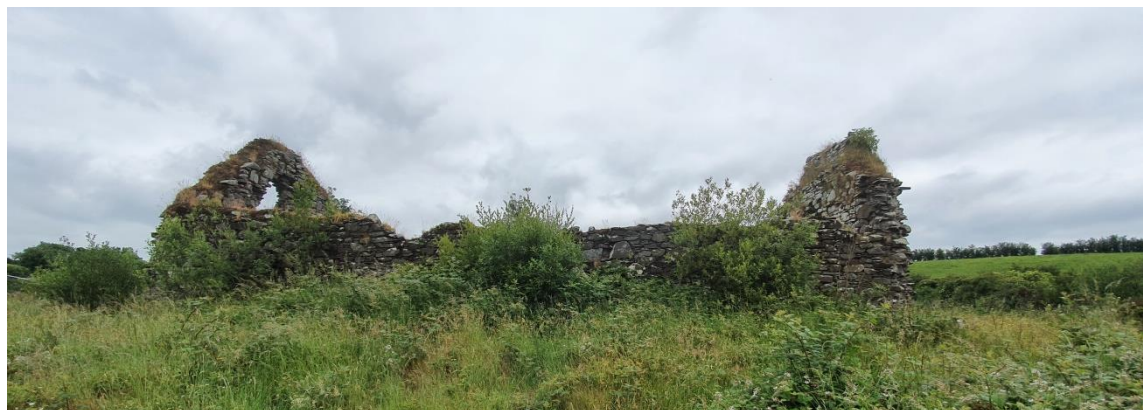
Plate 11: Northern face of chapel, facing S, showing overgrowth of brambles and shrubs, Facing S

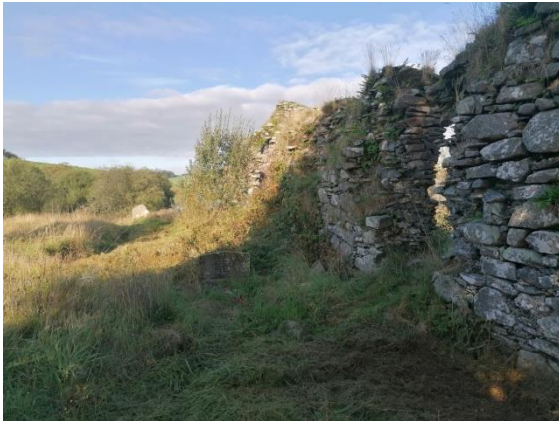
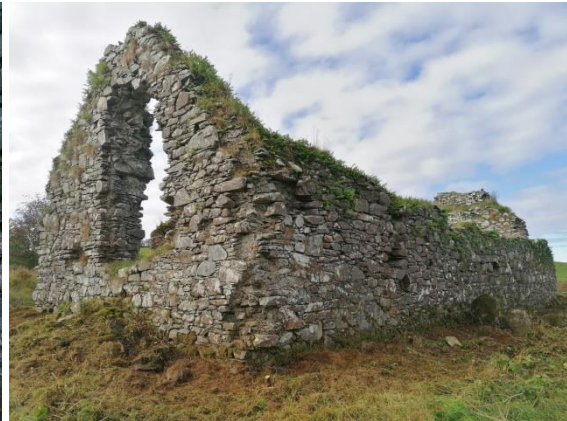
Plate 15 (L): Southern face of chapel heavily obscured, Facing W
Plate 16 (R): Landscaping works completed, NE corner of chapel, note previously unnoticed stone tumble at eastern gable and previously unseen headstones along northern wall, facing SW

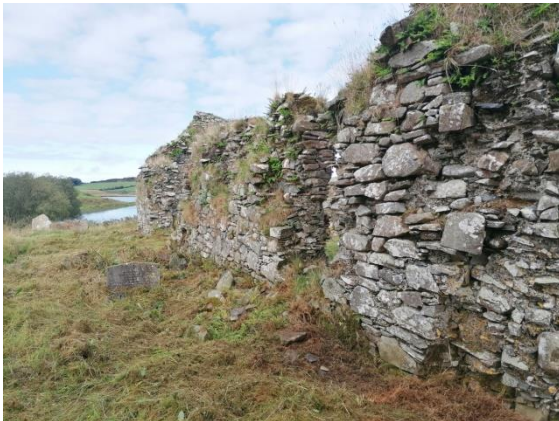
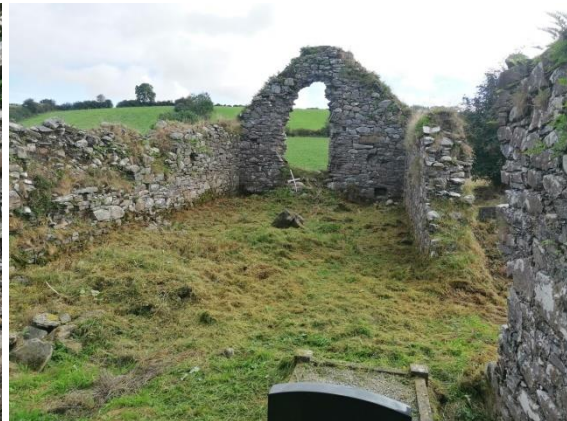
Plate 17 (L): Landscaping works completed, Southern wall of chapel, Facing W
Plate 18 (R): Landscaping work completed, Eastern interior of chapel, note heap of collapsed stone beneath window, Facing E

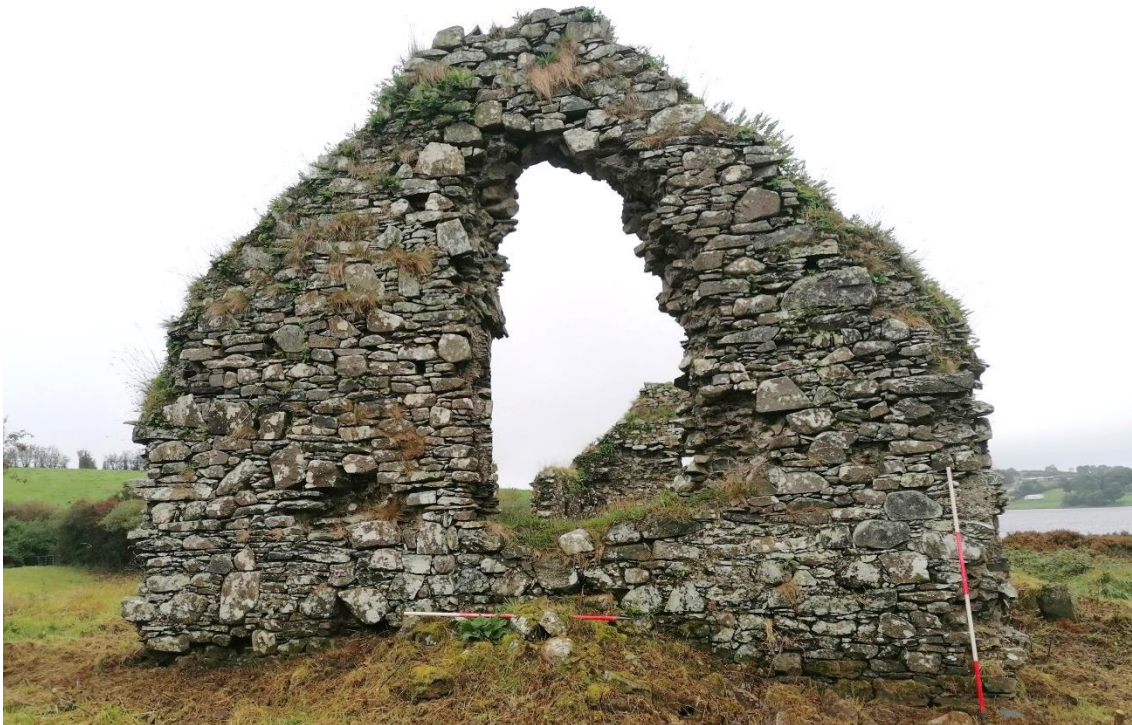
- Collapse of the stones within the window opening leading to lack of support and destabilisation of the top of the wall and remaining arch. This has resulted in a large open crack which suggests the arch is at risk of collapse.
- Loss of mortar on the corners of the building, the top of the wall and certain patches along the wall face is leading to weathering of mortar resulting in further dislodgement of stones.
- Growth of long grass, ferns and shrubs concealed the condition of the masonry along the wall.
- The large tree stump next to the internal face of the east elevation suggests a large tree once grew there which possibly contributed to the destabilisation of this wall.

Plate 21: Eastern Elevation (exterior), note the collapsed window and heap of stones at the base, the original window edge and partial arch can be seen along the southern (left) side of the window

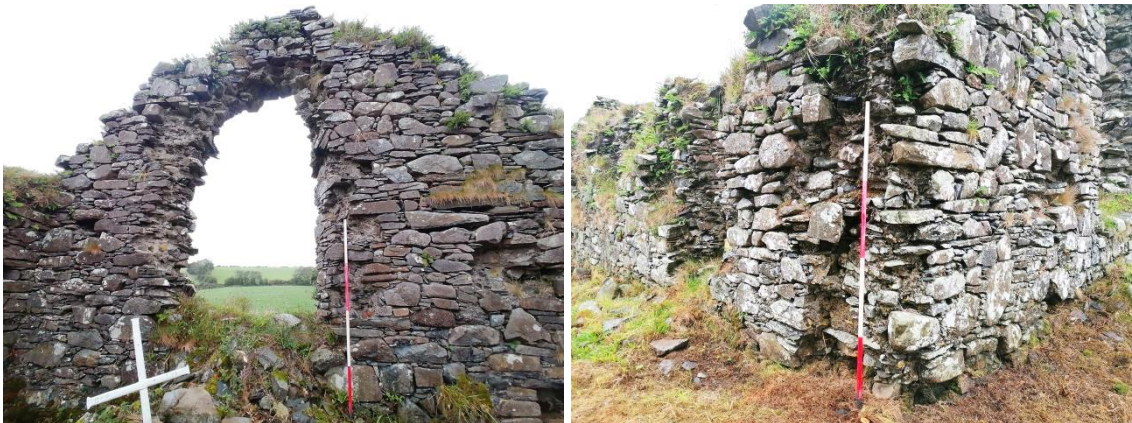
**Plate 22 (L): Eastern Elevation (interior), note original window edge and partial arch. Also note the large crack above the opening suggesting the wall is in danger of complete collapse.
Plate 23 (R): SE corner collapse, note the exposed mortar**

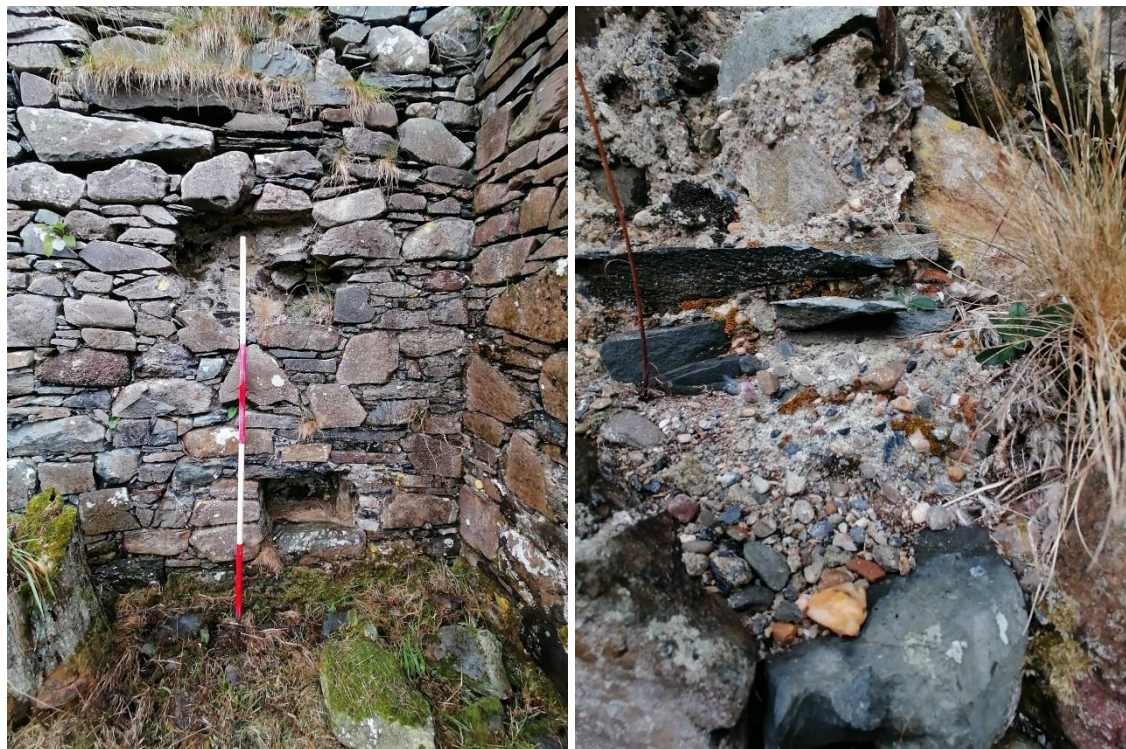
Across the east wall and all across the chapel, grass and ferns can be noted growing between stones. Grass is particularly prominent across the bottom of the window opening and along the top of the wall itself. Roots of grass and ferns are unlikely to cause great damage and it is advised not to remove them. Tall grass, shrubs and small trees in the form of ash and sloe were growing in this area. They were removed during the landscaping works. A large tree stump is present near the window opening on the interior of the chapel. It appears to be some decades old and was manually cut 0.50m from the ground. The root systems of this large tree are likely to have penetrated to some depth and could have added to the destabilisation of this wall (Plate 24).

Plate 24 (L): Small box built into the interior face of the Eastern elevation, to the lower southern (right) side. Possibly the ambry, Note areas of collapse and large tree stump (bottom left)

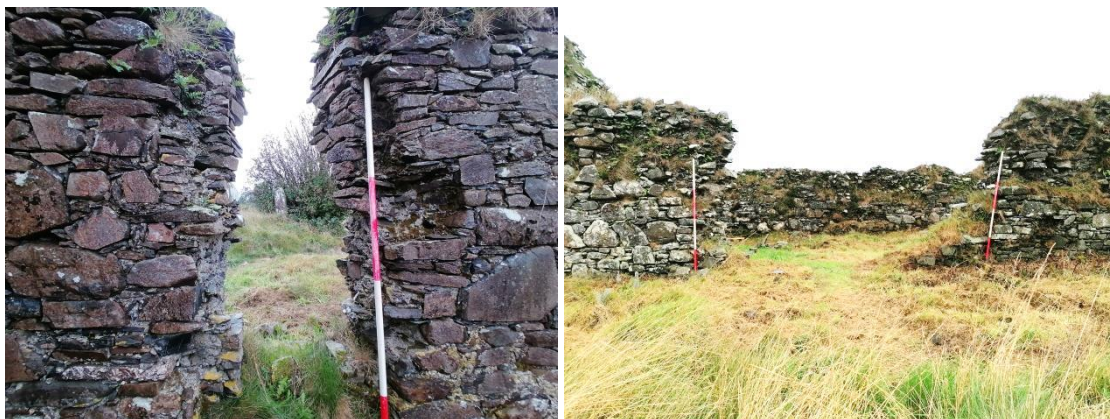
Plate 26 (L): Interior face of south elevation showing narrow collapsed window opening. Note how the stones are placed diagonally to allow for the interior of the window to be wider than the exterior, also note how it appears the window would have sloped upwards to meet in a point.

Plate 27 (R): South elevation, large gap towards western end.

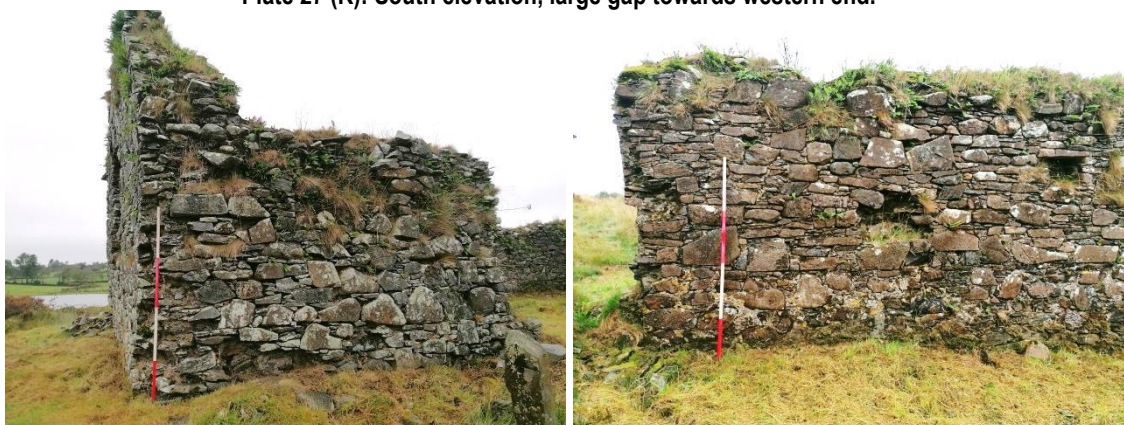
Plate 28 (L): Western side of the south elevation showing the erosion, grass growth and areas of damage and the eroding south western corner.

Plate 29 (R): Southern elevation, interior face. Note the narrow window (left) which is rising at an angle. An area of collapse can be seen in the centre and a large beam-hole can be seen to the right possibly for the rood-screen.

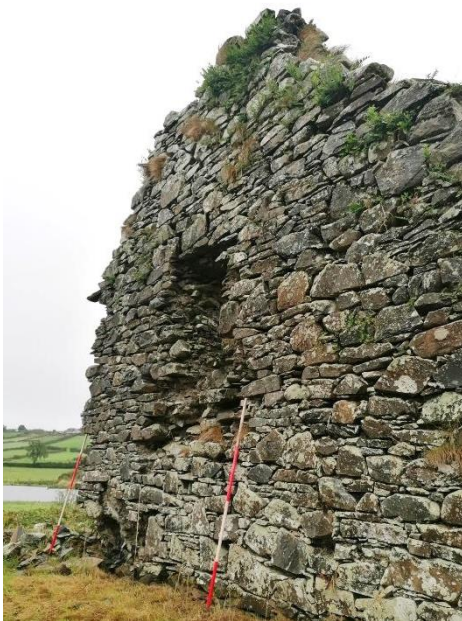
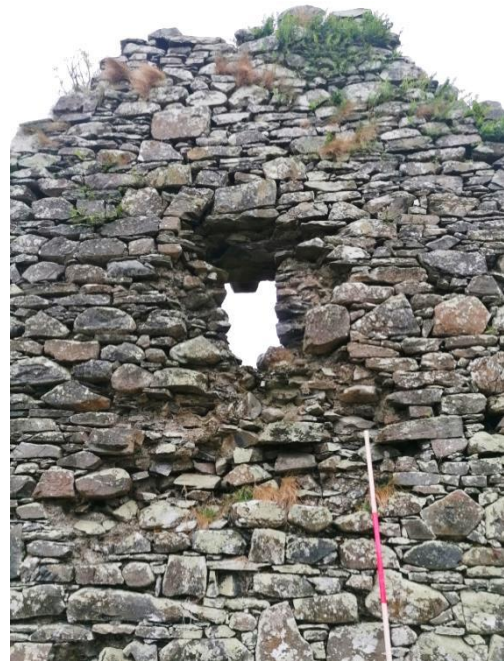
Plate 31 (L): West elevation, note severe collapse on the NW corner and high window
Plate 32 (R): Western Elevation, note collapse around the high window

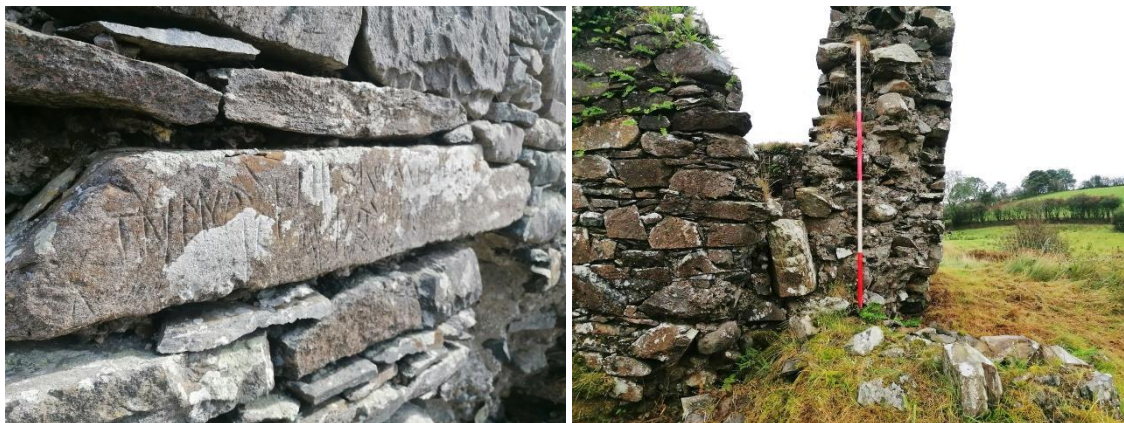
Plate 33: Engraved stone located in NW corner of west gable
Plate 34: Collapsed NW corner of the western elevation. Note the heavy westward tilt of the wall

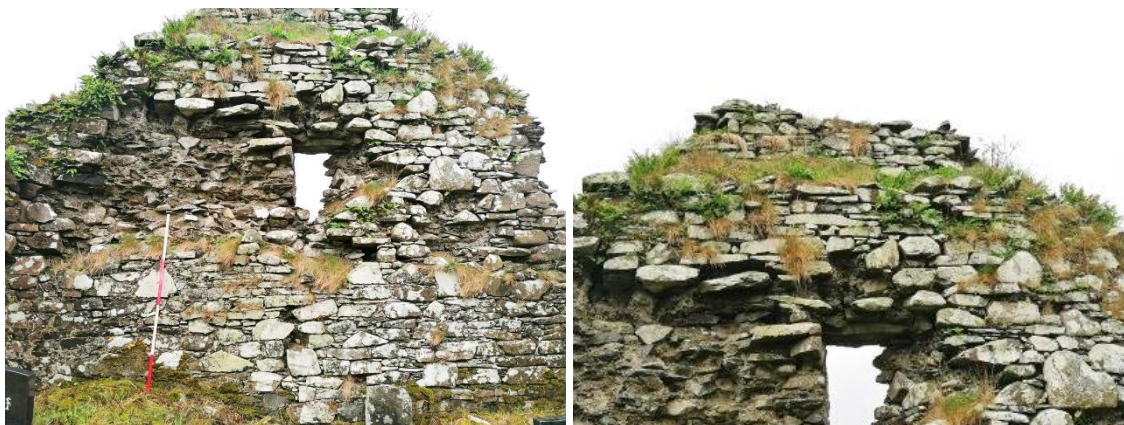
Plate 35: Inner face of west elevation, note the high windows and gaps for corbels, also note the collapse of the centre of the wall
Plate 36: Upper part of the wall, Note the grass covered horizontal ledge near the top of the wall for holding the roof rafters

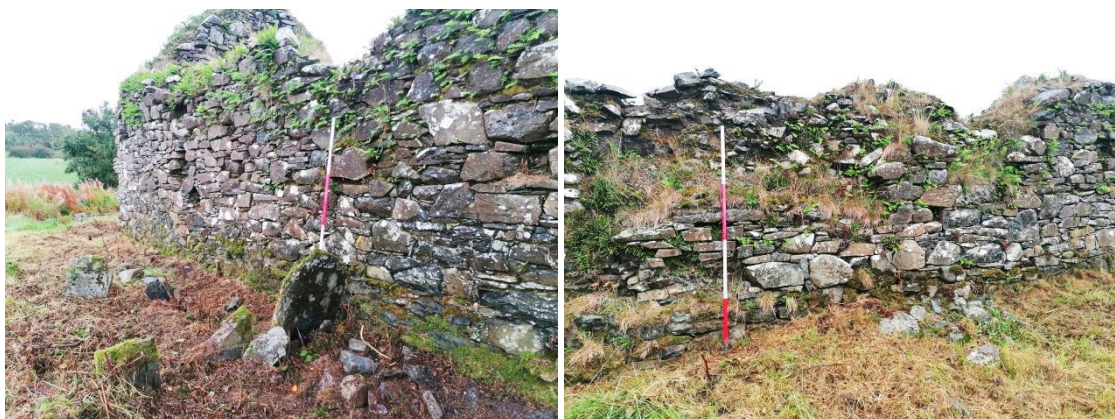
Plate 37 (L): Northern elevation, note the ferns in the wall and the remains of the dense thicket of brambles on the ground.

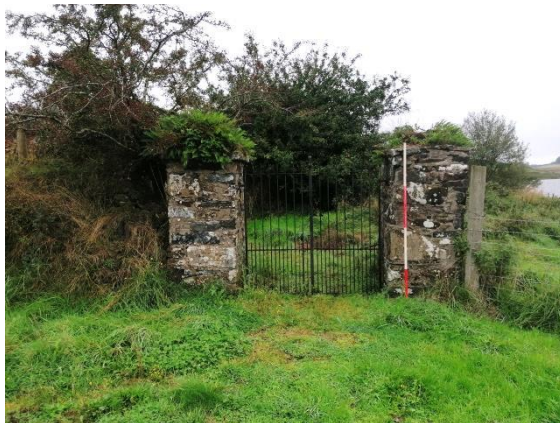
Plate 41 (L): Entrance gate to graveyard, note 2m high bank to left and the gap between the pillar and the bank

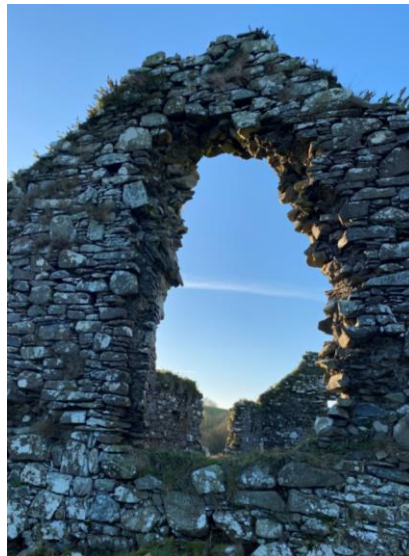
The loss of the shape of the gable window can be seen from the above photo and is particularly evident to the north side of the window outline.

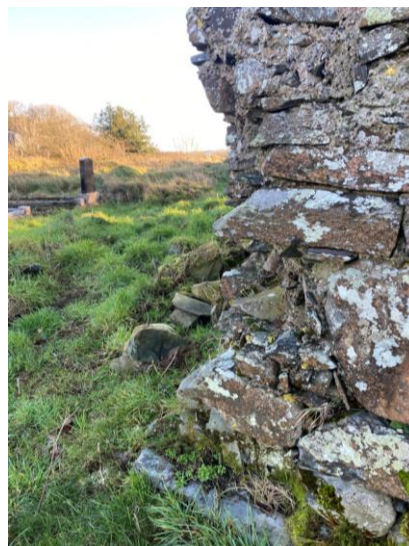
The north east corner to the church has lost a significant amount of stone which has undermined the main structural wall.

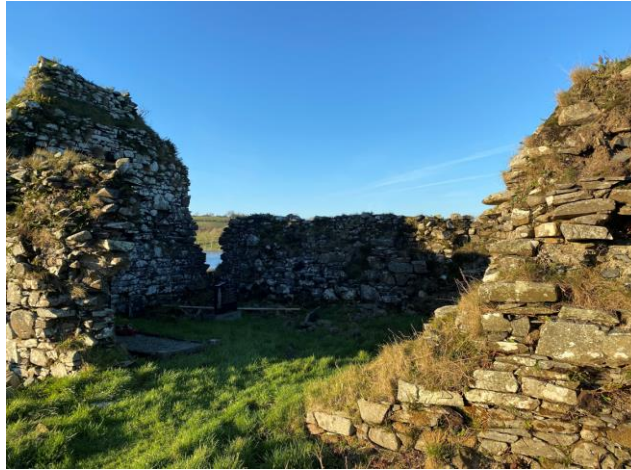
The vertical opening to the right-hand side of the wall has become undermined to the bottom of the window opening due to erosion. The window opening has become widened to its base and is unstable. The stone lintel to the window has become lost and has resulted in erosion and loss of the stone head to the opening.

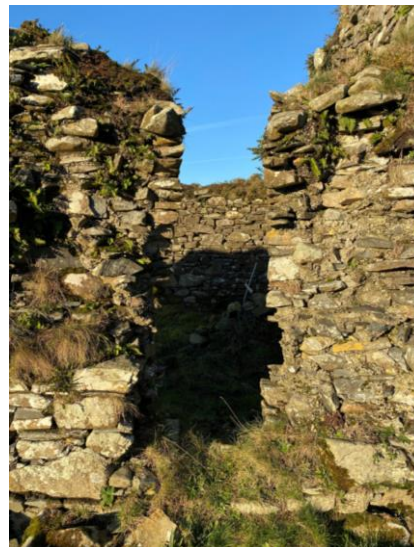
Large sections of the outer structural stone skin to the south wall have become removed for the wall and resulted in a significant weakening of the wall.

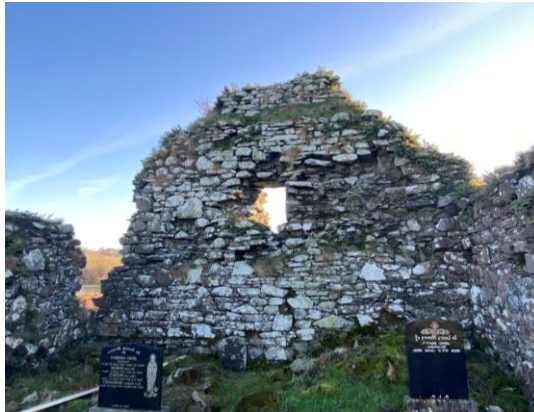
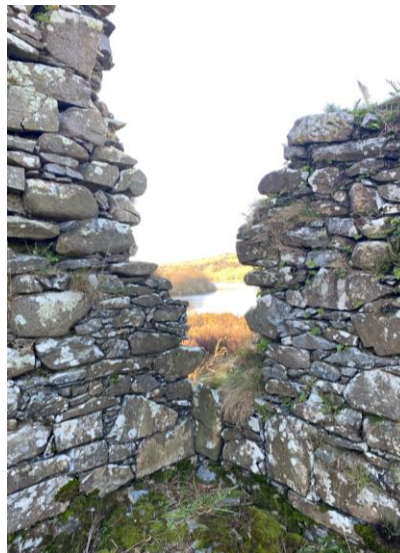
The north west corner to the church has experienced significant loss of structural stone, most likely due to erosion and weathering. The loss of the stone has resulted in the failure of the corner and the loss of the corner structure.

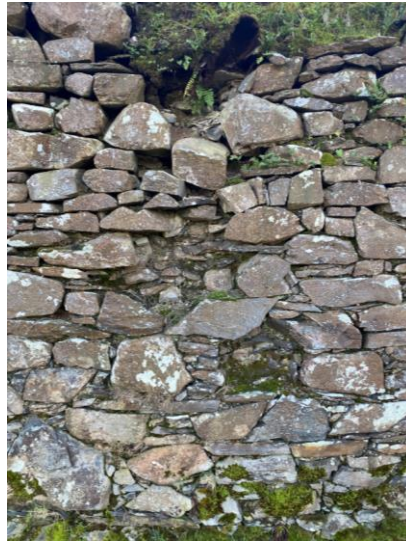
The foundations to the north facing wall have become exposed in a number of locations which leaves the foundations open to and susceptible to deterioration.
