Drinking Water Audit Report

Local Authority:	Monaghan County Council	Date of Audit:	22 May 2009
Plant(s) visited:	Carrickmacross Drinking Water Treatment Plant	File Reference:	DW 2009/54
		Auditors:	Mr. Darragh Page and Mr. Darren Walsh
Audit Criteria:	 The European Communities (Drinking Water)(No. 2) Regulations, 2007. EPA Drinking Water Regulations Guidance Booklet No. 1 – Regulation 9 and 10. The recommendations specified in the Handbook on Implementation of the European Communities (Drinking Water) Regulations 2000. The recommendations specified in the EPA Report titled The Provision and Quality of Drinking Water in Ireland. A Report for the Years 2007-2008.

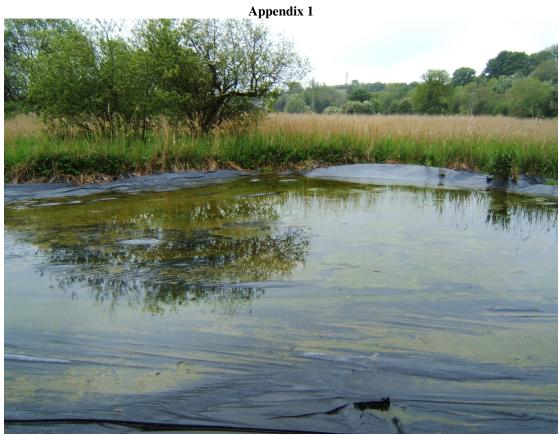
- An inspection of the four sources of the supply was carried out. The Nafferty Spring is located in a marshy hollow with an industrial estate close to the outflow of the spring with agricultural land upgradient of the source. The spring was covered with a polythene sheet to prevent algae getting into the intake which was below the sheet. There was evidence of algal growth on top of the polythene sheet which was just below the surface of the spring (Photo 1). There was also evidence of earthen fill material dumped below the outflow of the spring (Photo 2). Mr. P. McKenna stated that this was soil and stones that have been excavated from a nearby site and did not contain any C&D waste.

- ☐ Mr. V. McKenna stated that the spring was a karst spring and that a vulnerability assessment of the spring had been carried out which indicated that some of the zone of contribution was extremely vulnerable. However, the local authority had not identified any of the risks to the quality of the spring in the zone of contribution and were unable to say what was causing the algal growth on the surface of the spring. The local authority were unable to confirm whether the requirements of the Good Agricultural Practice Regulations were being complied with in the catchment areas of the various water sources.

Photo 1. Nafferty Spring.

- 2. **Management and Control:** The local authority should identify the potential risks to the quality of the Nafferty Spring and identify the cause of the algal blooms in the spring. An action plan should be prepared to reduce the risk of contamination of the spring.

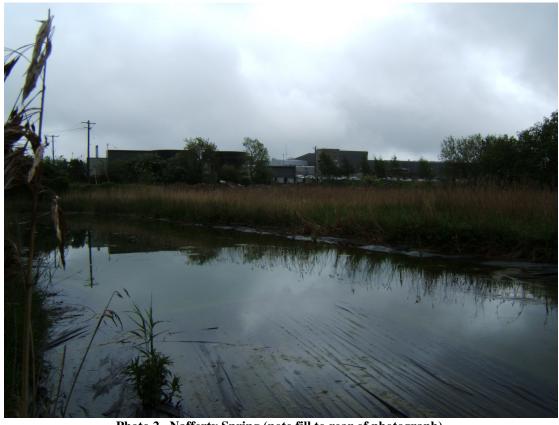
Photo 2. Nafferty Spring (note fill to rear of photograph).

- Farmyard manure held in a field prior to landspreading is not be placed within 250 m of the abstraction point.
- 4. **Source Protection:** The local authority remove the material deposited in the vicinity of the Nafferty Spring and dispose of the material in accordance with the appropriate statutory requirements.

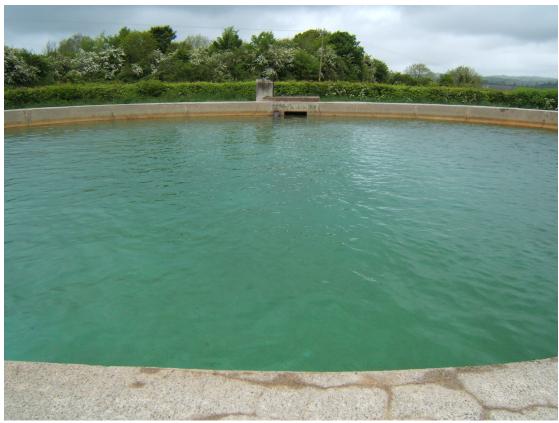
Photo 3. Nafferty Reservoir.

- 8. **Treated Water Storage:** The local authority should ensure that the Nafferty reservoir is covered to reduce the risk of contamination.
- 9. **Distribution System:** The local authority should ensure that there is a complete mixing (ie no preferential flows through the tank) in the Spring Lake reservoir and that no stagnant areas exist.

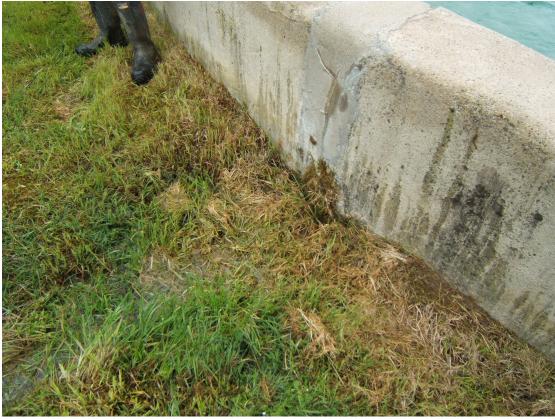
Photo 4. Crack in the Nafferty Reservoir (note outflow of water from crack).

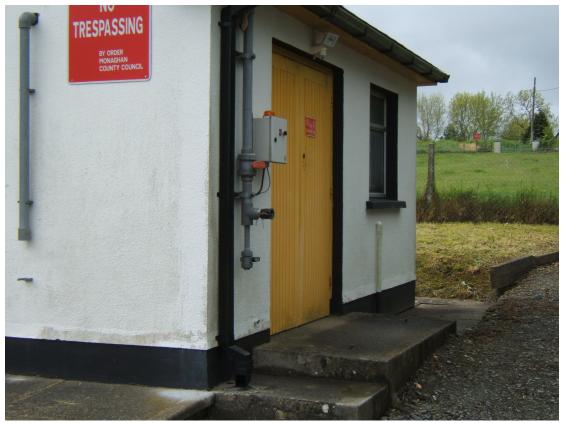
f) Exceedences of the Parametric Values A failure to meet the coliform bacteria parametric value was notified to the EPA on 20 April 2009. Mr. Rooney stated that this was due to mains works that were taking place at the time. Chemical storage and bunds Chemical storage at the various chemical treatment points in the supply were generally satisfactory, however the fill point for the bulk storage container for the fluoride tank was located outside a bunded area and was located directly above a surface water drain (Photo 5).

Photo 5. Fill Point for Fluoride Bulk Storage Tank.

- 11. **Chemical Storage and Bunds:** The local authority should ensure that the fill point for the fluoride bulk storage tanks is located within a bunded area.
