Submission to Monaghan County Development Plan, 2019-2025

GEOPHYSICAL SURVEY REPORT

Mullanary Glebe,
Carrickmacross Workhouse,
Co. Monaghan

Geophysical Survey Report

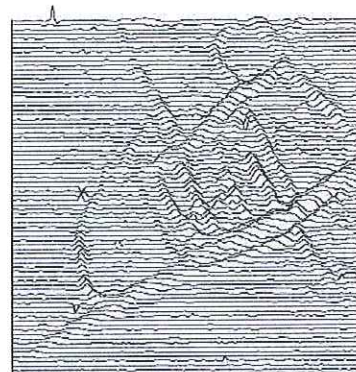
XY Trace

The data are presented as a series of linear traces, enabling a semi-profile display of the respective anomalies along the X and Y-axes. This display option is essential for distinguishing between modern ferrous materials (buried metal debris) and potential archaeological responses. The XY trace plot provides a linear display of the magnitude of the response within a given data set.

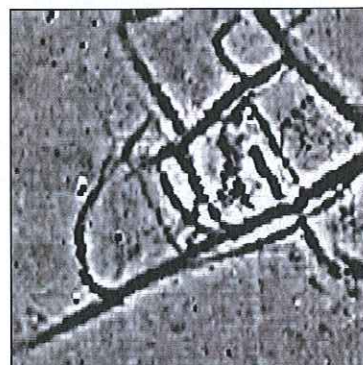
Greyscale*

As with dot density plots, the greyscale format assigns a cell to each datum according to its location on the grid. The display of each data point is conducted at very fine increments, allowing the full range of values to be displayed within the given data set. This display method also enables the identification of discrete responses that may be at the limits of instrument detection. In the summary diagrams processed, interpolated data is presented. Raw un-interpolated data is presented in the archive drawings along with the xy-trace plots.

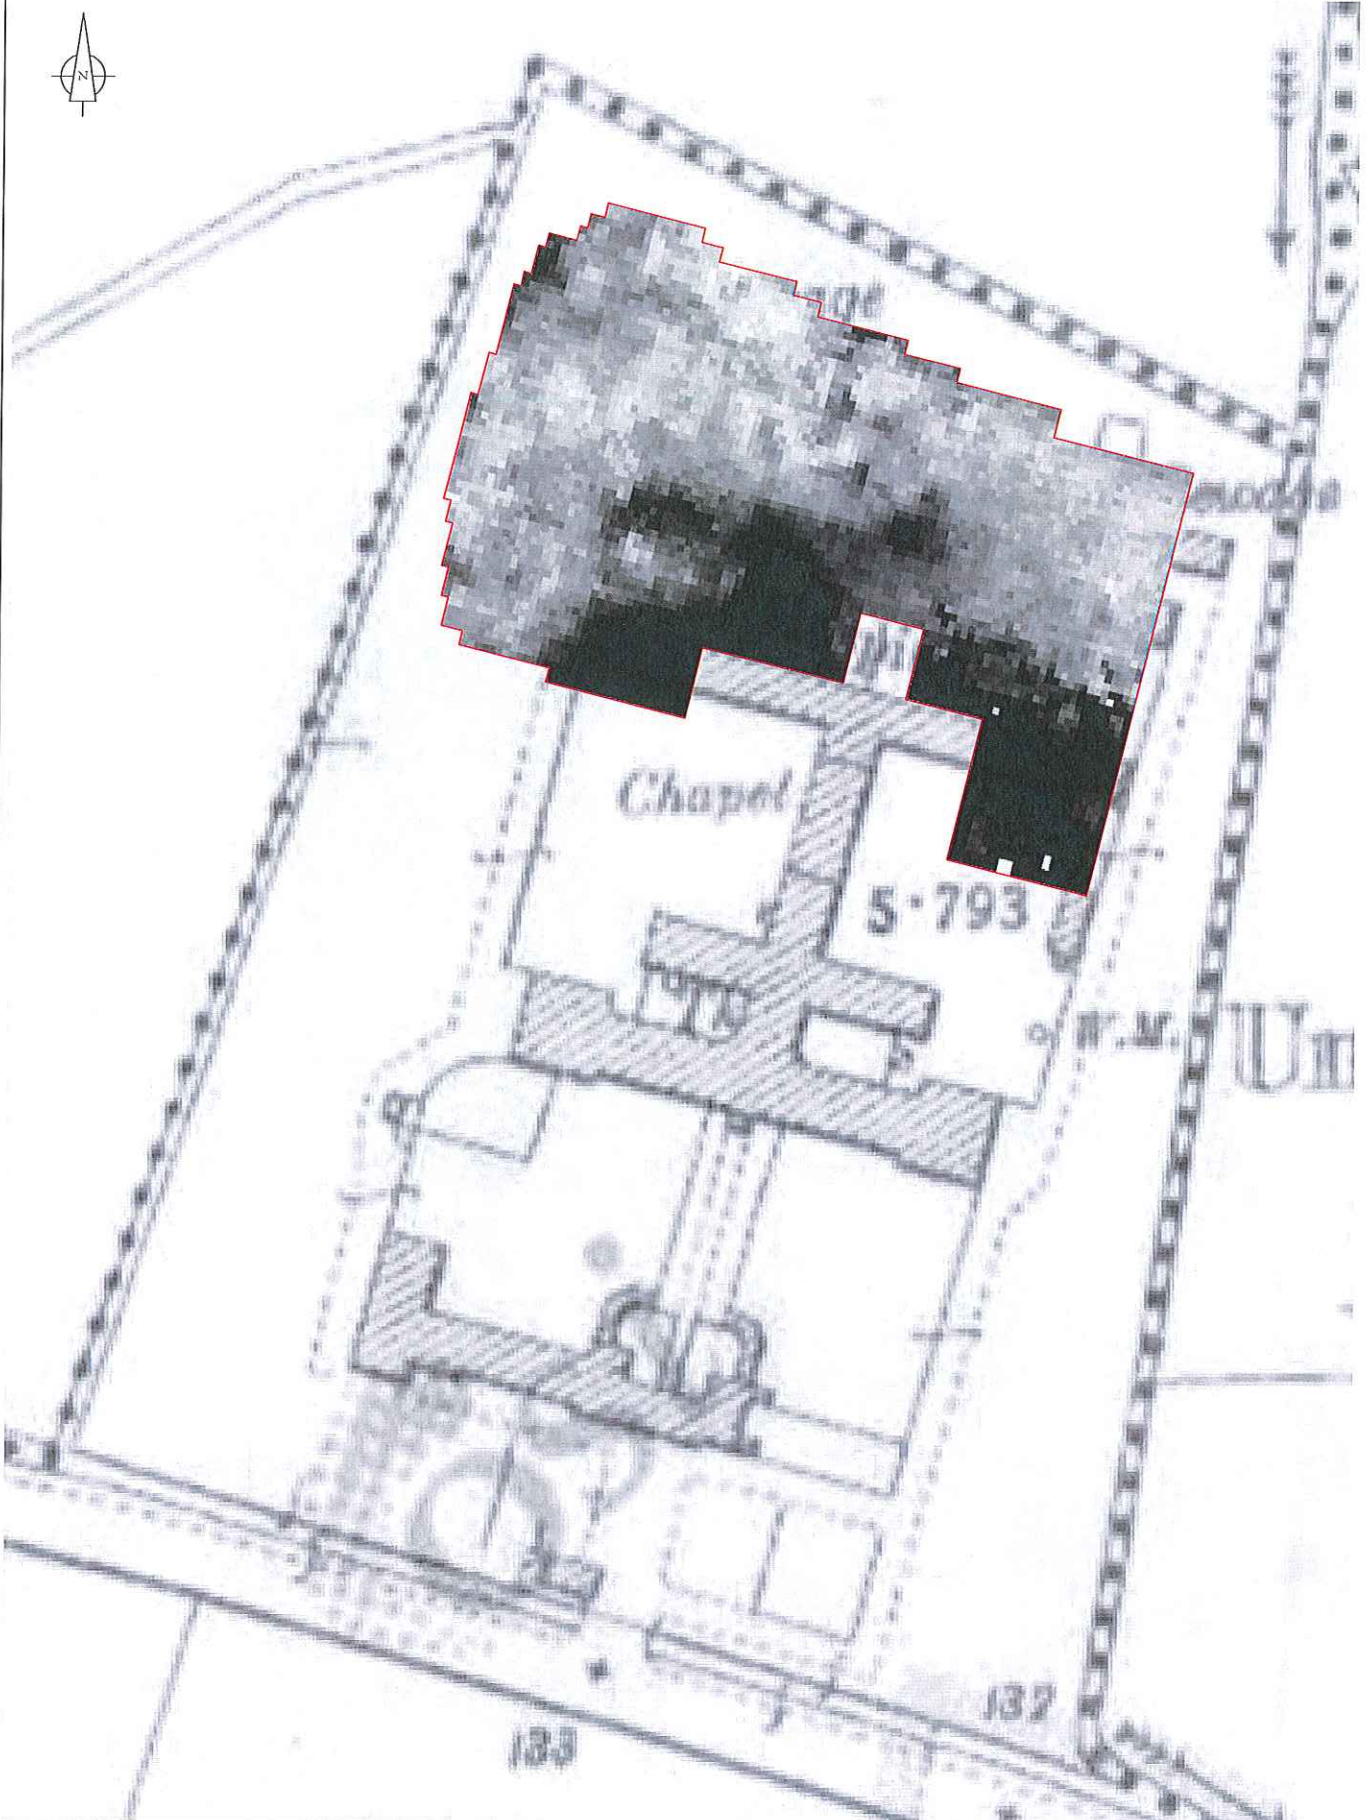
Scale @ A4: 1:1,000
Figure: 4
Licence No.: 17R0117
Issue Date: 14.07.2017

Resistance Survey (Figures 4, 5, 6 and 7)

- 5.3 The resistance survey has some responses of potential interest. High resistance response (1) is suggestive of structural remains and shows a clear correlation with the recorded remains depicted on the historic mapping.

- 4.1 A summary greyscale image of the gradiometer survey is presented in Figure 3. Figures 4 and 5 present the raw and processed resistance survey results, both at a scale of 1:1,000.
- 4.2 Figure 6 presents an interpretation diagram with the historic mapping, at a scale of 1:1,000. Figure 7 also presents the interpretation drawing, at a scale of 1:625.
- 4.3 Numbers in parenthesis in the text refer to specific responses highlighted in the resistance survey interpretation diagram (Figures 6 and 7).
- 4.4 The display formats referred to above and the interpretation categories are discussed in the summary technical information section at the end of this report.

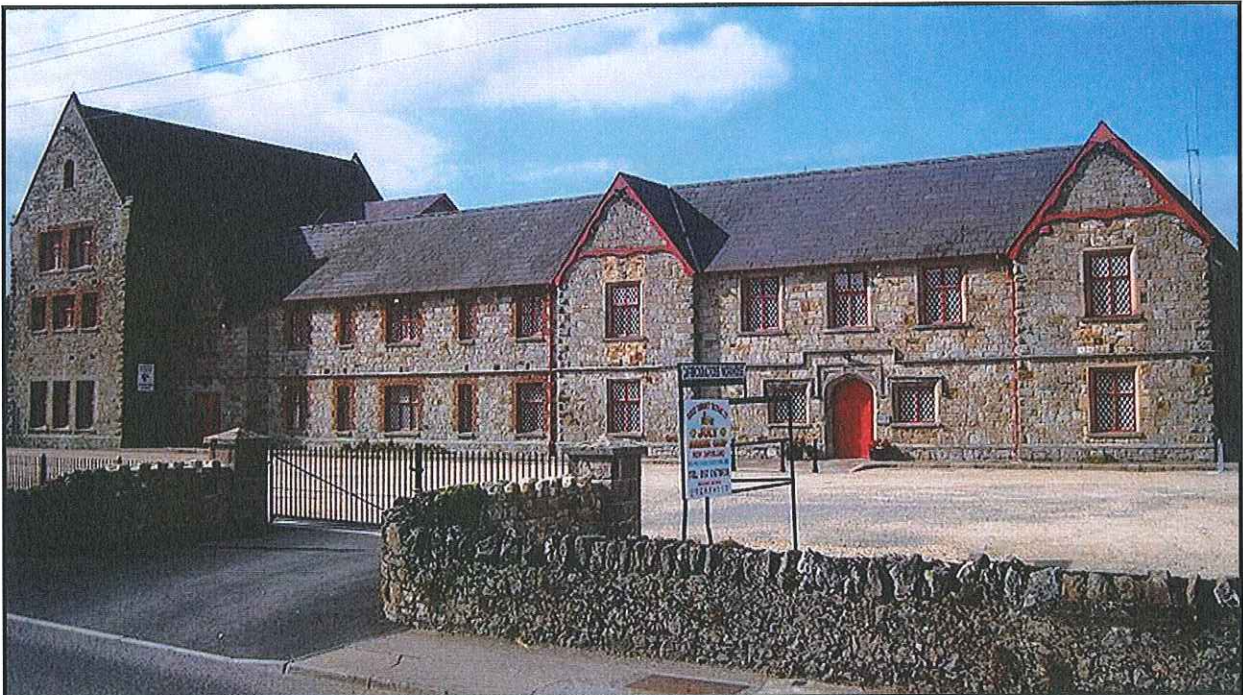
Plate 1 – The south front elevation of Carrickmacross Workhouse from the Shercock Road, Carrickmacross, Co. Monaghan looking north northwest

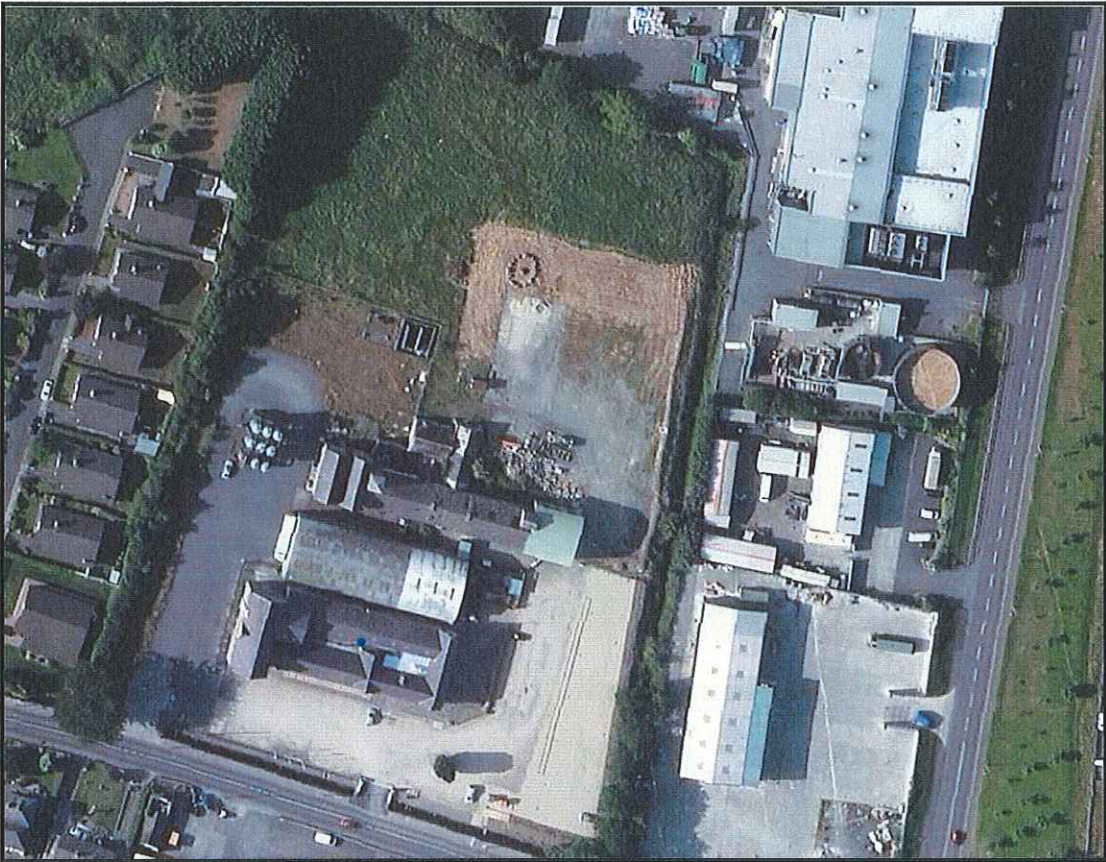
Plate 2 – Aerial View of the surviving Carrickmacross Workhouse buildings (after Bing Maps, 2013), Co. Monaghan

Ordnance Survey Aerial Photos (2005, 2000 and 1995), digital aerial photos from Google Maps and Bing Maps were examined in detail (Plate 2).

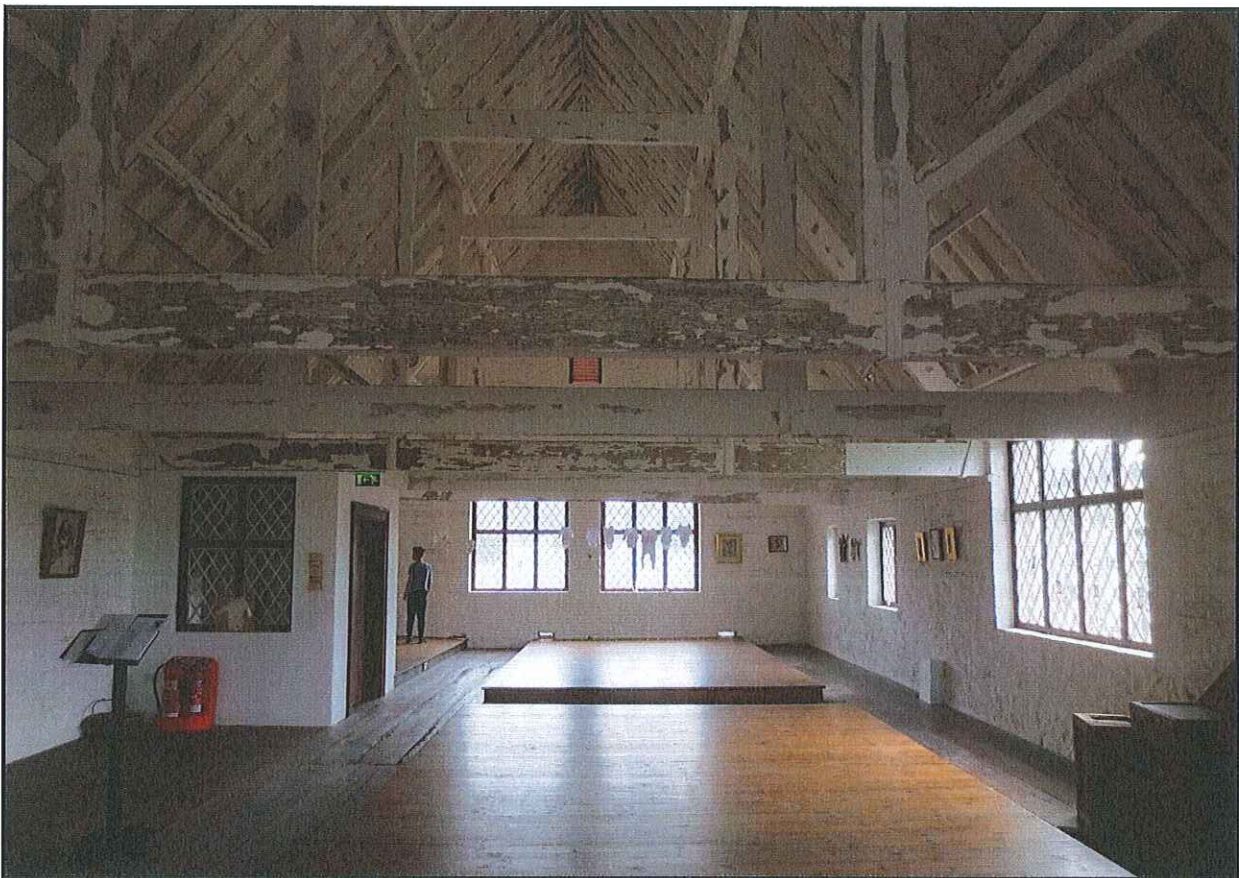
Plate 3 – The interior of one of the dormitories at Carrickmacross Workhouse located in the front western corner of the site, note the pine raised bedding area

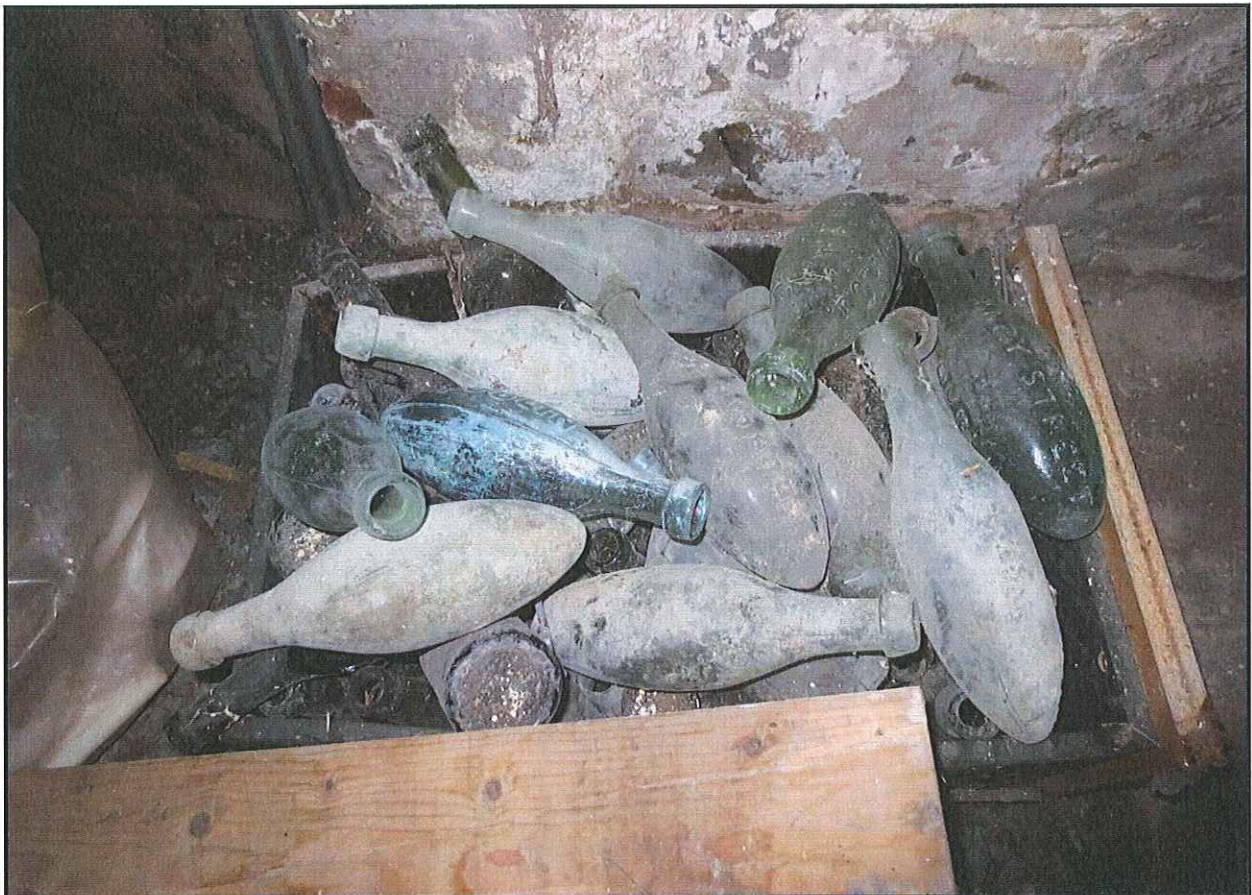
Plate 6 – Torpedo or Hamilton Bottles dating from between 1840-1870 in storage in disused building within Carrickmacross, Co. Monaghan

Artefacts dating from the famine and later times are also located on the site; these are both buried on site and are stored in the derelict buildings on site (Plate 6). The Torpedo Bottles identified in the rear storage sheds on site date from 1840-1870¹⁴, other architectural fragments are also located on site such as doors, window frames and other items of architectural material from the Workhouse that are no longer *in situ*.

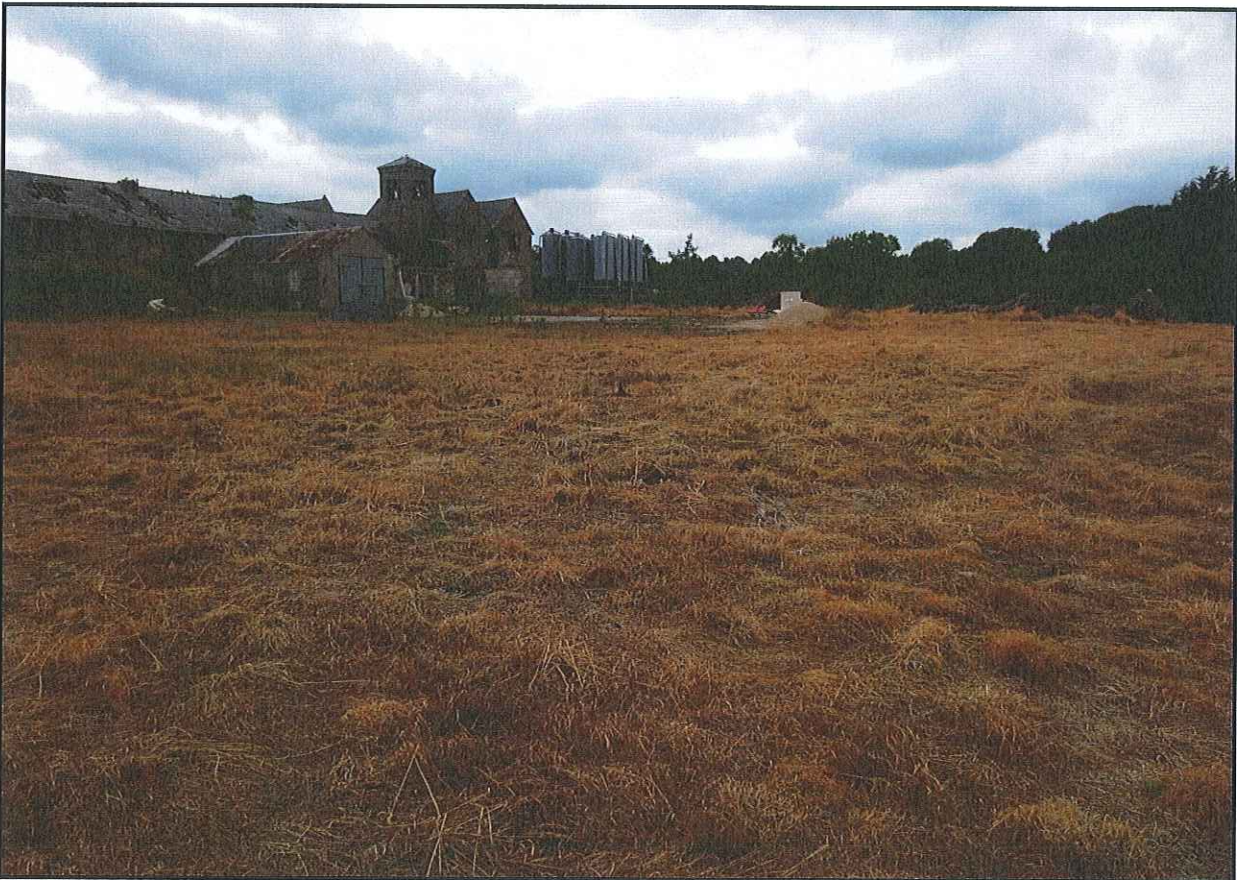
Plate 7 – The middle range of buildings on site at Carrickmacross Workhouse looking southwest, Carrickmacross, Co. Monaghan, note the precinct walls and rear range of buildings are now demolished

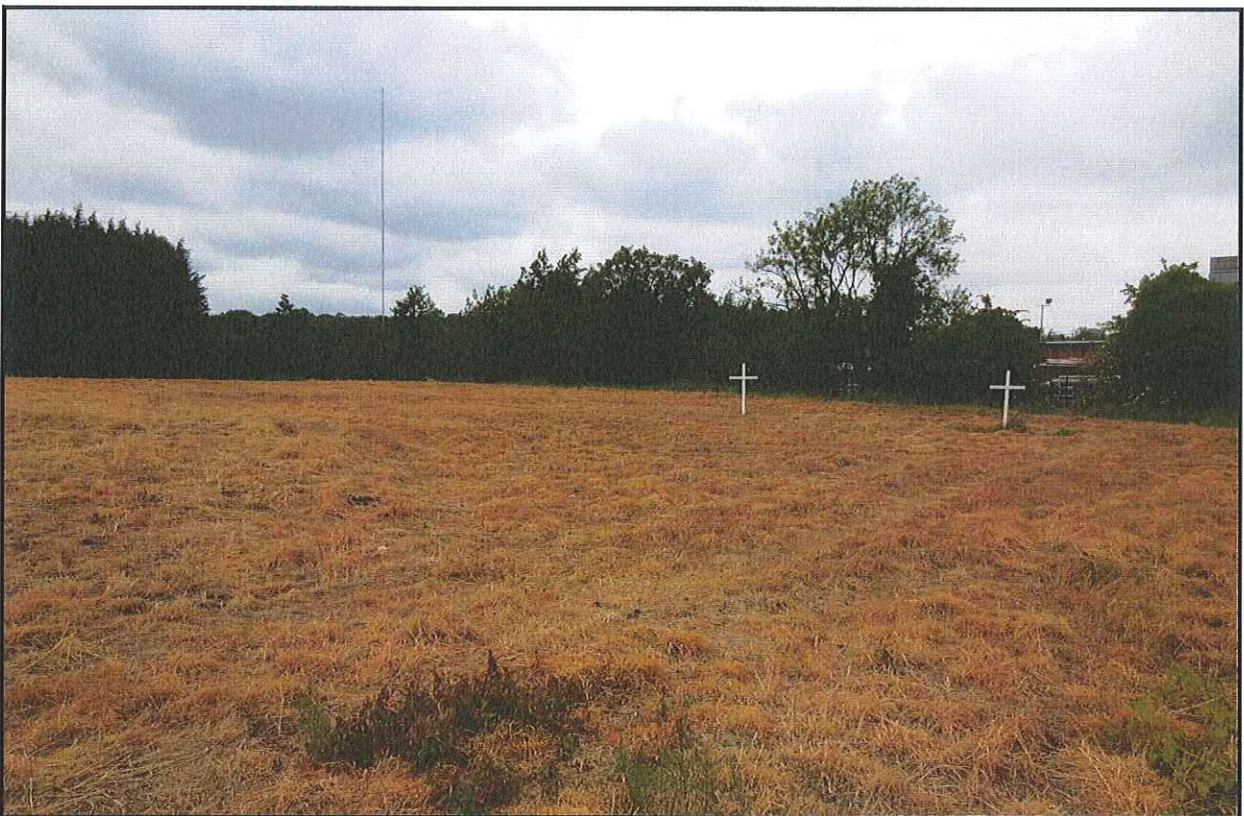
Plate 8 – The northern end of the site Area 6 where the burials are likely to be located at Carrickmacross Workhouse, Co. Monaghan, looking north

Consideration should be given to leaving the original ground beyond the precinct wall (north) as an open grassed space suitable as a contemplative 'garden' area to commemorate those who lived and died within the former Workhouse buildings. It is suggested that the area is not disturbed or excavated either for development or to exhume the burials that are likely to be interred in this location. Test excavation to ascertain if burials are present could be carried out, although it should be noted that this is technically and operationally difficult and previous assessments (archaeological) have often resulted in either over estimating or under estimating the scale and complexity of burials at these sites. The central concern should be for burials interred at the site to remain *in situ* if possible.
