advice series

THE CONSERVATION OF PLACES OF WORSHIP

An Roinn
Ealaíon, Oidhreacht agus Gaeltachta
Department of
Arts, Heritage and the Gaeltacht

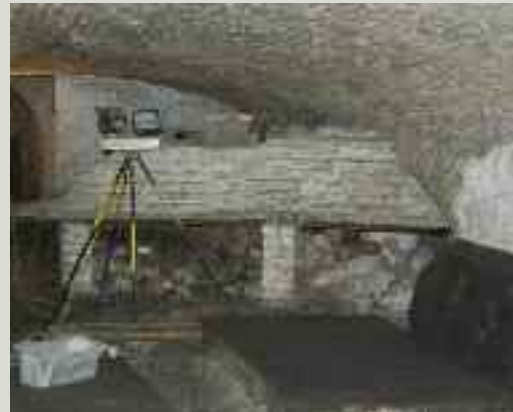
Inspecting a crypt presents risks such as trip hazards, toxic fumes, asbestos and rodent or fungal infestation. Personal protective equipment and adequate lighting are essential to reduce the risk of accident to the inspector or damage to the structure

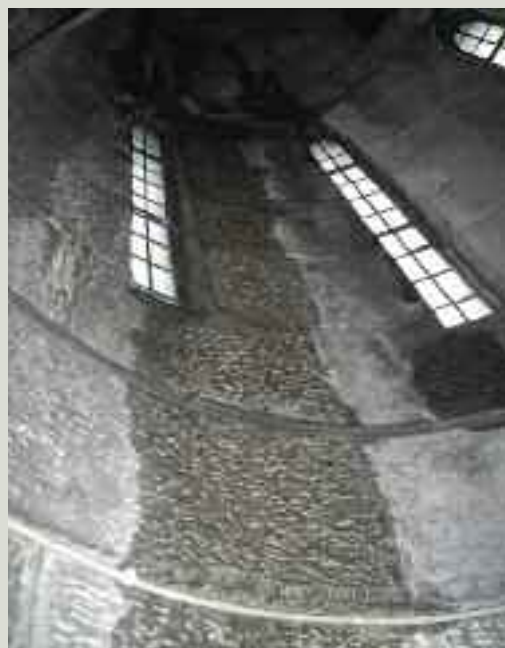
Difficulty of access no doubt contributed to lack of maintenance of this church tower, resulting in ingress of water to saturation level in the masonry. This will lead inevitably to serious damage unless it is remedied

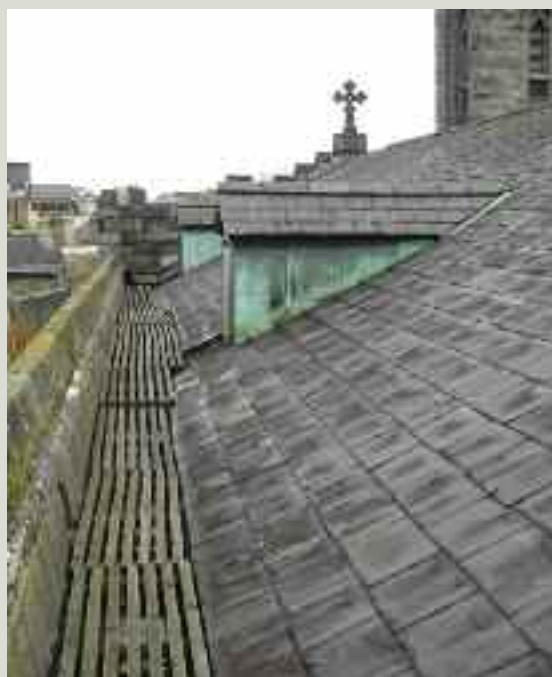
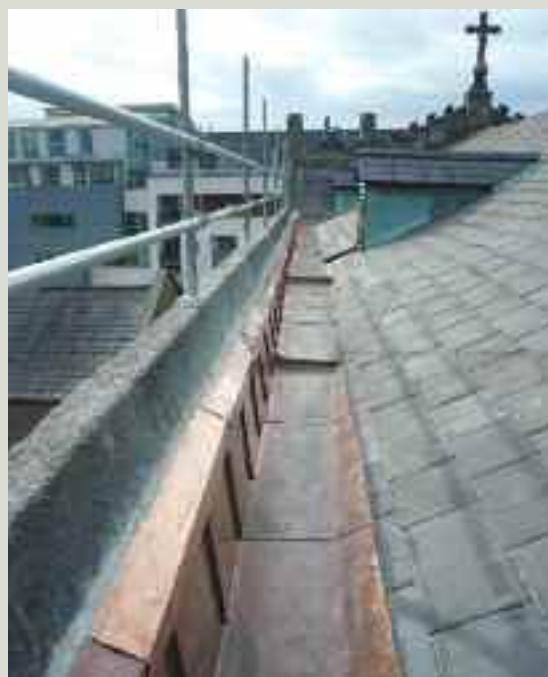
The failed copper guttering and parapet flashings on this church (left) were replaced with new copper guttering and flashing and the stone cleared of growth (right). The snow, or access, boards were not replaced as these can constitute a significant trip or fall hazard at roof level, particularly when they are in poor condition

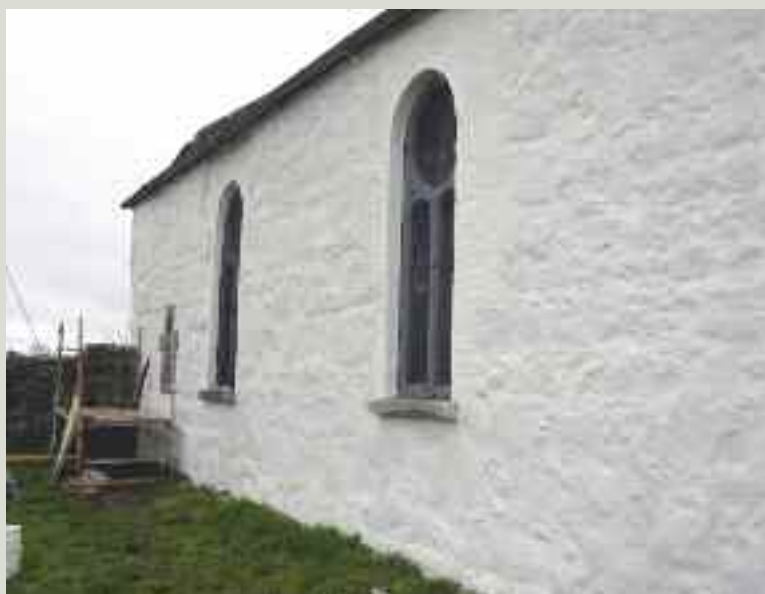
The rubble walls on this medieval parish church were stripped of roughcast cement render and re-rendered using a soft lime mortar. This helped the interior of the building to dry out, assisting to preserve the significant Romanesque stone carving

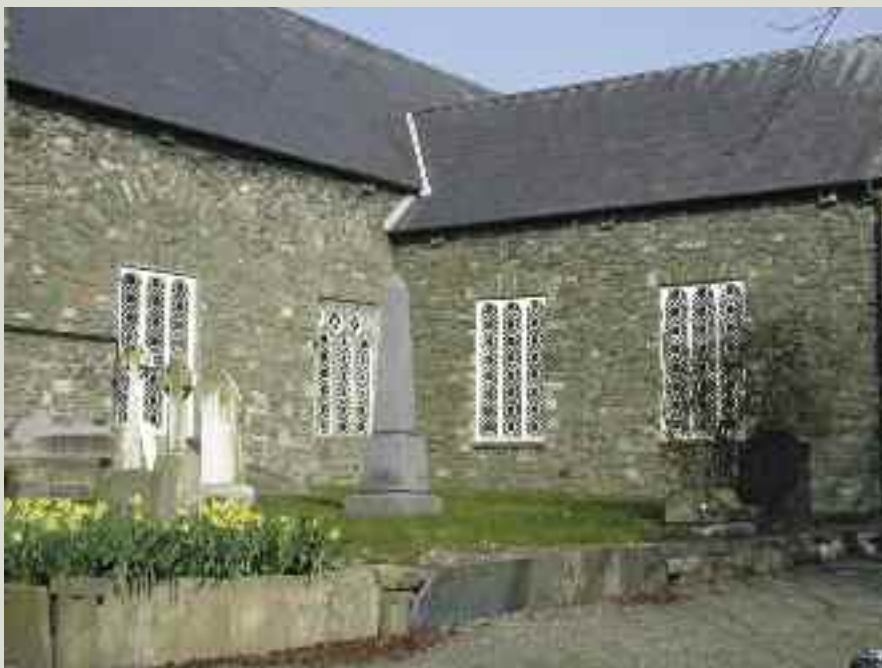
The grounds of this extended and altered medieval church have served as a graveyard for about six centuries, leading to a build-up of levels next to the church walls. Due to the archaeological sensitivity of a site such as this one, any proposals to lower the ground near the walls should be approached with caution, and expert advice followed

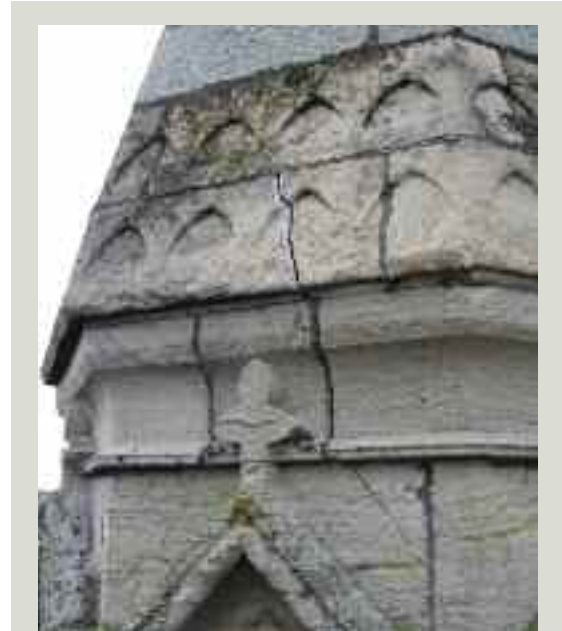
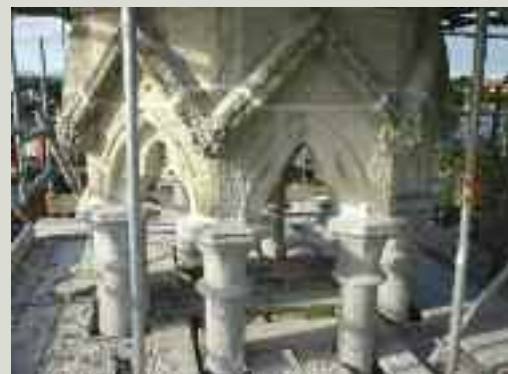
This Bath stone turret, which is also a bell-tower, is in a highly exposed location. Several stones cracked due to rusted cramps and the poor condition was exacerbated by previous misguided cementitious repair. New stainless steel collars and ties were fitted and the turret was repointed

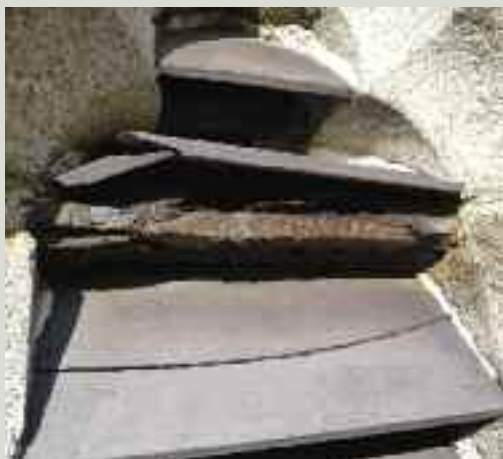
Embedded metal tie bars in this bell tower corroded and expanded, causing fractures in adjacent granite and slate louvres. Part of the repair solution involved installing a cathodic protection system to reduce the corrosion rate of the embedded ironwork

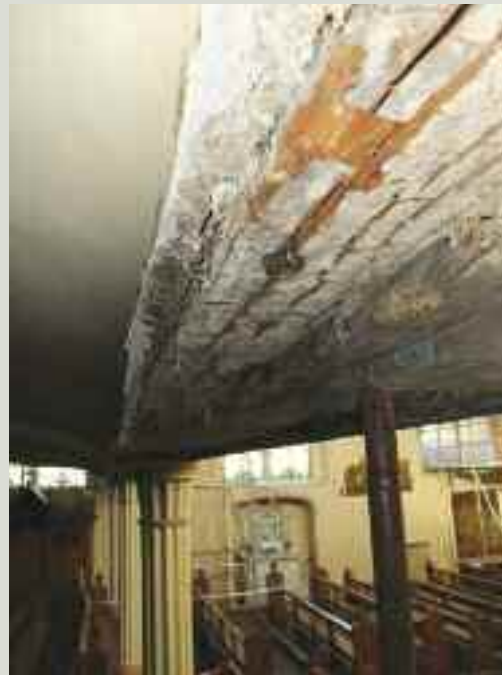
Regular inspections and scheduled maintenance work should prevent rot from taking hold to the degree that it causes structural damage, as has happened to this beam which supports an organ gallery

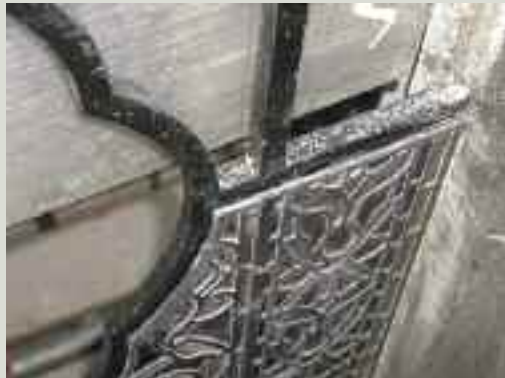
Substantial iron bars are required to support large stained-glass windows. Often the ironwork is shaped to mirror the borders of panels, especially where continuing a horizontal or vertical line would be visually disruptive of the design. This conserved panel has been refitted and a copper band is visible that will secure the panel to a saddle-bar

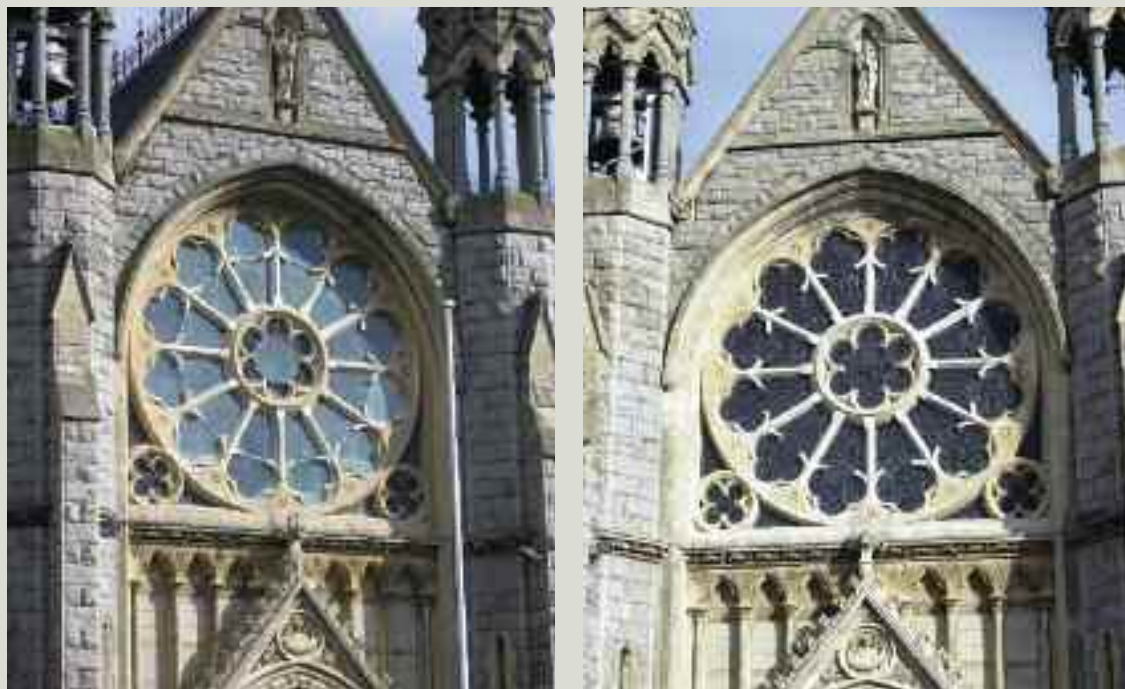
The storm glazing of this rose window was removed and powder-coated stainless-steel wire guards were fixed to the masonry. As a result the window is less likely to suffer from the effects of humidity and heat on the glass and leadwork. There is no loss of clarity to the stained glass and the stone tracery reads more clearly from the exterior

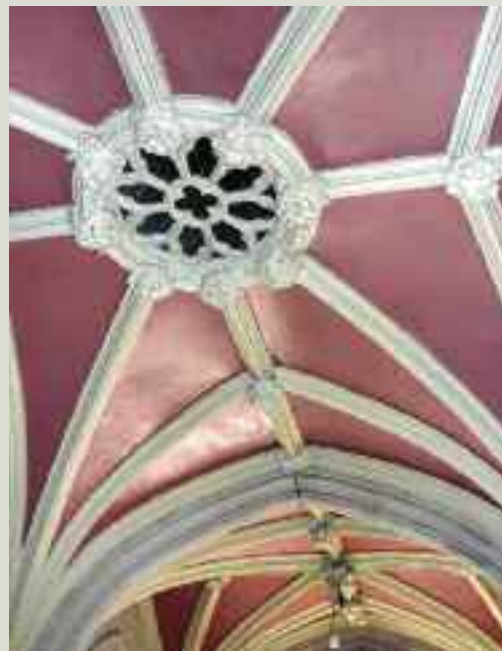
Ceiling grilles should be checked to ensure that the warm, humid air rising into the roof space is ducted through and discharges to the exterior to avoid raising the moisture content of the roof timbers to a level that might make them vulnerable to insect or fungal attack

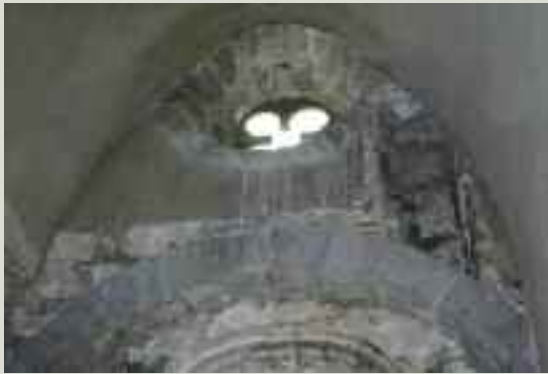
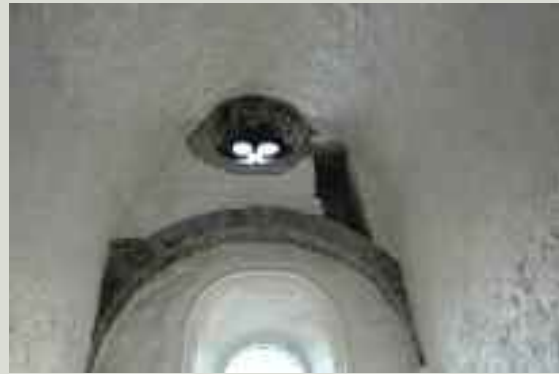
The cement plaster on this Romanesque church, which was damaging the stonework and associated timbers, was carefully removed and replaced with a soft lime plaster

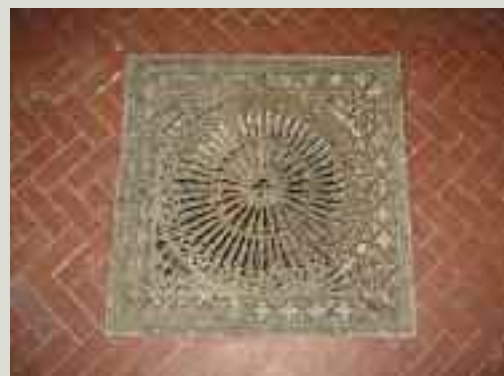
Several elements of a historic heating system often survive, as at this church where both boiler and perforated floor grilles remain

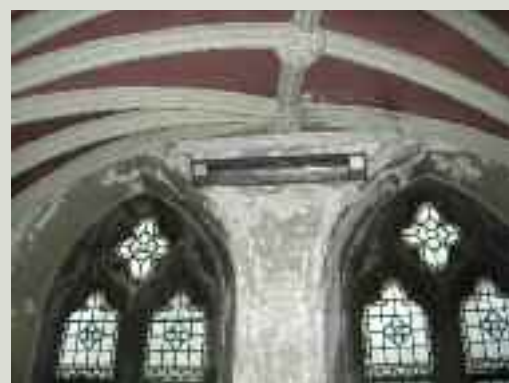
Church lighting and heating systems may evolve on an ad-hoc basis as funds become available. In this case, strip lights and electric bar heaters were fitted to some of the aisles. Conservation works to the church will include the removal of these fittings and repairs to the roof above to eradicate the damp in the wall

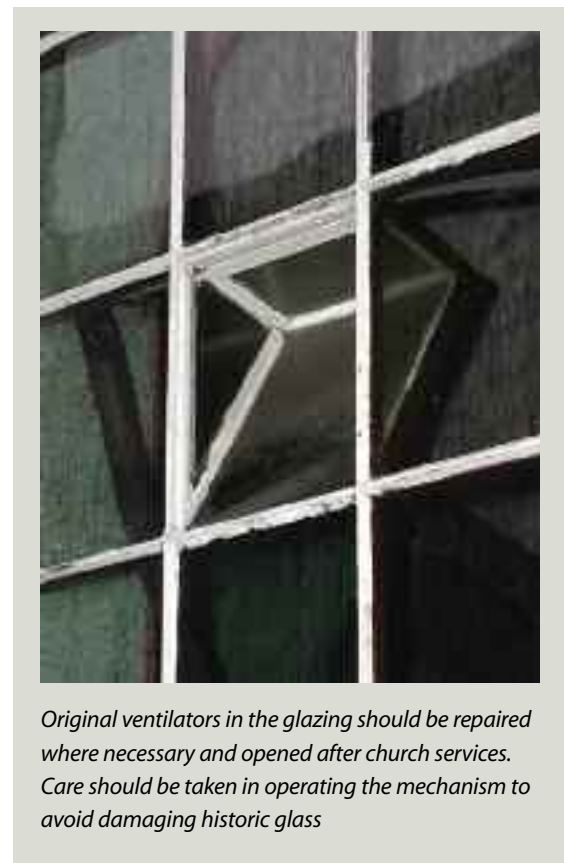
Original ventilators in the glazing should be repaired where necessary and opened after church services. Care should be taken in operating the mechanism to avoid damaging historic glass
