**Stage 2 Road Safety Audit,  
Dublin Street North, Regeneration  
Scheme, Monaghan Town**

**Document Control Sheet**

<b>Client:</b>	Monaghan County Council
<b>Document No:</b>	241701-ORS-XX-XX-RP-TR-13g-001_S2_RSA

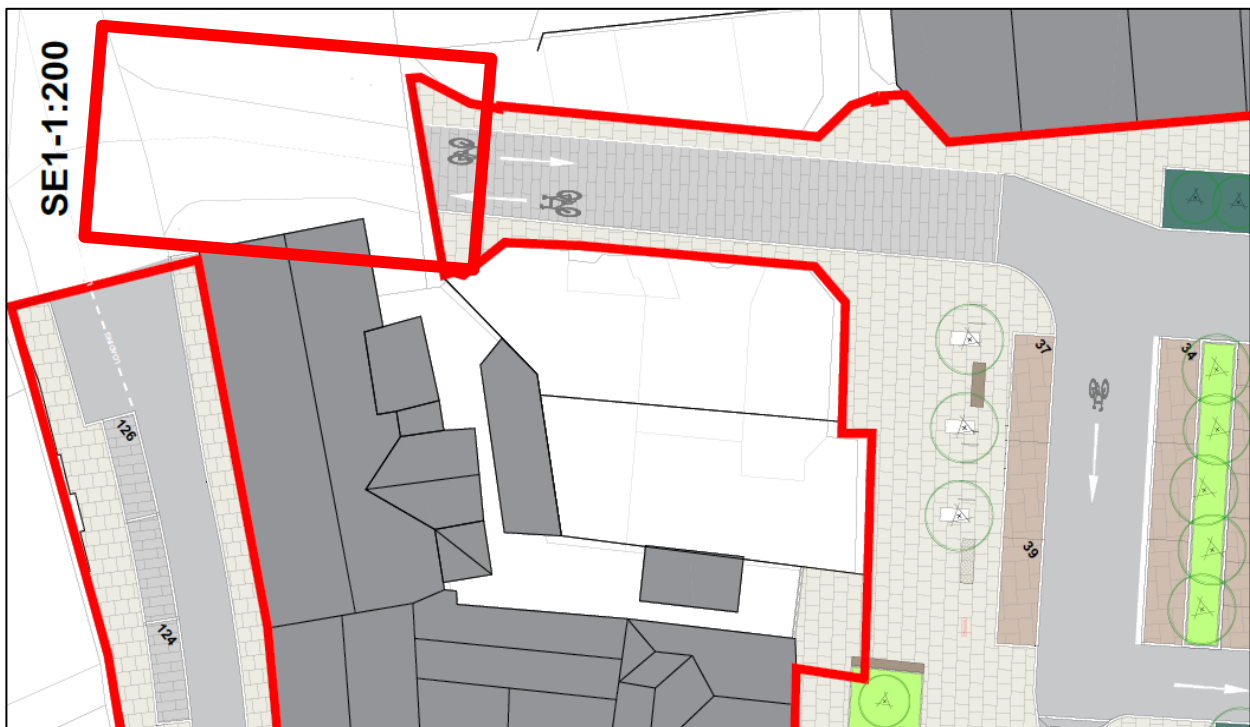
**Problem No.01: Cyclist Warning Signage and Road Markings (DBL-OPE-00-XX-DR-L-901301-Rev 04)**

The audit team note from the drawings provided that there is no cycle road markings or signage out to the junction with Dublin Street North to demonstrate that this is a shared surface with cyclists. The audit team has concerns that vehicles entering the site from Dublin Street North may not be aware of the change of road environment and may not change their driving habits to cater for the shared usage which could lead to collisions with cyclists.

The design team should provide appropriate road markings and signage to alert vehicles entering this area that they will be sharing the carriageway with cyclists traveling in both directions.

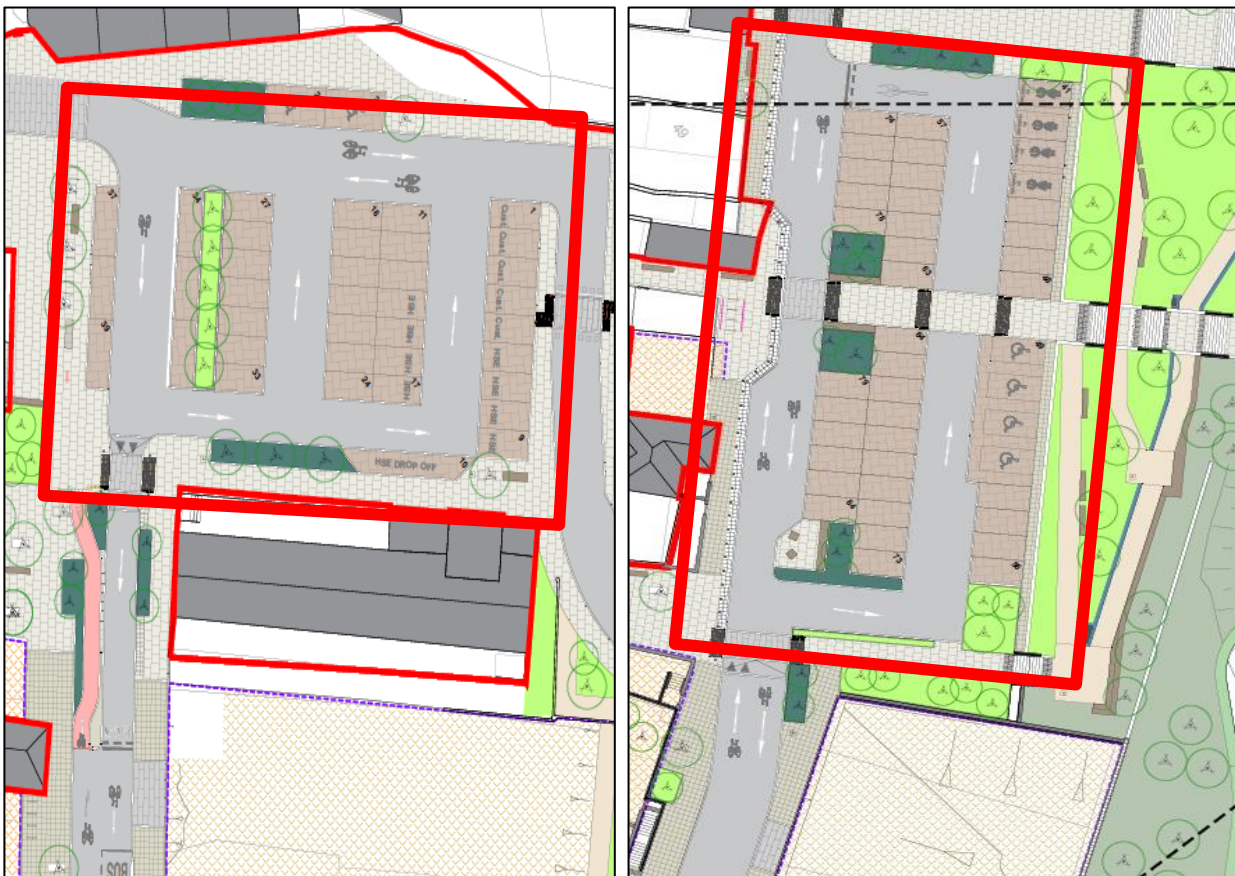
## Problem No.02: Road Markings within Car Park (DBL-OPE-00-XX-DR-L-901301-901302-Rev 04)

The audit team note from the drawings provided while there is direction of travel road markings for vehicles, no YIELD, STOP or No Entry Road markings or signage are detailed to give clear instructions to motorists of the priority of junctions and how the car park is to be used. The audit team has concern's that vehicles may enter parking isles against the flow of traffic and that vehicles exiting the spaces may not expect vehicles traveling in this direction which could lead to side swipe type collisions or reversing excessive distances to exit leading to potential collisions with cyclists.

The design team should ensure that road markings and signage are provided for within the carpark area to control and direct motorists.

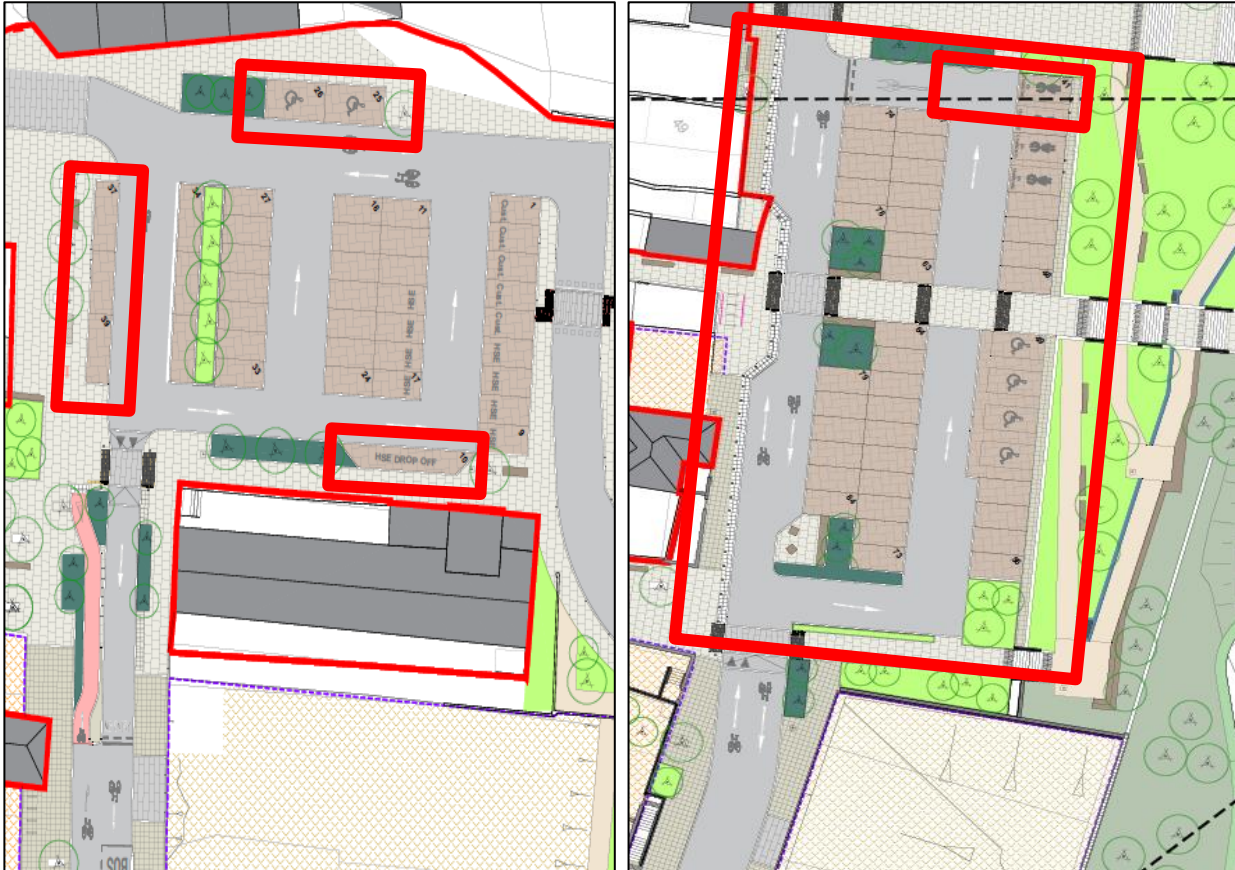
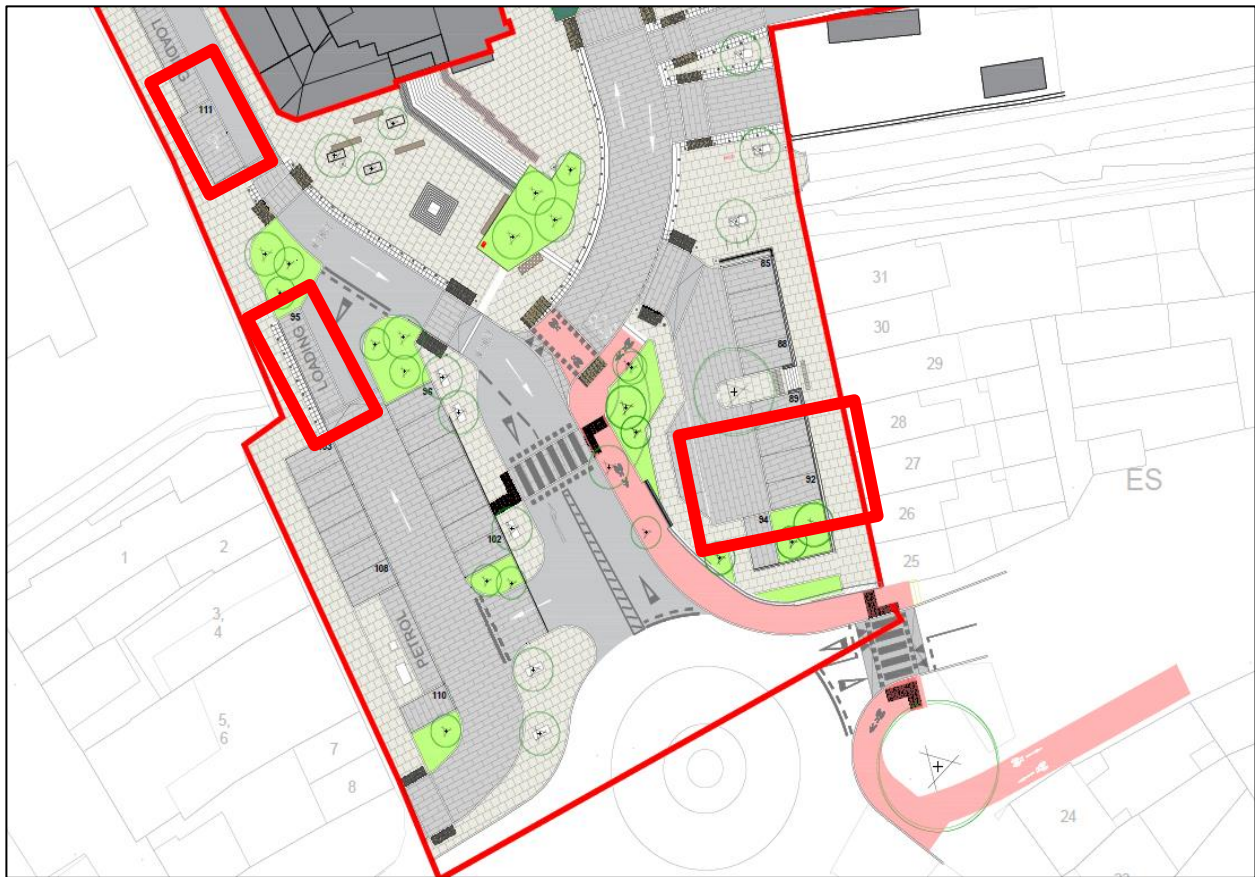
## Problem No.03: Restricted Car Parking Spaces (DBL-OPE-00-XX-DR-L-901301-901302-901304 Rev 04)

The audit team note from the drawing's provided that the parking spaces identified appear to be limited in space for entry and exiting. The audit team note that this could increase the risk of potential conflicts among vehicles or vehicle conflicts with cyclists or pedestrians as users may have to reverse onto the pedestrian footpath to exit the spaces.

The designers should ensure that vehicles can safely enter and exit these parking spaces.

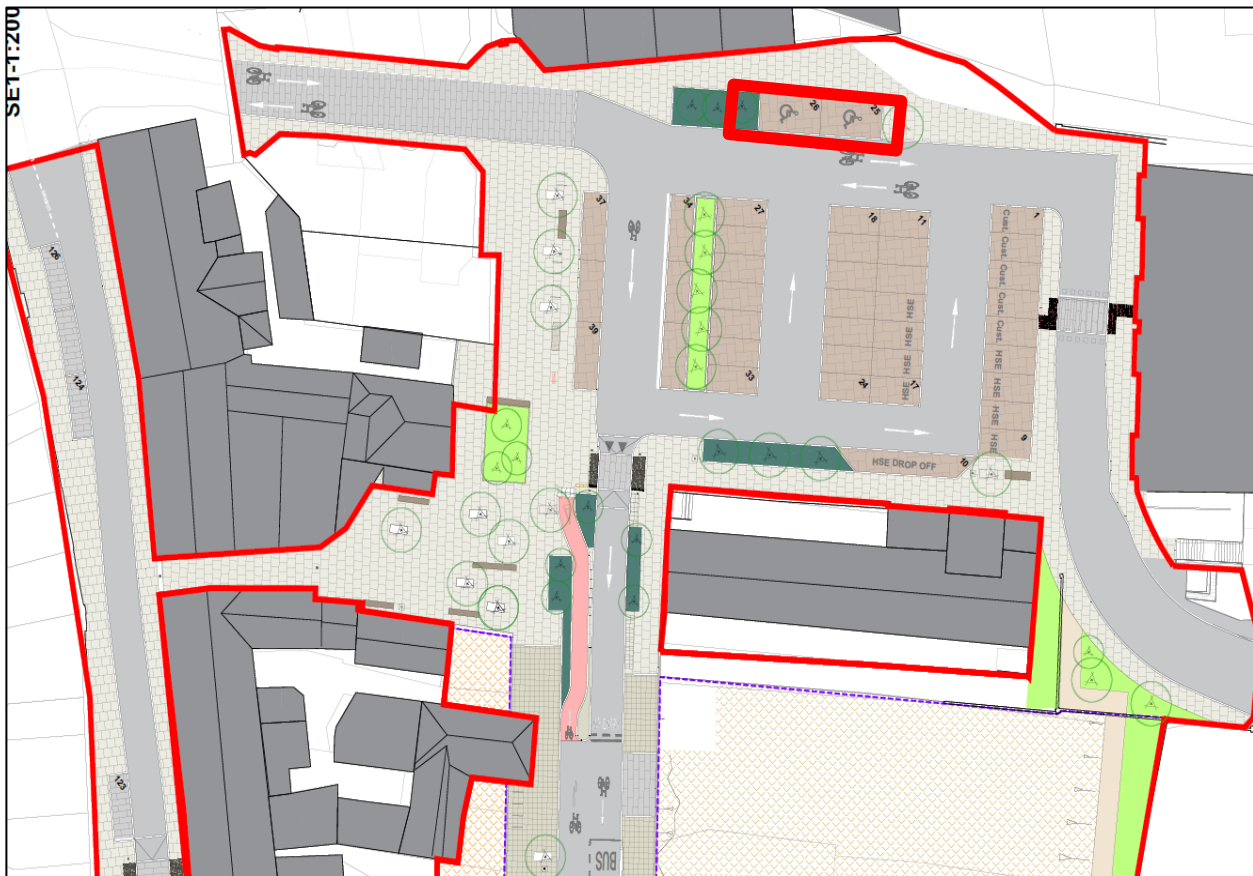
## Problem No.04: Disabled Parking Spaces Width (DBL-OPE-00-XX-DR-L-901301-Rev 04)

The audit team note from the drawing's provided that there is two disabled parking spaces provided. It is not clear from the drawings provided that the spaces are the appropriate width to facilitate safe entry and exit from vehicles for mobility impaired users and that the appropriate dropped kerbing to access the footpath is provided. The audit team is concerned that if the spaces are not the appropriate width that mobility impaired users of the spaces will not have the required space to safely enter and exit their vehicles. The users of the spaces may also have to travel excessive distances to a dropped kerb which may lead to mobility impaired users trying to access footpath at the closest location at a full height kerb leading to slips trips and falls.

The design team should provide appropriate space for the parallel accessible parking spaces to facilitate safe entry and exit to vehicles using the spaces and the appropriate dropped kerbing.

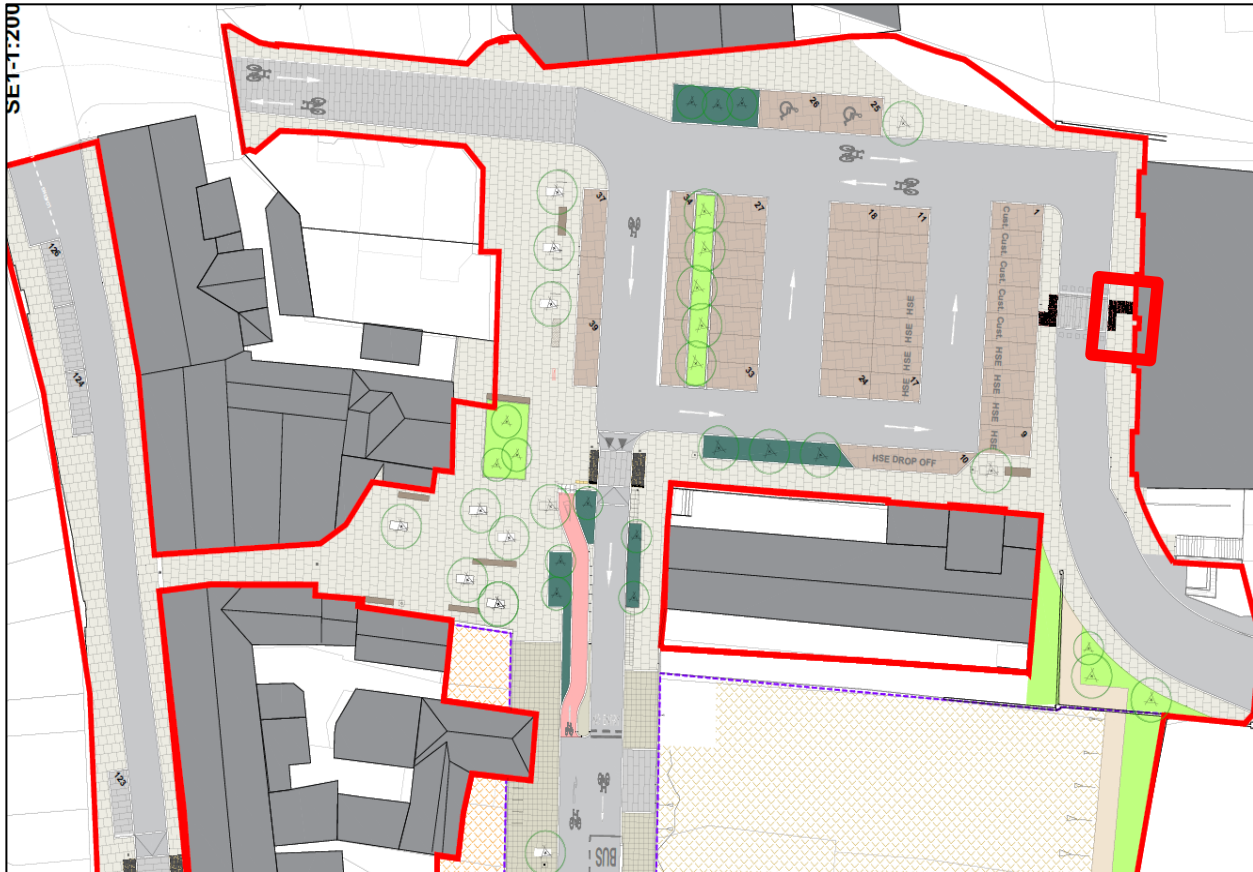
## Problem No.05: Proposed Controlled Crossing (DBL-OPE-00-XX-DR-L-901301-Rev 04)

The audit team note from the drawings that there is a proposed controlled crossing at the location identified. It appears from the site visit that the crossing location is at the door of one of the retail units. There may be limited space in front of the unit to provide a level access, tactile paving for the controlled crossing and the beacon for the crossing which could lead to the footpath width being reduced below the minimum forcing pedestrians onto the carriageway.

The design team should locate the proposed crossing at a more suitable location to facilitate a consistent footpath width and maintaining the level access in front of the retail unit.

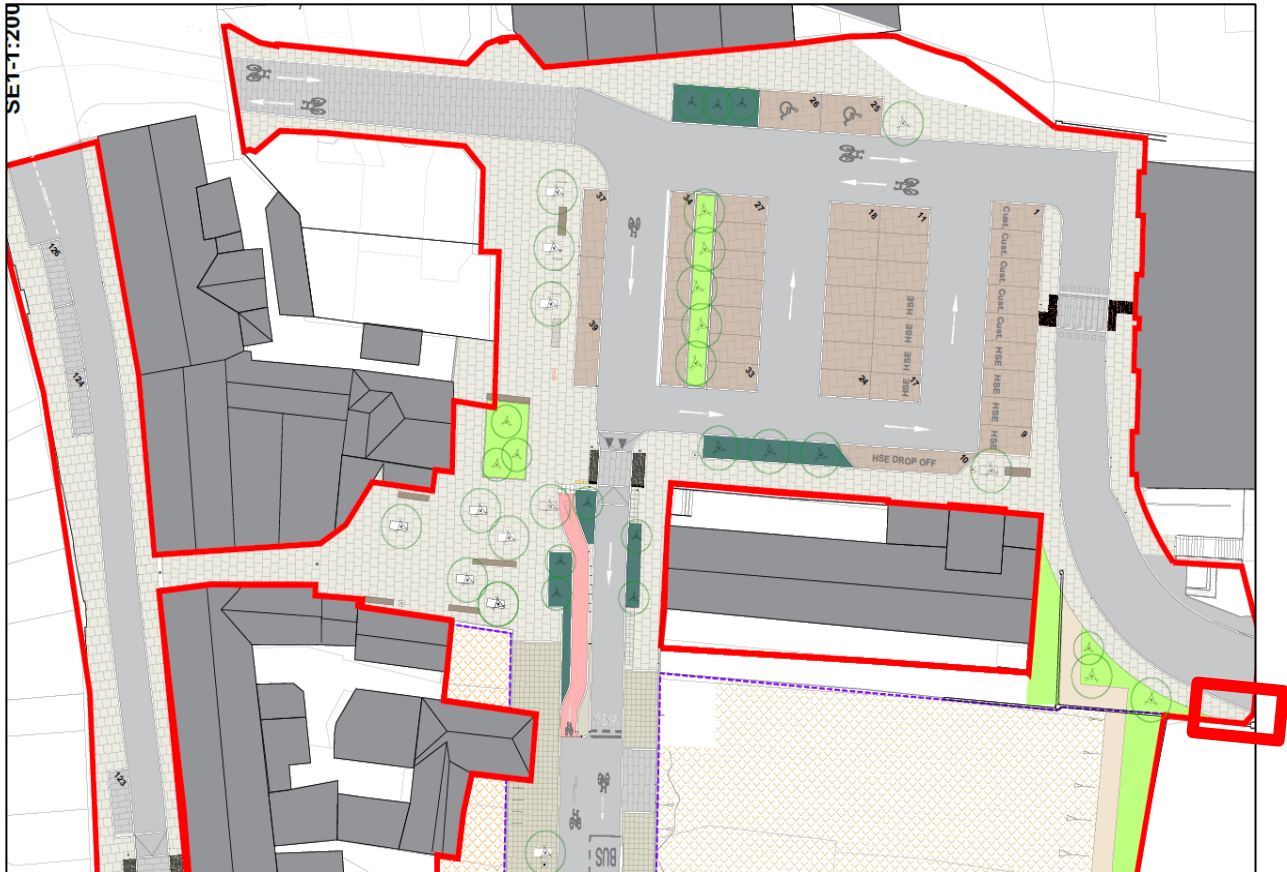
## Problem No.06: Termination of Proposed Footpaths (DBL-OPE-00-XX-DR-L-901301-Rev 04)

The audit team note from the drawings that the proposed footway works do not appear to connect into any existing pedestrian infrastructure within the area. Lack of an appropriate tie-in to an existing footpath or termination could lead to pedestrian confusion, slips, trips or collisions with vehicles on the carriageway.

The design team should provide provision for appropriate termination of the proposed footpath along with any tactile paving and signage.

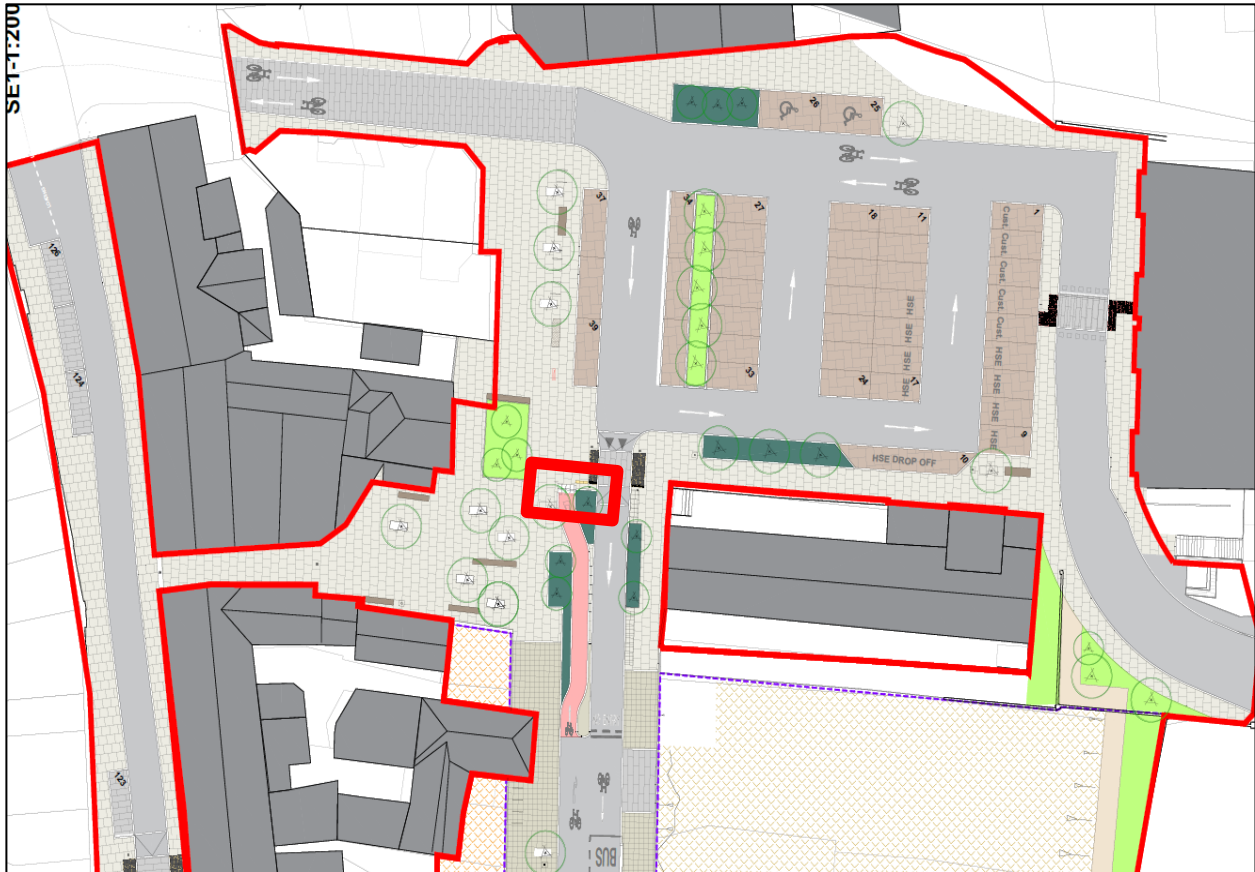
## Problem No.07: Termination of Cycle track (DBL-OPE-00-XX-DR-L-901301-Rev 04)

The audit team note from the drawings that the proposed dedicated cycle track terminates at the location identified. It is unclear if the appropriate tramline tactile paving and signage are being provided to alert cyclists of the termination of the cycle track. Lack of appropriate signage and tactile paving could lead to cyclists entering the dedicated pedestrian area and this could lead to collisions between cyclists and pedestrians.

The design team should provide for appropriate termination tactile paving and signage on the cycle track.

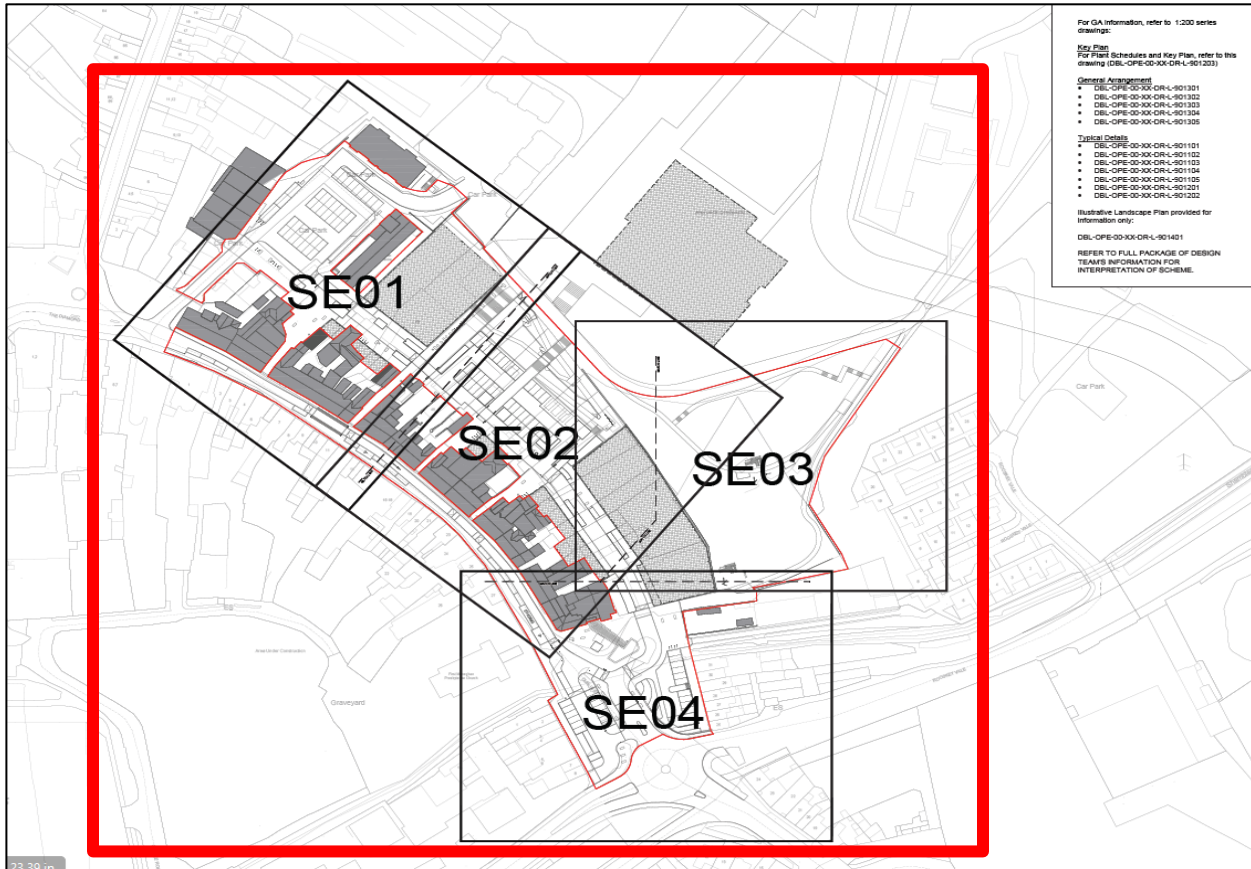
## Problem No.08: Swept Path Analysis (DBL-OPE-00-XX-DR-L-901301-04-Rev 04)

The audit team note from the drawings provided that there is no swept path analysis for service vehicles or buses that must enter the scheme. It is unclear if there is sufficient space to facilitate larger vehicles especially those that must access daily. Lack of swept path analysis for the scheme could lead to instances where vehicles mount footpaths and cycle tracks which could lead to collisions with pedestrians and cyclists.

The design team should provide swept path analysis for the scheme detailing how service vehicles and buses can safely enter and exit the scheme.

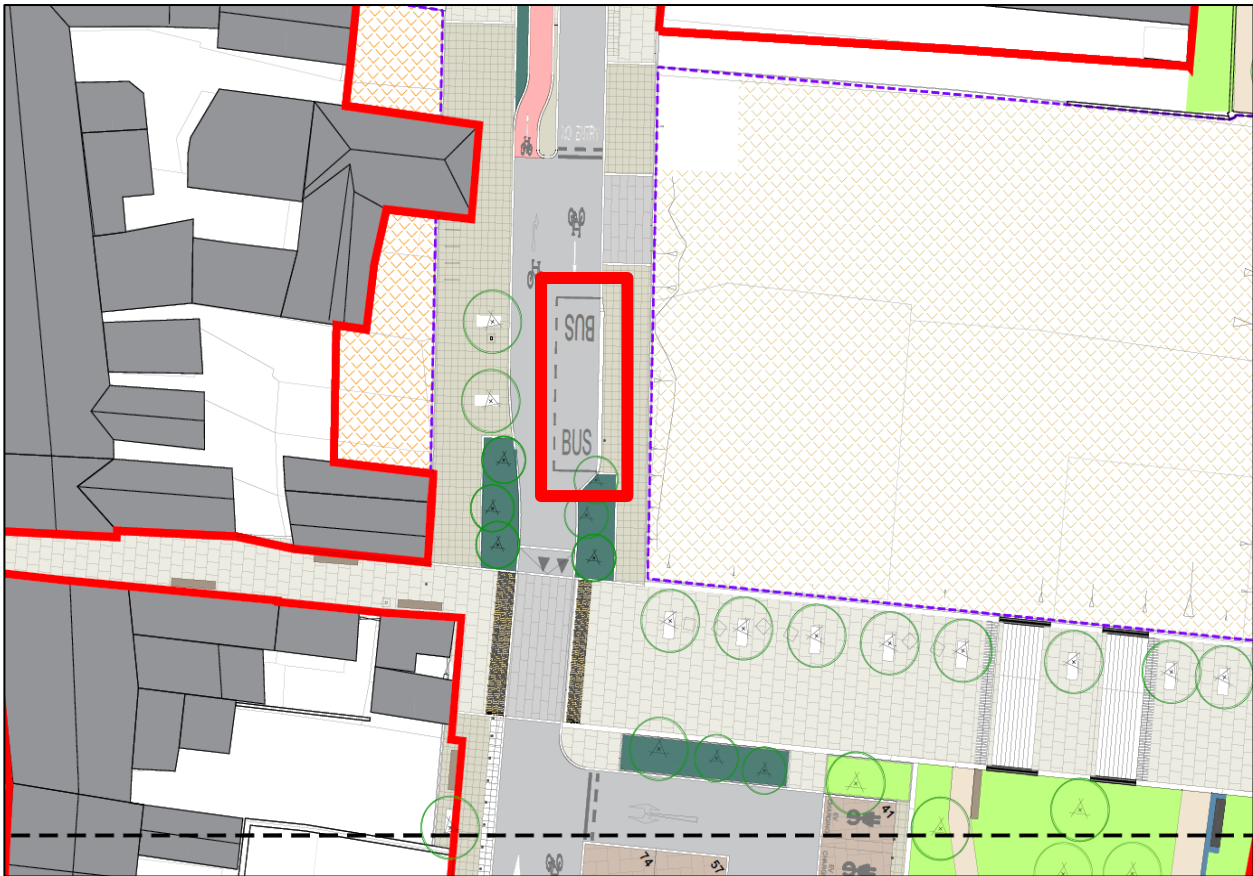
## Problem No.09: Bus Stop (DBL-OPE-00-XX-DR-L-901301-Rev 04)

The audit team note from the drawings provided at the location identified. It is unclear from the drawings provided if hazard warning tactile paving, kassel kerbs and the bus stop pole are being provided. The audit team has concerns that visually impaired users may not identify the edge of the bus stop if the appropriate hazard warning tactile paving is not provided, and mobility impaired users may have a higher step up or down from a bus if Kassel kerbs are not provided. This could lead to slips, trips and falls.

The design team should ensure that the bus stop is provided with the appropriate hazard warning tactile paving, Kassel kerbs and the location of the bus stop pole is not in the line of the footpath.

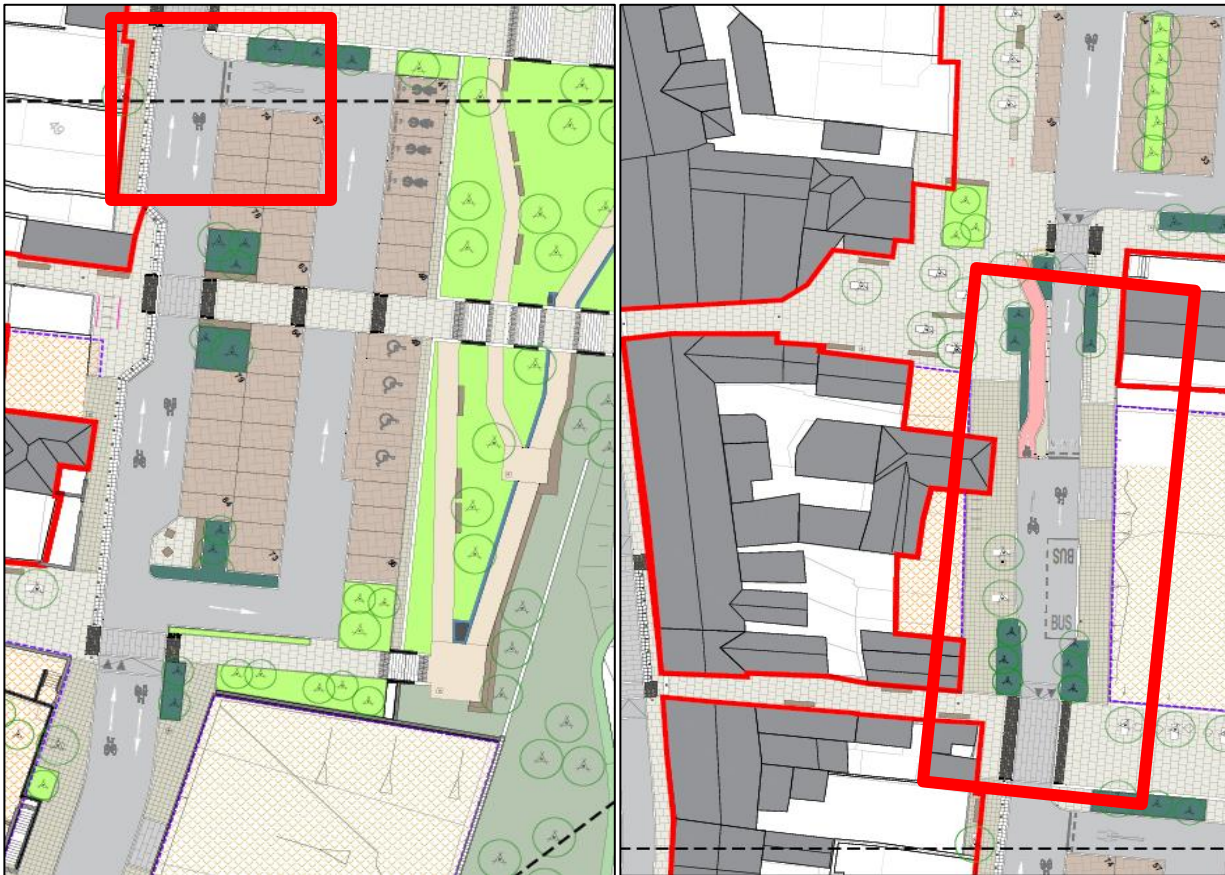
## Problem No.10: Conflicting Road Markings (DBL-OPE-00-XX-DR-L-901301-901302-Rev 04)

The audit team note from the drawings provided that there appears to be conflicting road markings. Approaching from the north appears to be a one-way system whereas the road markings in the southern car park indicates that two-way travel is possible. The audit team has concerns that these conflicting road markings could lead to motorists misunderstanding the layout and direction of travel around the car park which could lead to driver confusion which could lead to collisions.

The design team should provide clear road markings and signage around the car park and provide any No-Entry Road markings and signage where necessary.

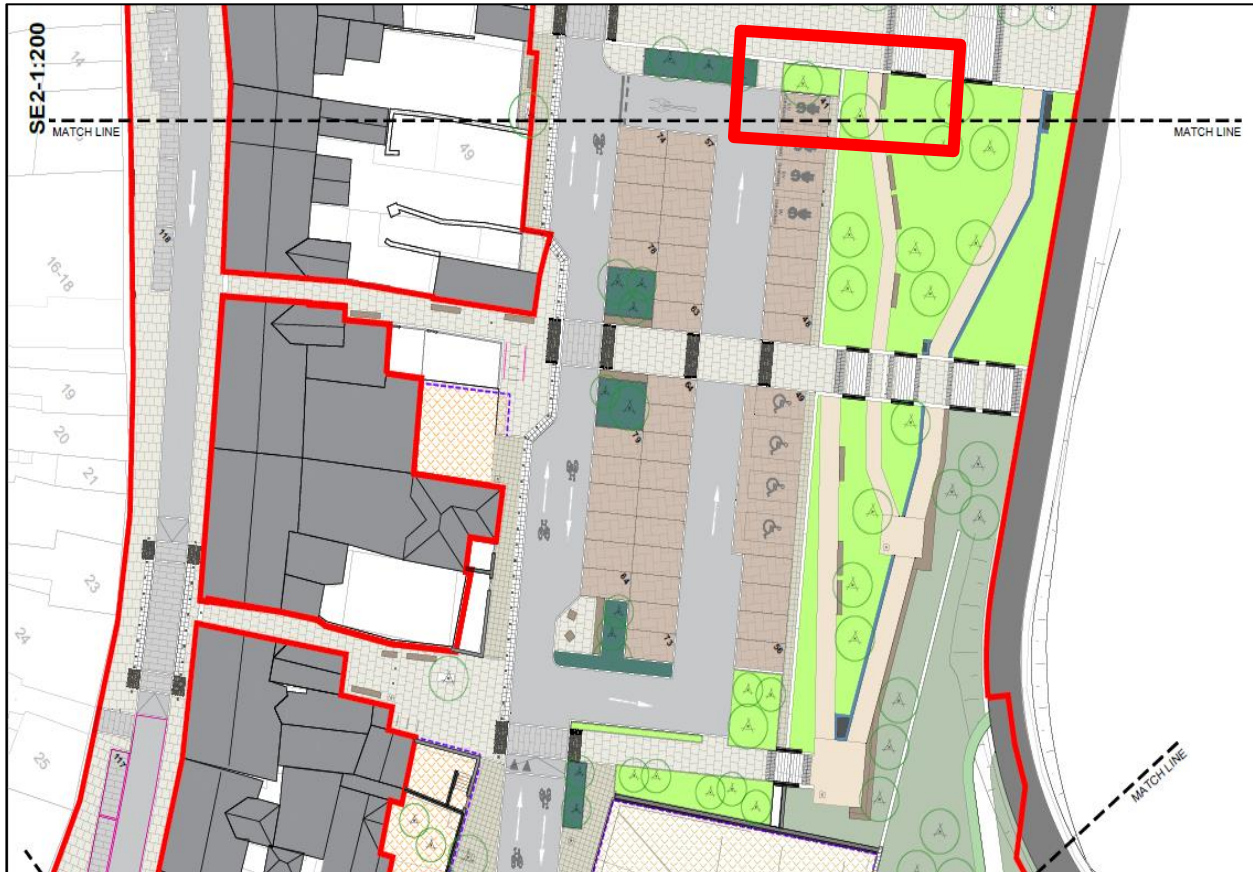
## Problem No.11: No Turning Area (DBL-OPE-00-XX-DR-L-901302-Rev 04)

The audit team note from the drawings provided that vehicles exiting the spaces identified may find it difficult to exit the space and be orientated the incorrect way for the one-way system. The audit team is concerned that vehicles exiting these spaces may have to reverse an excessive distance to exit the space and be orientated correctly. This could lead to instances whereby a vehicle exiting the space could be reversing into on-coming traffic.

The design team should ensure that vehicles have the appropriate turning space and can exit the spaces and be orientated in the correct direction to exit in forward gear.

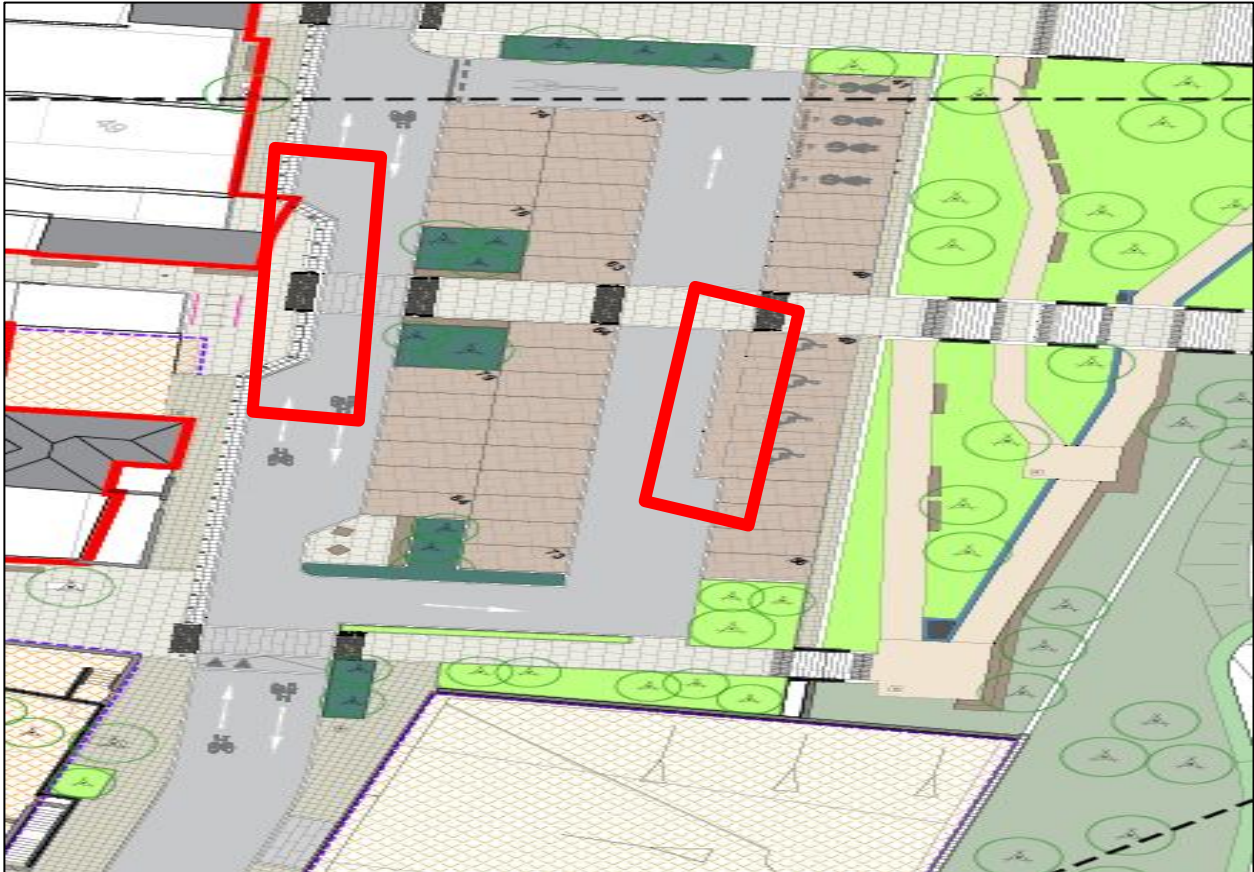
## Problem No.12: Sudden Road Narrowing (DBL-OPE-00-XX-DR-L-901302-Rev 04)

The audit team note from the drawings provided that the driving isle suddenly narrows. The audit team is concerned that this sudden narrowing could lead to abrupt manoeuvres from motorists. This could lead to instances whereby a vehicle collides with a narrowing to the west or wheelchair users exiting their vehicles to the east.

The design team should ensure that the appropriate signage and road markings are provided to alert motorists to the upcoming narrowing.

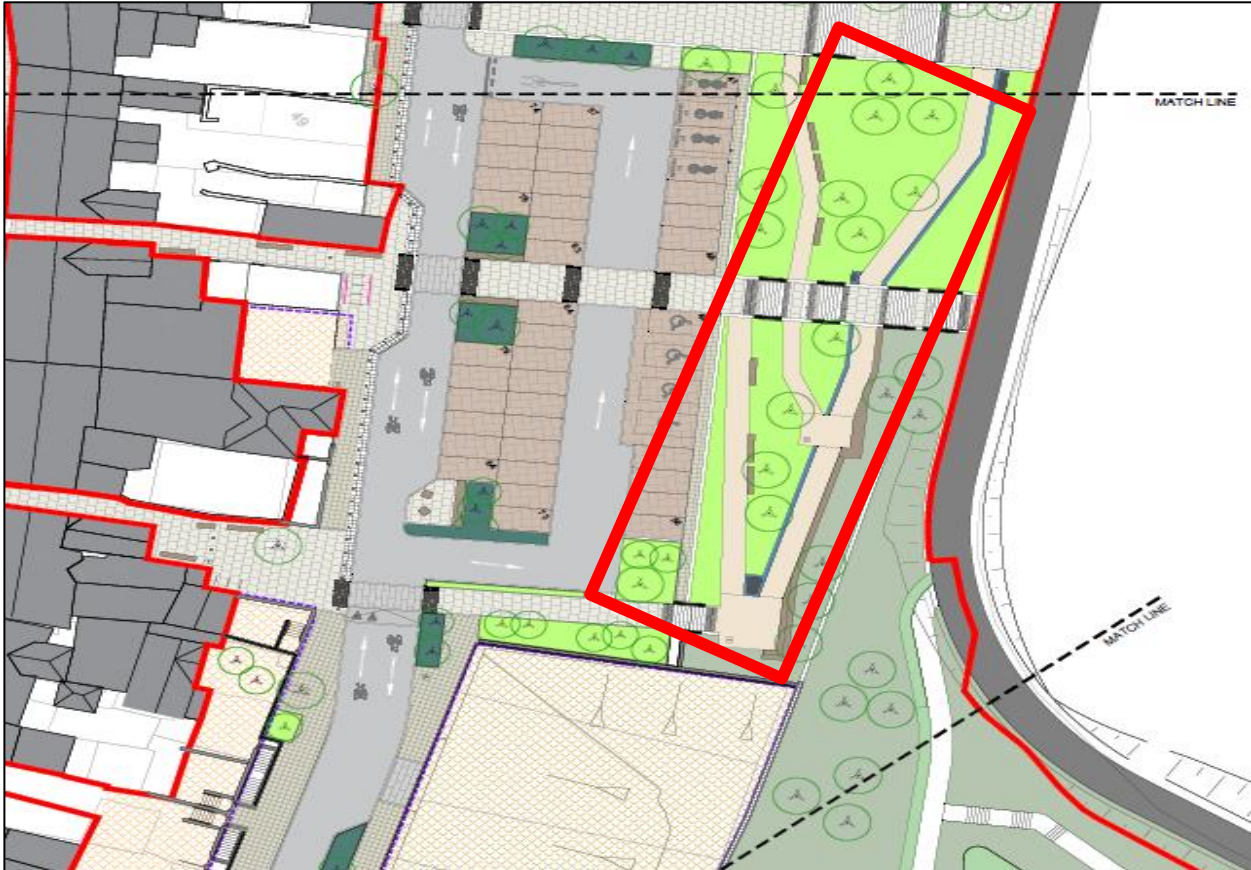
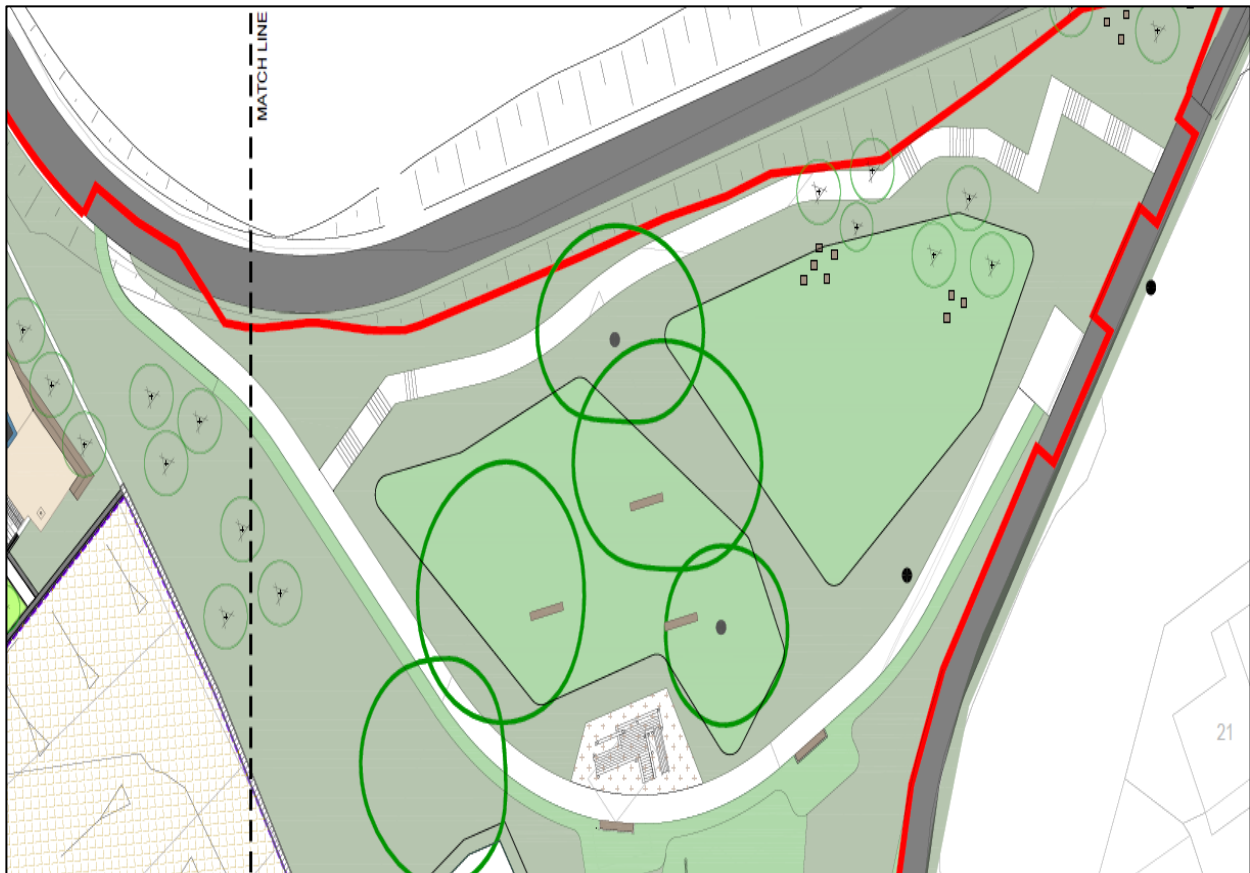
## Problem No.13: Footpath Gradients (DBL-OPE-00-XX-DR-L-901302-901303 Rev 04)

The audit team note from the drawings provided that there are no levels or gradients provided on the proposed footpaths or steps. It is unclear from the drawings provided if the footpaths are considered ramps or gently sloping. The lack of gradients and levels could result in inappropriately positioned intermediate landings, with a lack of rest areas leading to slips, trips or falls.

The design team should provide details of the gradients and levels for the proposed footpath and ensure that no gradient is too steep or an individual ramp flight too long.

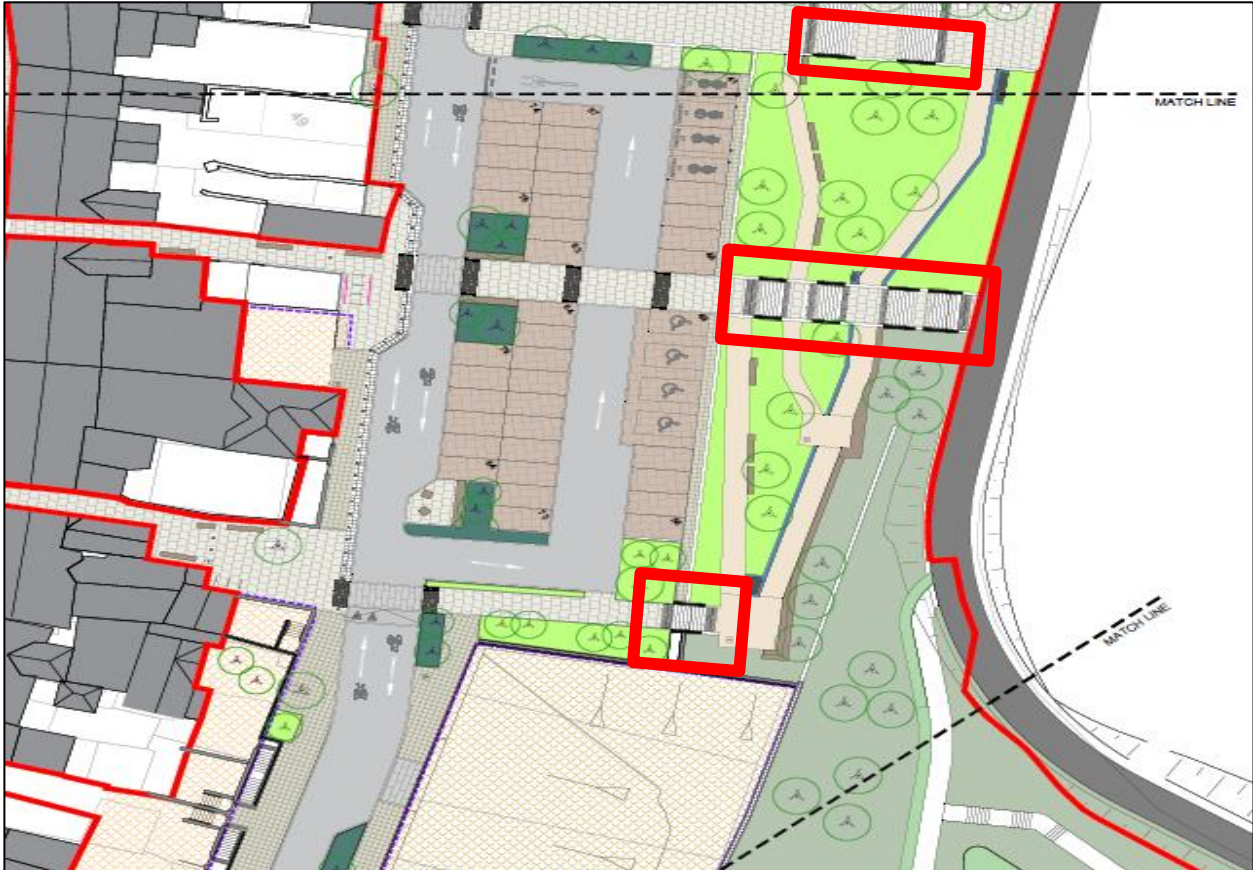
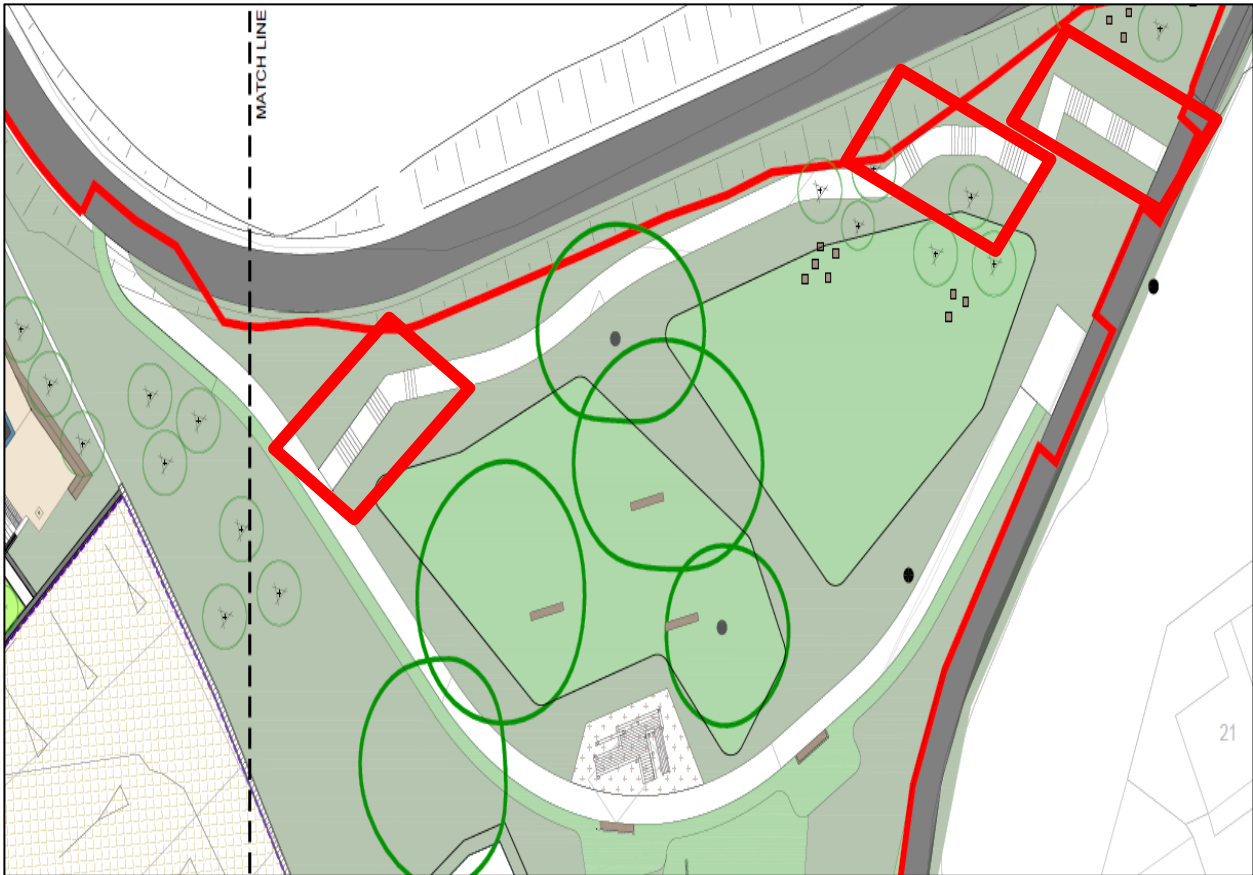
## Problem No.14: Hazard Tactile Paving (DBL-OPE-00-XX-DR-L-901302-901303 Rev 04)

The audit team note from the drawings provided that it is unclear if hazard tactile paving is being provided at the top, intermediate and bottom of the flights of steps. Visually impaired users may not comprehend that they are at the top or bottom of the flight of steps. Additionally, a visually impaired user may enter the intermediate landing where the path crosses not being aware of the hazard each side.

The design team should provide hazard warning tactile paving at the top, bottom and intermediate landings including where the paths cross the flight of stairs.

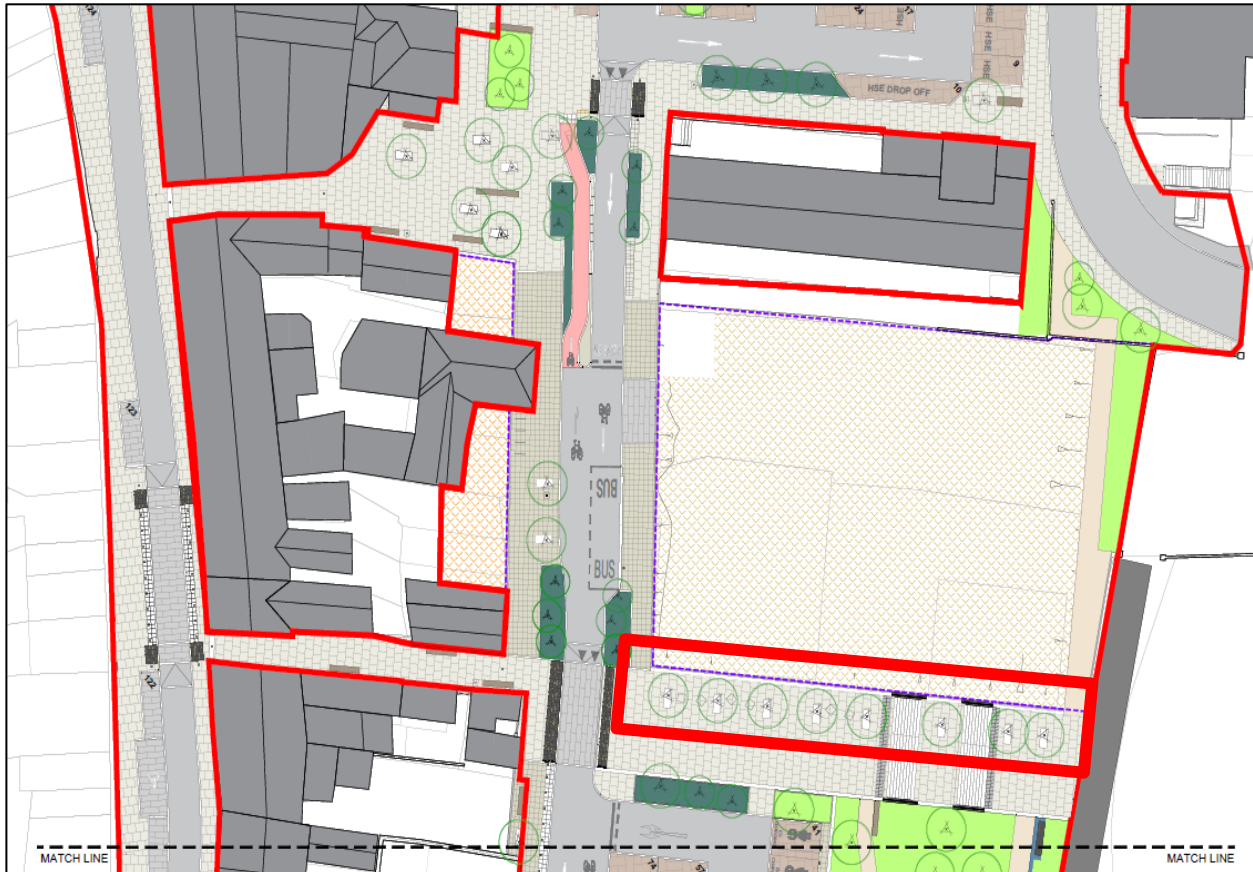
## Problem No.15: Inappropriately Located Landscaping (DBL-OPE-00-XX-DR-L-901301-Rev 04)

The audit team note from the drawings provided there is landscaping provided in the line of travel of the external stairs. Visually Impaired and Mobility Impaired users especially will have to adjust the path at which they navigate the stairs to manoeuvre around the trees. Additionally, this reduces the space to the handrails on splitting the flights and could lead to slips and trips.

The design team should position landscaping to not impeded the line of travel for the external steps especially where the central handrail extends out past the line of the steps.
