**Stage 2 Road Safety Audit,  
Dublin Street North, Regeneration  
Scheme, Monaghan Town**

**Document Control Sheet**

<b>Client:</b>	Monaghan County Council
<b>Document No:</b>	241701-ORS-XX-XX-RP-TR-13g-001_S2_RSA

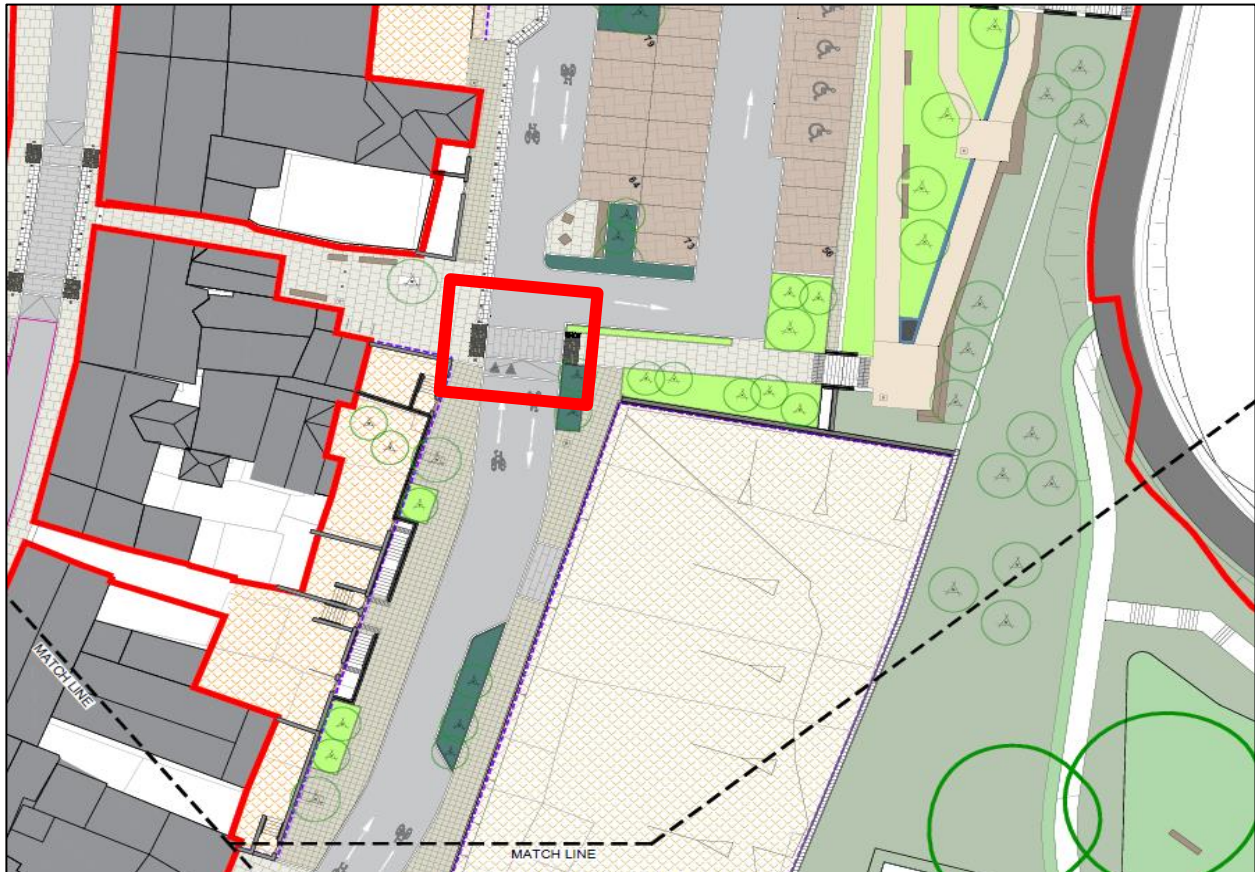
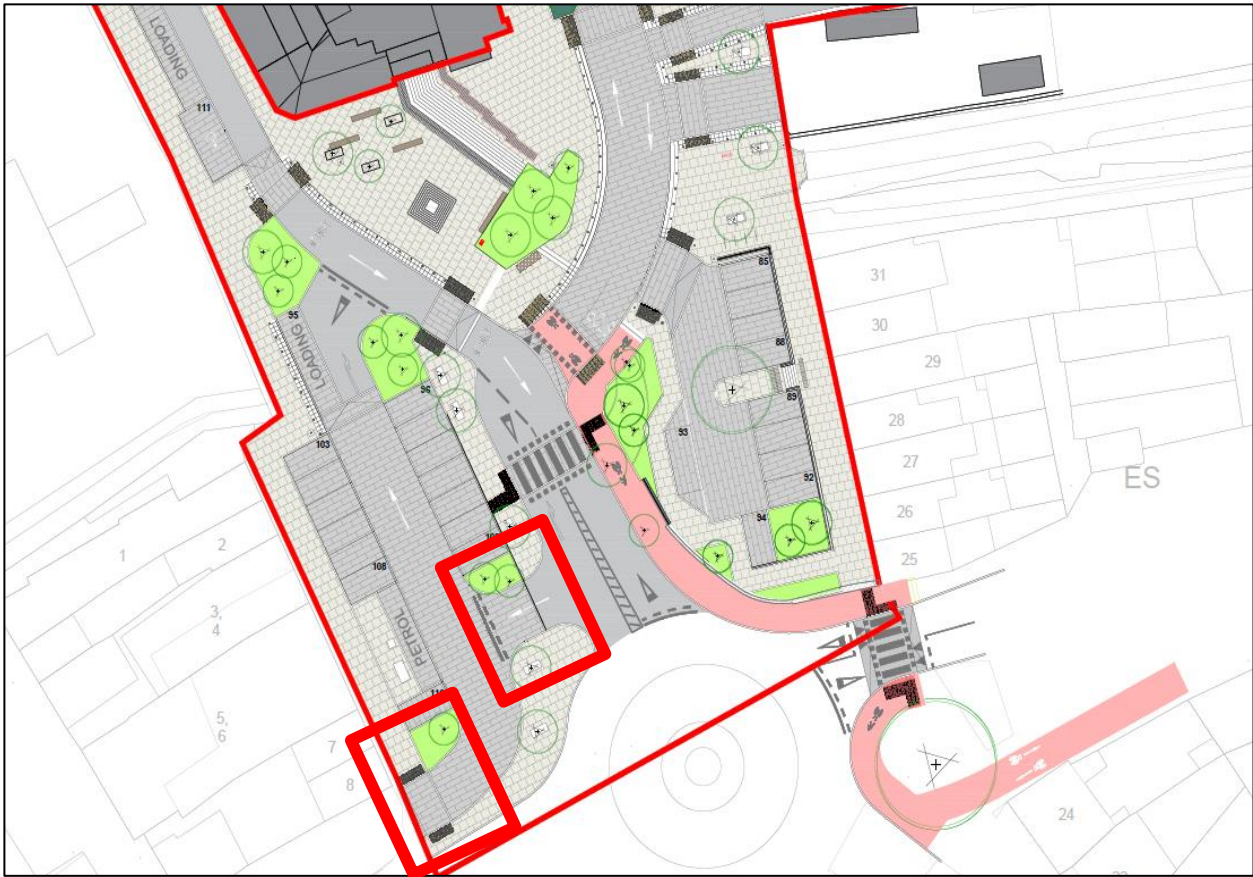
## Problem No.16: Incomplete Raised Table (DBL-OPE-00-XX-DR-L-901302-901304 Rev 04)

The audit team note from the drawings provided there is an incomplete raised table shown at the location identified. It is unclear if the whole area is to be raised in the car park. The audit team has concerns that if it is intended to be raised that vehicles could mount footpaths/shared surfaces causing collisions with vulnerable road users.

The design team should detail the extents of the raised area or if it is intended to be a raised table for a crossing. Also, any ramped area should not obstruct the driving isle around the car park.

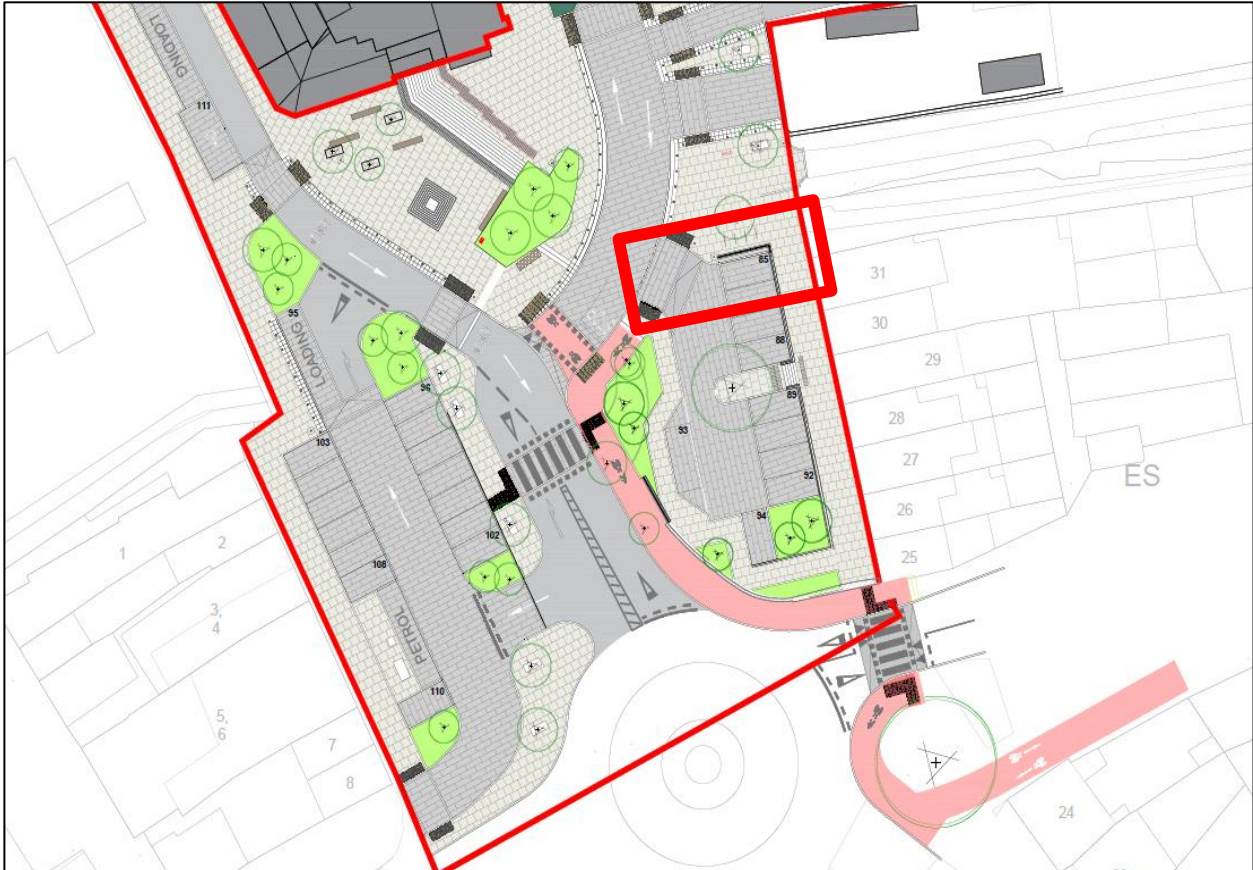
## **Problem No.17: Car Parking Spaces at Junction (DBL-OPE-00-XX-DR-L-901304-Rev 04)**

The audit team note from the drawing's provided that the parking spaces identified appear to be difficult to exit safely. The audit team has concerns that this may lead to instances where vehicles reverse out of the spaces across the raised table and onto the main road to exit and be orientated in the incorrect direction. The audit team has concerns that this will lead to unsafe driver behaviour and cause vehicle to vehicle collisions or collisions with pedestrians on the crossing.

The designers should remove the parking spaces identified to prevent unsafe driver behaviour.

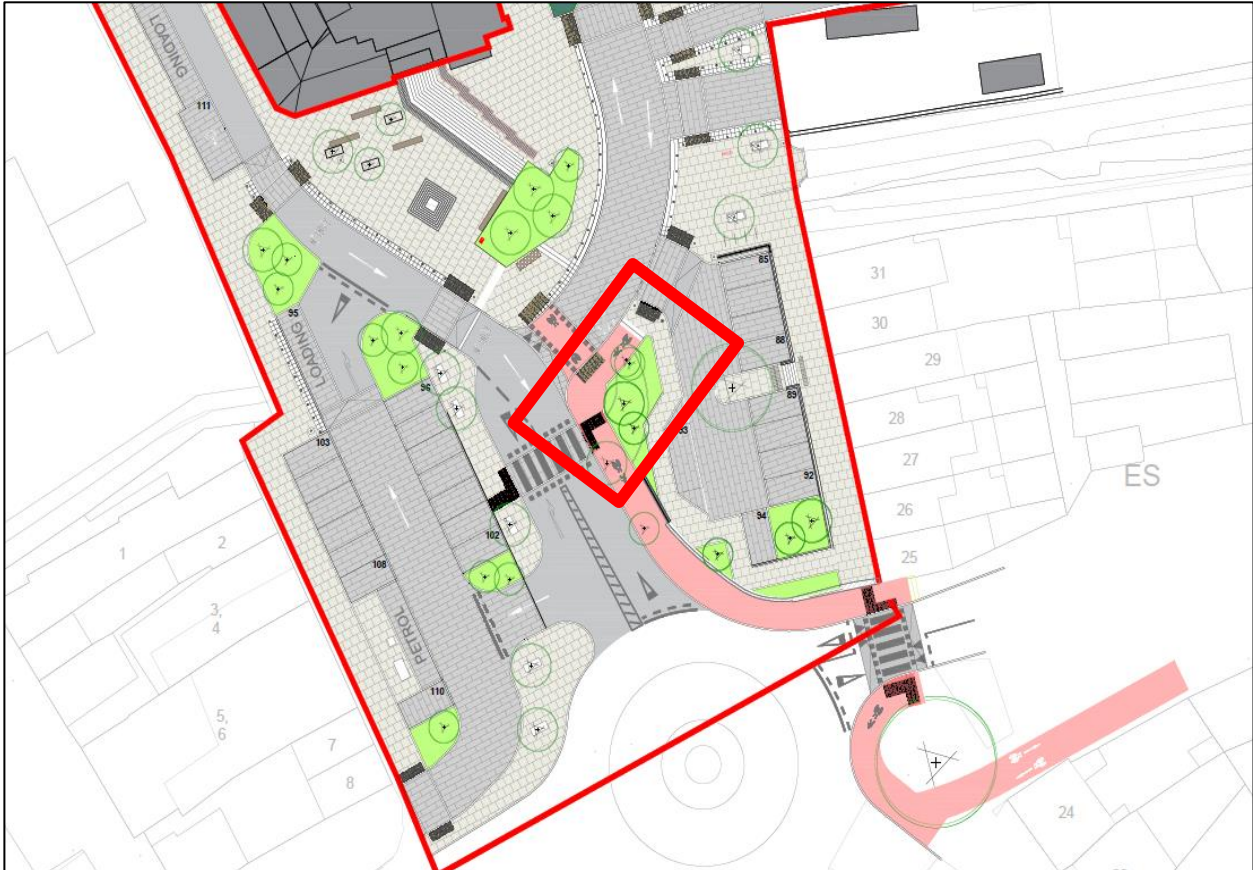
## **Problem No.18: Termination of Shared Surface at Crossings (DBL-OPE-00-XX-DR-L-901304-Rev 04)**

The audit team note from the drawing's provided that the appropriate corduroy hazard warning paving is not provided. The audit team has concerns that this may lead to instances where cyclists travel through controlled crossings and cycle on the footpaths leading to collisions with pedestrians on the footpath or vehicles at uncontrolled crossings.

The designers should provide the appropriate corduroy hazard warning paving at the termination of the shared surface and at the controlled crossing zone.

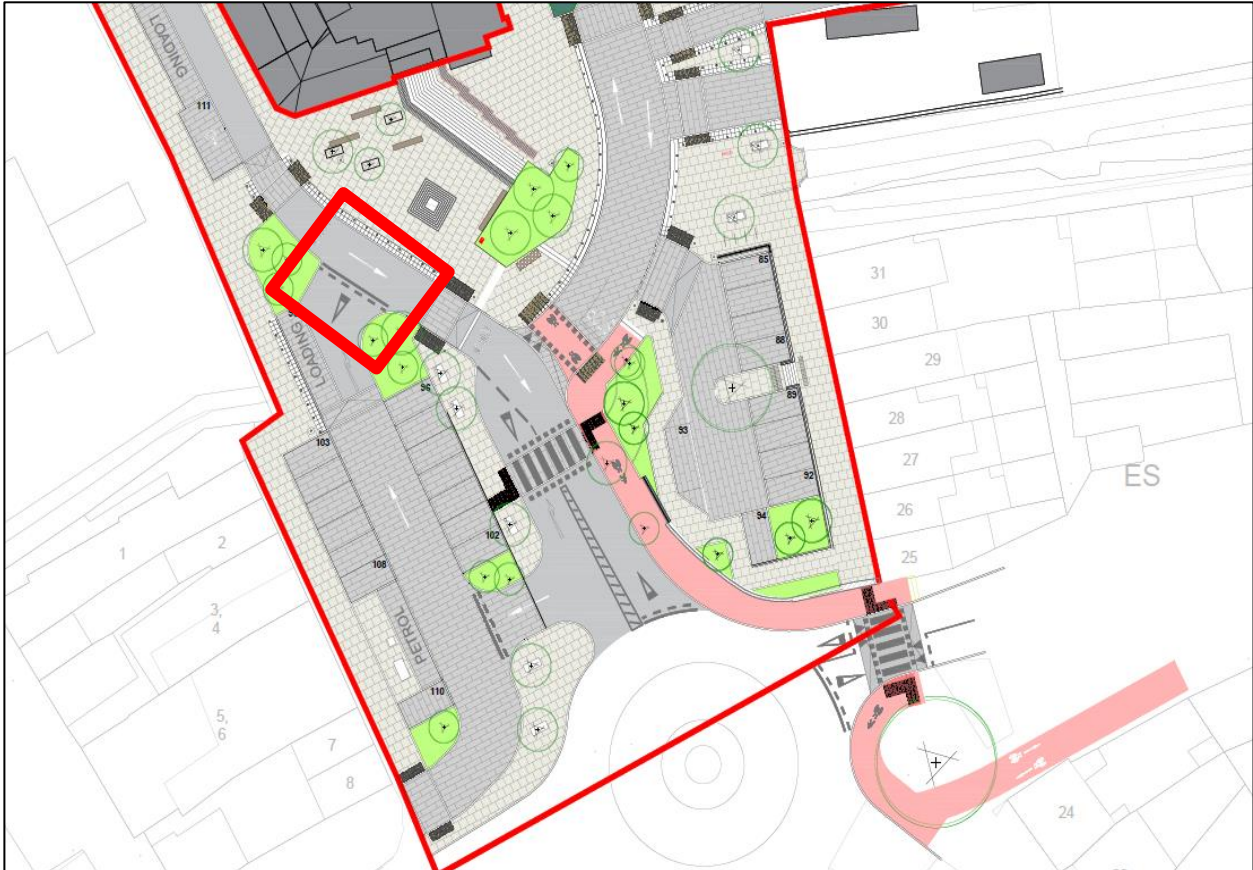
## Problem No.19: Right Turn at Filling Station (DBL-OPE-00-XX-DR-L-901304-Rev 04)

The audit team note from the drawing's provided that vehicles exiting the filling station can only turn right. It is unclear if HGV's and vehicles exiting the filling station can make this right turn without mounting the footpath on the northern side of the road. The audit team has concerns that this could lead to vehicles mounting the footpath causing collisions with pedestrians. It could also lead to vehicles reversing back into the filling station to achieve a better angle to make the turn.

The designers should provide a swept path analysis detailing HGV's and Cars exiting the filling station and turning right.

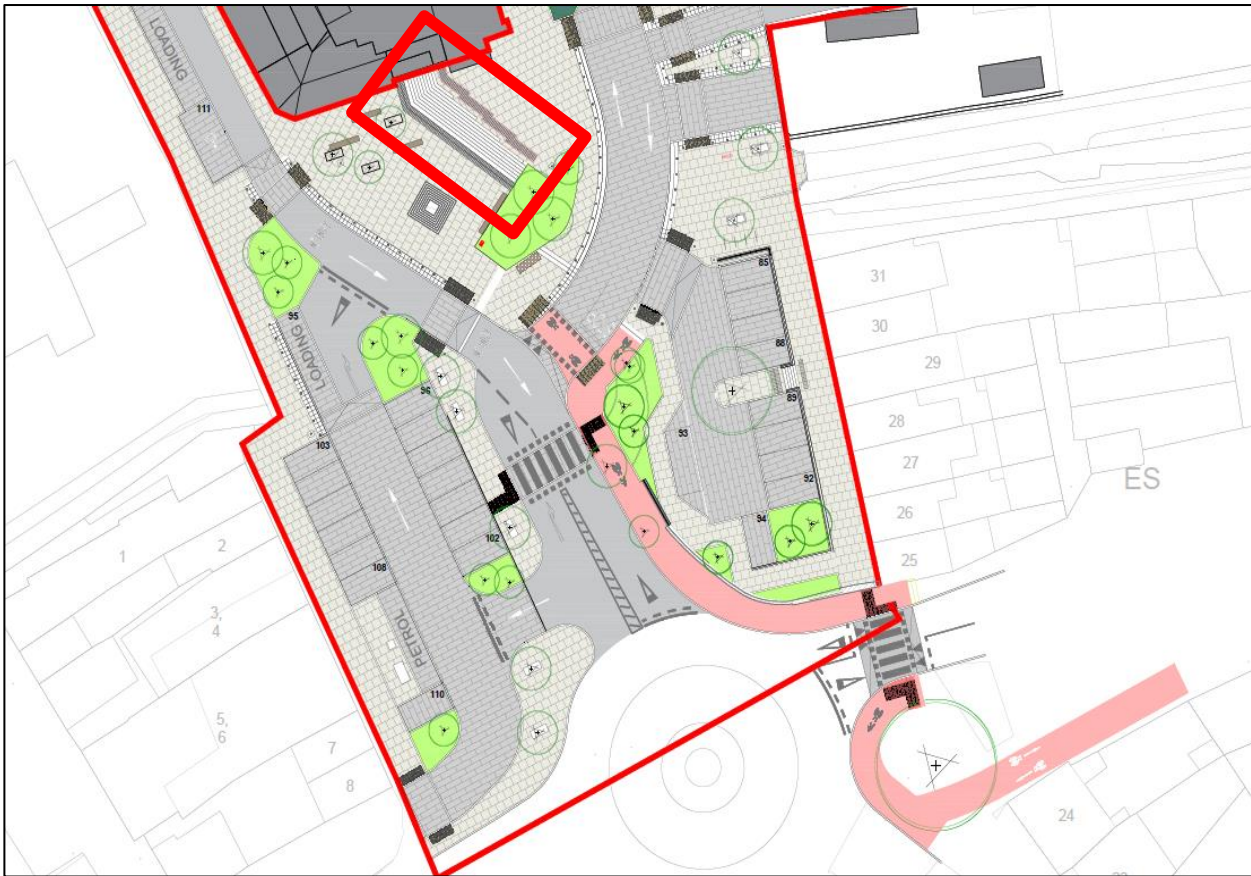
## **Problem No.20: Colour at Locations Other than Crossings (DBL-OPE-00-XX-DR-L-901303-Rev 04)**

The audit team note from the drawings provided that the paving in the location identified is called up as Granite Aggregate Precast Paving Units which is unlikely to be a good colour contrast between path and any hazards i.e. the external steps. Some visually impaired users rely on the colour contrast in materials to determine the location of hazards and the edge of the threads in steps. Some visually impaired users may fail to note any warning paving on the ramp and steps.

The designers should provide materials that achieves a good colour contrast and that the edge of the threads contrast to the rest of the step.

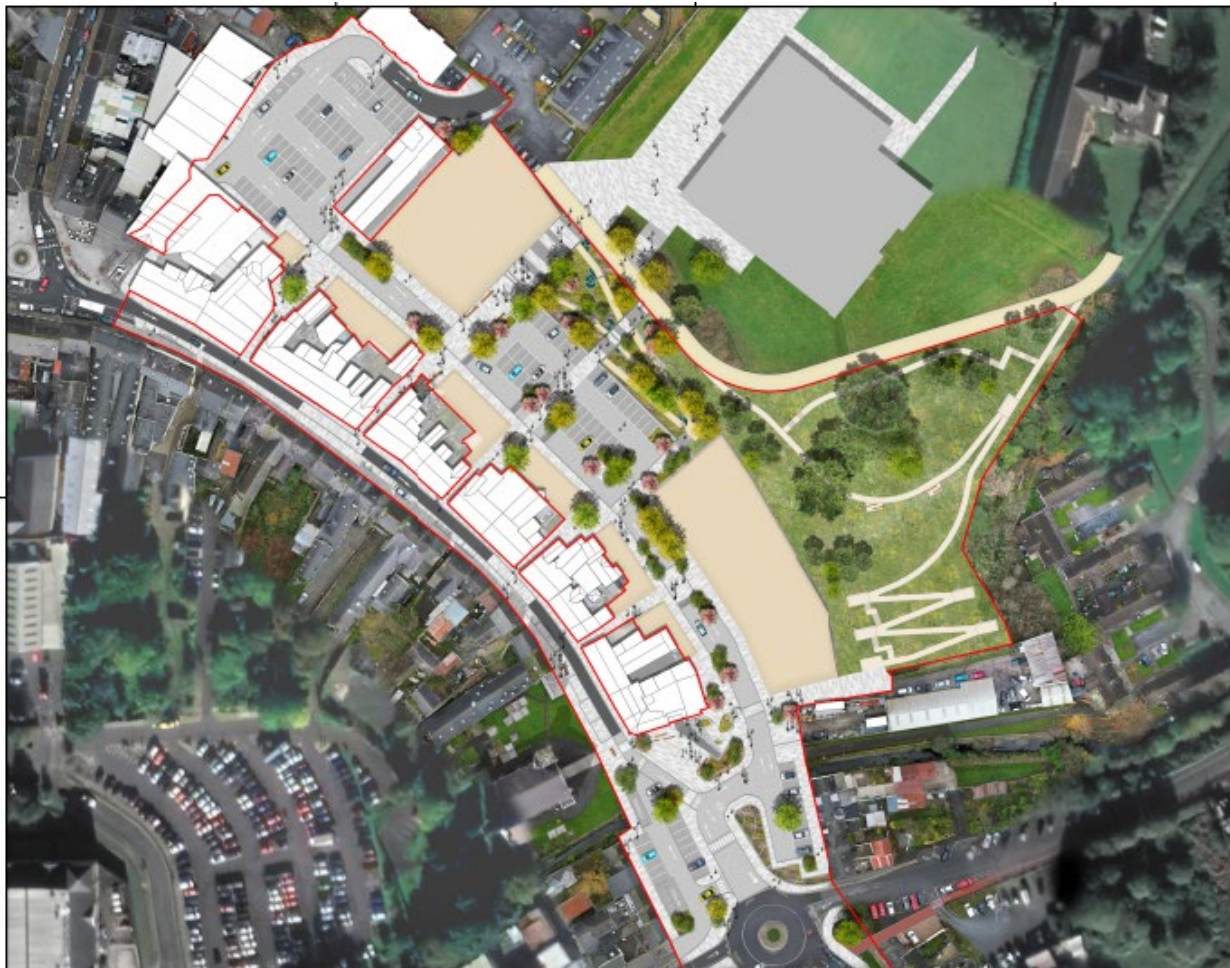
**Figure 2.2:** Site Layout (Source: Open Optimised Environments Ltd)

**Figure 2.2** shows the proposed site layout provided by Open Optimised Environments Ltd.

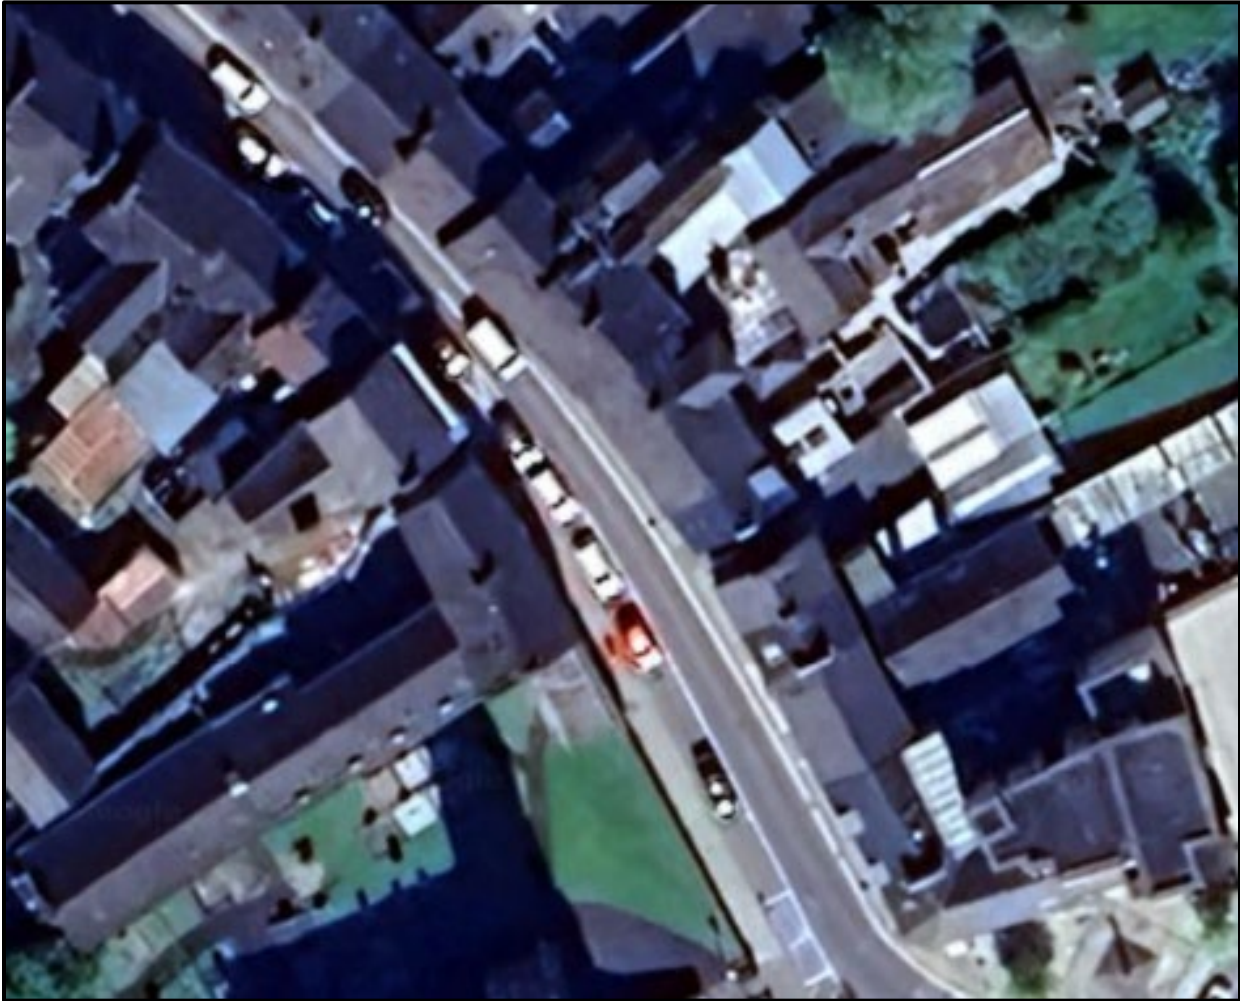
**Figure 2.3:** Pedestrian facilities along Dublin St. (Source: Google Earth)

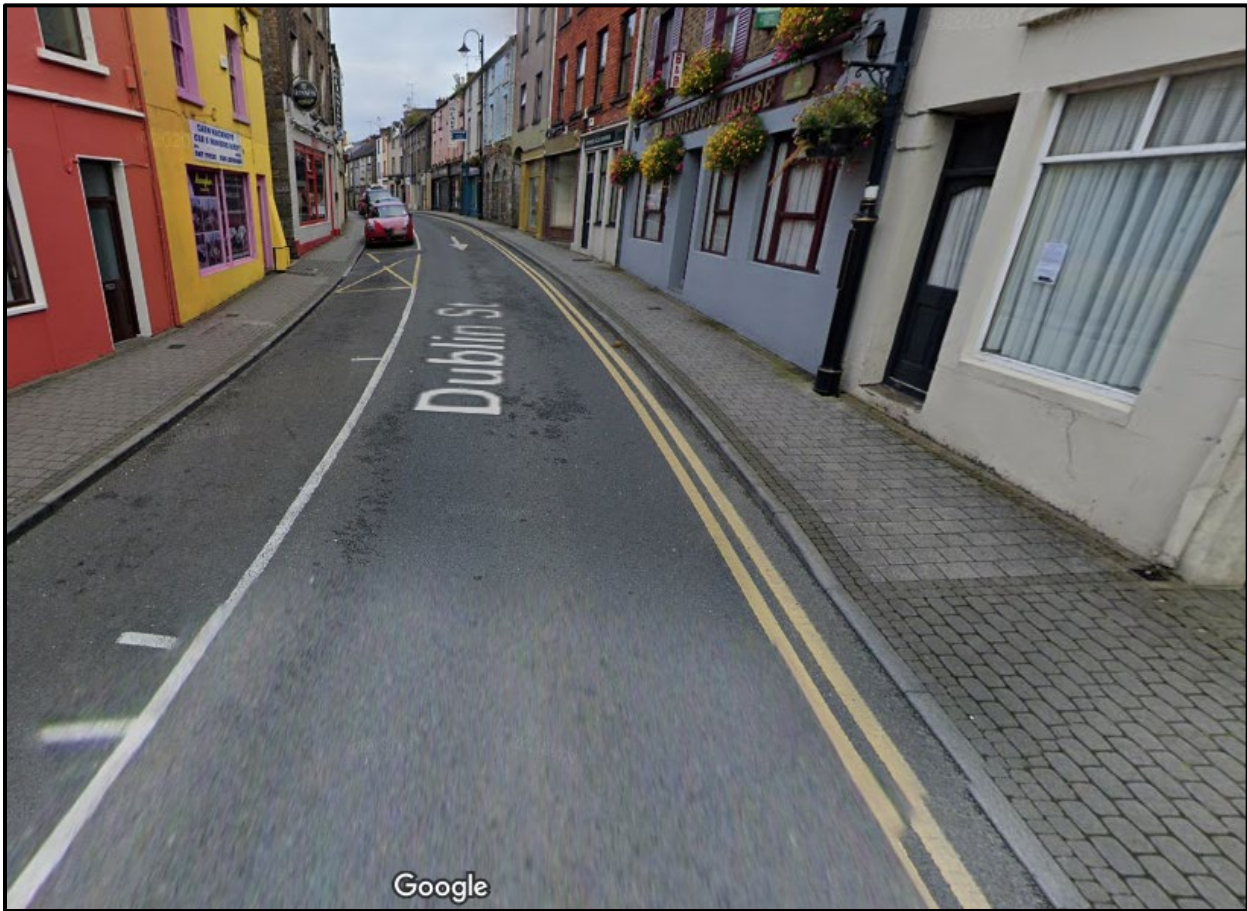
**Figure 2.4:** Existing Dublin Street paved path (Source: Google Maps)

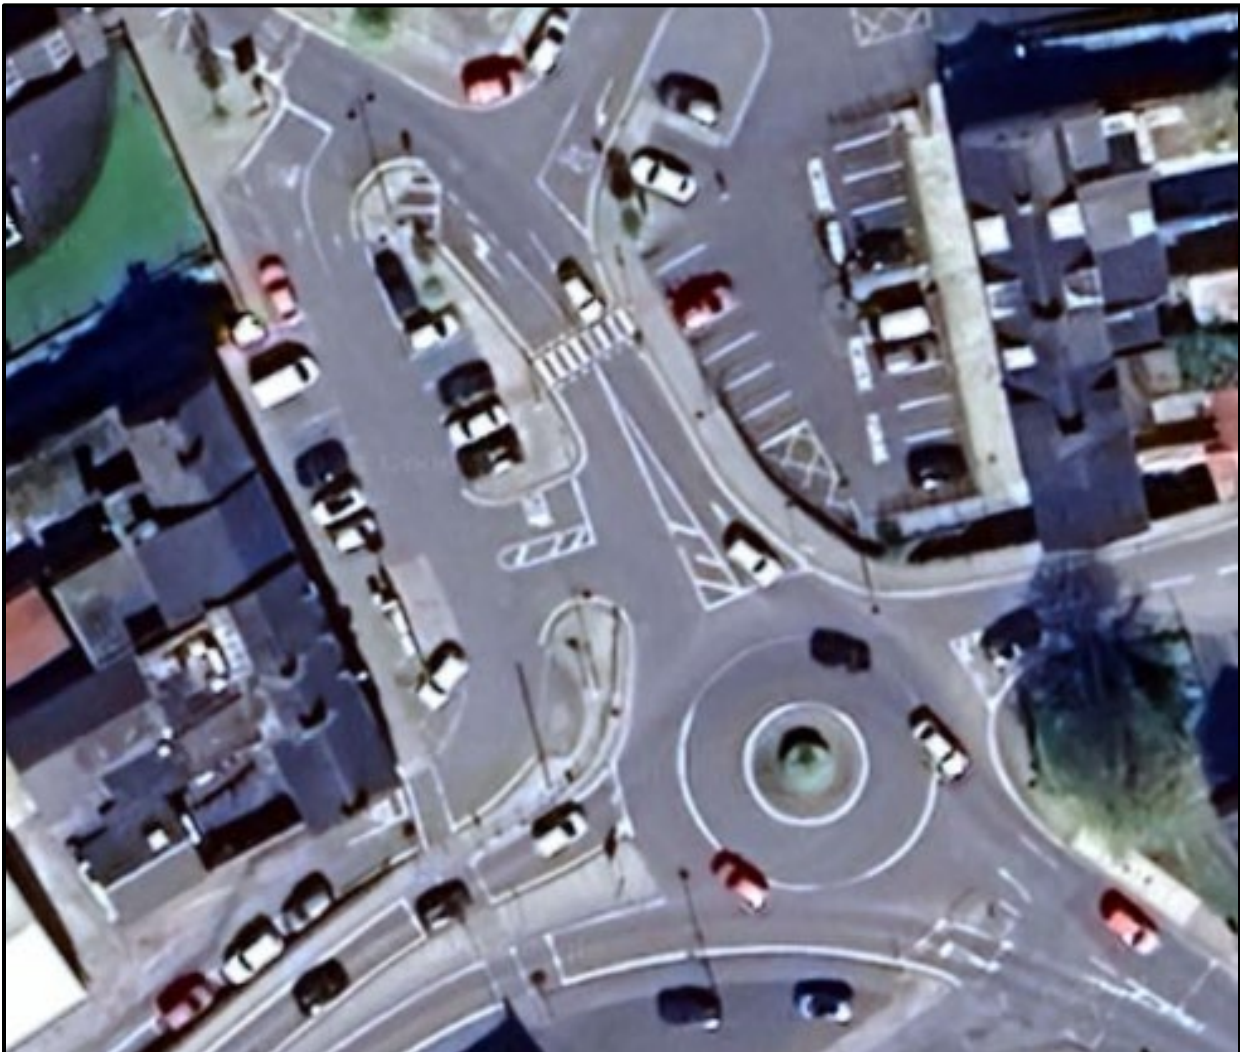
**Figure 2.5:** Overview of Old Cross Roundabout (Source: Google Earth)

Old Cross is a Roundabout to the South of the application site off which vehicular traffic is proposed to access the application site and its car parking area. Old Cross roundabout has four main exits with the northern most exit being the most relevant to the proposed site. Streetlights are present in the vicinity of the application site, as shown in **Figure 2.5** and **Figure 2.6**.

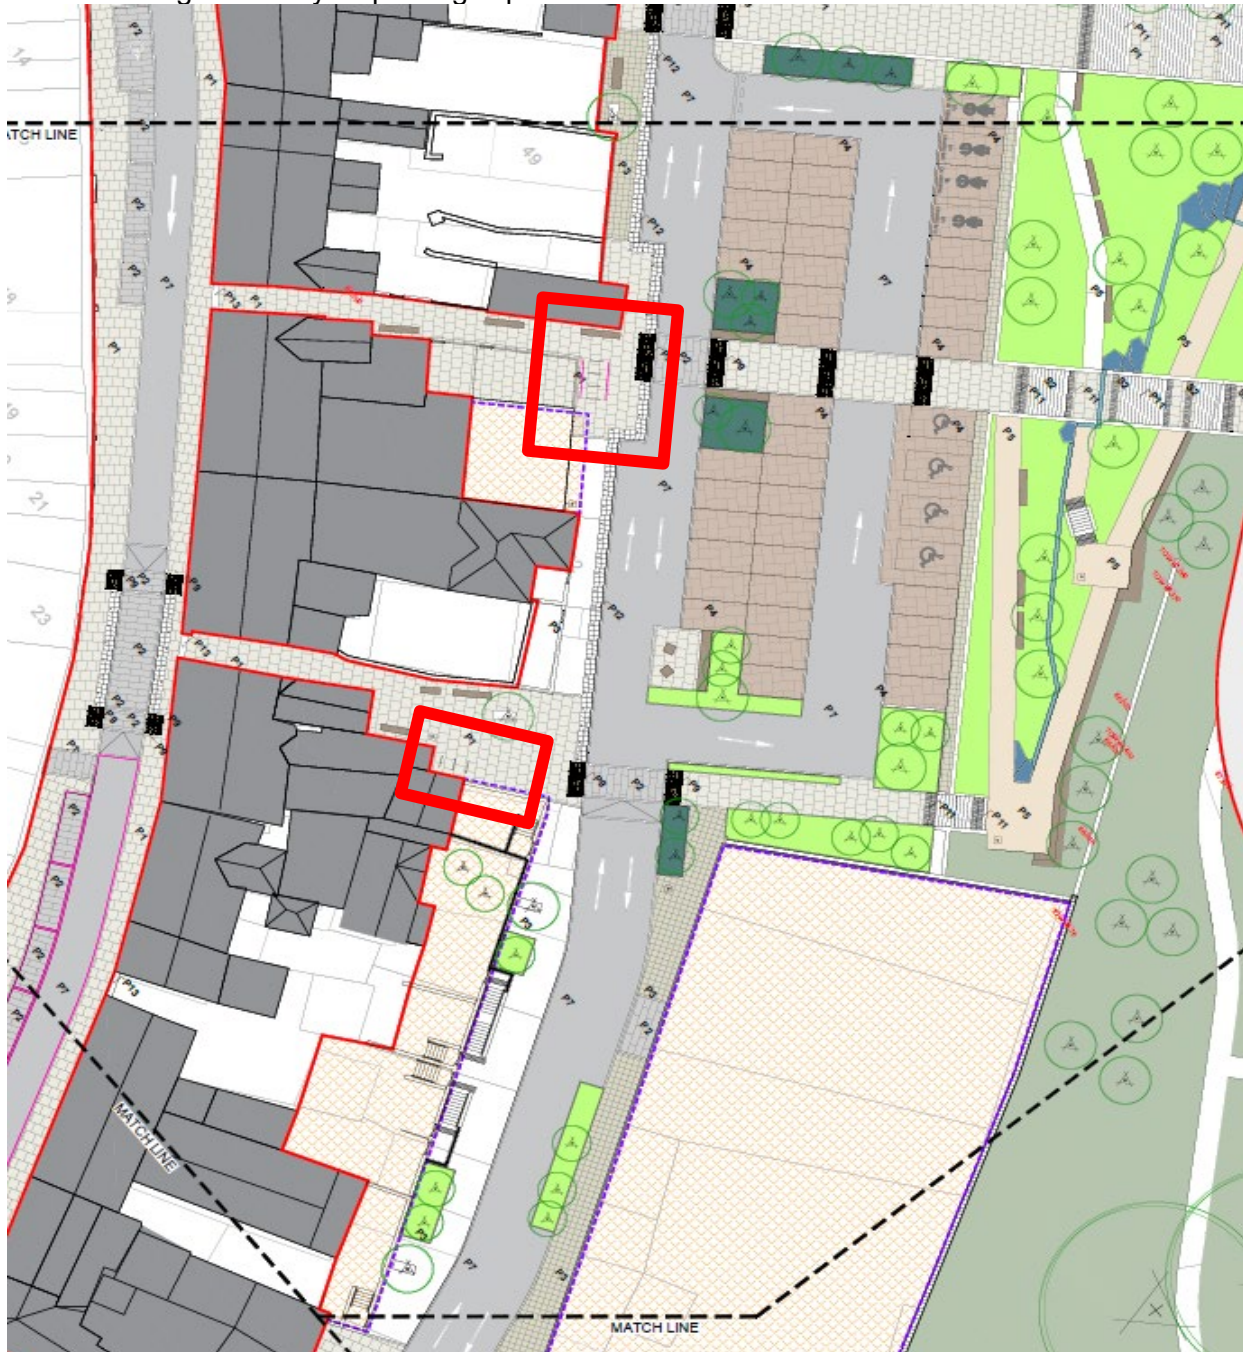
External designated bicycle parking is provided in two locations outlined below.

**Figure 5.2:** Location of bicycle stands (Source: Open Optimized Environments)
