## Dublin Street North Preliminary Geoenvironmental Risk Assessment

Project Title:	Dublin Street North PRA
Report Title:	Dublin Street North Preliminary Geoenvironmental Risk Assessment
Document Reference:	23165-PRA-001-00

Client:	McAdam Design Limited
Confidentiality	Client Confidential

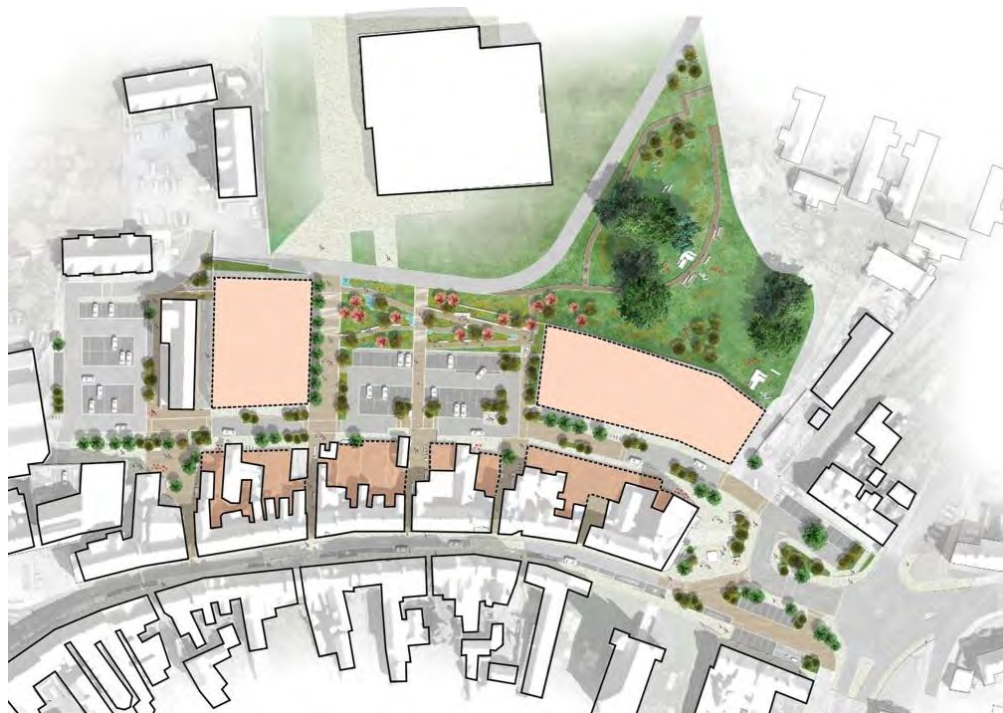
**Figure 1-1 Indicative Site Plan**

Gavin and Doherty Geosolutions (UK) Ltd (GDG) were commissioned by McAdam Design Ltd. to complete a Preliminary Geoenvironmental Risk Assessment (Desk Study) Report of environmental ground conditions for a proposed development site on Land North of Dublin Street, Monaghan. The site location and site boundary are outlined in Figure 1-2 and the indicative site layout, provided by the client as the Public Consultation Design - Illustrative Plan, is outlined in Figure 1-1.

The indicative site plan is proved as Figure 1-1. This report aims to assess potential contamination constraints on the site as it currently stands, and concerning the potential development, and to provide outline recommendations for additional works required to address areas of uncertainty.

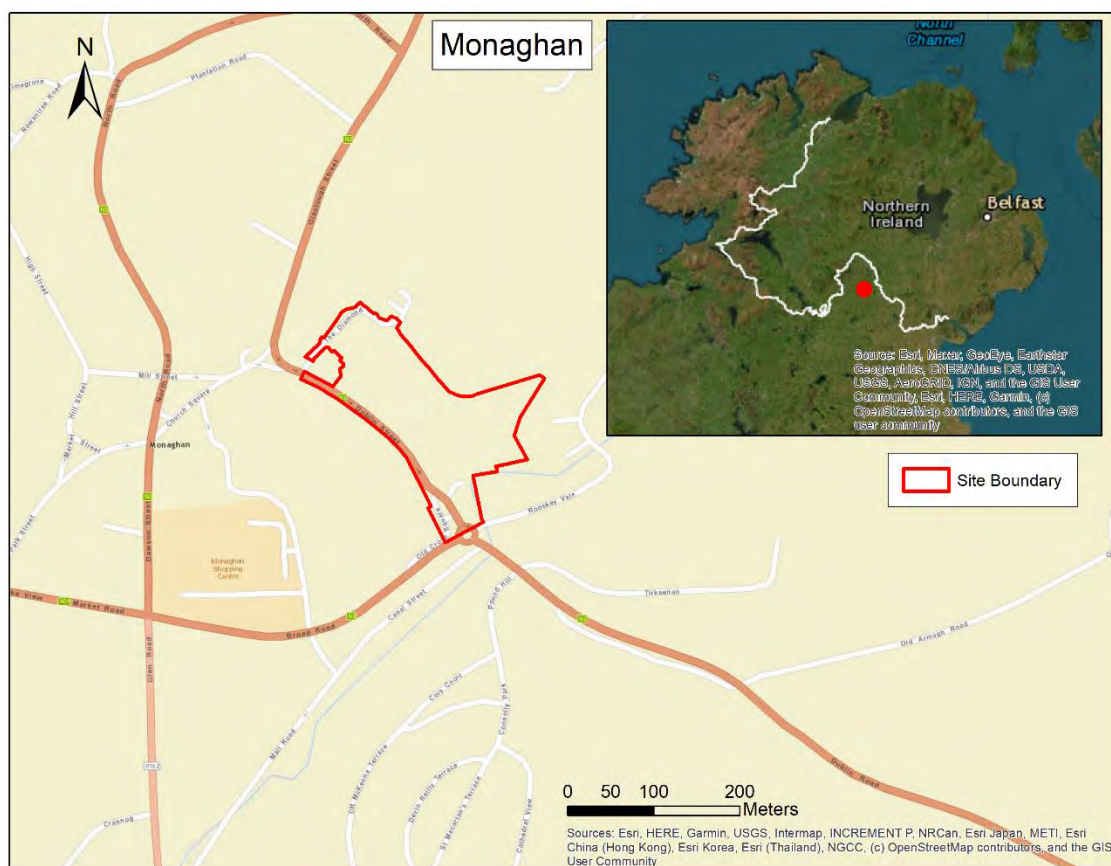
**Figure 1-2 Site Location Plan**

The 21,168 m<sup>2</sup> site is located in the town of Monaghan, which is the county town of County Monaghan, Republic of Ireland. The ITM Reference for the approximate centre of the site is 667400 Easting, 833700 Northing and the location is shown in Figure 1-2 and Figure 2-1.

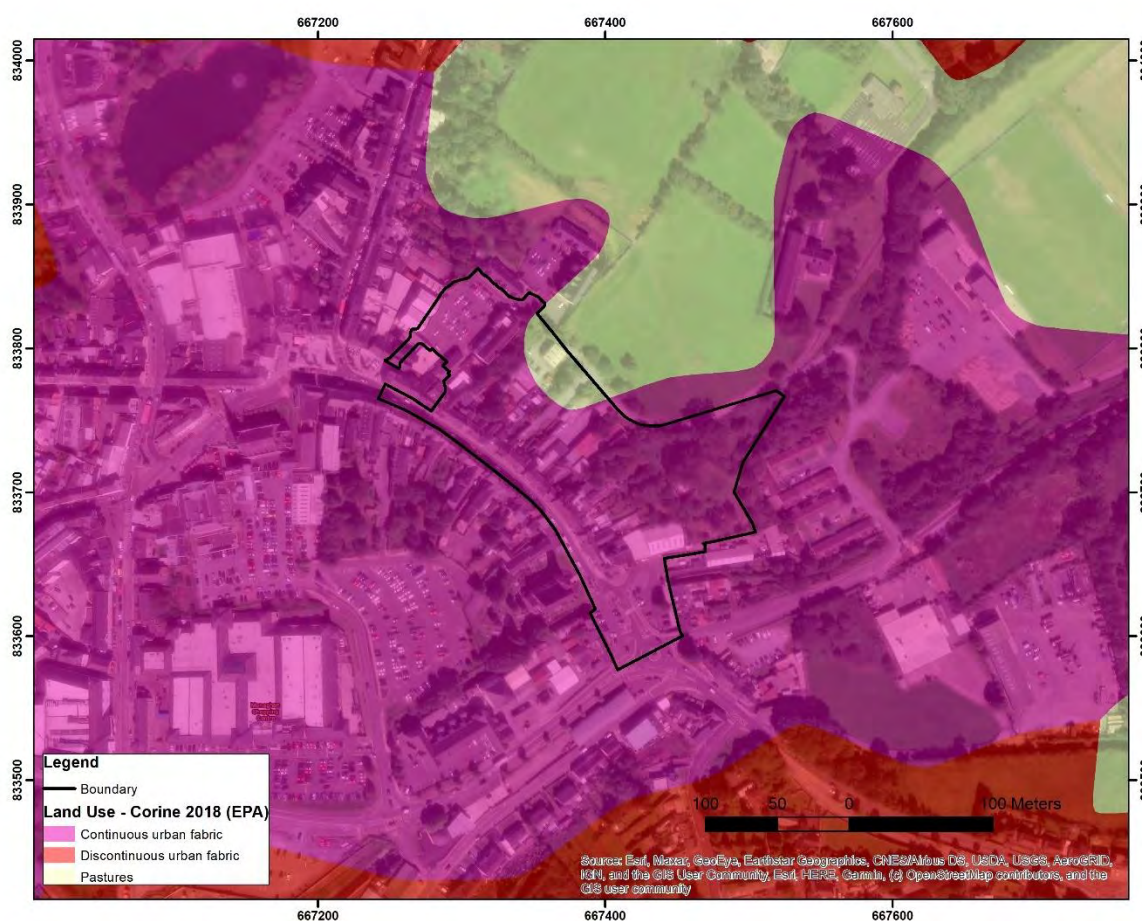
**Figure 2-2 Land use (Corine 2018, EPA 2023)**

The map in Figure 2-2 is a cropping of the Corine Land Cover 2018 (EPA) which shows the land use classifications for the site and its surroundings. The dataset is based on the interpretation of satellite imagery and national in-situ vector data. The project boundaries fall into two classes "Continuous urban fabric" (purple hatching) for the largest area and a smaller area classified as "Pastures" (green hatching).

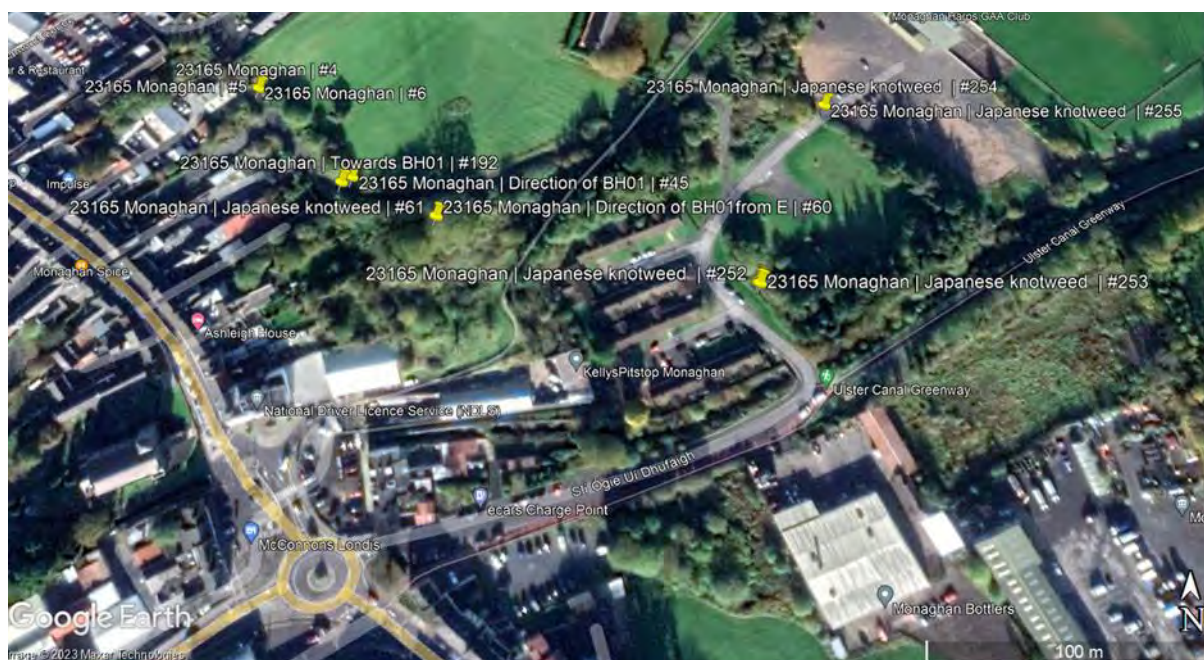
**Figure 2-3 Japanese Knotweed Locations**

Although the walkover survey conducted on the 16<sup>th</sup> of August 2023 was not undertaken by an ecologist, GDG noted the presence of probable Japanese Knotweed at the following locations presented in Figure 2-3.

As part of any site investigation or other intrusive works, we would recommend prohibiting access to these areas and establishing a no-dig zone of min. 7m offset in the vicinity of these knotweed stands, based on the following: *It is an offence under Article 49 (2) of the European Communities (Birds and Natural Habitats) Regulations 2011 for any person to plant, disperse, allow to grow or cause to disperse, spread or otherwise cause to grow throughout the state any plant included in Part 1 of the Third Schedule. Japanese knotweed is included in the Third Schedule of the Regulations.*

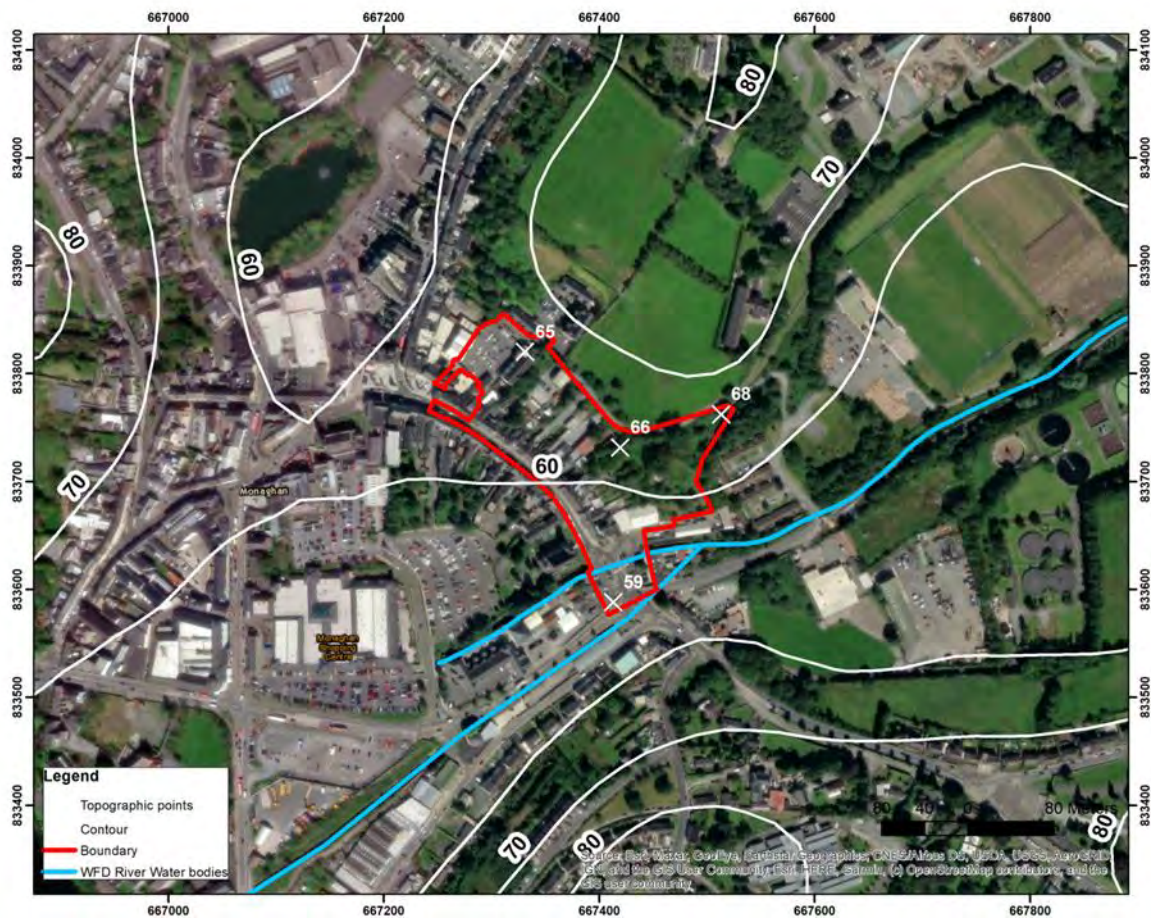
**Figure 2-9 Topography**

The landform of the region is presented in Figure 2-9, with elevations on the site varying between 68m Above Ordnance Datum (AOD) (in the east) and 59mAOD (in the south). The base level of the region and the site are the Ulster Canal and the River Shambles, which on the site are at elevations of around 59mAOD.

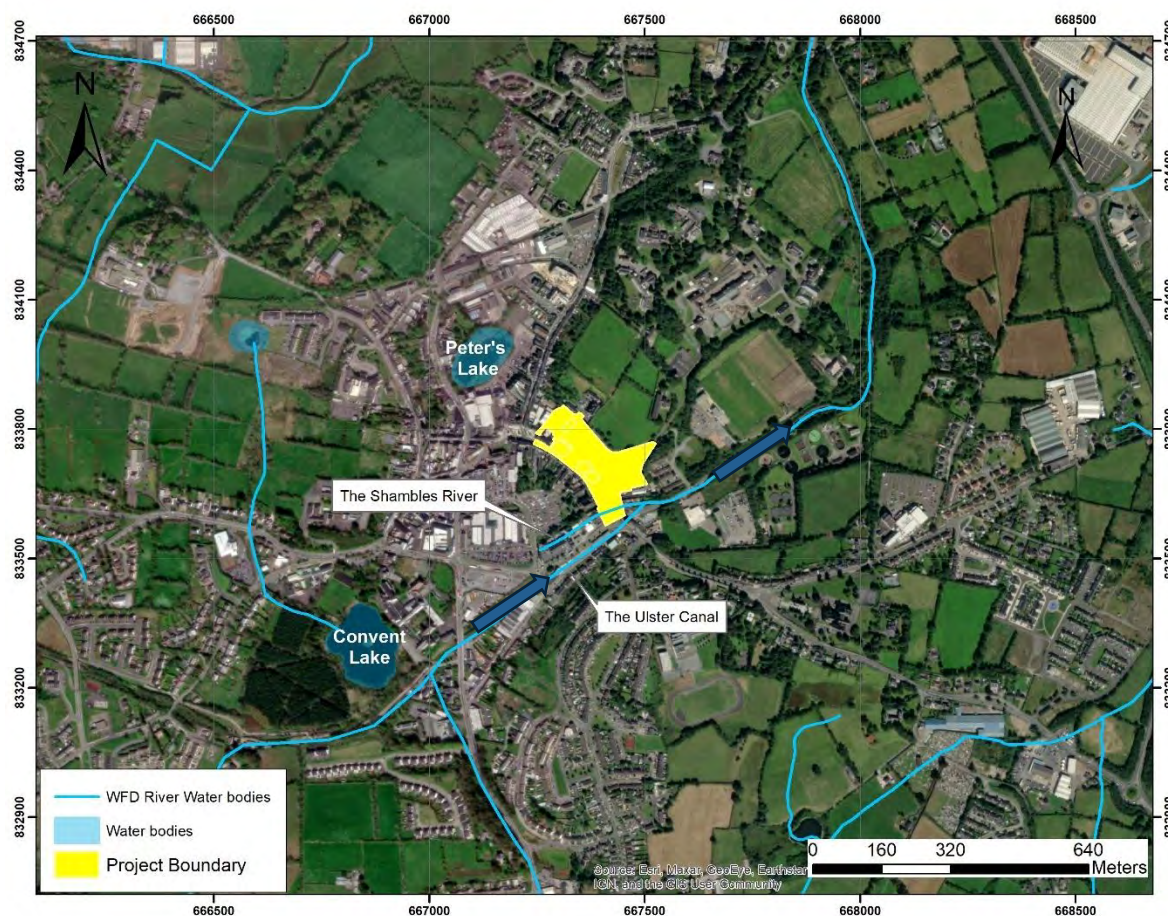
**Figure 2-11 Site hydrography**

Locally, the Ulster Canal runs south of the project area and the River Shambles cuts through the site. Ulster Canal and the Shambles River separate just upstream of the site and the Ulster Canal, diverting south of the River Shambles, has been culverted under several areas through the town (Canal Street), including the square. The river flows locally in a north-easterly direction, Figure 2-11. Two bodies of water are also in the vicinity of Dublin Street North Regeneration Project: Patena Lake (or Peter's Lake) 175 m to the northwest and Convent Lake 550 km to the west.

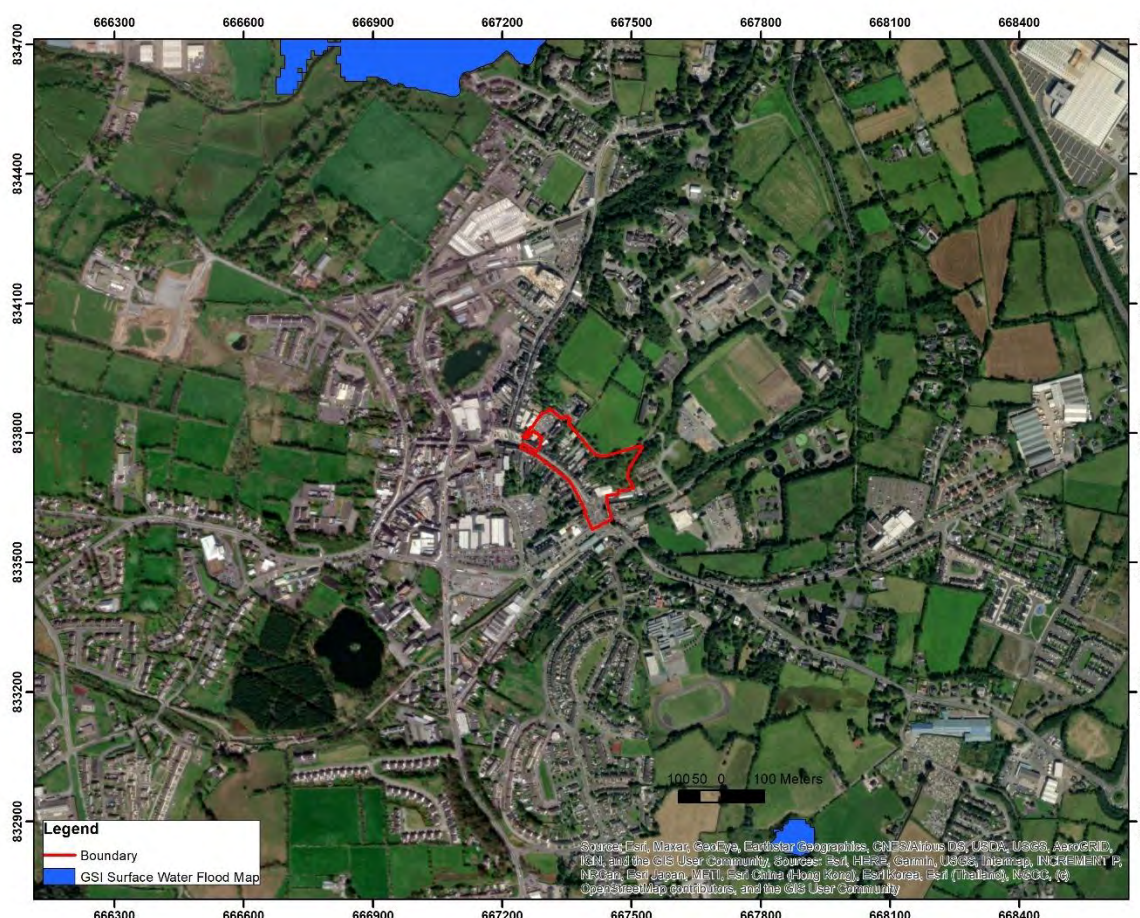
**Figure 2-13 Historic Flood Maps produced (GSI, 2023)**

The Historic Flood Maps produced by GSI in collaboration with Trinity College Dublin and the Institute of Technology Carlow (Figure 2-13) don't show any flood areas within 750 m of the site. However, the requirement for a flood risk assessment should be undertaken by a suitably qualified hydrologist.

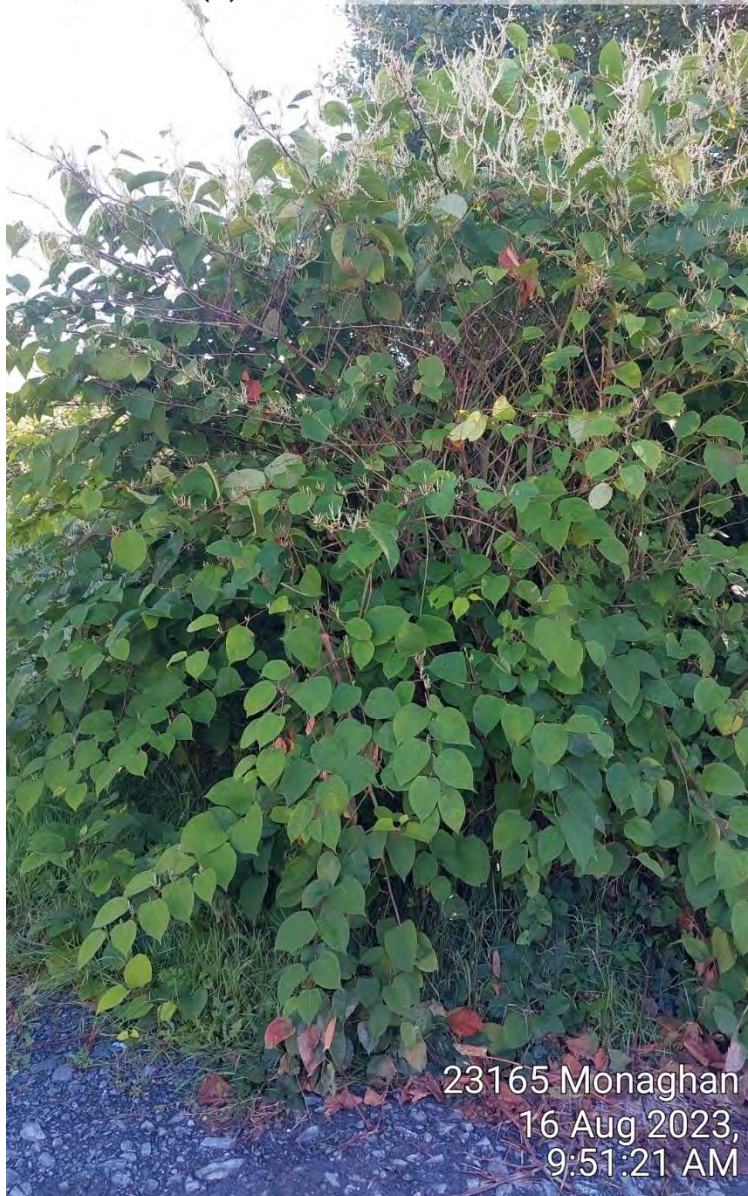
Japanese knotweed close to TP07.

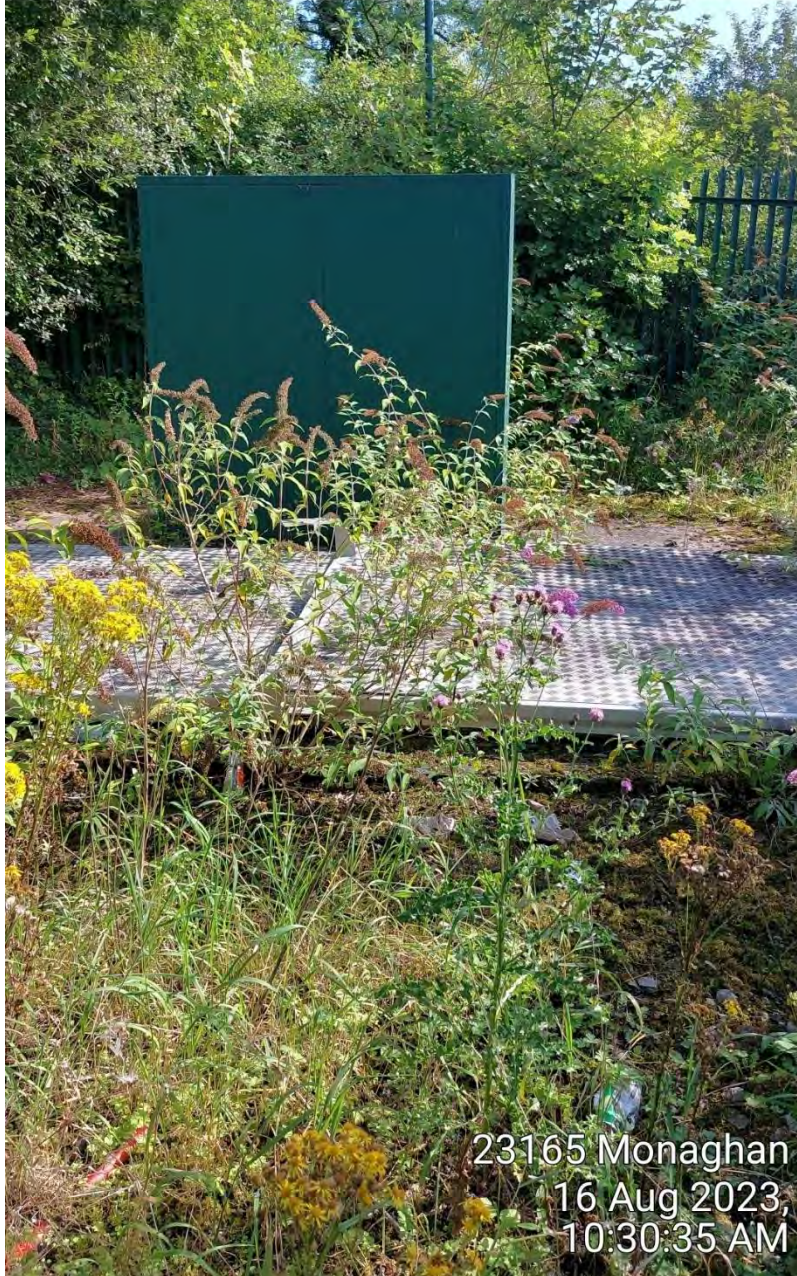
Possible pumping station.

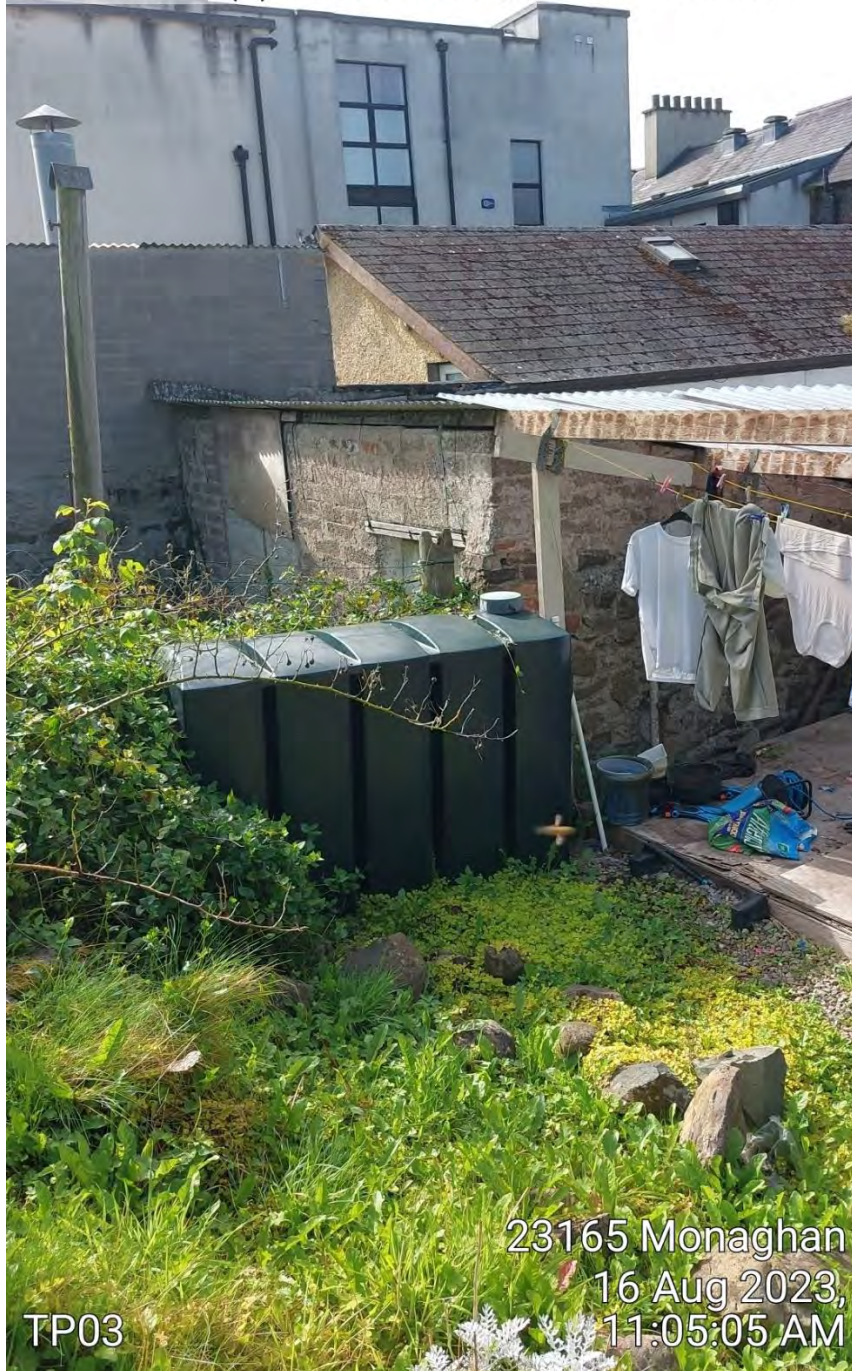
Oil tank behind private house on Dublin Street at former TP03 location.

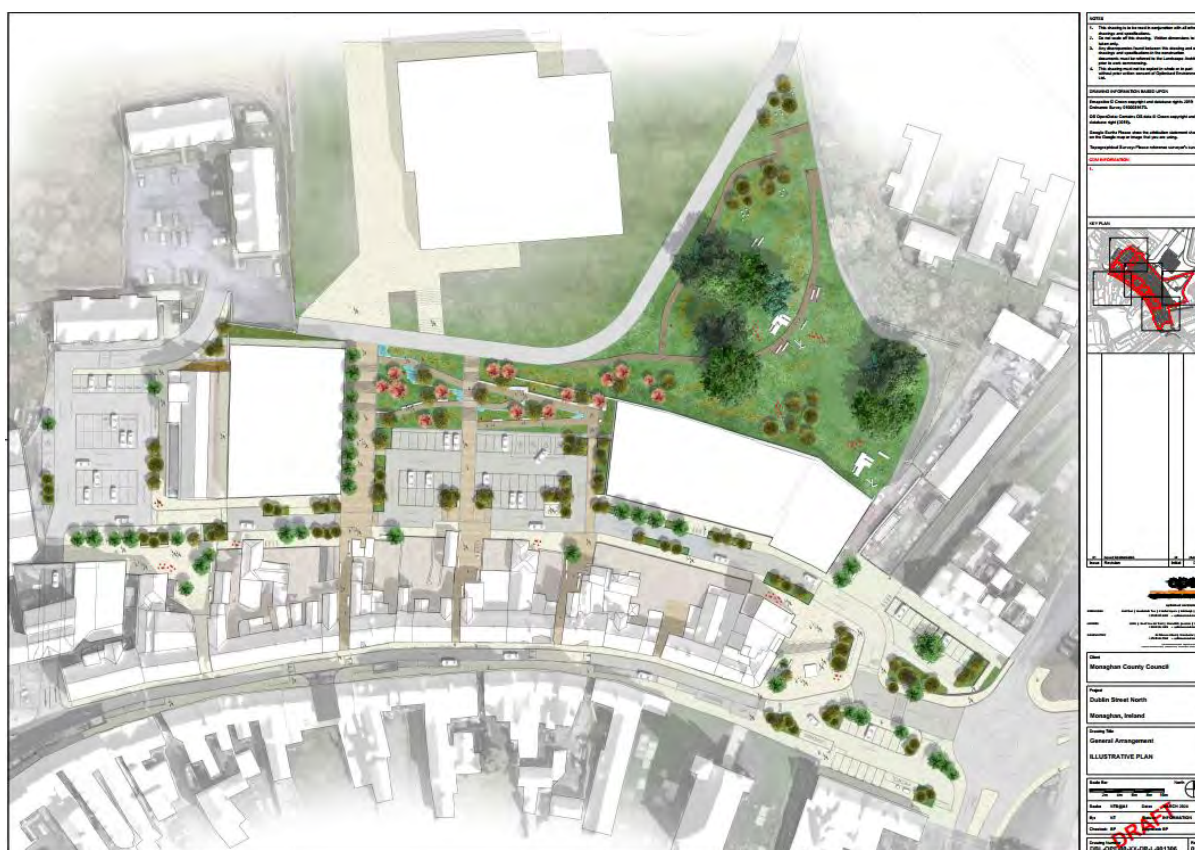
**Figure 1-1: Illustrative Plan (Drawing number: DBL-OPE-00-XX-DR-L-901306)**

The proposed development is part of the Regeneration plan prepared on behalf of Monaghan County Council, which envisages the redevelopment of an area located on Dublin Street North. As stated in Regeneration Plan *'The plan area benefits from an existing Dublin Street Local Area Action Plan, 2011 (LAAP 2011) [13] . The LAAP 2011 proposes a new street to the rear of Dublin Street, with infill and new mixed-use development, and a new interim surface car parking area of 0.5ha, with amenity and recreational area. There are also proposed improved pedestrian links, and local access from the new street to The Diamond and Old Cross Square.'* ) [13] The site is located across a mixed use of land types some residential and some of past industrial use. The indicative site layout, provided by the client as the Public Consultation Design - Illustrative Plan, is outlined in Figure 1-1.

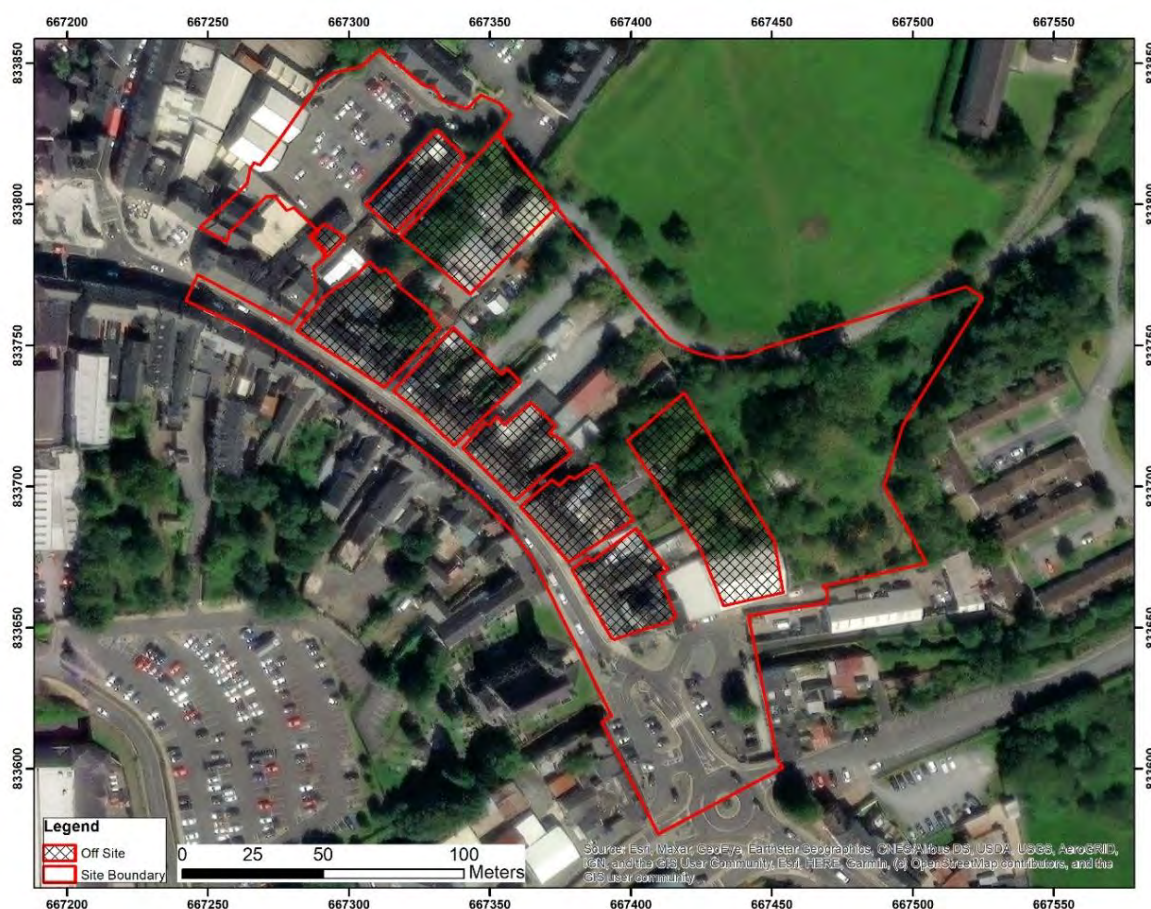
**Figure 2-1: Site boundary**

This assessment is focused on the development areas shown in Figure 2-1, which comprise areas of semi-private public open space and associated infrastructure. Residential and commercial development which will take place in the hatched areas does not form part of this assessment.

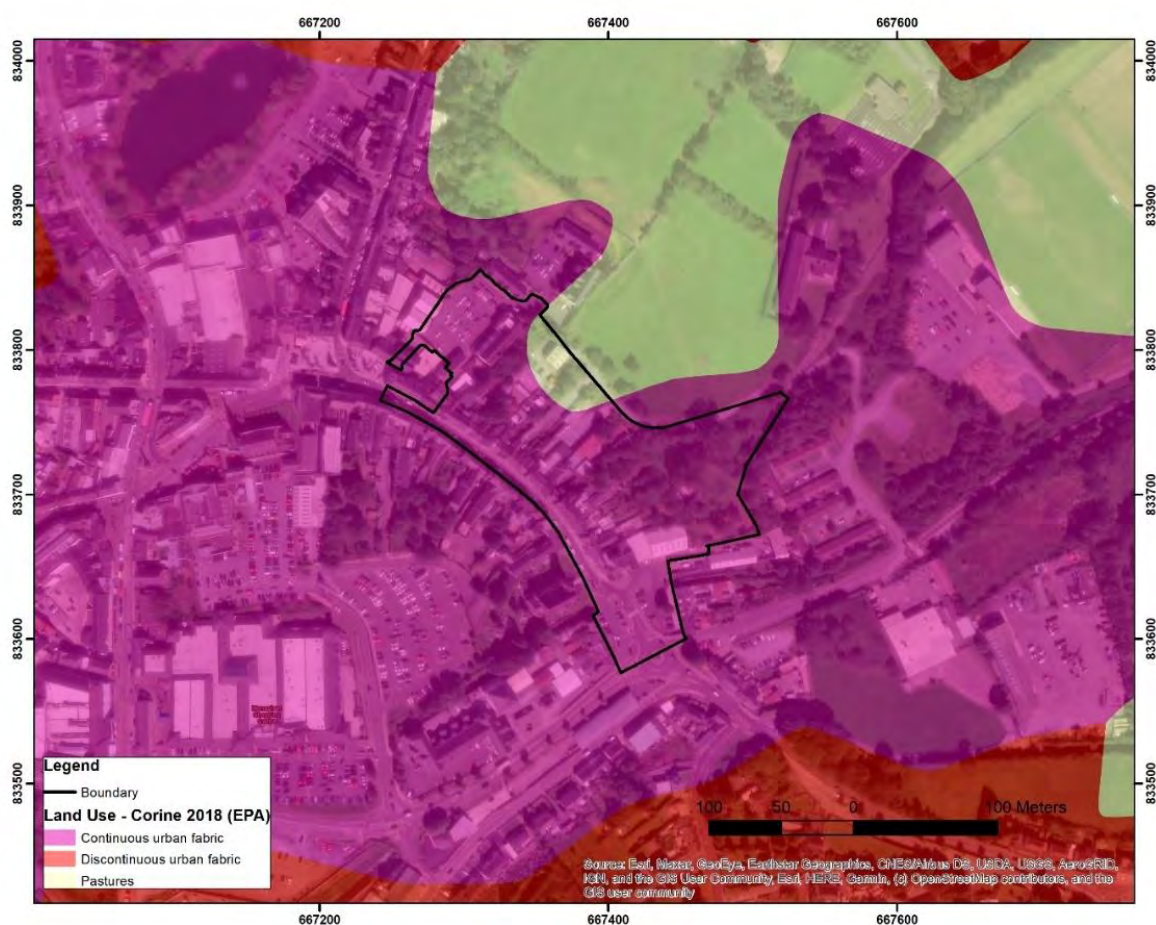
**Figure 2-2: Land use (Corine 2018, EPA 2023)**

The map in Figure 2-2 extracted from the Corine Land Cover 2018 (EPA) which shows the land use classifications for the site and its surroundings. The dataset is based on the interpretation of satellite imagery and national in-situ vector data. The project boundaries fall into two classes 'Continuous urban fabric' (purple hatching) for the largest area and a smaller area classified as 'Pastures' (green hatching).

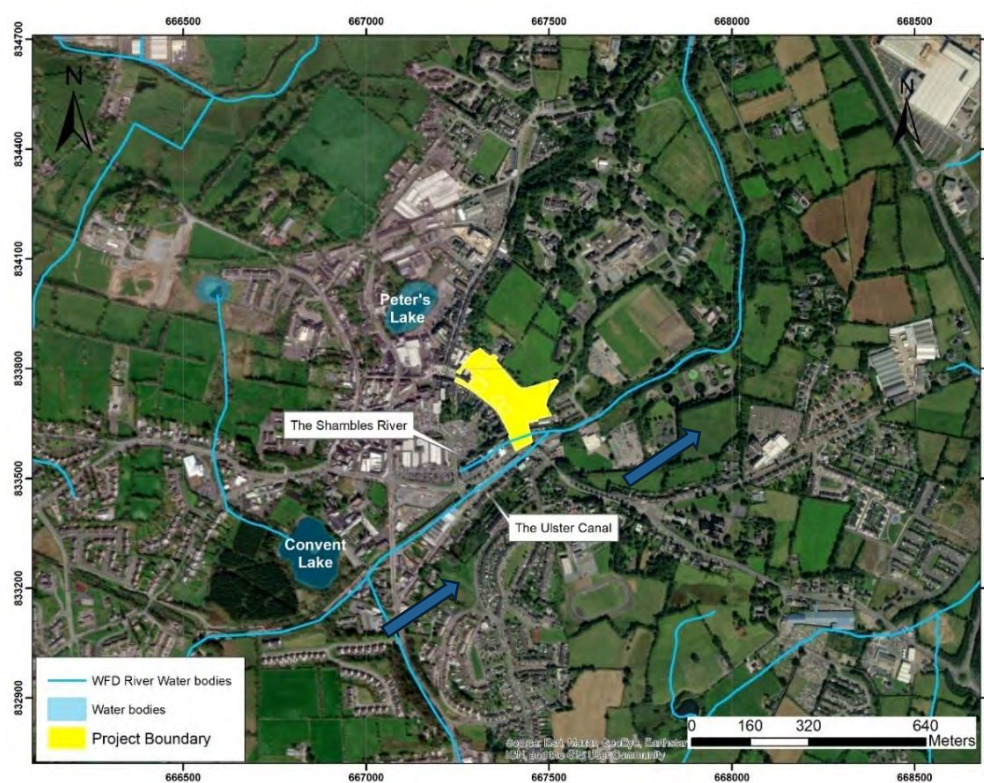
**Figure 2-8: Site hydrography**

The site is part of the larger Lough Neagh-Lower Bann catchment (Figure 2-7). Locally, the Ulster Canal runs south of the project area and the River Shambles cuts through the site. Ulster Canal and the Shambles River separate just upstream of the site and the Ulster Canal, diverting south of the River Shambles, has been culverted under several areas through the town (Canal Street), including the square. The river flows locally in a north-easterly direction, Figure 2-8. Two bodies of water are also in the vicinity of Dublin Street North Regeneration Project: Patena Lake (or Peter's Lake), 175 m to the northwest and Convent Lake, 550 m to the west.

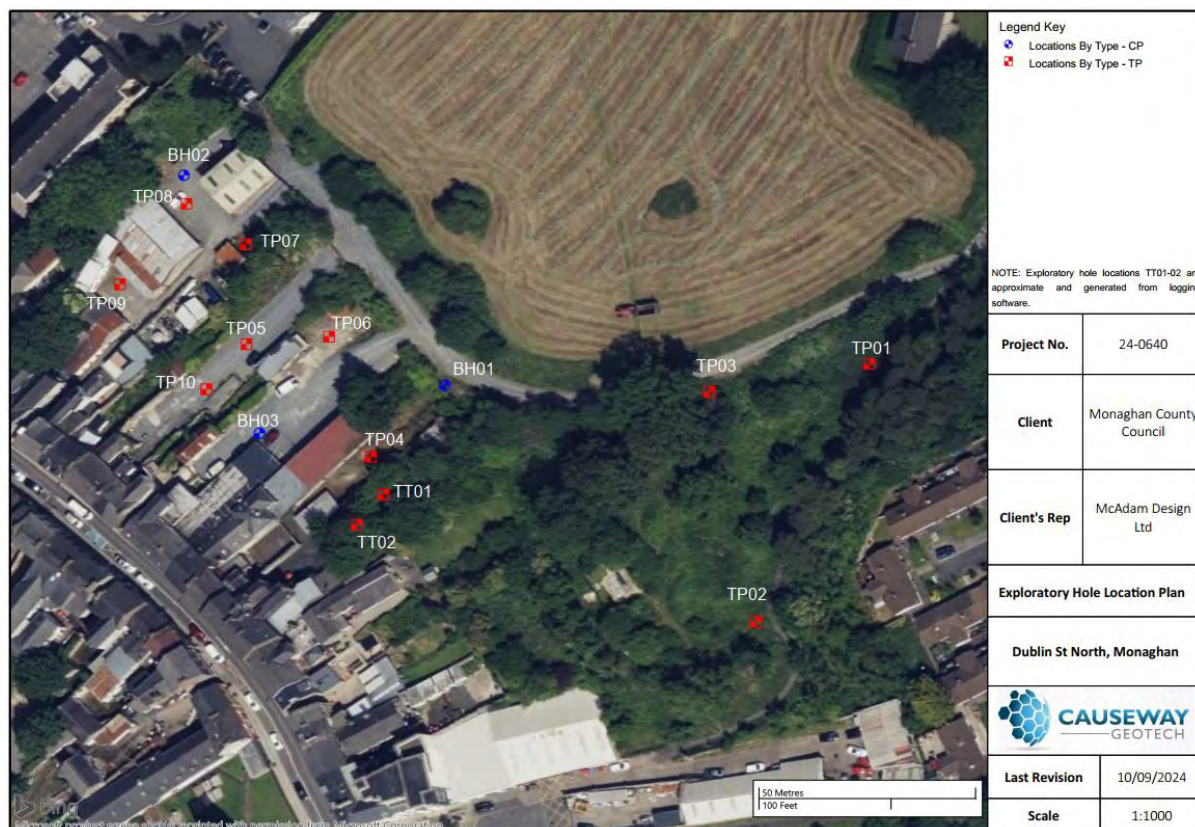
**Figure 3-2: Ground investigation plan (Causeway Geotech, 2024)**

The plan of the Causeway (2024) ground investigation showing the locations of exploratory holes is presented in Figure 3-2.

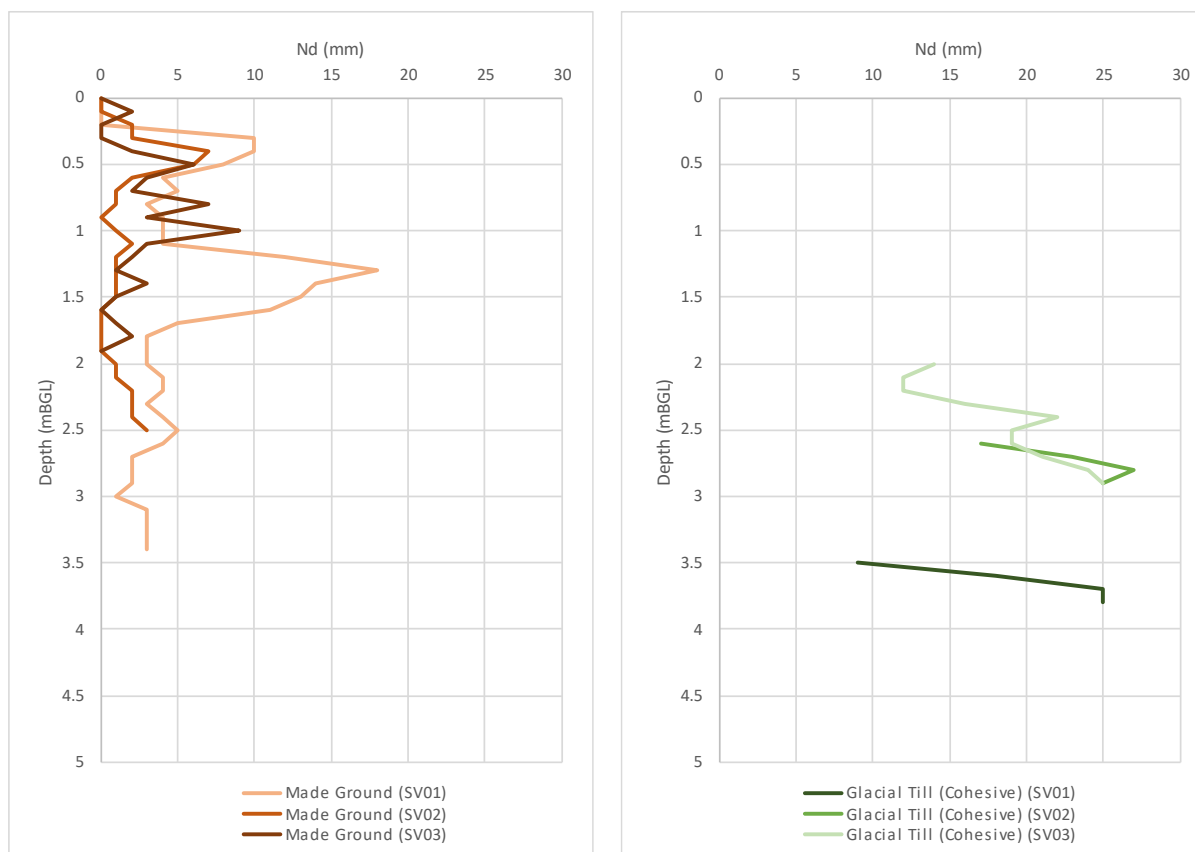
**Figure 5-4: Dynamic Probes results for Made Ground (left) and Glacial Till (right) - IGSL Site 2**

As part of the IGSL-Site 2 campaign, three heavy dynamic probes (DPH) were conducted to a maximum depth of 3.8 meters using 50kg hammer with a fall height of 500mm and penetration increments of 100mm. The number of blows required to penetrate 100 mm ( $N_d$ ) was recorded along the full depth of penetration by the DP. Ten dynamic probes were advanced using a window sampling at same as DPs, to provide supplementary coverage of the site between borehole locations. The  $N_d$  values for the Made Ground were recommended to be interpreted between 0 and 18 blows per 100mm penetration which is soft to very stiff material. For Glacial Till (Cohesive)  $N_d$  values ranging between 9 to 27 which corresponds to firm to very stiff material ([10], [22]). The results of the dynamic probes are presented in Figure 5-4.

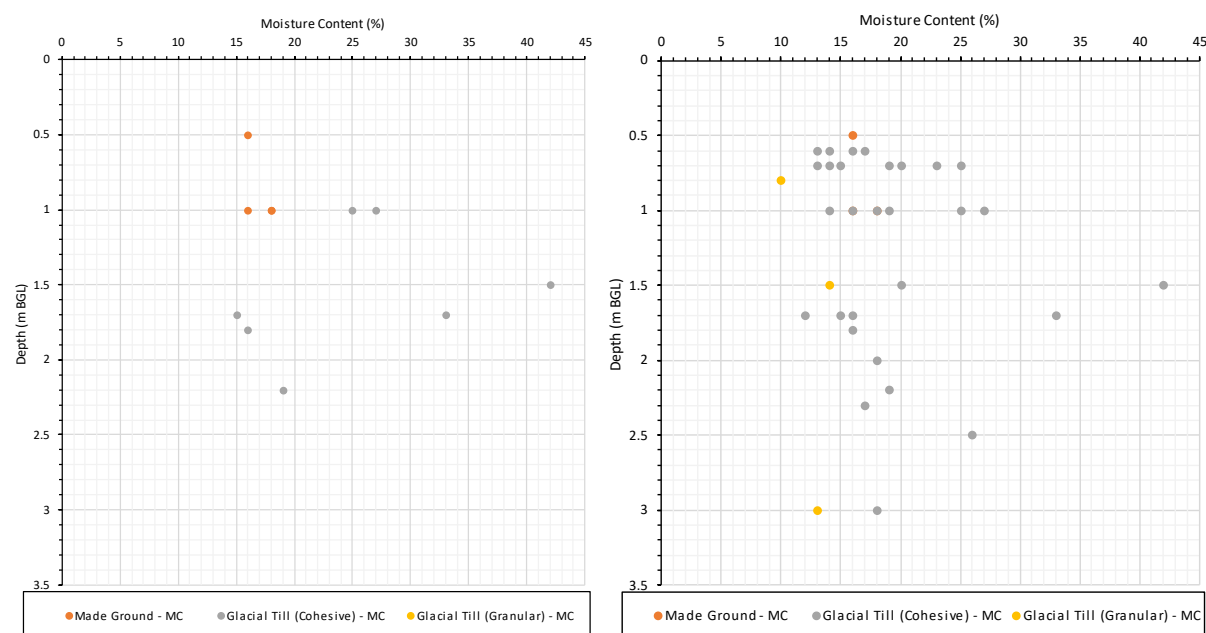
**Figure 6-9: Moisture Content – 2024 GI (left) and all dataset (right)**

and the results are summarised in Table 6-2. The MC of the Glacial Till (Cohesive) (6 No. samples) was measured between 15% and 42%, while in the historic GI the moisture content was raging from 12%-26%. The low MC measurement (i.e. 12%) could be due to sample recovery/storage and thus excluded from the average MC value. High MC (33%, 42%) was measured in samples encountered from TP9 and TP10 where water strikes occurred (2024 GI). Moisture content (MC) for Made Ground is consistent across GIs and raging from 16%-18%. Only one record of 13% MC was reported for Glacial Till (Granular). Figure 6-9 presents the MC values for 2024 GI and all datasets together.

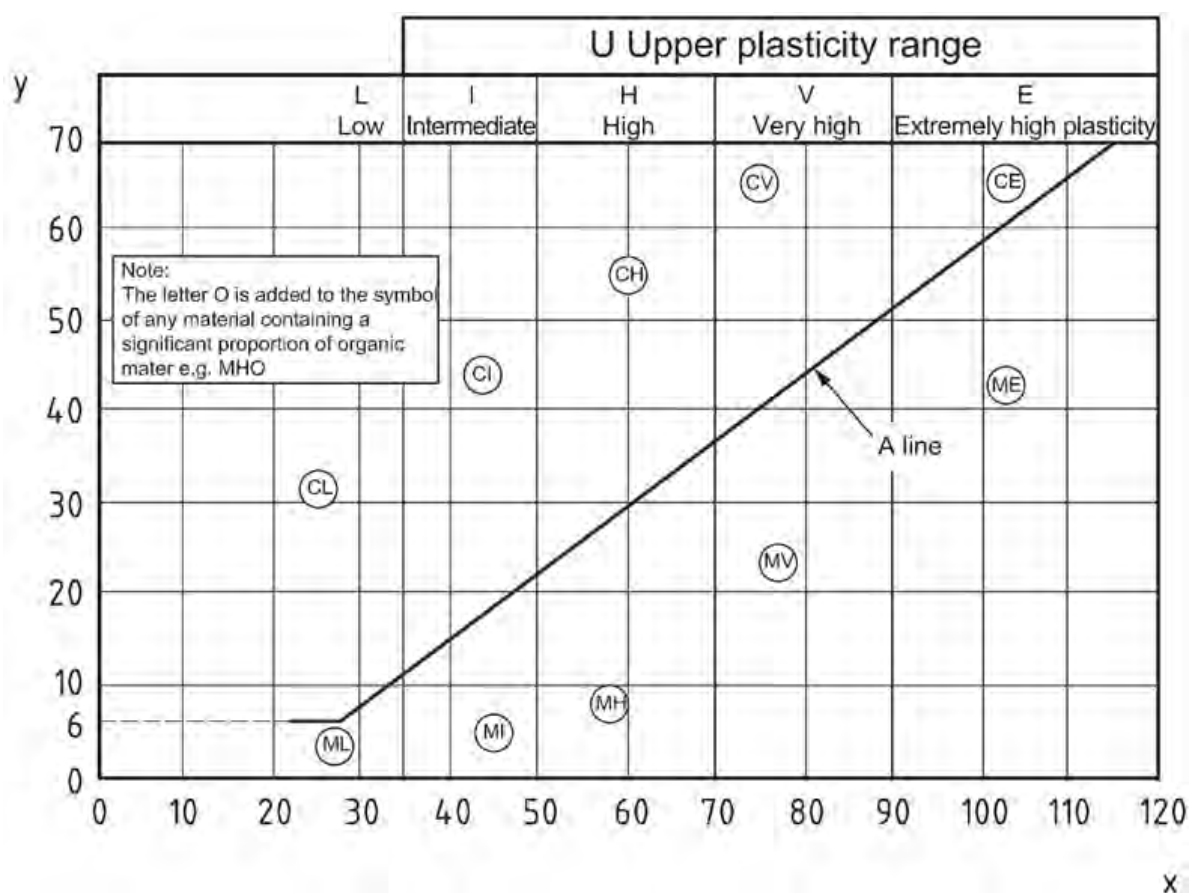
**Figure 6-12: BS5930:2015 plasticity chart**

The BS 5930:2015 plasticity chart, which assesses the material behaviour by plotting the LL of each material against the Plasticity Index (Ip) of the same soil sample, is shown in Figure 6-12. The Ip of a soil sample equals the difference between the LL and PL. Each data point is then compared to the A-Line, which distinguishes between clays and silts.

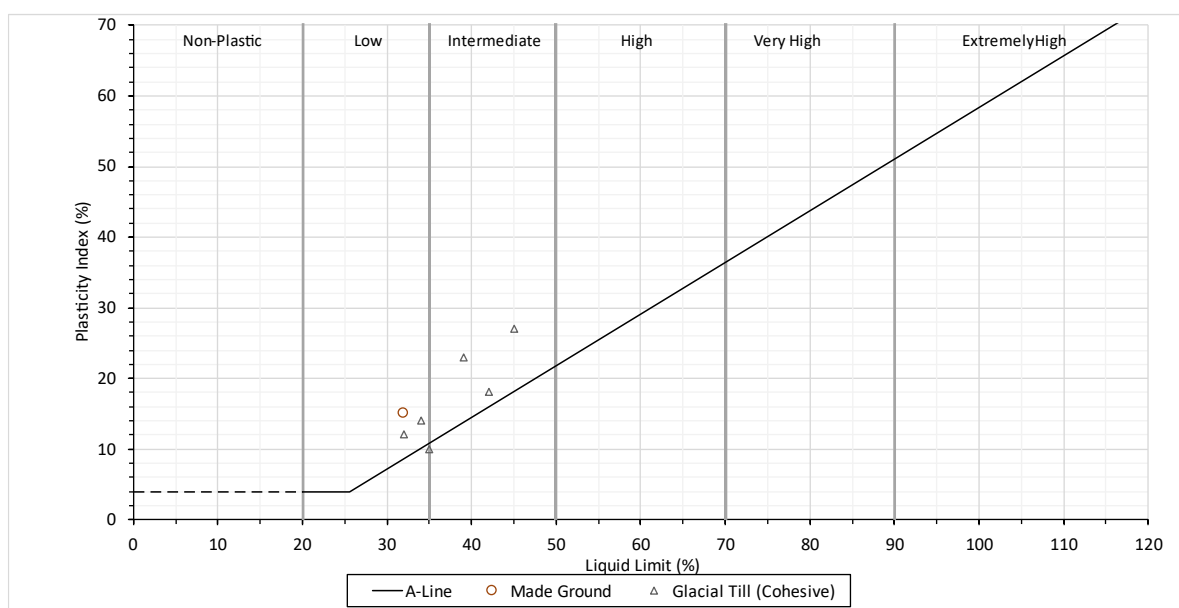
**Figure 6-13: BS 5930:2015 plasticity chart – 2024 GI**

For the Glacial Till (Cohesive) stratum, the moisture content values were typically between the measured LL and PL values but closer to the PL than the LL. This indicates that the material is likely high strength with low compressibility, which agrees with the SPT results. The  $I_p$  values of the Glacial Till (Cohesive) were calculated to range between 10% and 27%, as shown in the plasticity charts. The LL and  $I_p$  combinations suggest the cohesive material is low to intermediate plasticity clay.

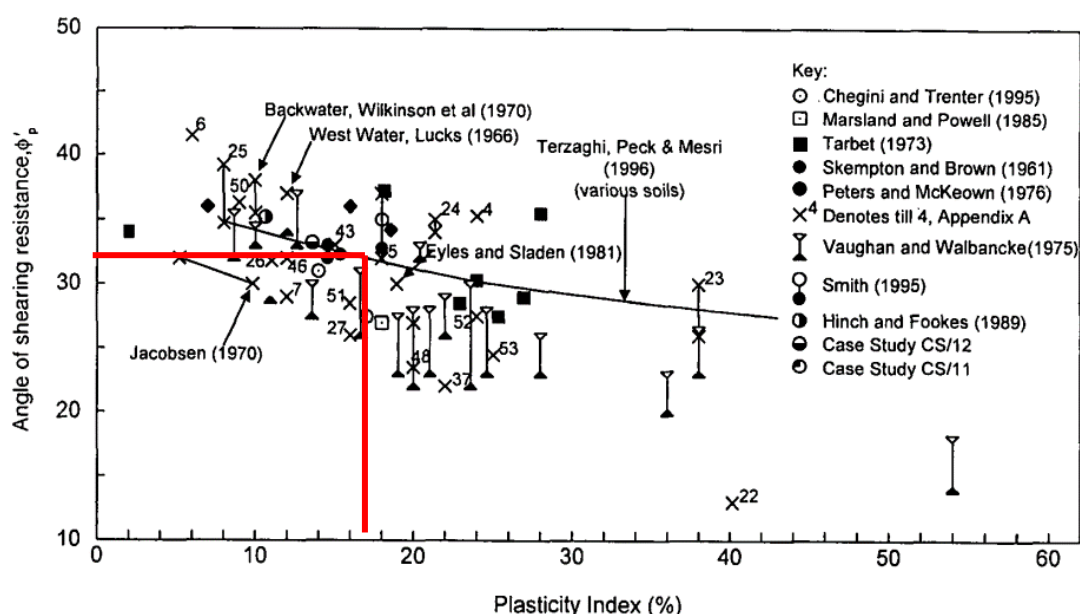
**Figure 7-5:  $I_p$  vs angle of shearing resistance (Sladen and Wrigley, 1983) for cohesive material**

In addition to the BS 8004:2015 and Sladen and Wrigley (1983) empirical correlations, guidance from the engineering experience of Irish Glacial Tills was also reviewed including Skipper et al. (2005), Long & Menkiti (2007), and Long et al. (2012). These peer-reviewed sources presented typical angle of shearing resistance values in the range of  $34^\circ$  to  $38^\circ$  for Irish Glacial Tills.
