## Dublin Street North Preliminary Geoenvironmental Risk Assessment

Project Title:	Dublin Street North PRA
Report Title:	Dublin Street North Preliminary Geoenvironmental Risk Assessment
Document Reference:	23165-PRA-001-00

Client:	McAdam Design Limited
Confidentiality	Client Confidential

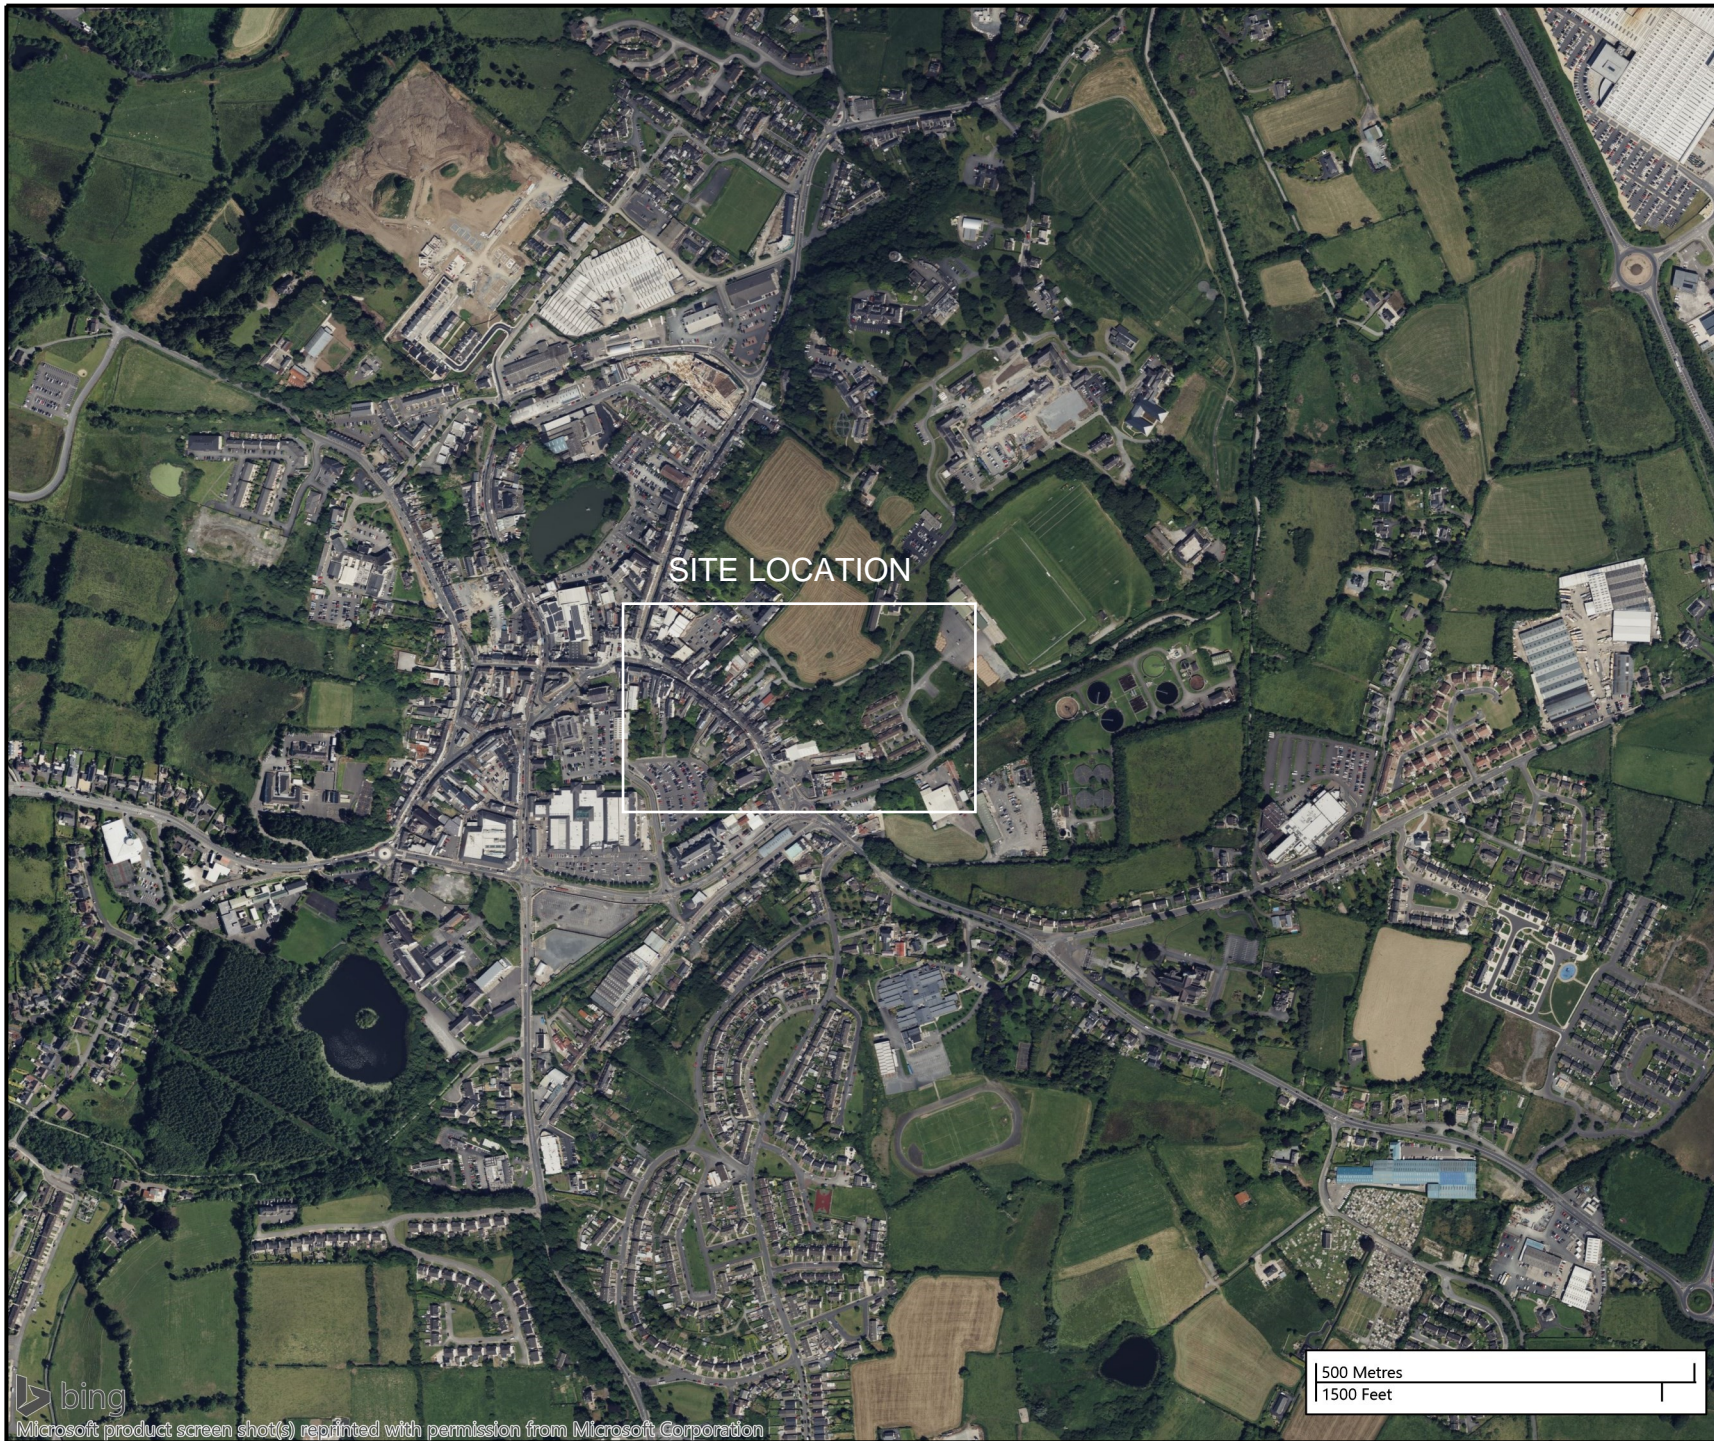
Legend Key	
Project No.	24-0640
Client	Monaghan County Council
Client's Rep	McAdam Design Ltd
Site Location Plan	
Dublin St North, Monaghan

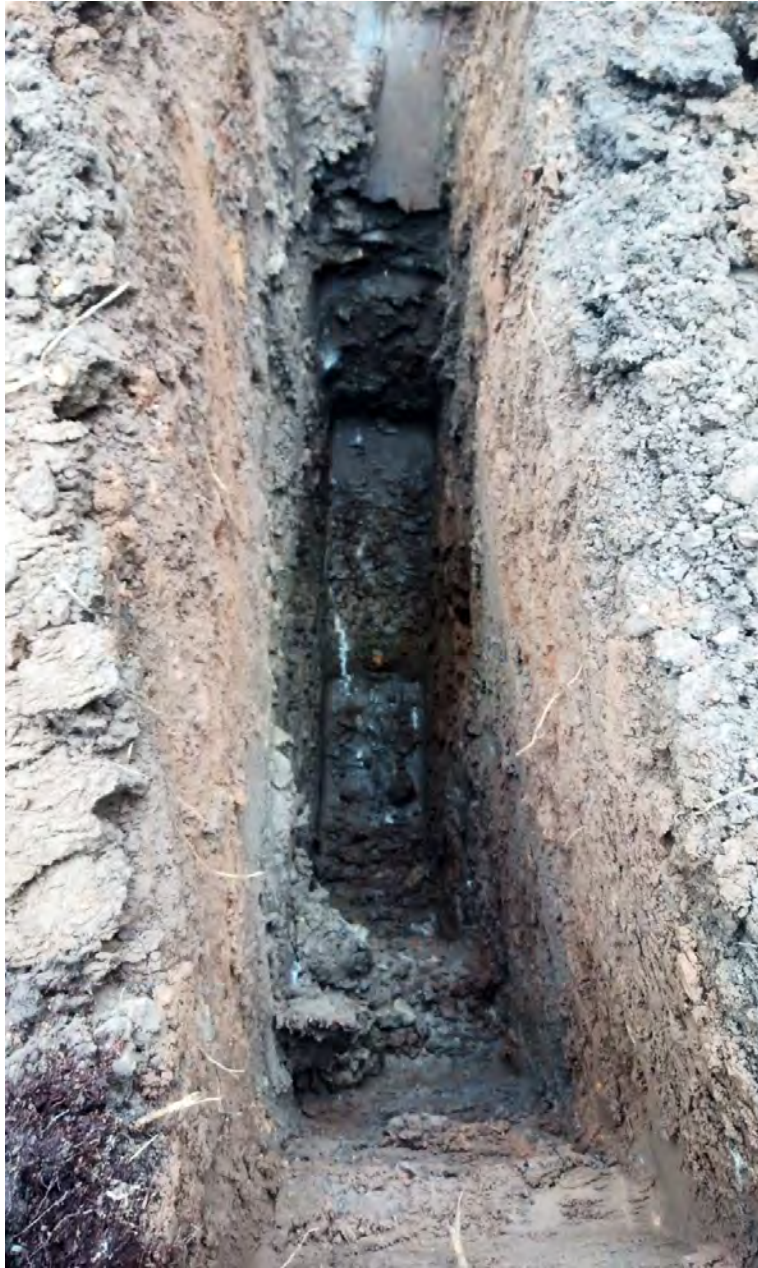
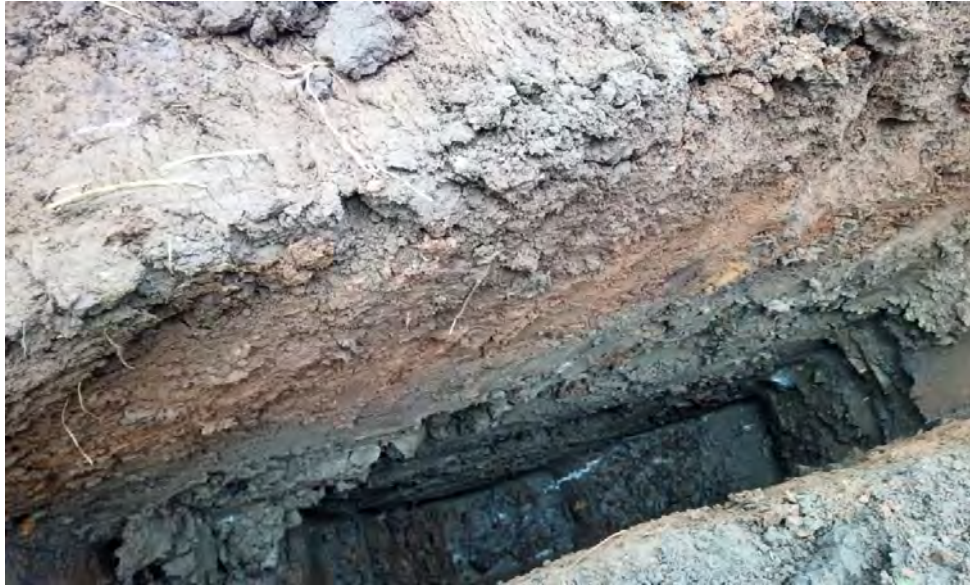
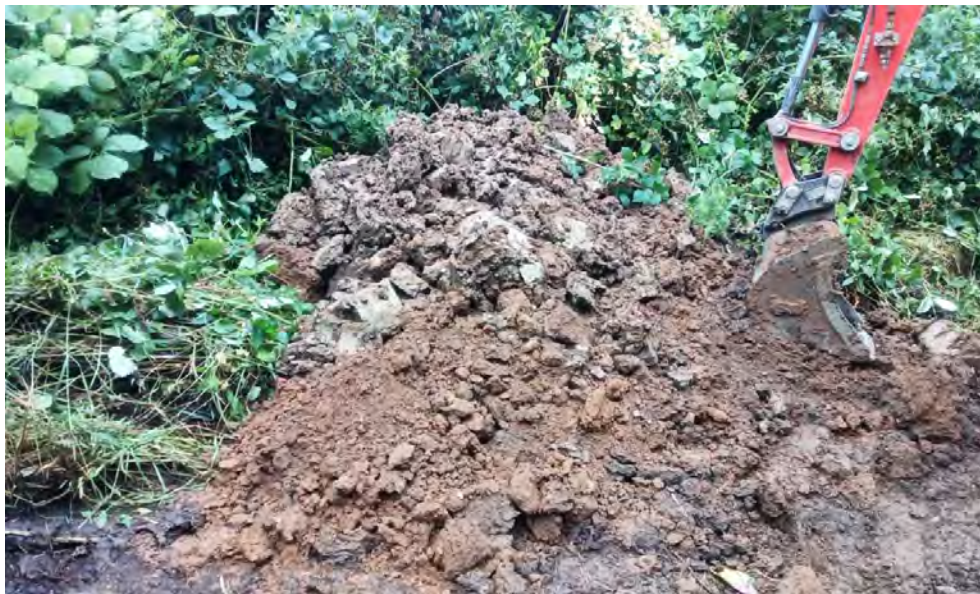
<div>CAUSEWAY GEOTECH</div></div>			Project No. 24-0640		Project Name: Dublin St North, Monaghan			Trial Pit ID  TP01			
			Coordinates 667510.50 E 833755.90 N		Client: Monaghan County Council						
Method: Trial Pitting			Elevation 67.25 mOD			Client's Representative: McAdam Design Ltd			Sheet 1 of 1 Scale: 1:25		
Plant: 3t Tracked Excavator			Date: 09/08/2024			Logger: RW		FINAL			
Depth (m)	Sample / Tests	Field Records	Level (mOD)	Depth (m)	Legend	Description			Water

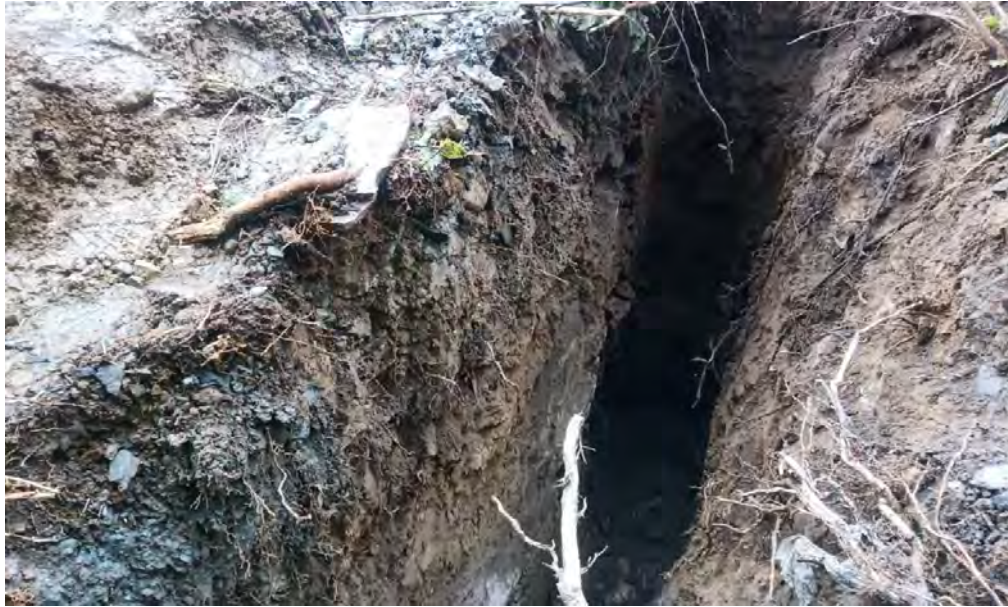
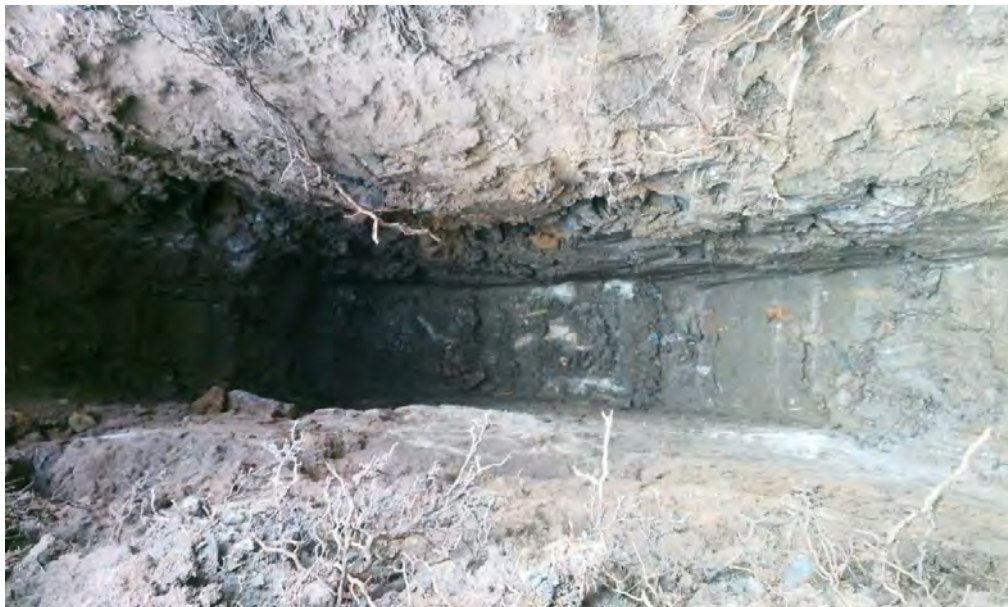
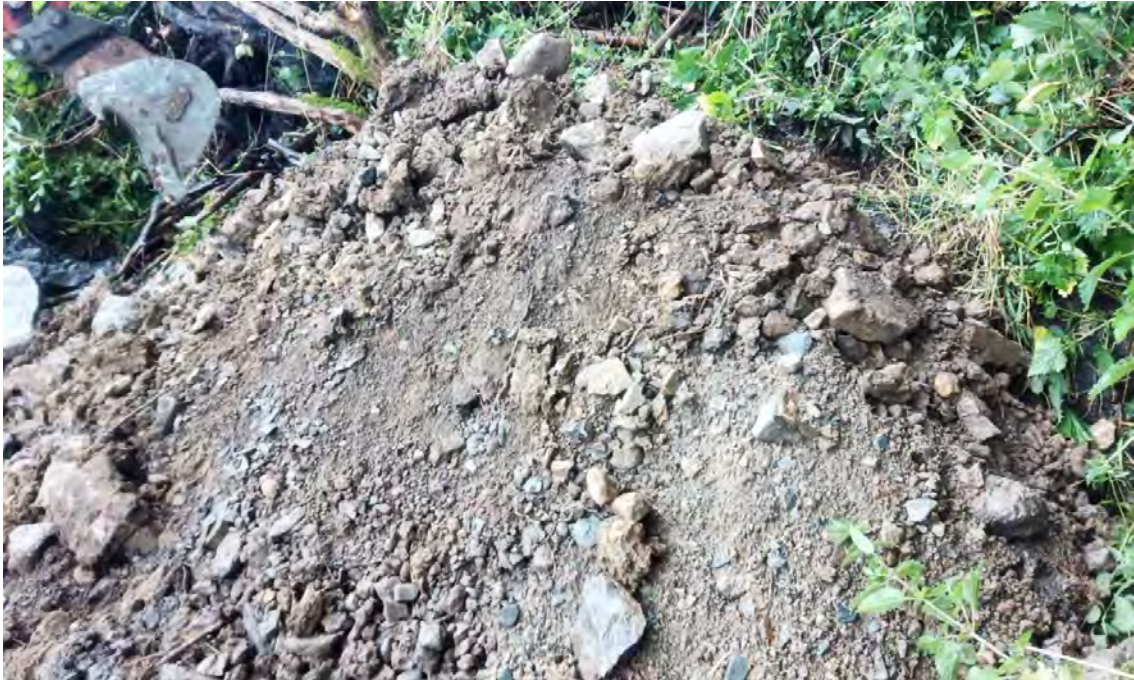
<div>CAUSEWAY GEOTECH</div></div>			Project No. 24-0640		Project Name: Dublin St North, Monaghan			Trial Pit ID  TP03																																																																																																																						
			Coordinates 667473.40 E 833748.90 N		Client: Monaghan County Council																																																																																																																									
Method: Trial Pitting			Client's Representative: McAdam Design Ltd			Sheet 1 of 1 Scale: 1:25																																																																																																																								
Plant: 3t Tracked Excavator			Elevation 71.73 mOD		Date: 08/08/2024		Logger: RW		FINAL

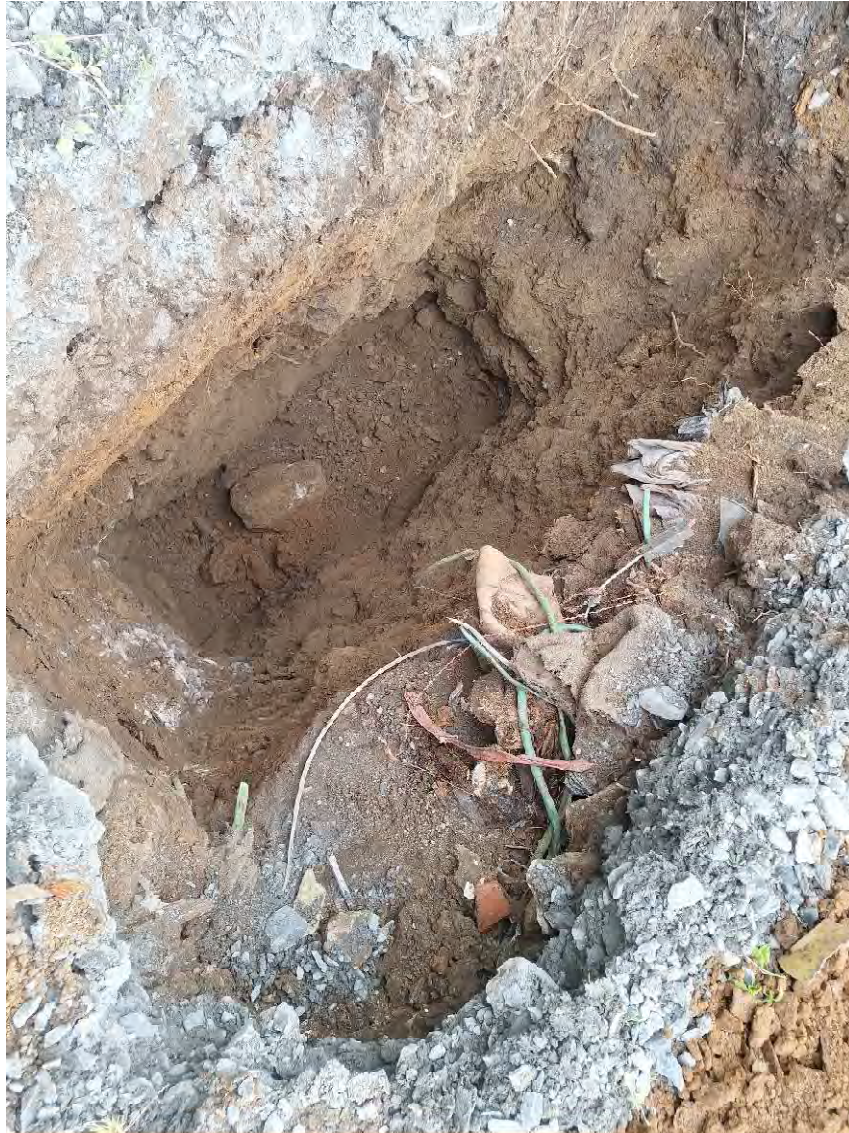
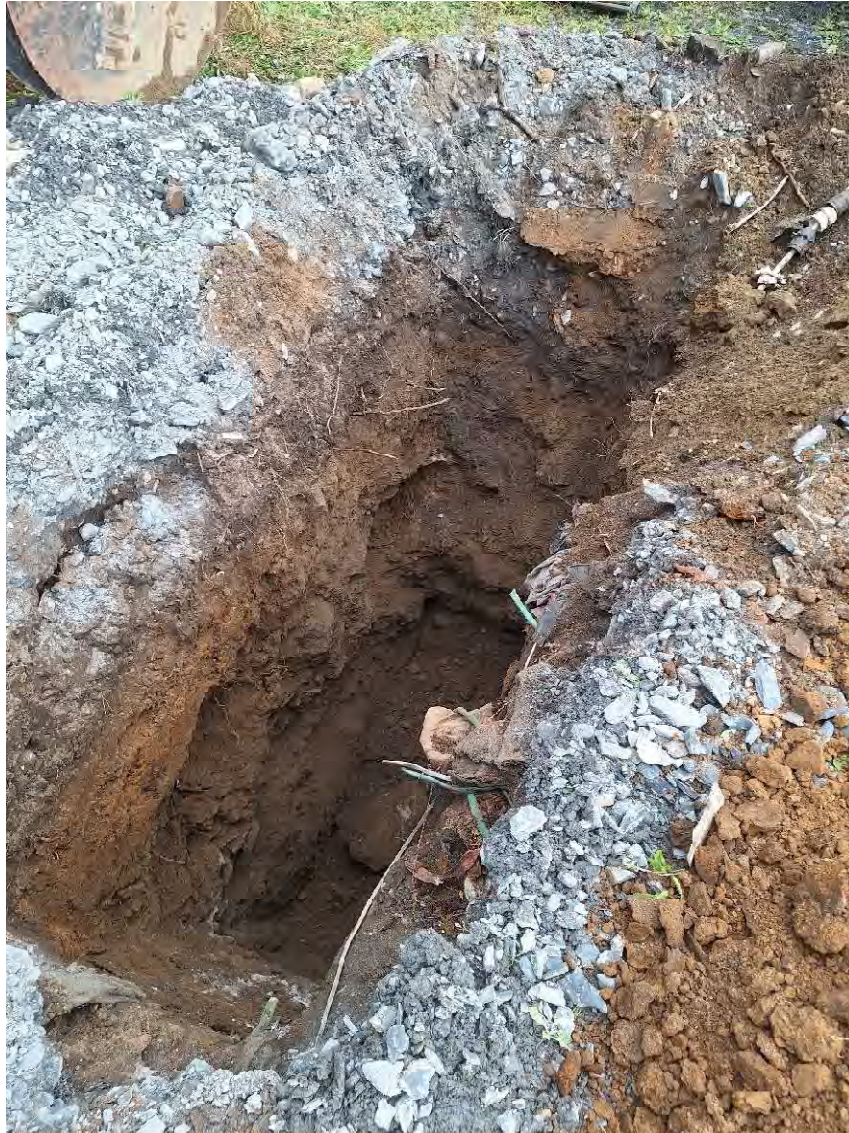
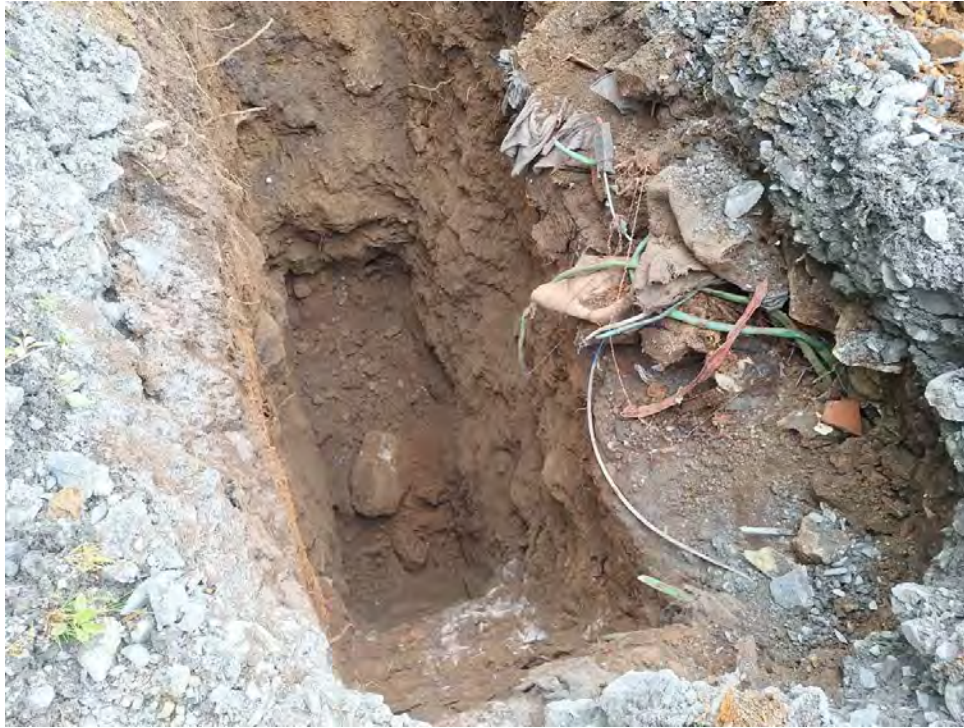
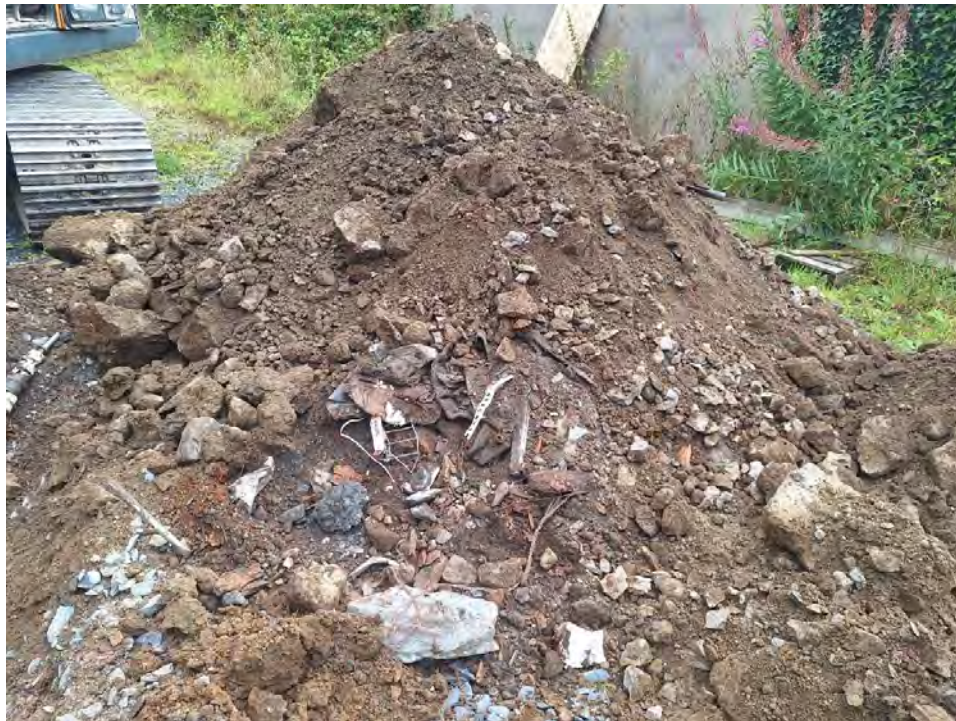
<div>CAUSEWAY GEOTECH</div></div>			Project No. 24-0640		Project Name: Dublin St North, Monaghan			Trial Pit ID  TP05					
			Coordinates 667365.70 E 833758.40 N		Client: Monaghan County Council								
Method: Trial Pitting						Client's Representative: McAdam Design Ltd			Sheet 1 of 1 Scale: 1:25				
Plant: 14T Tracked Excavator			Elevation 61.80 mOD		Date: 13/08/2024			Logger: MMC		FINAL			
Depth (m)	Sample / Tests	Field Records	Level (mOD)	Depth (m)	Legend	Description				Water

Firm rusty brown slightly gravelly CLAY with low cobble content. Gravel is subangular fine to coarse of limestone. Cobbles are subangular to subrounded of limestone.					
								Firm slightly greyish brown slightly sandy gravelly CLAY with high cobble content. Sand is fine to coarse. Gravel is subangular to angular of limestone. Cobbles are subangular to angular of limestone.

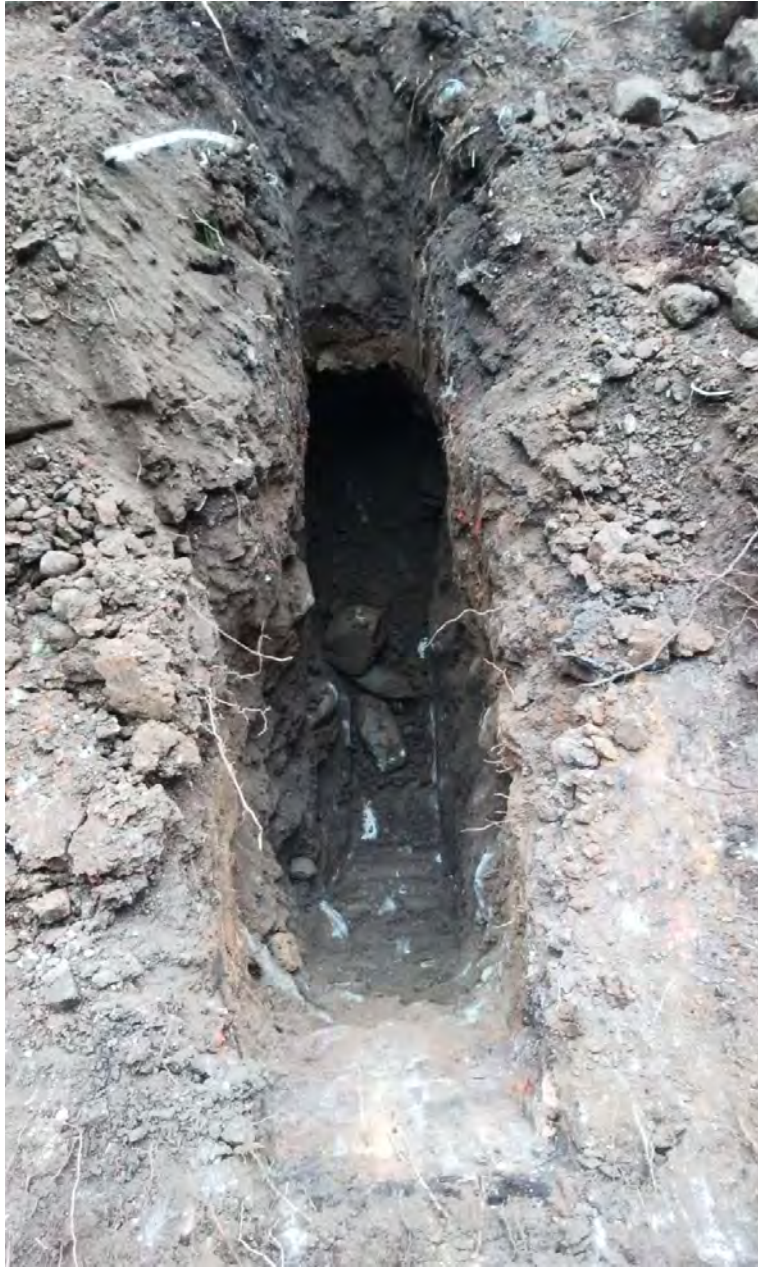
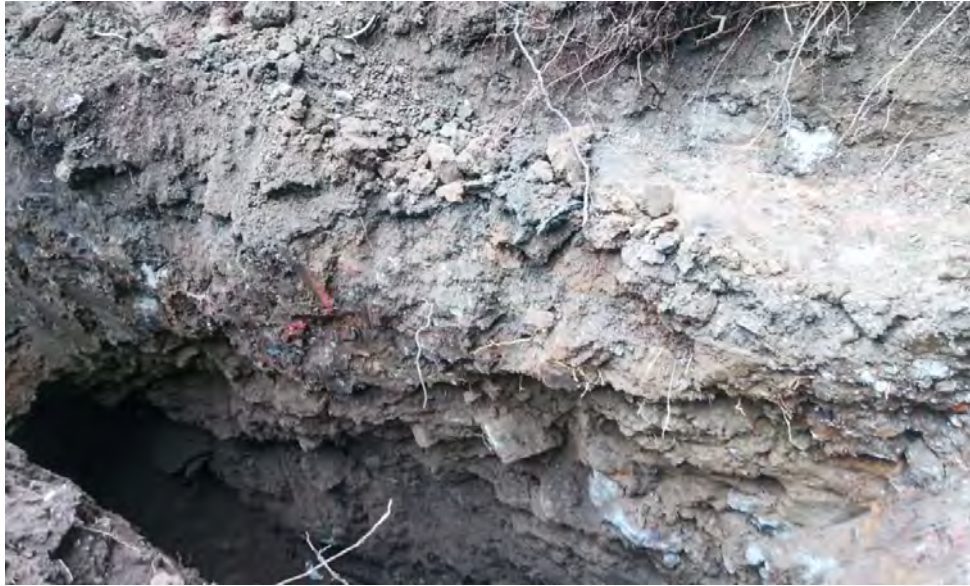
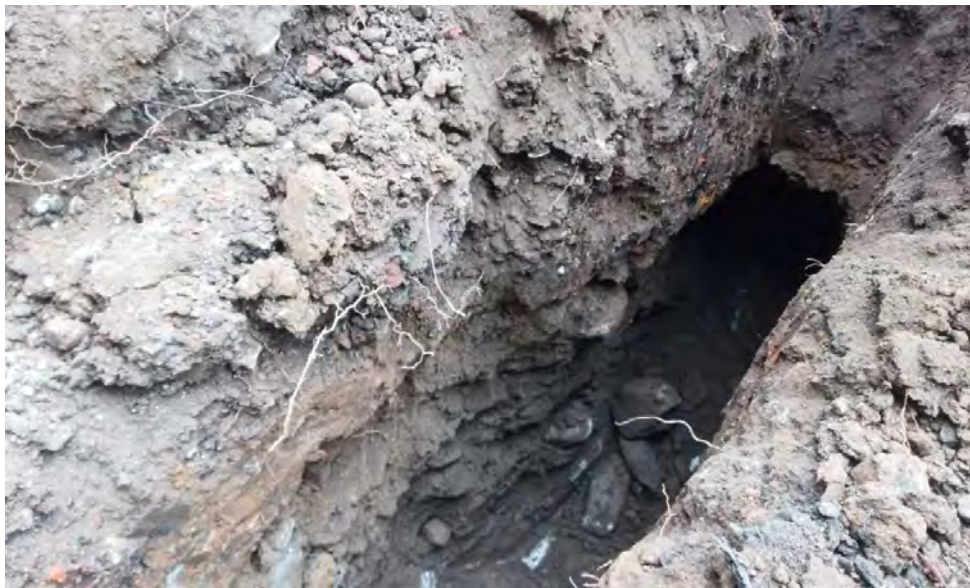
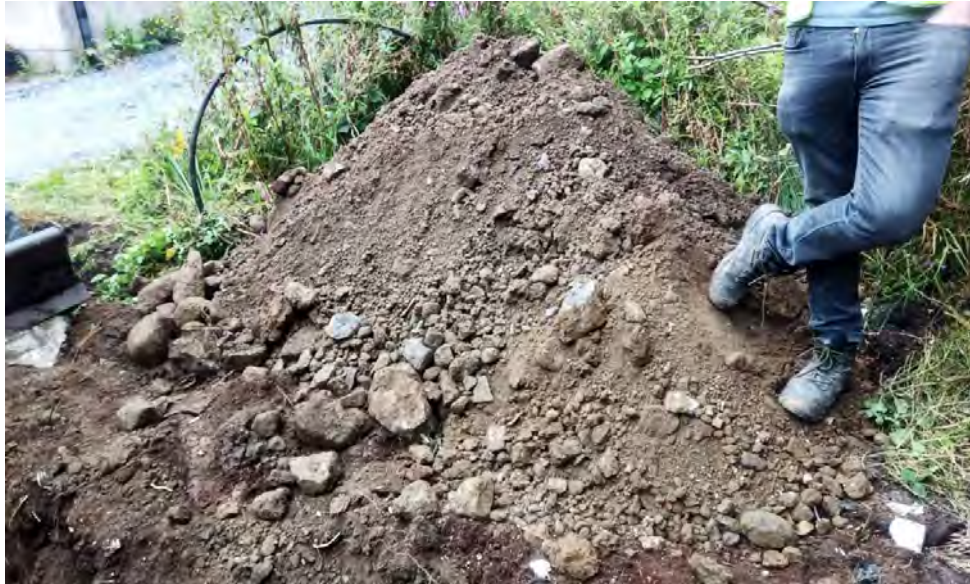
<div>CAUSEWAY GEOTECH</div></div>			Project No. 24-0640		Project Name: Dublin St North, Monaghan			Trial Pit ID  TP07		
			Coordinates 667365.20 E 833781.50 N		Client: Monaghan County Council					
Method: Trial Pitting			Elevation 62.54 mOD			Client's Representative: McAdam Design Ltd			Sheet 1 of 1 Scale: 1:25	
Plant: 3t Tracked Excavator			Date: 08/08/2024			Logger: RW		FINAL		
Depth (m)		Sample / Tests	Field Records		Level (mOD)	Depth (m)	Legend	Description	Water

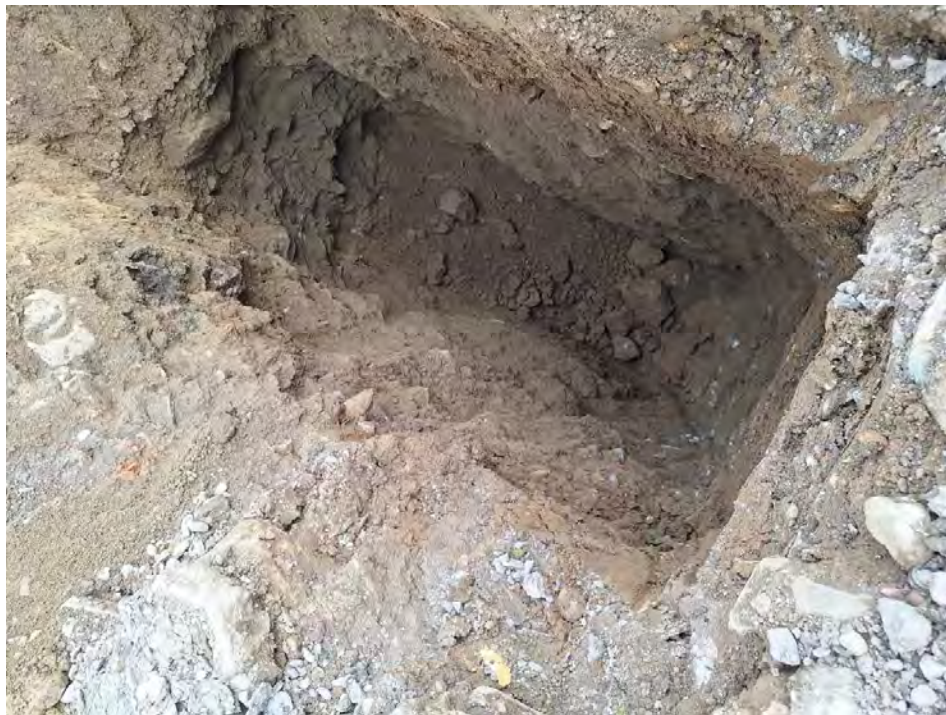
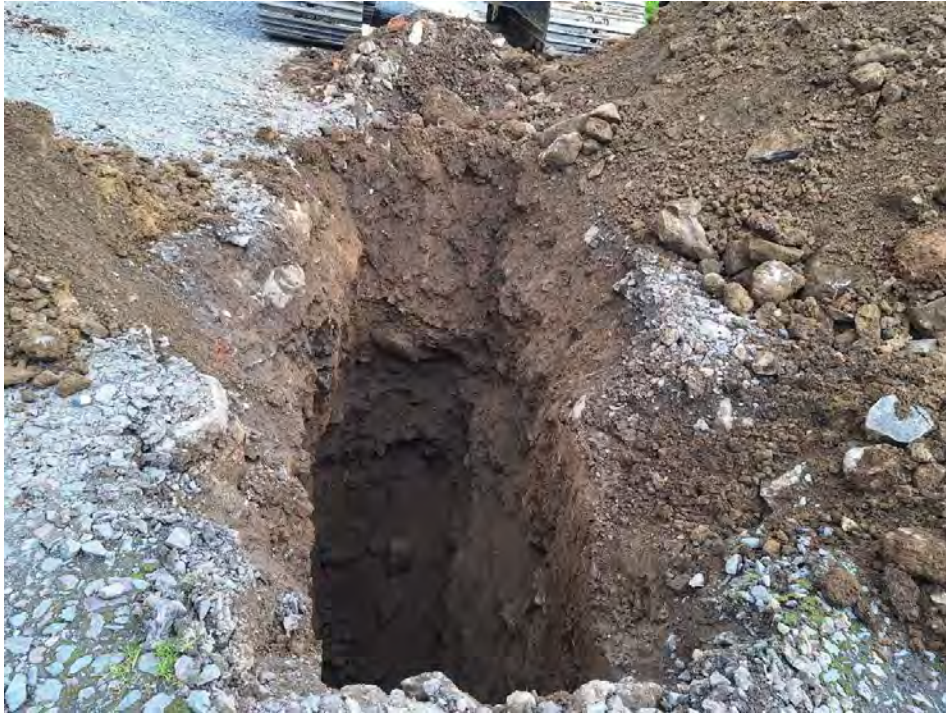
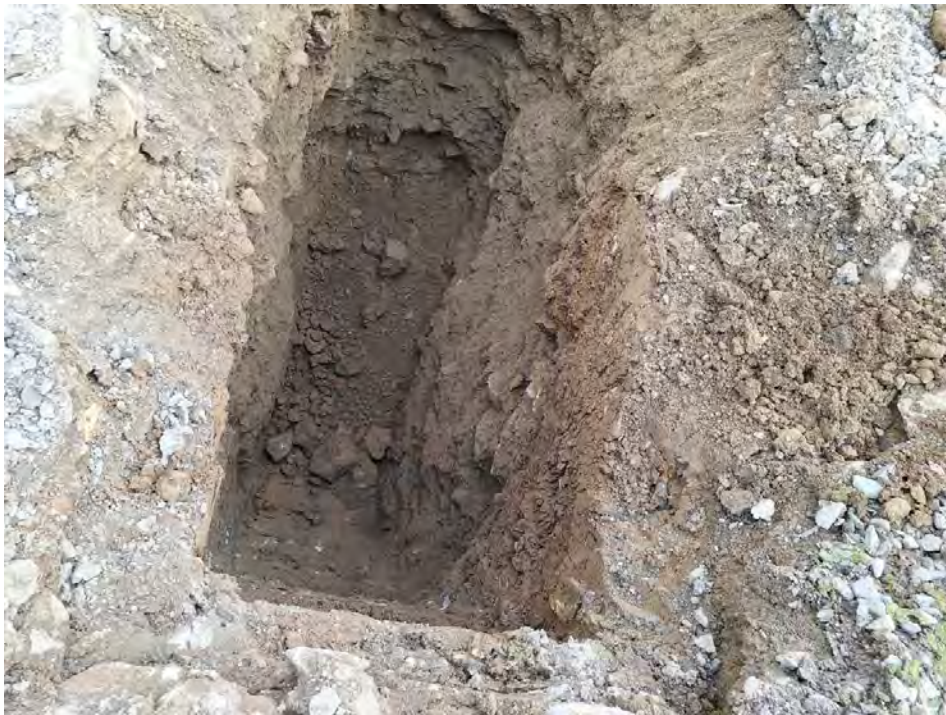
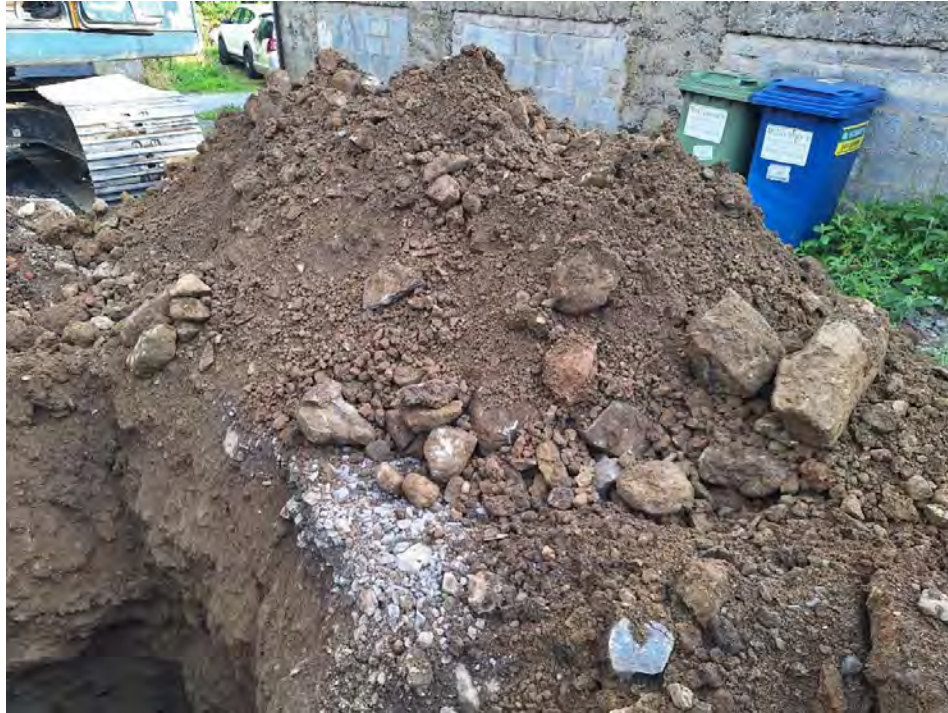
TP08

<b>Project Client</b>	Dublin street Monaghan County Council	<b>Test No:</b>	TP-08
		<b>Lab Ref No:</b>	24-0640
		<b>Date Reported</b>	27.08.24
		<b>Weather Conditions</b>	Dry
<b>Technician</b>	MMC	<b>Air Temperature °C</b>	20
<b>Date Tested</b>	13.08.24	<b>Plate Dia (mm)</b>	455
<b>Location</b>		<b>Depth (m)</b>	0.6
<b>GPS Coord's</b>		<b>Reaction Type</b>	14t Excavator
<b>Material Type</b>	Clay	<b>App Weight (kg)</b>	62
<b>No Cycles</b>	1

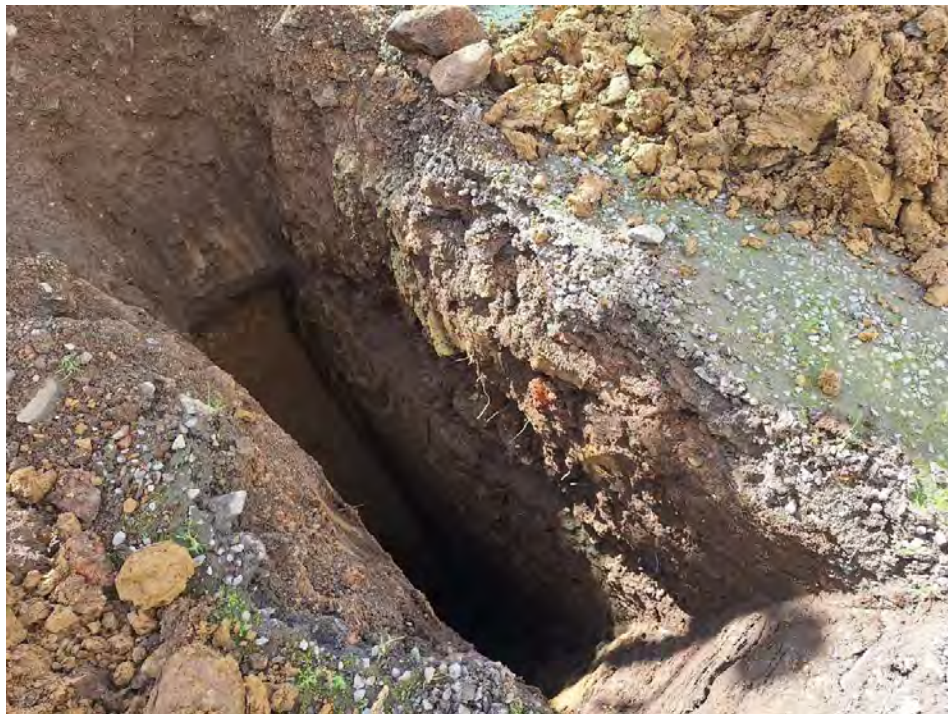
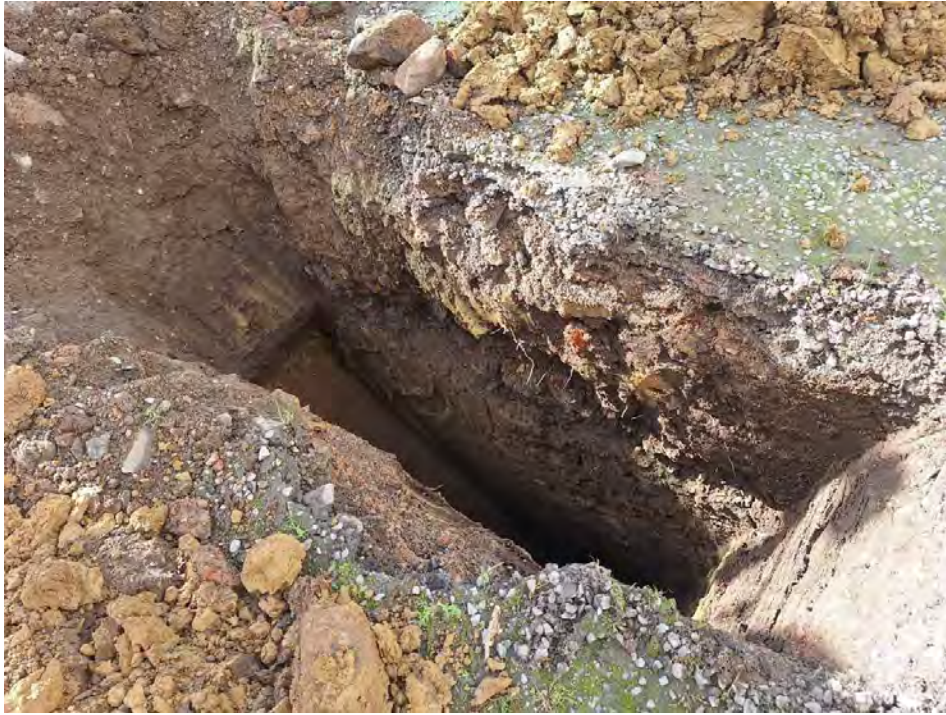
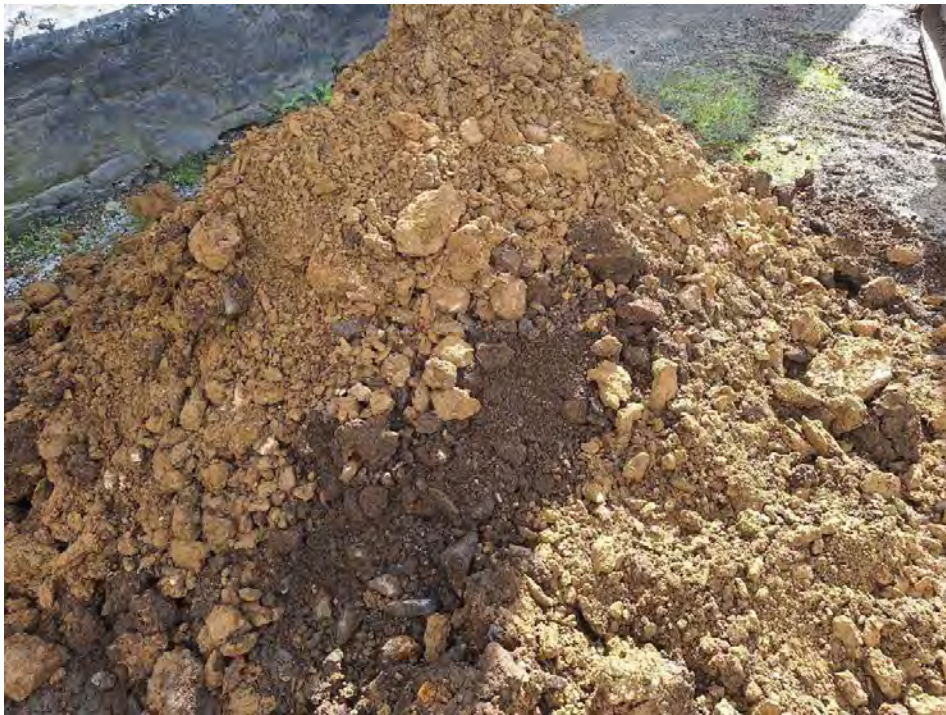
TP09

Groundwater was noted in TP10 at a depth of 2.70m and damp below 2.20m in TP09. There were no other groundwater strikes noted during drilling/excavation of the remaining exploratory holes. However, it should be noted that the casing used in supporting the borehole walls during drilling may have sealed out any groundwater strikes and the possibility of encountering groundwater during excavation works should not be ruled out.

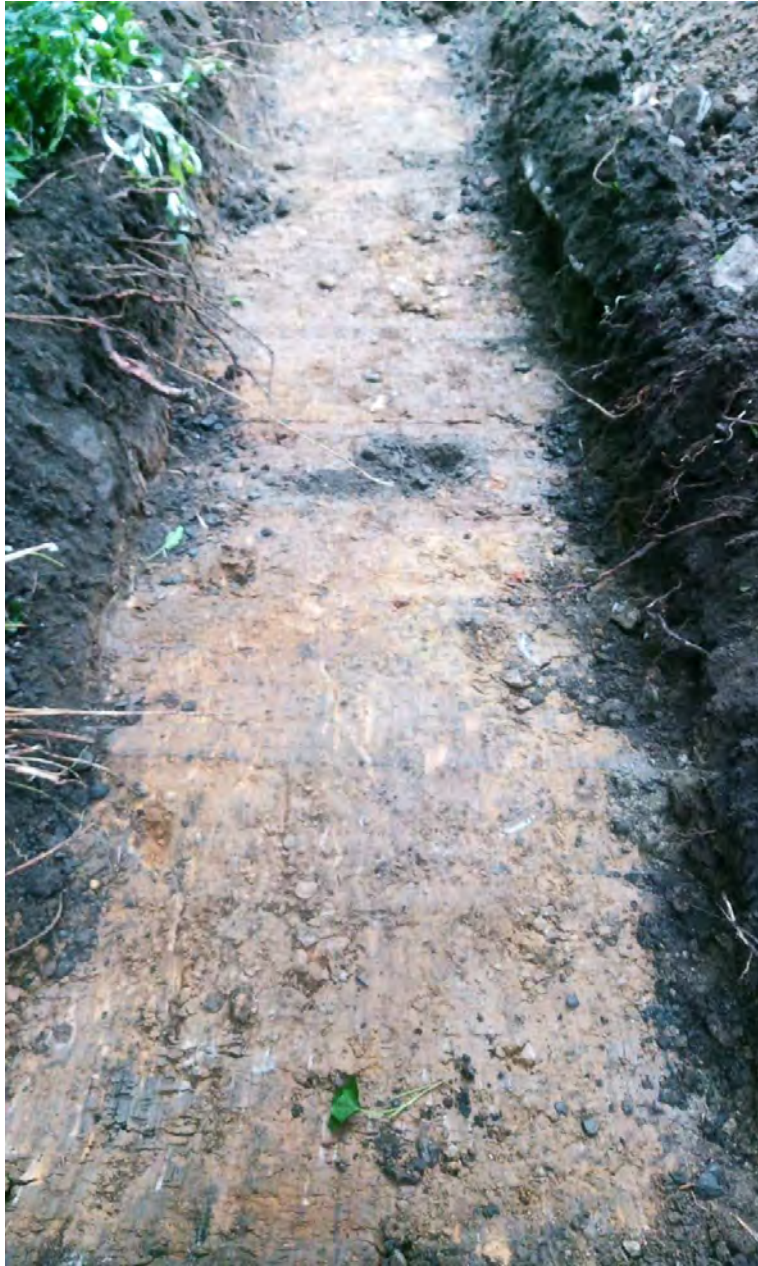
<div>CAUSEWAY GEOTECH</div></div>			Project No. 24-0640		Project Name: Dublin St North, Monaghan			Trial Pit ID  TT02			
			Coordinates E N		Client: Monaghan County Council  Client's Representative: McAdam Design Ltd						
Method: Archaeological Trench			Elevation mOD		Date: 08/08/2024			Logger: RW		Sheet 1 of 1 Scale: 1:25	
Plant: 3t Tracked Excavator								FINAL			
Depth (m)	Sample / Tests	Field Records	Level (mOD)	Depth (m)	Legend	Description			Water		
						TOPSOIL

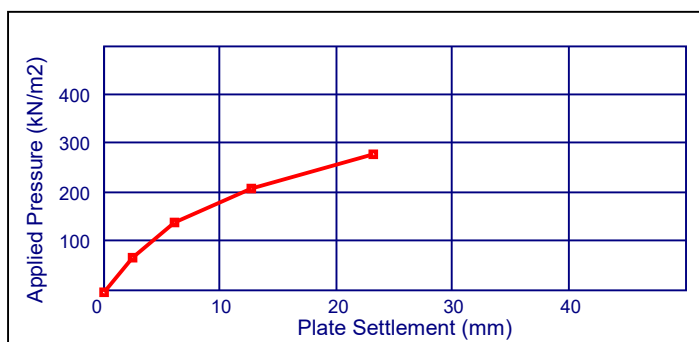
**PLATE LOADING TEST REPORT**  
 in accordance with BS 1377 : Part 9 Cl. 4.1 : 1990  
 Incremental loading test

Plate Settlement (mm)	Applied Pressure (kN/m²)
0.00	0.0
2.44	71.2
6.04	143.3
12.63	212.7
23.12	282.9

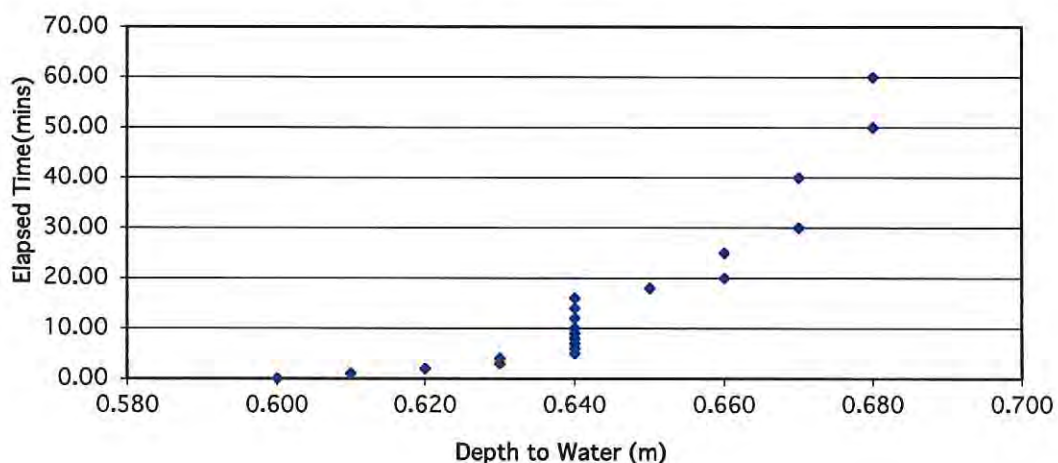
$$f = 0.00023 \text{ m/min} \quad \text{or} \quad 3.83142\text{E-}06 \text{ m/sec}$$

Depth of water vs Elapsed Time (mins)
