# Soakaway Design f -value from field tests

Contract: Monaghan, Active Travel

**Project Number: 24665**  
**Site: Monaghan Active Travel**  
**Project Engineer: DBFL/CORA**

**Flood Risk Assessment – Desktop Study**

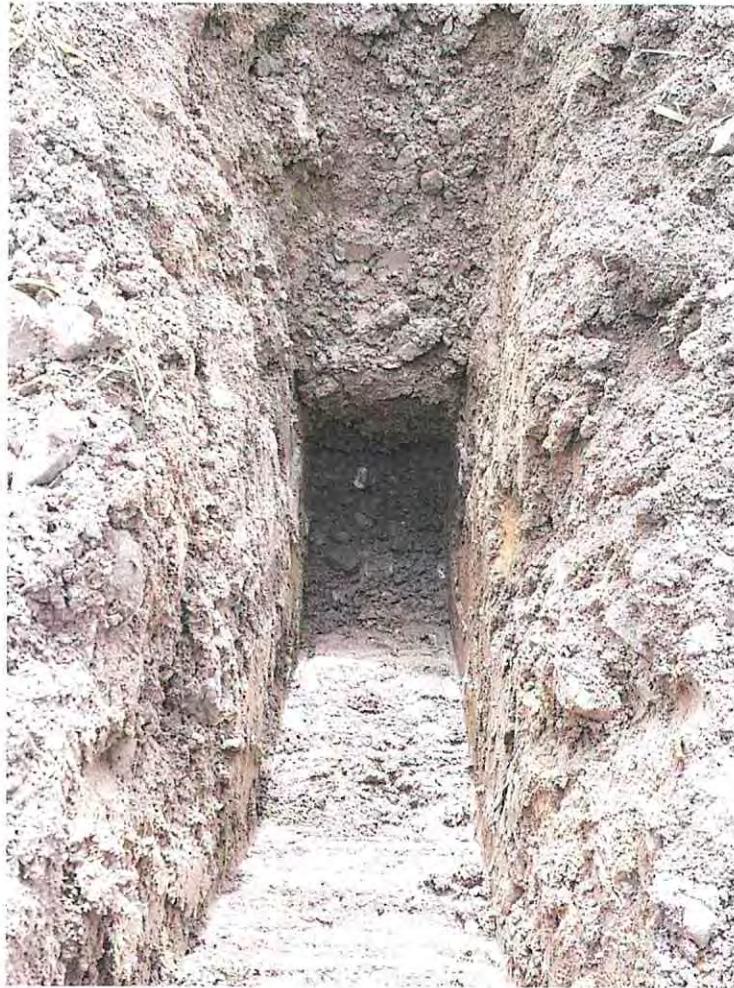
**TRIAL PIT PHOTOGRAPHY RECORD**  
**SA 03**

from	to	Description	Ground water
0.00	0.30	TOPSOIL	DRY
0.30	1.60	Firm to stiff, greyish brown, slightly sandy gravelly slightly silty CLAY with high cobbles and low boulders content

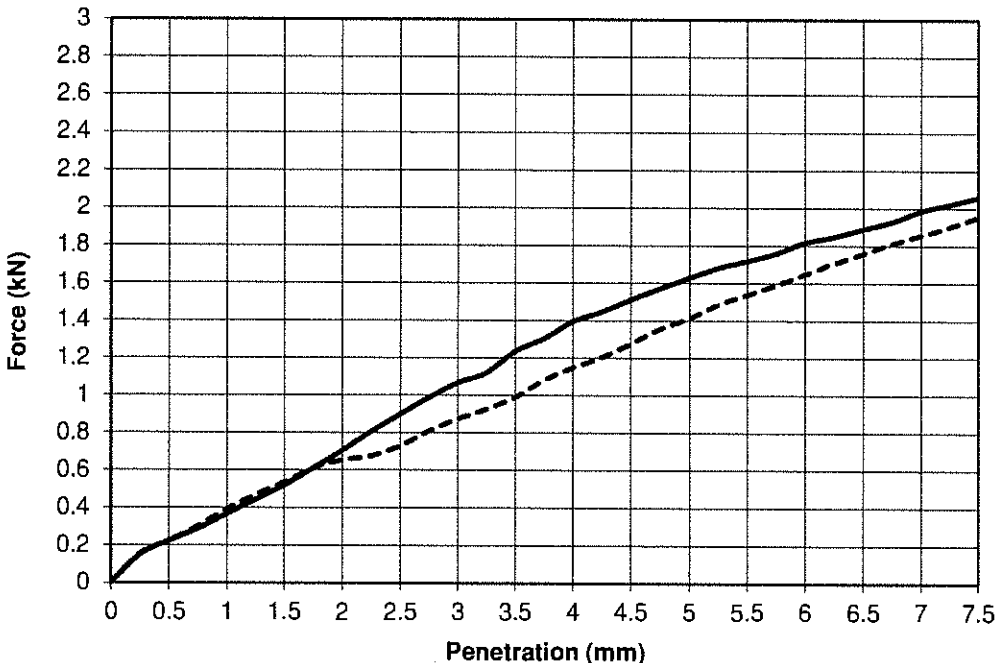
Description: Brown slightly sandy, gravelly, SILT/CLAY																										
Initial Condition: Unsoaked																										
Moisture Content (%):	10	Bulk Density (Mg/m <sup>3</sup> ):	2.15																							
Surcharge (kg):	4	Dry Density (Mg/m <sup>3</sup> ):	1.95																							
% Material >20mm:	21																									
Method of compaction: Static Compaction Method 2																										
<table border="1" style="width: 100%; border-collapse: collapse; text-align: center;"> <tr> <th>Test Result</th> <th>Top</th> <th>Base</th> </tr> <tr> <td>CBR %</td> <td>8.2</td> <td>7.1</td> </tr> <tr> <td>Moisture Content %</td> <td>10</td> <td>10</td> </tr> </table>			Test Result	Top	Base	CBR %	8.2	7.1	Moisture Content %	10	10															
Test Result	Top	Base																								
CBR %	8.2	7.1																								
Moisture Content %	10	10																								
Results relate only to the specimen tested, in as received condition unless otherwise noted Opinions and interpretations are outside the scope of accreditation. * denotes Customer supplied information This report shall not be reproduced except in full without written approval from the Laboratory.		Persons authorized to approve reports J Barrett (Quality Manager) H Byrne (Laboratory Manager)

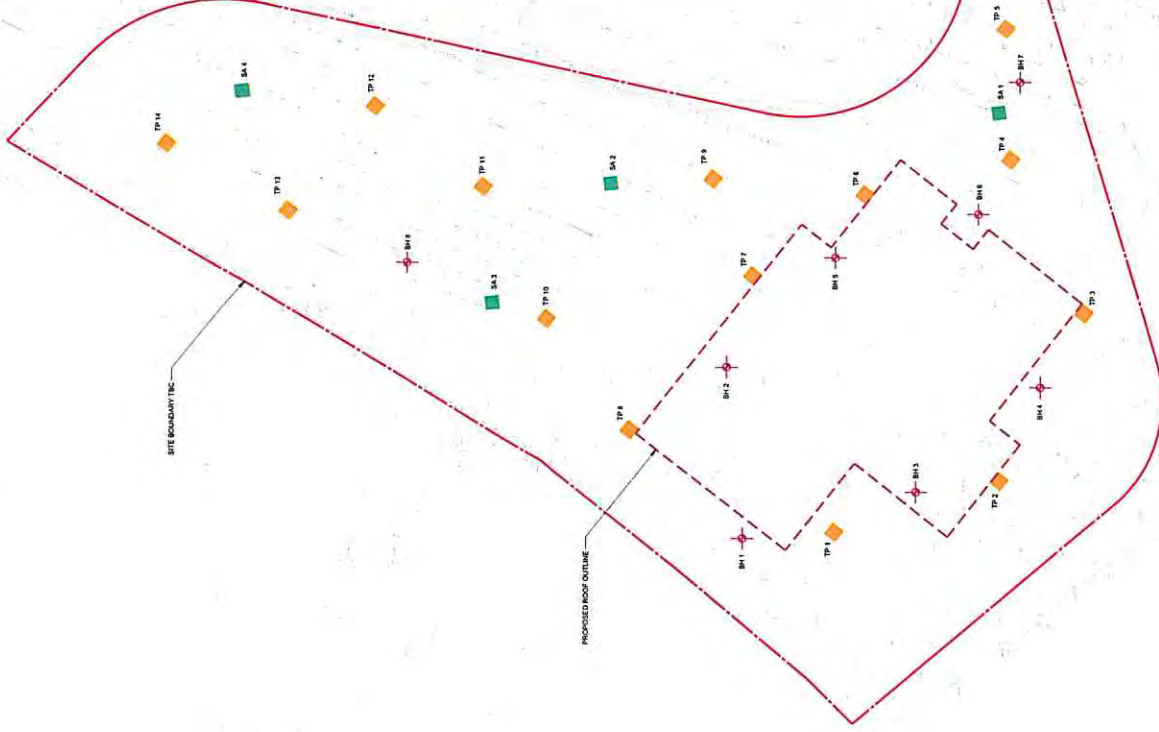
SITE INVESTIGATION  
SCALE 1:500

TAKE SAMPLES AT 1M INTERVALS FOR VAC ANALYSIS IN BORERHOLES BH1 AND THINK PITS TP1

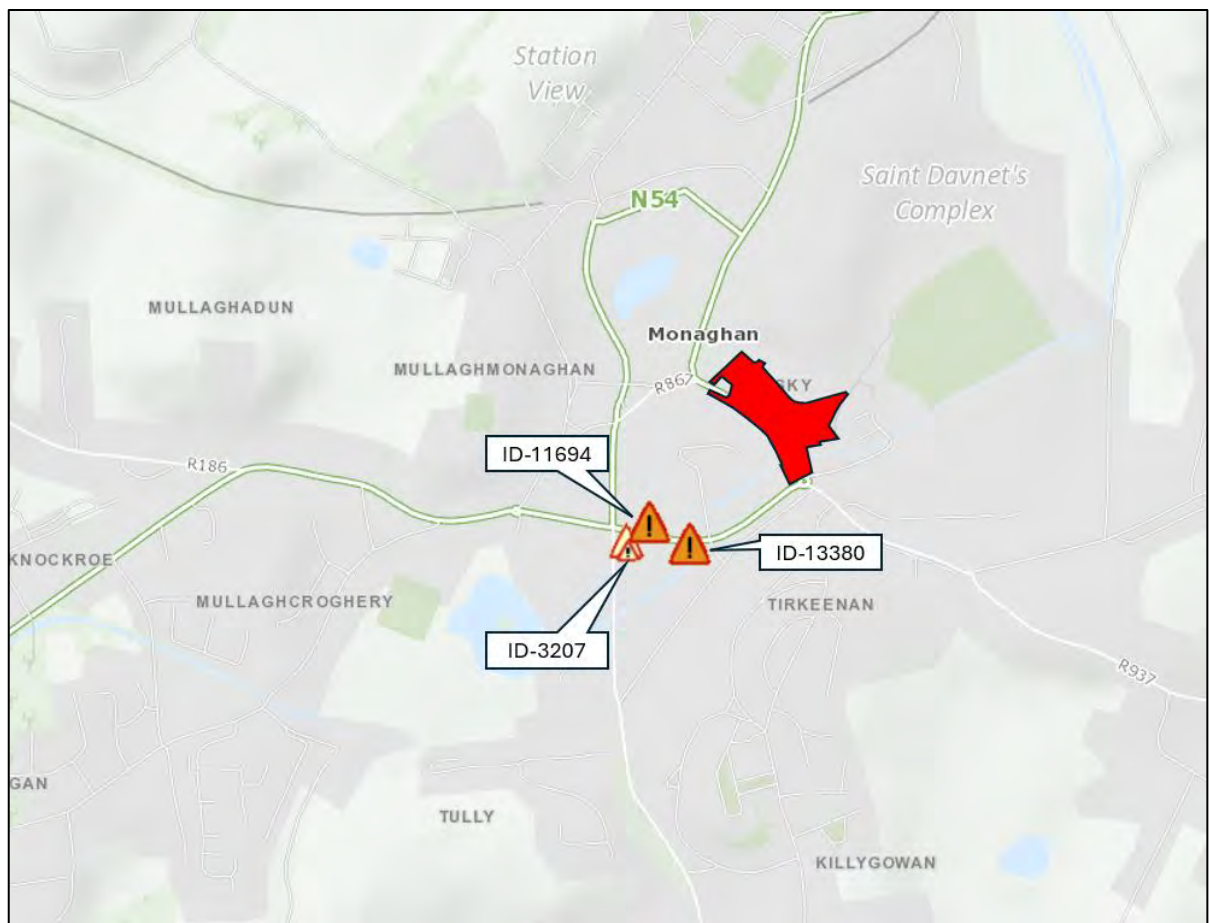
Figure 3.2: OPW Past Flood Events Map

The nearest past flood event from the project site is event ID- 13380 and is located 380m away from the proposed development.

Figure 3.2 below shows the location of the past flood events in the vicinity of the proposed development.

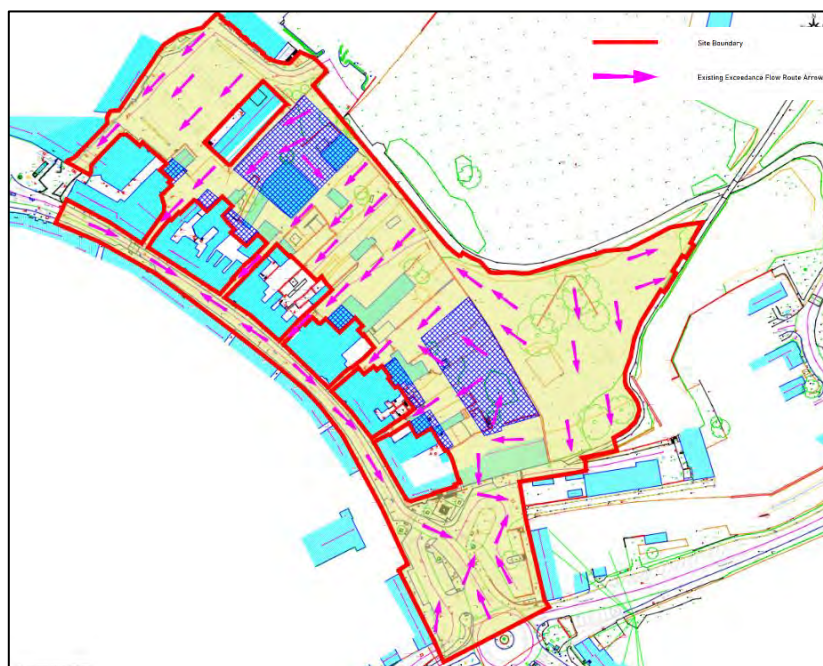
Figure 5.1: Existing Flow Route Analysis for proposed development site.

Surface water runoff from the proposed development has been assessed with consideration for the existing site characteristics, using flow route analysis to determine the natural behaviour of the site prior to development. The existing flow path analysis, illustrated in Figure 5.1 below, indicates that during exceedance events or in the event of system blockages, flow will be directed toward Dublin Street Road in the northern portion of the site, while parts of the southern portion will direct flow toward the soft areas to the east.

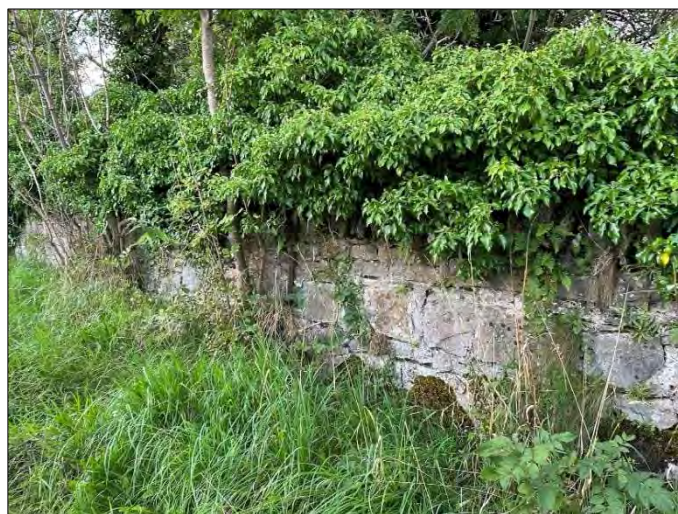
Figure 14. Example of exposed stone wall structure (rear of No.46d)

Stone walls were recorded throughout the survey area, typically bounding lands to the rear of properties along Dublin Street North, and separating these properties from the eastern portion of the site which was recorded as scrub, woodland and scattered trees / parkland. Many of the stone wall structures were overgrown with Maidenhair spleenwort (*Alsplenium trichomanes*), common ivy (*Hedera helix*), Dog rose (*Rosa canina*) and grass spp. (*Aira* & *Catapodium* spp.), however in most cases the stone wall structures were clearly visible (see example in Figure 14). Therefore, many of the structures have been mapped as BC1 rather than WL1 (hedgerows) or WS1 (scrub).

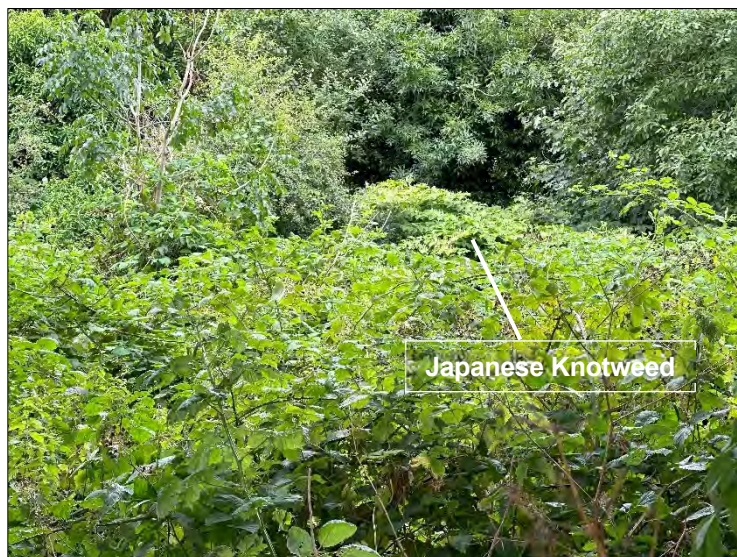
Japanese Knotweed (*Fallopia japonica*) was identified at three locations within the site. The first stand is marked as target note 12 in Figure 2, and is located within an area of dense scrub within ~10m of St. Davnet's Row laneway corridor (photograph 1). The stand extends to approximately 2m in height and covers a ground area of approximately 6m<sup>2</sup>.

Photograph 1. Japanese Knotweed (target note 12)

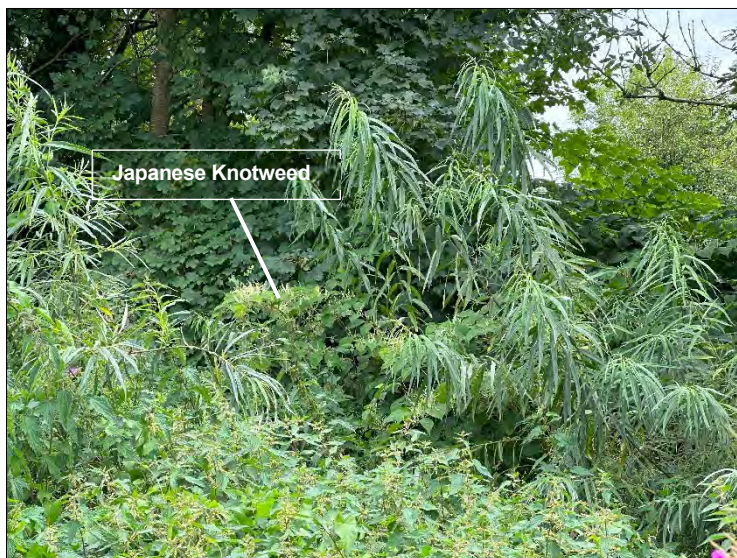
Photograph 2. Japanese Knotweed (target note 14)

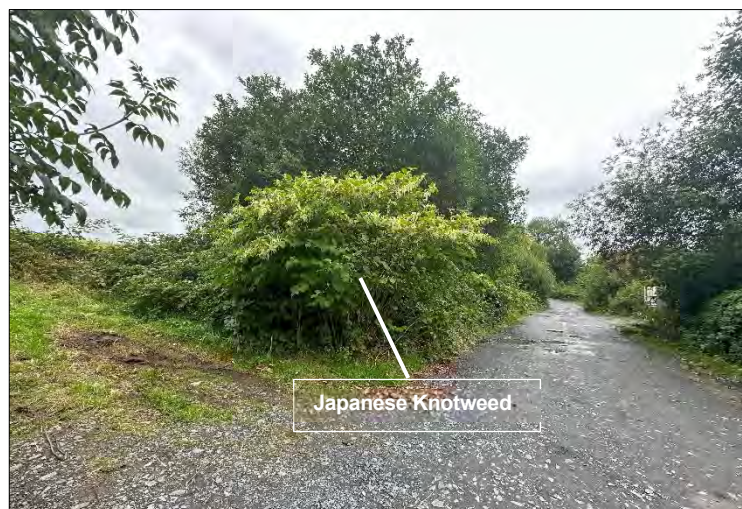
Photograph 3. Japanese Knotweed (target note 17)
