# Rossmore Forest Park Built Heritage Conservation Management Plan

## 1.1 Introduction

The objective of this document is to provide heritage advice on the appropriate conservation and management of the built heritage assets in Rossmore Forest Park. This report was jointly commissioned by Cavan County Council and Monaghan County Council. It is an action of the Rossmore Masterplan.

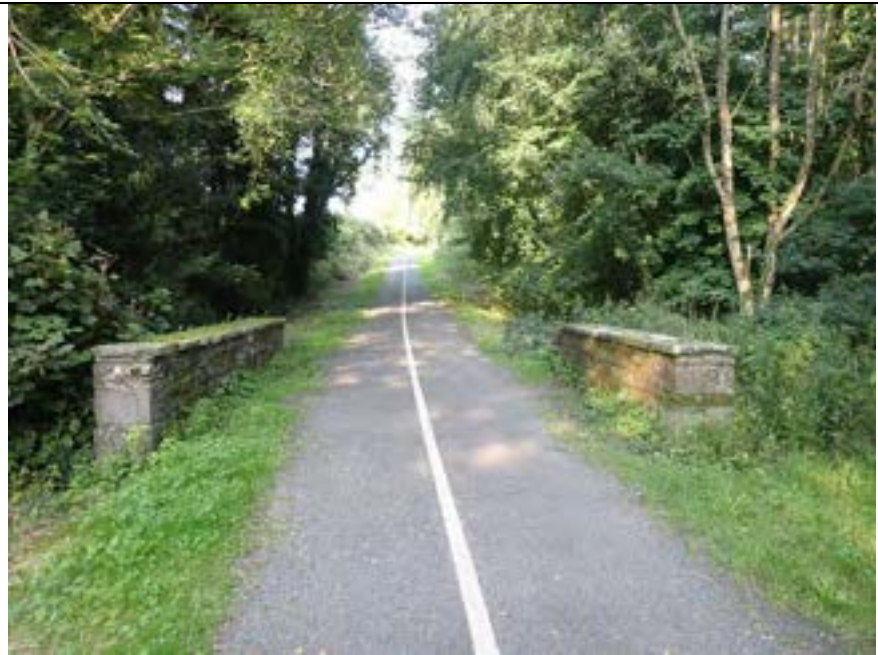
**1. Bridge Close to Front Gate**

Bridge looking northeast

Missing parapet stones with slate DPC
Coordinates	54°13'57.7"N, 6°59'53.5"W
Townland	Killicushil & Killydrutan
Description	Simple but elegant 19 <sup>th</sup> century single span masonry bridge. Limestone rubble voussoirs. Roughly dressed limestone spandrels. Peck-dressed limestone parapet with slate dpc under dressed limestone capstones.
Condition	From the areas that were accessible the bridge appeared in reasonable/poor condition. The curve of the arch towards the middle of the underside appears slightly flatter than should be the case. Furthermore, some stones have fallen from the arch at the northern side of the bridge. A large tree was growing from masonry retaining the riverbank to the immediate south of the bridge. Pointing has been lost throughout the bridge. Several parapet stones have been lost on the southern parapet wall. This has allowed water ingress. Movement of several parapet stones is obvious below the area where the missing parapet stones once lay.

Suggested conservation actions	<p><b>Structural issues</b>  Observation: Several stones from the arch have popped out. The underside of the arch also appears flatter than it should be.  Action: Inspection required from a conservation engineer to diagnose the issues and propose solutions.  Timing: Immediate</p> <p><b>Missing parapet stonework and loose stone</b>  Observation: Parapet stonework is missing and some stone is loose  Action: Replace missing parapet stone with matching. Make sure to also reinsert missing section of slate DPC. The parapet stones may be located close by. Reset loose stones underneath. Repoint masonry joints as required with appropriate lime-based mortar. Samples of existing mortar should be analysed to guide replacement mortar.  Timing: Short term</p> <p><b>Woody vegetation</b>  Observation: Tree and vegetation with woody roots likely to cause damage</p>

<p>Action: Carefully remove the large tree and any plants with woody roots (i.e. ivy). Insert appropriate stone infills and point as required. Timing: Short term</p> <p><b>Stone pointing</b> Observation: Replace failed pointing throughout the bridge and associated retaining walls with appropriate lime-based mortar. If possible and deemed to not be damaging to the structure, vegetation with non-woody roots (e.g. lichens, small ferns) should be retained. Timing: Short term</p>
Possible visitor experience actions	None
Protected Structure	No
Record of Monuments and Places	No
Significance rating	Local
Category	19 <sup>th</sup> century bridge
Other notes	The full extent of the bridge was difficult to access. Accordingly, only a partial survey was possible.
References	n/a

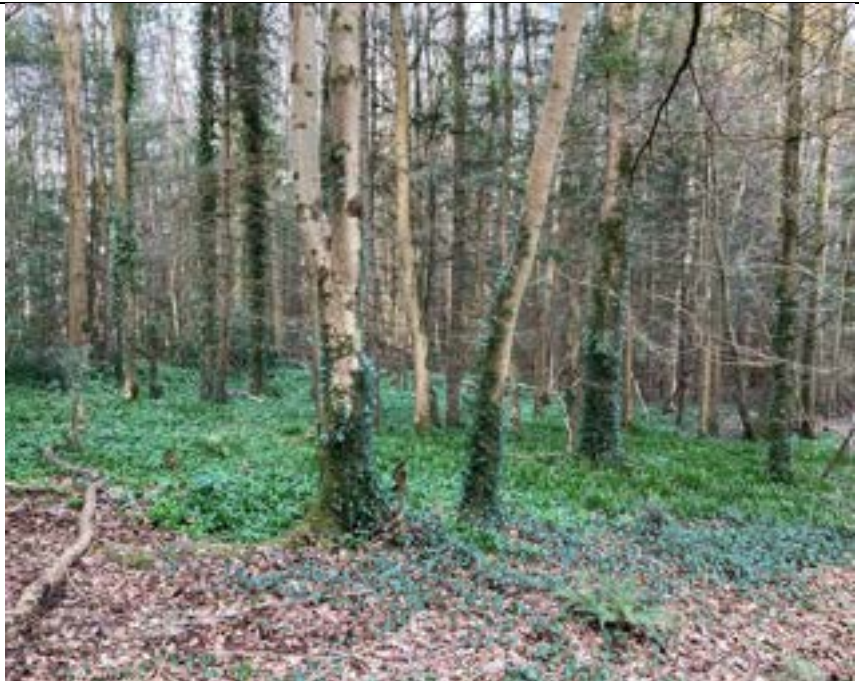
<p><b>2. Gortakeegan Megalithic Tomb – unclassified</b></p>

<p>Area where tomb is apparently located</p>
Coordinates	54°14'11.7"N 6°59'29.0"W? (unable to locate)
Townland	Gortakeegan
Description	<p>Located on the crest of a hill in a forested area with commanding views of the Twin Lakes to the south. The remains consist of four deeply set orthostats, aligned E-W, and a large boulder like capstone 0.2m to the north. The capstone rises to a height of c.0.5m above the surrounding ground level and there is a small cavity c.0.25 deep underneath it. No evidence of a cairn survives. (CRDS 1998, 33) (source: <a href="https://maps.archaeology.ie/historicenvironment/">https://maps.archaeology.ie/historicenvironment/</a>). Not marked on 1<sup>st</sup> edition OS Map or on the historic 25" OS Map.</p>

Condition	Unknown. Was unable to locate. Possibly covered by vegetation. Another possibility is that it has been seriously damaged.
Suggested conservation actions	<p><b>Locate</b></p> <p>Observation: Was unable to locate the tomb.</p> <p>Action: Locate tomb during winter when there is less vegetation. This will inform appropriate conservation actions. A key conservation action is likely to be vegetation management.</p> <p>It is possible that a recommendation could be the removal of trees around the monument and the creation of a 15m buffer zone. Under Department of Agriculture Forest Service guidelines on Forestry and Archaeology the current forestry and archaeology guidelines, once an operation is planned in an area, as part of the felling licence approval, an archaeological plan will be approved by an archaeologist in the Department of Agriculture Forest Service. All Coillte operators must complete training on environmental awareness. This approach significantly reduces the risk of damage being caused to archaeological sites during felling.</p> <p>Timing: Medium</p>

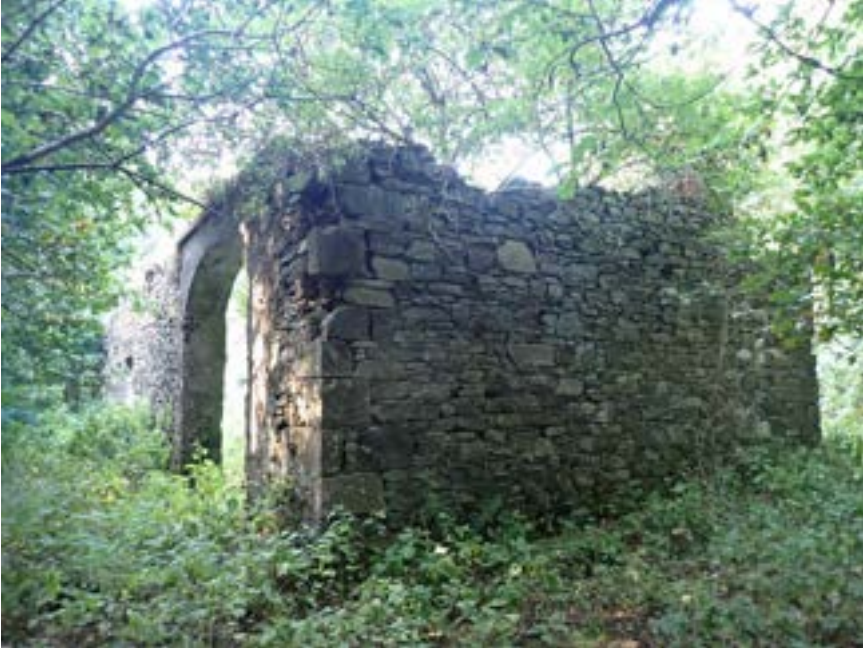
<p><b>3. The Barn / Pavilion</b></p>

<p>Exterior of Barn/Pavilion</p>
--------------------------------------	---

Coordinates	54°13'47.4"N, 6°59'30.3"W
Townland	Killydrutan
Description	Simple four walled structure with large barrell arch for entry/exit. Random rubble walling with dressed quoin stones. One window ope present with holes indicating that iron bars covered ope. Probable barn. Site now known as 'The Barn' but in Historic 25" map it is marked as 'Pavilion'.
Condition	Overall, the structure is in poor condition. It is likely to be dangerous. Pointing has failed throughout this now unroofed structure. Inappropriate concrete repairs are evident, especially around the entrance arch. Individual stones have fallen from the four walls. The wall tops are exposed and uneven. In some areas fallen stones have

<p>created visible gaps through the masonry. Despite the condition of the stonework, no obvious bulges or leans in the walls were visible. Indeed, the four walls are still well tied together. Hence, there is still time to conserve this structure.</p>
<p>Suggested conservation actions</p>	<p><b>Safety</b>  Observation: The missing stonework and pointing has led to concerns of partial collapse.  Action: Commission a conservation engineer to conduct a full structural survey and create a schedule of repairs. Do not encourage visitation of the site and erect suitable warning signage (during the site visit a campfire was noticed close to the structure). The vegetation within the structure acts a natural barrier to ingress. Nonetheless, suitable safety fencing surrounding the structure should be considered. From previous experience, despite the presence of safety fencing people often force entry regardless. Hence, it is important that the structural survey and associated safety works are completed in a timely fashion. Although the site is not a protected structure, any repair works should be specified and carried out as if it was so (i.e. the use of traditional materials and experienced craftspeople).  Timing: Immediate</p> <p><b>Stone walls</b>  Observation: The walls have missing stones and are uncapped. Pointing has failed throughout the structure.  Action: The following actions – or similar – are likely to be needed to conserve the structure. However, any such works are contingent on the structural report carried out by a conservation engineer.  Cap stone walls with appropriate lime mortar or flat capping slabs of natural stone. Point walls with natural lime mortar. Carefully remove woody vegetation from walls and infill with natural stone and lime mortar as appropriate. Replace missing stones with matching. Infill sections of missing stonework with matching. Take care to match existing coursing. Samples of existing mortar should be analysed to guide replacement mortar.  Timing: Short term</p> <p><b>Entrance arch</b>  Observation: Entrance arch has significant concrete repairs  Action: Although the arch has ben subject to concrete repairs, it is still standing and did not appear to be in imminent danger of collapse. Removing concrete may cause more damage than it could solve. Consequently, guidance on how the arch should be addressed will have to wait until after it has been inspected by a conservation engineer.  Timing: Short term</p> <p><b>Window opening</b>  Observation: Rear gable window opening is missing stonework  Actions: Rebuild stonework to original profile of window reveals. Take care to match existing. A conservation engineer should appraise if a new lintel is required.  Timing: Short term</p>

Possible visitor experience actions	Once made safe, the site would benefit from interpretation. A well-designed interpretive panel with complementary audio track would be appropriate. Improved signage directing people to the site is needed. However, conservation works are necessary before the site can host visitors.
Protected Structure	No
Record of Monuments and Places	No
Significance rating	Local
Category	Likely 19 <sup>th</sup> century barn
Other notes	Due to vegetation, it was not possible to conduct a full survey.
References	n/a

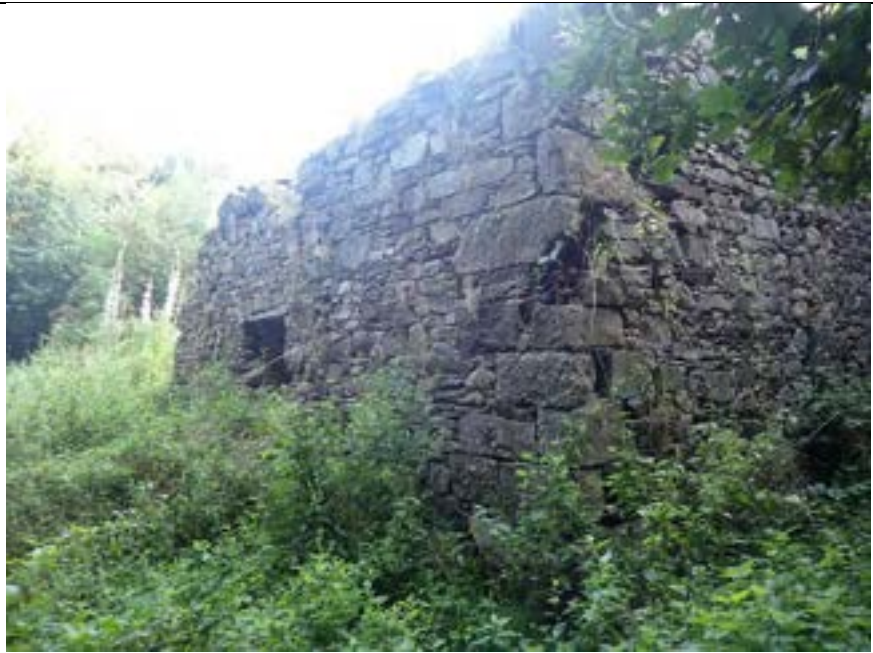
Rear exterior of Barn/Pavilion with window ope visible

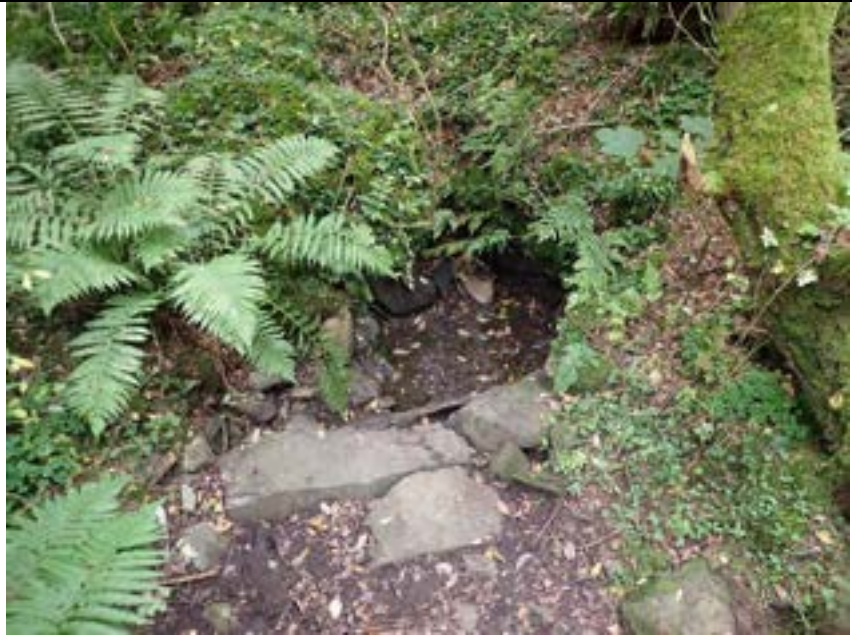
**5. Well**

Looking into the well

Description	Simple dry stone well immediately adjacent to track. Rudimentary lining of spring with random rubble limestone. Not marked on 1 <sup>st</sup> edition OS Map. Marked as 'well' on historic 25" OS Map.
Condition	In good condition due to its simple construction with robust materials. The main danger to this modest structure is roots from nearby trees disturbing the walls. Due to its discrete character within a forest setting, the well is also vulnerable to being obscured from view and as a result, being forgotten about.
Suggested actions	<p><b>Trees and other vegetation with woody roots</b>  Observation: Danger of roots disturbing the stonework.  Action: Any plants with woody roots that either are currently or are likely to disturb the walling should be removed. Cut down the tree and treat root stumps with ecologically acceptable herbicide (make sure to seek expert advice on this matter).  Timing: Short term</p> <p><b>Debris and vegetation</b>  Observation: Debris within the well. Vegetation overhanging the well and obscuring it from view.  Action: Regular removal of leaves and other debris from the well is required. Vegetation should be managed so that it does not overwhelm the well. Only hand tools are to be used. This is a maintenance issue.  Timing: Medium term</p>

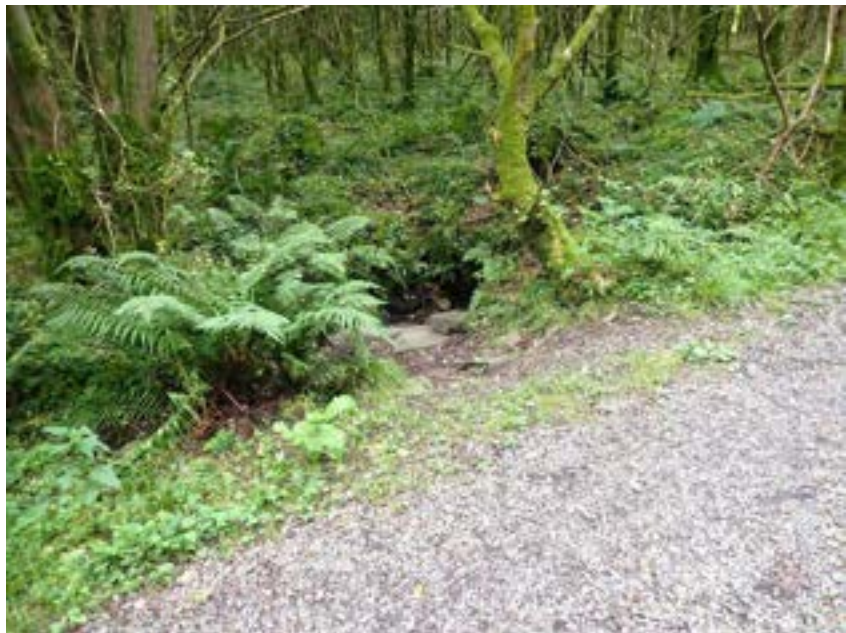
Well from trackway

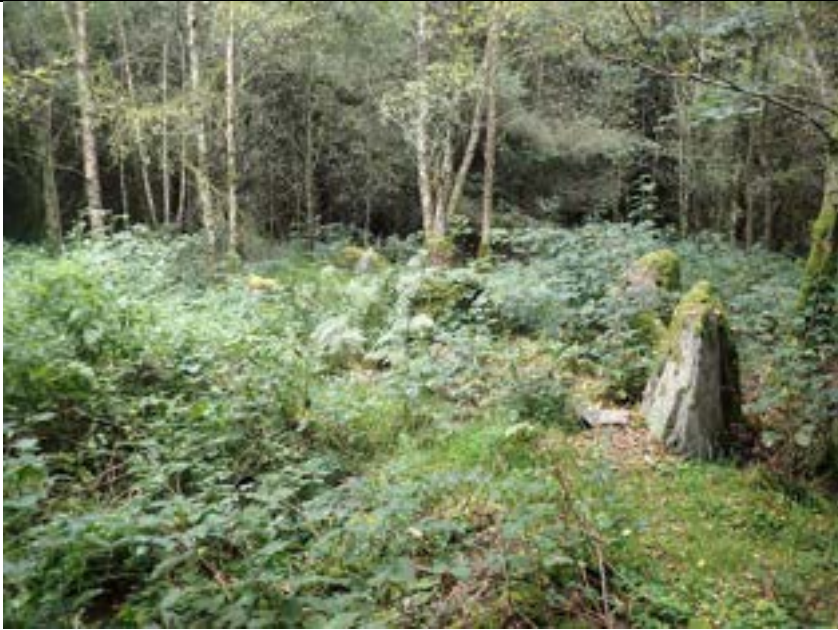
<p><b>6. Killydrutan Court Tomb</b></p>

<p>View of court tomb with tree growth present amongst the stones</p>
<p>Coordinates</p>	<p>54°13'42.0"N, 6°59'12.8"W</p>
<p>Townland</p>	<p>Killydrutan</p>
<p>Description</p>	<p>Court tomb located in overgrown area, c130m east of Barn Hill Lough. 'There is a shallow court at east consisting of two stones, one on either side of the entry jambs. The chamber (L 3.7m; Wth 1.1m) is aligned E-W and its sides are represented by a single stone to the south and two stones on the north side. A transversely set stone to the west probably indicates segmentation of the gallery. Three large flags 4m north of chamber may be the remains of a kerb' (source: <a href="https://maps.archaeology.ie/historicenvironment/">https://maps.archaeology.ie/historicenvironment/</a>). Not marked on 1<sup>st</sup> edition OS Map or on the historic 25" OS Map.</p>
<p>Condition</p>	<p>Due to the overgrown nature of the site, it is difficult to fully appraise the monument's condition. Nonetheless, despite being robbed historically of much of its building material, the remaining stones appear in reasonable condition. There was no evidence of anti-social behaviour. Despite being just a few metres from a public trackway, it is not easy to access. The main area of the court tomb is disturbed by natural woodland. The roots of these are likely to be disturbing subterranean archaeology and may disturb the foundations of the remaining standing stones. Although commercial forestry appears to be avoiding the main area of the tomb, planted trees are just a few metres from megalithic stones. The roots of these trees are possibly disturbing subterranean archaeology. There is also the possibility of trees falling on the remaining slabs and causing damage.</p>

<p>Suggested conservation actions</p>	<p><b>Trees</b>  Observation: Tree roots are likely to be disturbing archaeology. Falling trees are also a threat.  Action: Judiciously cut down and remove trees within area of tomb. Allow roots to rot. Treat root stumps with ecologically acceptable herbicide (make sure to seek expert advice on this matter). The Department of Agriculture Forest Service guidelines on Forestry and Archaeology states that a 15m buffer zone should be created surrounding known archaeological sites (Dept. of Environment and</p>

<p>Local Government and Coillte, n/d). This is not the case at the court tomb. Accordingly, all trees within 15m of the monument's edge should be cut down, removed and their roots remain to rot. Treat root stumps with ecologically acceptable herbicide (make sure to seek expert advice on this matter).</p> <p>Under the current forestry and archaeology guidelines, once an operation is planned in an area, as part of the felling licence approval, an archaeological plan will be approved by an archaeologist in the Department of Agriculture Forest Service. All Coillte operators must complete training on environmental awareness. This approach significantly reduces the risk of damage being caused to archaeological sites during felling.</p> <p>Timing: Medium term</p>
Possible visitor experience actions	<p>This court tomb is the most accessible of the megalithic monuments in the park. It is just 20-30m from a trackway. The remaining stones aligned with good interpretation provide the opportunity to tell the story of the site and introduce visitors to Neolithic Ireland.</p> <p>Accordingly, a well located and designed multilingual interpretive panel should be installed at the edge of the site. The interpretive panel is to be positioned on a frame that does not disturb the archaeology. An accessway needs to be cleared to permit site visits. Furthermore, a simple fingerpost sign is required at the existing nearby trackway to indicate its location. Finally, vegetation needs to be managed around the site. The impact of the site's opening to visitors needs to be monitored and any necessary management actions taken.</p>

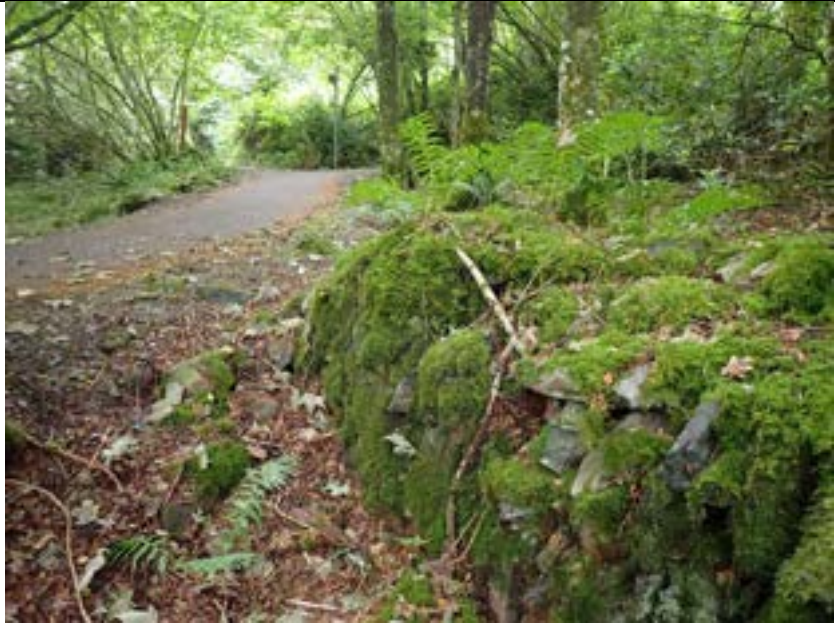
7. Field boundaries

Field boundary

Townland	Throughout the park
Description	There are a variety of simple earthen/stone field boundaries and track boundaries throughout the park. These are likely to date from the 18 <sup>th</sup> and 19 <sup>th</sup> centuries (Hickie, 2004). Some may be older, particularly those defining townland boundaries. Aside from their built heritage value, they also serve as habitats for flora and fauna. Within the park they exist in various states of repair. The historic 25" OS map (early 20 <sup>th</sup> century) shows a dense network of field boundaries. Many of the field boundaries depicted are shown within what are now forested areas planted by the Westernras, thereby illustrating the change of land use from agriculture to parkland. Many more field boundaries are now located within commercial forest planted by the state.
Condition	From much denuded to good. The thick forest cover has significantly reduced the vegetation cover on most of the remaining field boundaries.

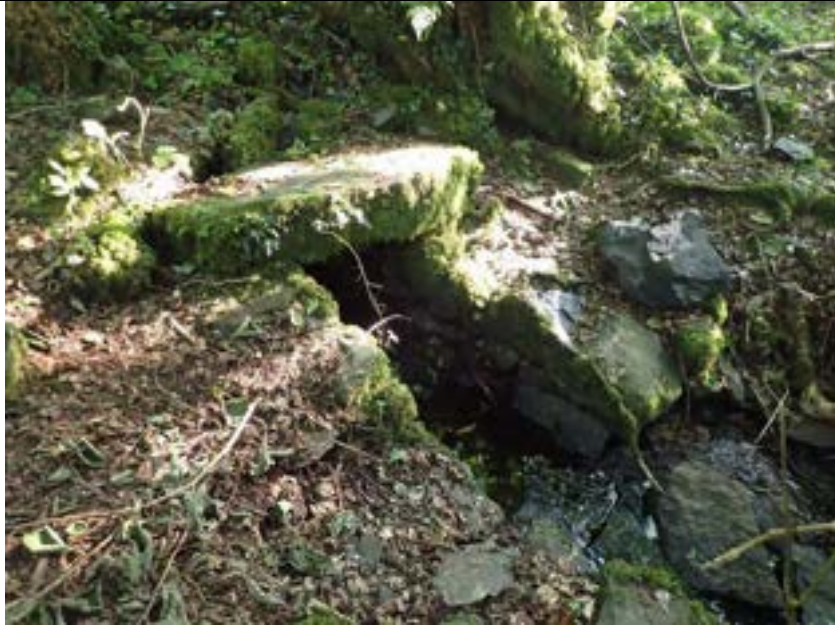
<b>8. Drains and channels</b>

<p>Random rubble stone channel</p>
Coordinates	Throughout the park
Townland	Throughout the park
Description	<p>The park is a patchwork of springs, streams and manmade or enlarged lakes. Throughout Rossmore is evidence of attempts to control the flow of water. From map evidence most of this effort appears to have taken place in the 19<sup>th</sup> century. There is also the work associated with the hydro-electric scheme. Some of these interventions are modest (i.e. simple control of minor streams). Other efforts involve more significant engineering, such as large banks to create a lake. These modifications to the landscape are important pieces of infrastructure that were central to the creation of the historic demense and current amenity.</p>
Condition	From much denuded to good
Suggested Actions	<p><b>Awareness</b></p> <p>Observation: Simple historic drains/channels can be easily taken for granted due to their proliferation and unprotected status.</p> <p>Action: Site managers and all though those planting and harvesting trees within the park should be made aware of the importance of the network of historic drains, channels and banks within Rossmore. An effort to locate and map all possible historic efforts to control water in Rossmore should be conducted. The Department of Agriculture Forest Service guidelines on Forestry and Archaeology does not explicitly address historic drains created for estates (ibid). However, there is a provision within the guidelines that no planting take place</p>

<p>within 2m of non-archaeological sites. Going forward, this should be the case for the park's historic drainage network. Timing: Medium term</p> <p><b>Repair/reinstatement</b> Observation: Historic drains are easily replaced by modern materials rather than being repaired. Action: Where feasible, any identified historic pieces of infrastructure used in the control of water should be repaired using traditional materials and methods. Timing: Long term</p> <p><b>Legal Protections</b> Observation: There is some protection afforded to the Park's network of drains and channels in the County Development Plan by being part of an area of secondary amenity site (i.e, Rossmore Park and environs). However, this is insufficient given the heritage significance of Rossmore's eight lakes and the role of the channels in feeding and connecting these lakes Action: Include a specific policy in the next County Development Plan providing stronger protections to the lakes and the water system that feeds them. Timing: Medium term</p>

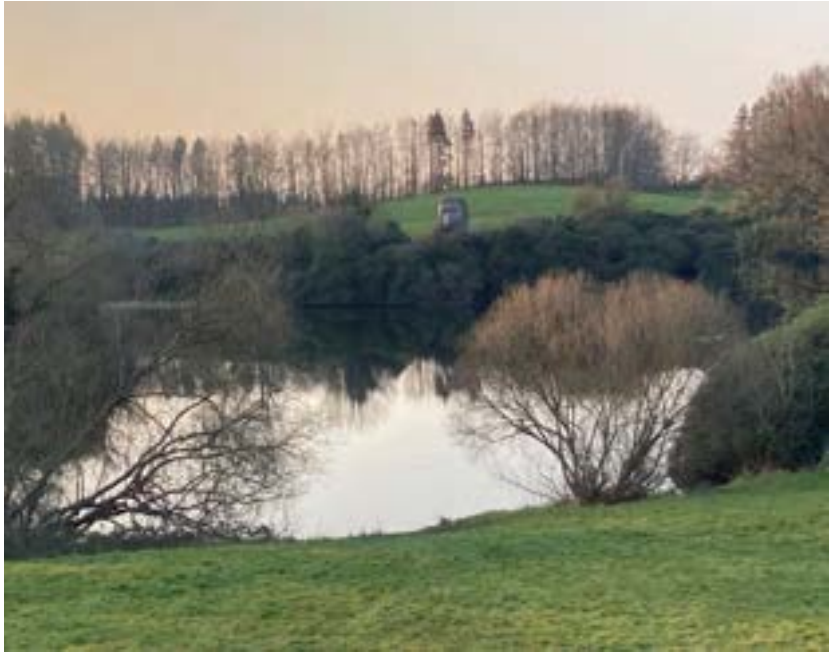
A giant wooden head overlooks Castle Lake. The installation dominates the lake while having no direct connection with the story of Rossmore Park.

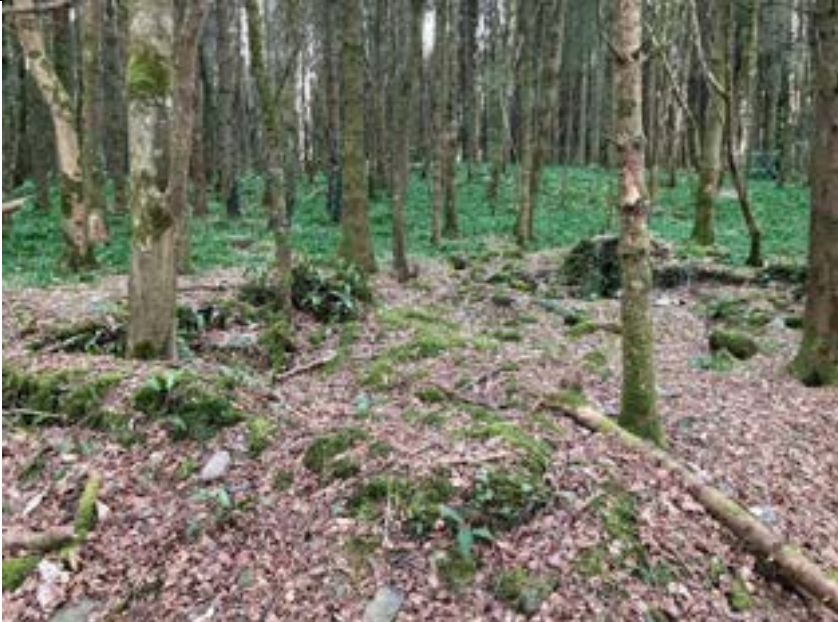
<p><b>10. Outbuildings/misc. masonry structures</b></p>

<p>One of the park's modest masonry ruins</p>
Coordinates	Throughout the park
Townland	Throughout the park
Description	Ruined modest masonry structure associated with servicing the residents of Rossmore Castle.
Condition	Usually severely ruined
Suggested Actions	<p><b>Awareness</b>  Observation: Simple outbuildings and other modest masonry structures can be easily taken for granted due to their proliferation and unprotected status.  Action: Site managers and all those planting and harvesting trees within the park should be made aware of the importance of these structures within Rossmore. An effort to locate and map all modest masonry structures in Rossmore should be conducted. The Department of Agriculture Forest Service guidelines on Forestry and Archaeology does not explicitly address unprotected modest masonry structures associated with demesnes (ibid). However, there is a provision within the guidelines that no planting take place within 2m of non-archaeological sites. Going forward, this should be the case for the park's unprotected modest masonry structures.  Timing: Medium term</p> <p><b>Trees</b>  Observation: Tree roots are likely to be disturbing wall foundations. Falling trees are also a threat.</p>

<p>Action: Judiciously cut down and remove trees within and immediately adjacent to structures. Allow roots to rot. Treat root stumps with ecologically acceptable herbicide (make sure to seek expert advice on this matter). Timing: Medium term</p> <p><b>Stone walls</b> Observation: The walls may have missing stones and are uncapped. Pointing has likely failed throughout the structure. Action: The following actions – or similar – are likely to be needed to conserve the structure. However, any such works are contingent on the structural report carried out by a conservation engineer. Cap stone walls with appropriate lime mortar. Point walls with natural lime mortar. Remove woody vegetation from walls and infill with natural stone and lime mortar as appropriate. Replace missing stones with matching. Infill sections of missing stonework with matching. Take care to match existing coursing. Samples of existing mortar should be analysed to guide replacement mortar. Timing: Medium term</p>

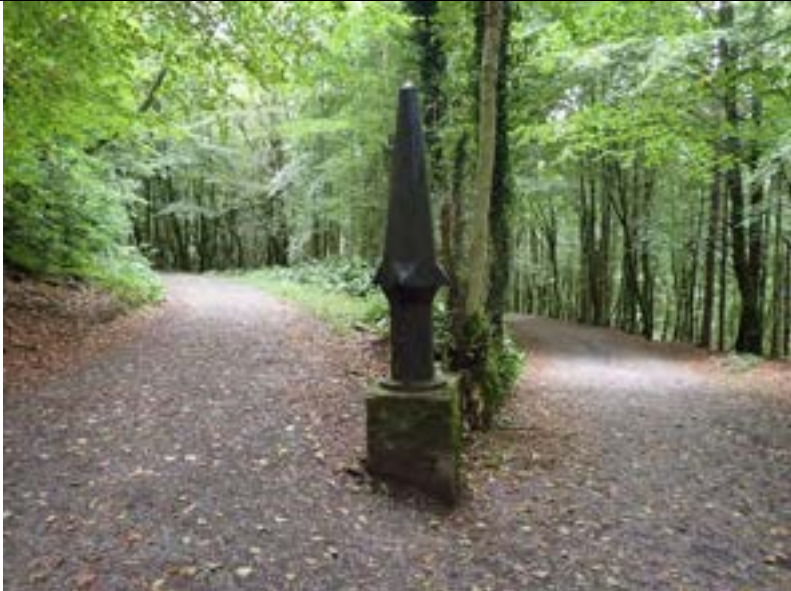
<p><b>11. Cast-iron cooling chamber</b></p>

<p>Cast iron cooling chamber</p>
---	---

Condition	The cast-iron obelisk is in excellent condition. One bolt is missing that attaches it to the brick pier. Another bolt is loose. Some of the brick in the pier appears degraded. Despite this, the pier seems to be in reasonable condition.
Suggested Actions	<p><b>Ironwork</b>  Observation: Maintenance needed.  Action: Repaint cast-iron obelisk. Do not paint over any rust. Where existing paint appears sound, it may be possible to use this as a base for a fresh coat. Repaint at least once every five years. Inspect annually. During the inspection, clean the iron with a cloth and water (use a bristle brush if needed for soiling).  Ensure the finial is securely bolted to the pier.  Timing: Short term</p> <p><b>Brick pier</b>  Observation: Degraded brick, not helped by hard cement pointing.  Action: Remove vegetation from pier to conduct a full assessment by a conservation engineer.</p>

<p>It is possible that individual brick replacement may be needed. The pointing also appears harder than the brick itself. This could necessitate the pointing being removed and replaced by an appropriate lime-based mortar, softer than the brick. However, if the pier was built in the 1940s for the finial, the mortar used throughout may be cement. Of course, should the conservation engineer conclude that the pier is structurally sound, then there may be little required in the medium term.</p> <p>Timing: Medium term</p>
Possible visitor experience actions	<p>Well-designed interpretive panel located nearby providing information on the gas works (its scale, cost, function). Include map showing location of chimney and an illustration showing how the gasworks may have looked like.</p> <p>Ultimately, this could mean comprehensive interpretation of the scheme in any new interpretive/information centre at the main car park.</p> <p>Another more dynamic way of interpreting the gas generating heritage of Rossmore would be to restore and reuse – as much as possible – the park’s hydroelectric scheme to once again create electricity. The electricity could then be used to make hydrogen. This hydrogen could then be stored and used during the colder months to heat a proposed visitor/interpretation centre or a reconstructed Lady Rossmore’s Cottage. The interpretive centre would also contain formation on the gasworks.</p>

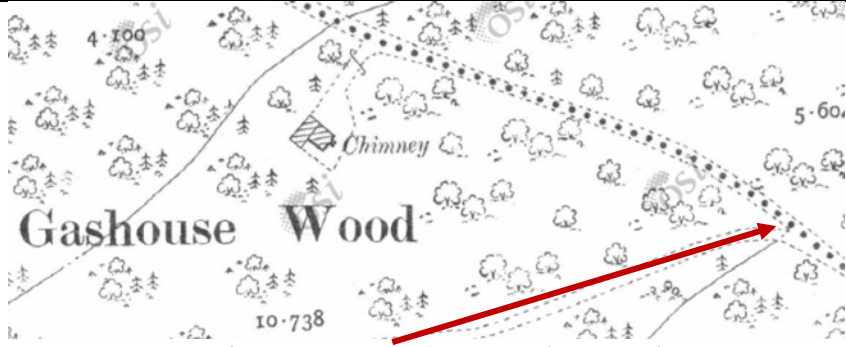
<p>Current location of cooling chamber obelisk. 'Chimney' on Historic 25" OS map indicates location of gasworks and likely original location of obelisk.</p>
Coordinates	54°13'33.3"N 7°00'03.3"W
Townland	Killicushil
Description	<p>Cast-iron cooling chamber. Built c.1880 as part of wider gasworks. On historic 25" map a site named 'chimney' is located to the west within 'Gashouse Wood'. No masonry ruins remain of the chimney site. However, some undulations in the landscape may represent its location. According to its NIAH entry, the gasworks were likely demolished in the 1940s, along with Rossmore Castle itself. The surviving cooling chamber element is the most obvious remnant of the gasworks. It may have been moved from another location. The obelisk is fixed with bolts to a predominately red brick pier. There is a stone wall running off to the west.</p> <p>Gasworks were locations where coal gas was manufactured for use as lighting and as a fuel for heating and cooking. By the late 1850s many of Ireland's county towns were lit by gas lighting. The gas was created using a process called carnonisation, whereby bituminous coal was distilled in a refractory vessal (Rynne, 2006). The crude gas was conducted via cast-iron pipes to a condenser where the gas was cooled. A by product of the gas manufacturing process is spent iron oxide. This was sometimes used as weed killer and may have been used by the gardeners at Rossmore.</p>

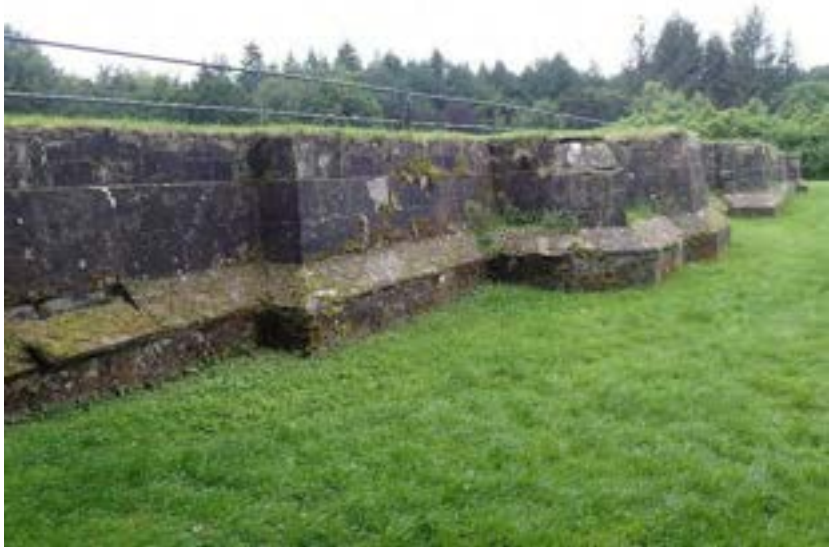
Ashlar limestone walls on chamfered plinth with inappropriate railings

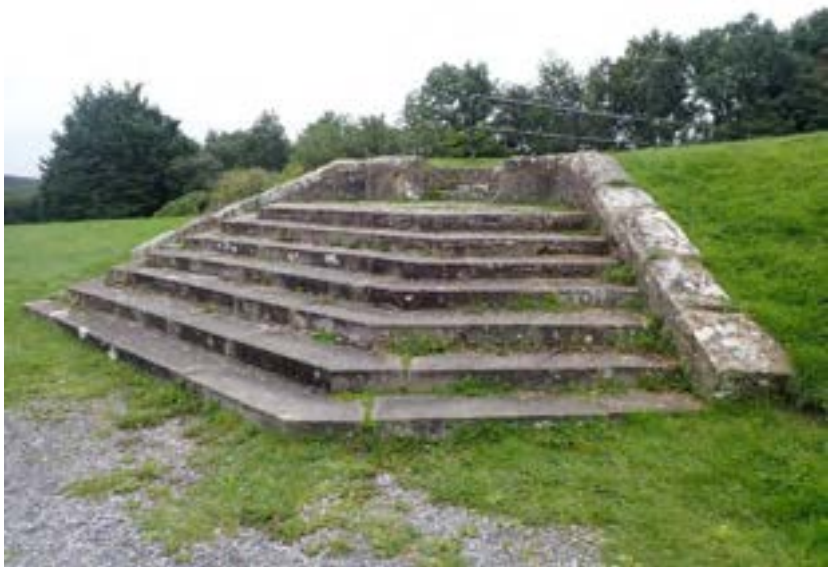
Corner steps, now uneven

stop people walking on the steps and connecting grass during the winter months. The reason for this restriction should be communicated to visitors. A safe route should be indicated along the existing gravelled road. Timing: Short term
Possible visitor experience actions	Possible interpretive panel with associated audio track on how the steps and platforms were connected with creating a landscape designed to impress visitors and communicate the wealth and sophistication of the landowners.
Protected Structure	No
Record of Monuments and Places	No
Significance rating	Regional (categories: architectural, technical)
Category	Steps
Other notes	n/a
References	<a href="https://www.buildingsofireland.ie/buildings-search/building/41401307/rossmore-forest-park-monaghan">https://www.buildingsofireland.ie/buildings-search/building/41401307/rossmore-forest-park-monaghan</a>

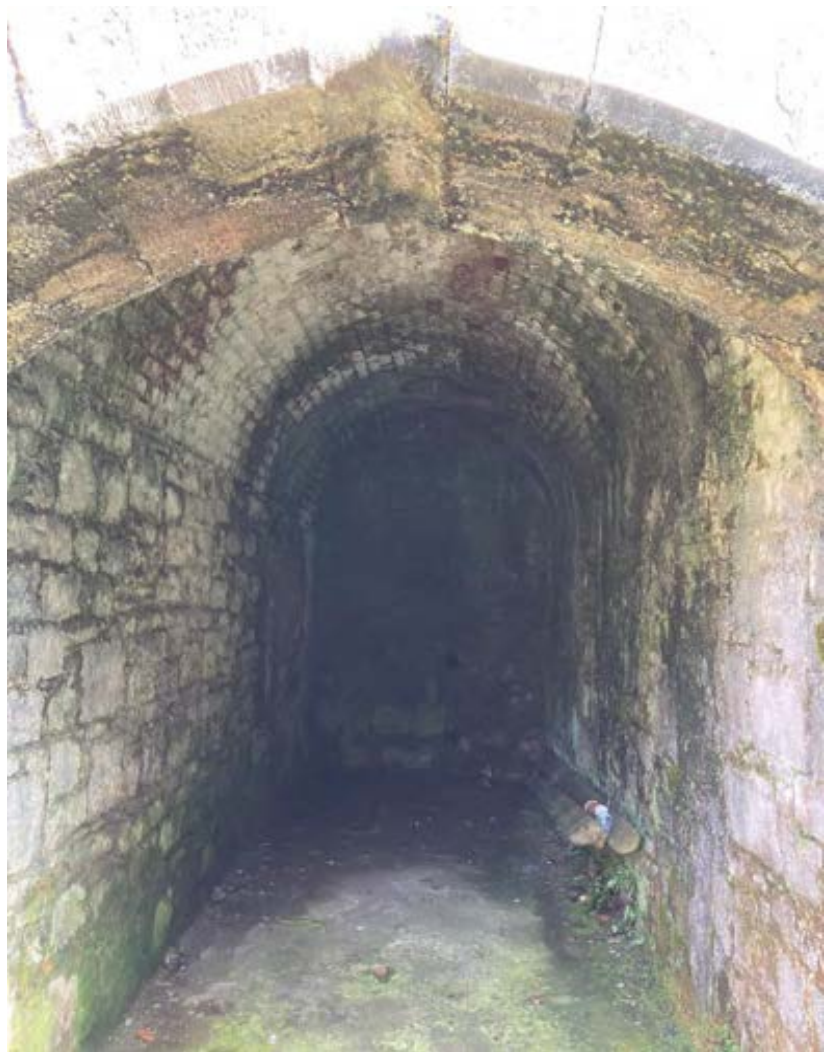
Interior of Servant's Entrance. Passageway blocked.

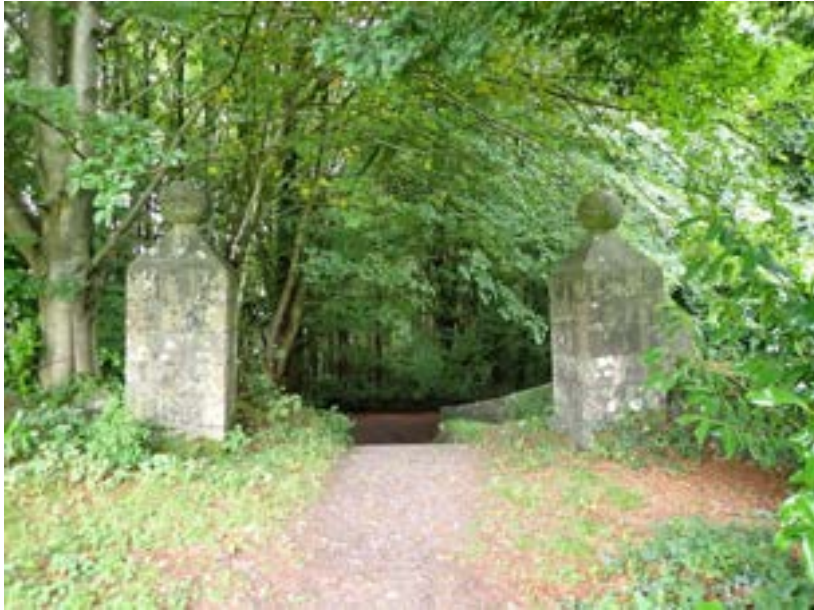
Leaning piers, especially the pier on the right of the image

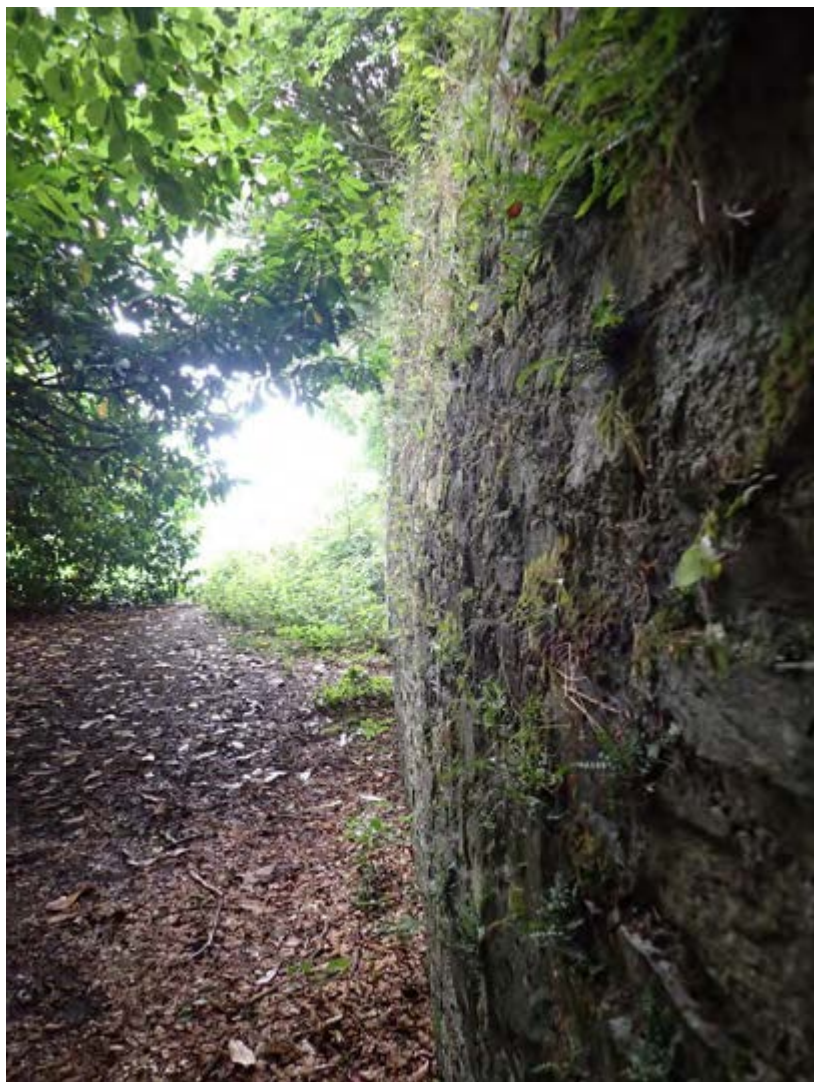
Bulge in the screen wall

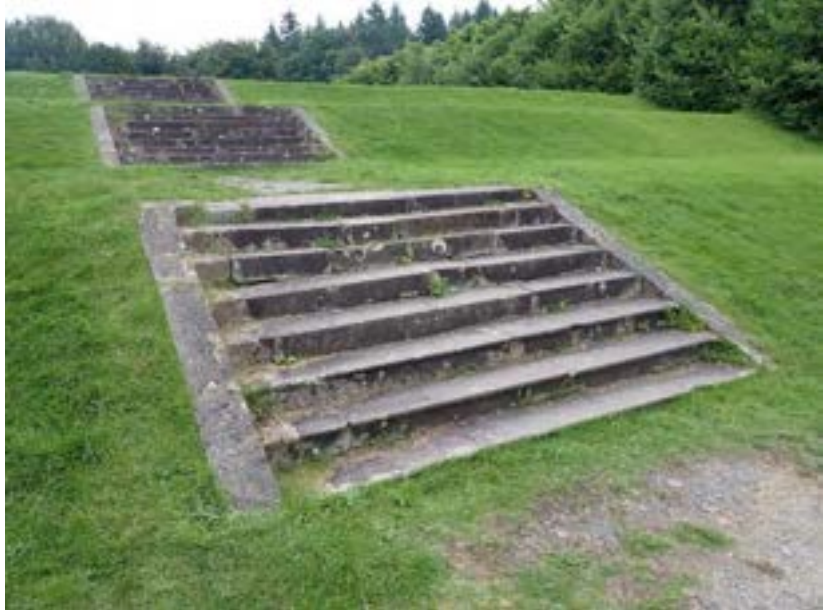
13. Terrace steps

Three of the five sets of steps. Note worn grass in foreground

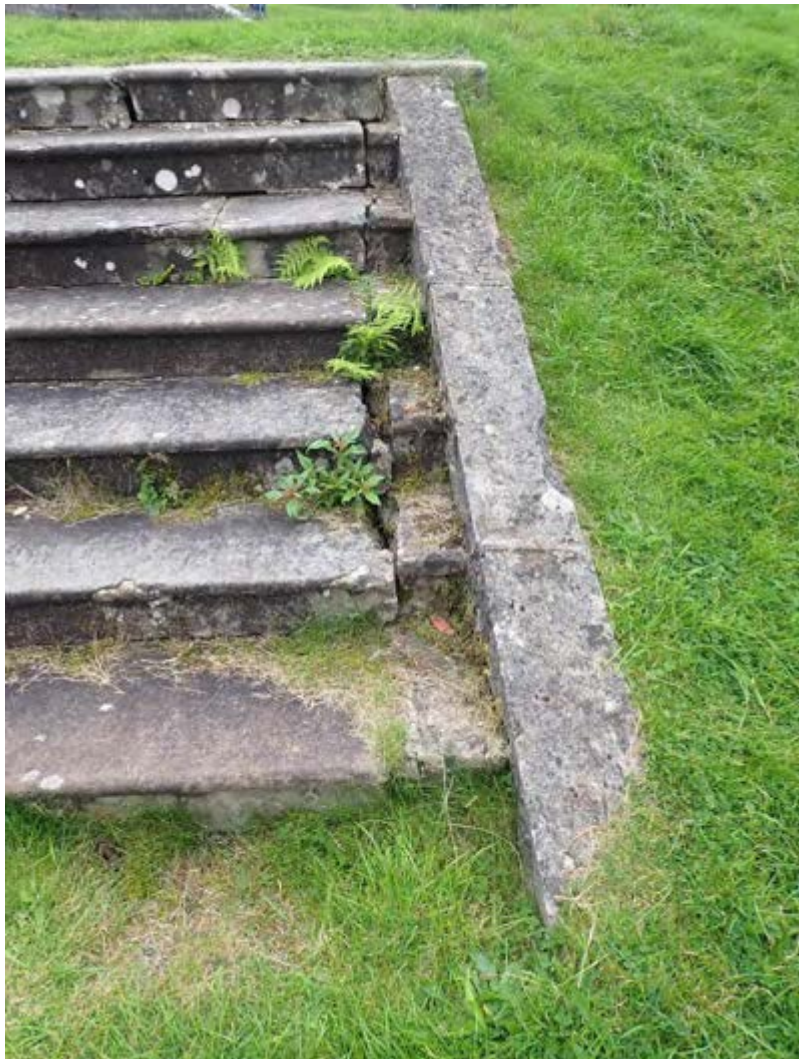
Uneven top step, gaps between stones, concrete repairs and vegetation growth are all visible

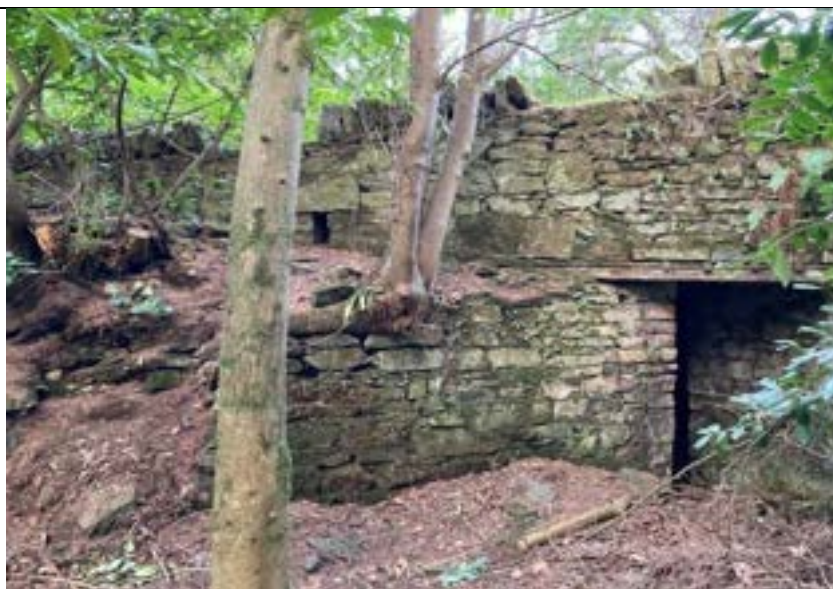
**14. Underground passageway**

Entrance to passageway with large tree growing from reveal wall head

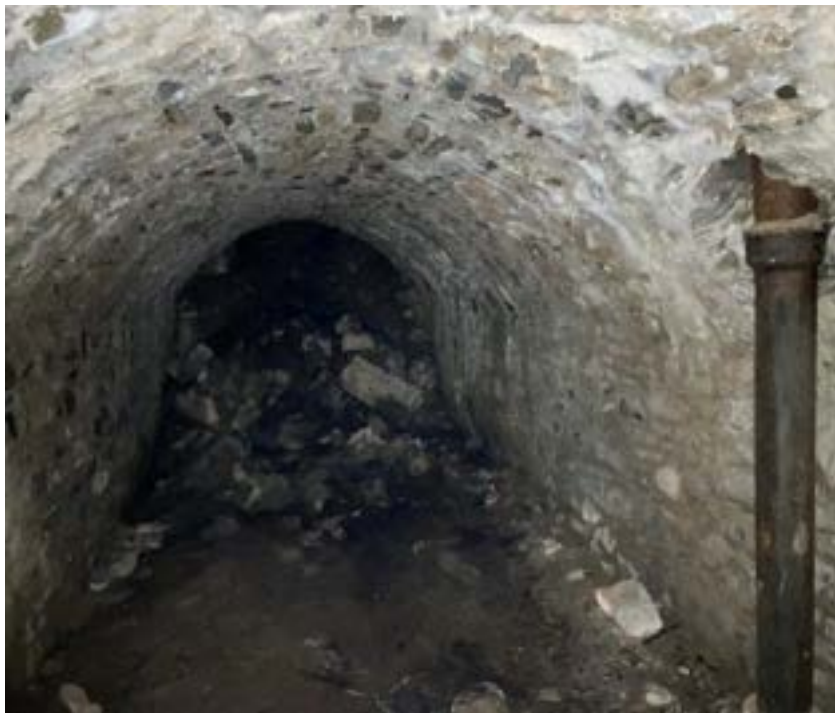
Interior of passageway with pipe associated with outside tank

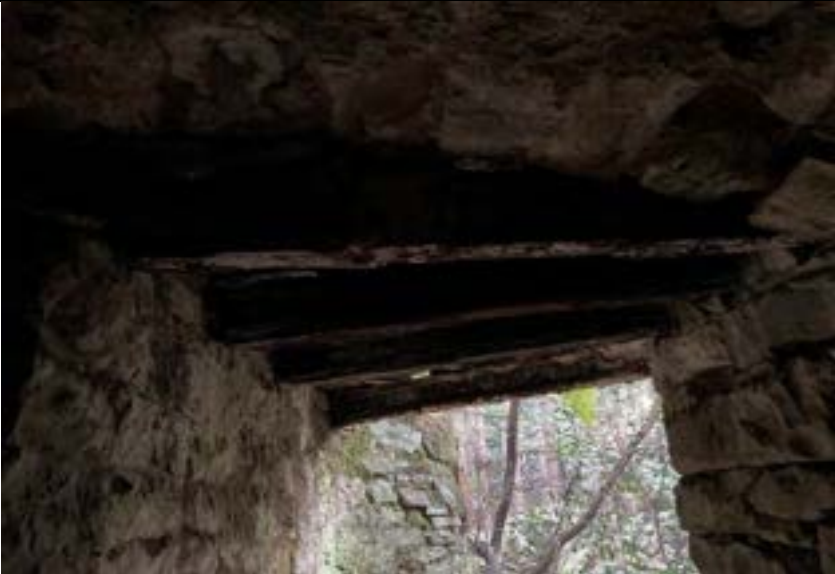
Coordinates	54°13'32.6"N 6°59'59.7"W
Townland	Killicushil/Corlattan
Description	<p>Cut and fill underground passageway that apparently led to Rossmore Castle. The passageway is directly under the main access route from the carpark to the castle site. Barrel vaulted with random rubble limestone. Walls also random rubble limestone. Entrance way has a lintel head supported by four iron bars. The passageway was purposely filled in/collapsed after the demolition of the castle. There is a verticle iron pipe that connects with a tank just outside the passageway. This pipe is likely to have led to the castle. The reveal walls at the entrance are random rubble limestone. There are indications of a possible path leading towards Castle Lough.</p>
Condition	<p>The interior of the tunnel appears in reasonable condition. However, an inspection by a conservation engineer is required to fully appraise the conservation needs.</p> <p>The external reveal walls are missing pointing. There is also a large tree growing out from the wall head of one of the reveal walls.</p>

Suggested Actions	<p><b>Survey</b>  Observation: Conservation needs of the tunnel require assessment by a conservation engineer.  Action: Conservation engineer to access condition and repair needs.  Timing: Immediate</p> <p><b>Vegetation</b>  Observation: Vegetation with root woody roots causing damage.  Action: Carefully remove any plants growing on the walls with woody roots (i.e. tree, ivy, saplings). To remove large plants cut them off at the roots. To kill the roots, use a “cut-and-paint” technique: where the plant is cut down and the cut surface is then painted with a herbicide. Fill resulting gaps in the wall as needed with appropriate with lime mortar and limestone, to match surrounding.  Timing: Short term</p>

<p><b>External reveal stone walls</b></p> <p>Observation: The walls need repointing and capping.</p> <p>Action: The following actions – or similar – are likely to be needed to conserve the structure. However, any such works are contingent on the structural report carried out by a conservation engineer.</p> <p>Cap stone walls with appropriate lime mortar. Point walls with natural lime mortar. Remove woody vegetation from walls and infill with natural stone and lime mortar as appropriate. Samples of existing mortar should be analysed to guide replacement mortar.</p> <p>Timing: Medium term</p>
Possible visitor experience actions	<p>The presence of the passageway could be mentioned in any interpretive panel dedicated to the Servant's Entrance passage. However, due to safety issues, visiting the site should not be encouraged or facilitated.</p> <p>Long term, the feasibility of reopening the passageway fully should be assessed.</p>

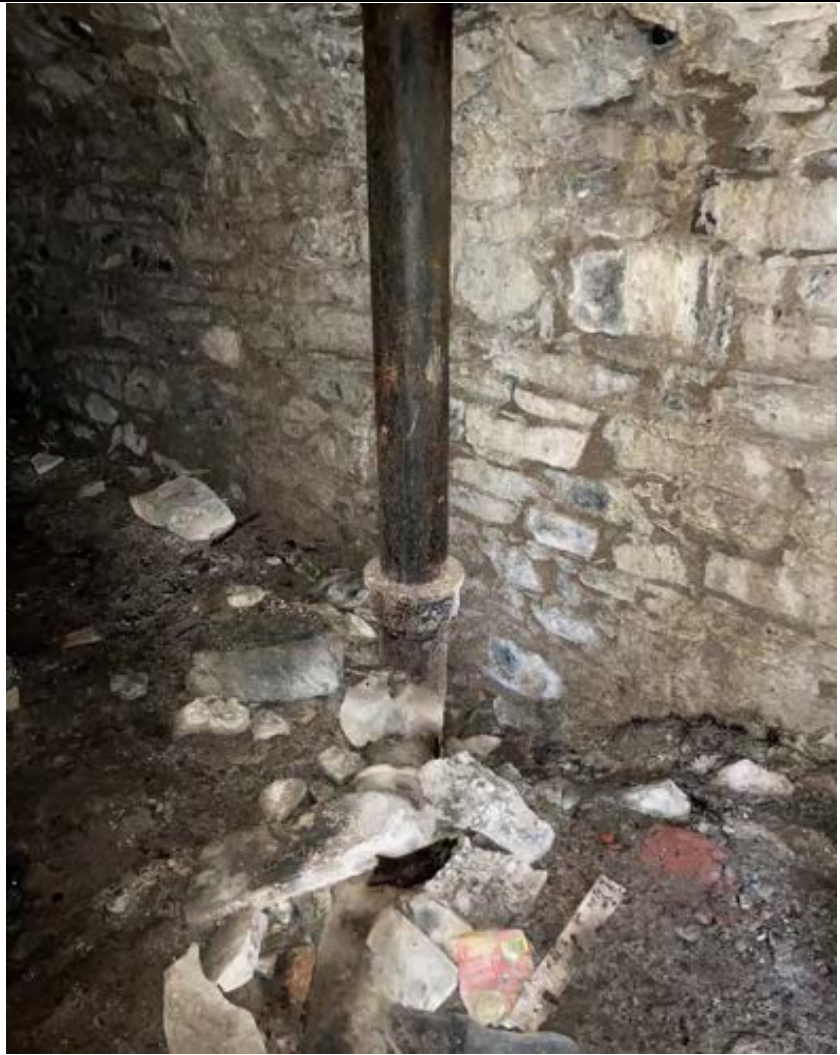
15. Tank

Iron water pipe (wastewater?) in adjacent underground passage which leads to the tank

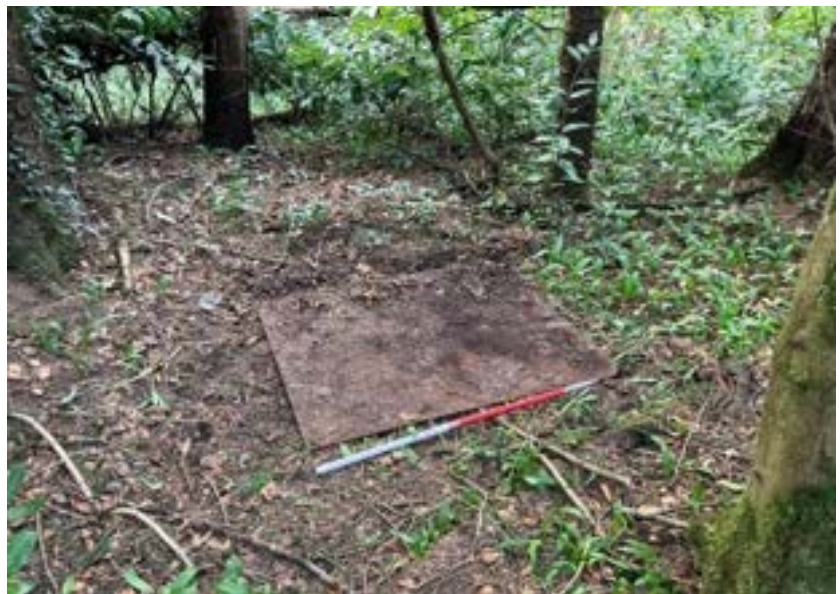
Loose steel plate over the hatch. Image taken looking from nearby passageway entrance
