# Rossmore Forest Park Built Heritage Conservation Management Plan

## 1.1 Introduction

The objective of this document is to provide heritage advice on the appropriate conservation and management of the built heritage assets in Rossmore Forest Park. This report was jointly commissioned by Cavan County Council and Monaghan County Council. It is an action of the Rossmore Masterplan.

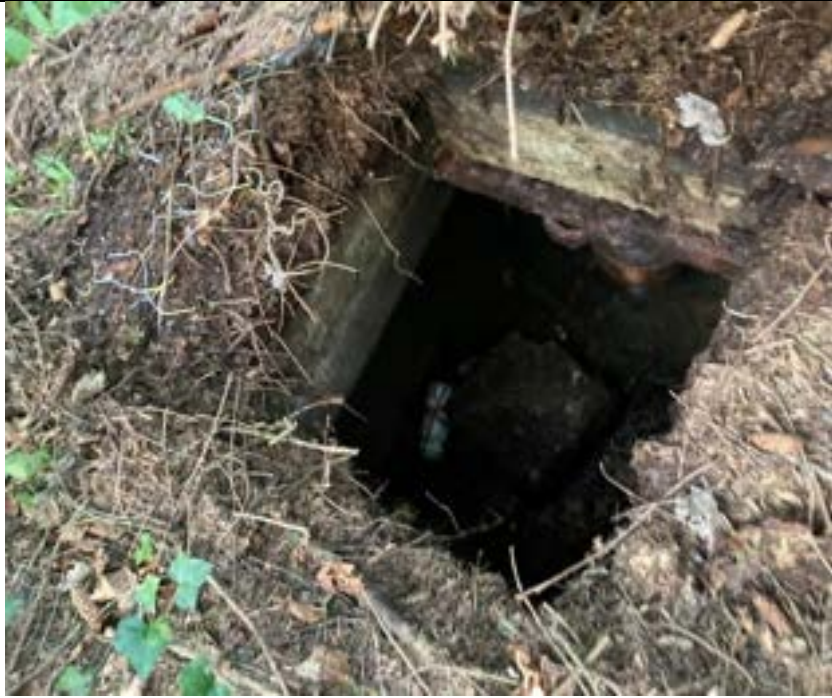
Hatch with tank underneath

Coordinates	54°13'32.8"N 7°00'00.2"W
Townland	Killycushil
Description	Described in the historic 25" OS Map as 'Tank'. Possibly associated with water supply to the castle. Also possibly associated with waste water. Iron pipe in nearby tunnel leads to the underground tank. The opening has what appears to be an iron sliding door with piping underneath. The opening is covered by a loose steel plate.
Condition	Appears to be in reasonably good condition, although a full survey by a suitably qualified conservation engineer is necessary to conduct an accurate appraisal.
Suggested Actions	<b>Secure covering</b> Observation: The steel plate simply lies over the opening. Action: Fit a more secure covering for the opening which is accessible to site managers only. Timing: Immediate

<p><b>Survey</b></p> <p>Observation: For safety reasons, the interior of the tank was not surveyed.</p> <p>Action: A survey by a conservation engineer is required to investigate any structural issues.</p> <p>Timing: Immediate</p>
Possible visitor experience actions	The existence of the tank could be made known on any interpretation focusing on the water ram(s). However, due to safety issues, visiting the site should not be encouraged or facilitated.
Protected Structure	No
Record of Monuments and Places	No
Significance Rating	Local
Category	Tank
Other notes	Tank was not accessed for this study.
References	n/a

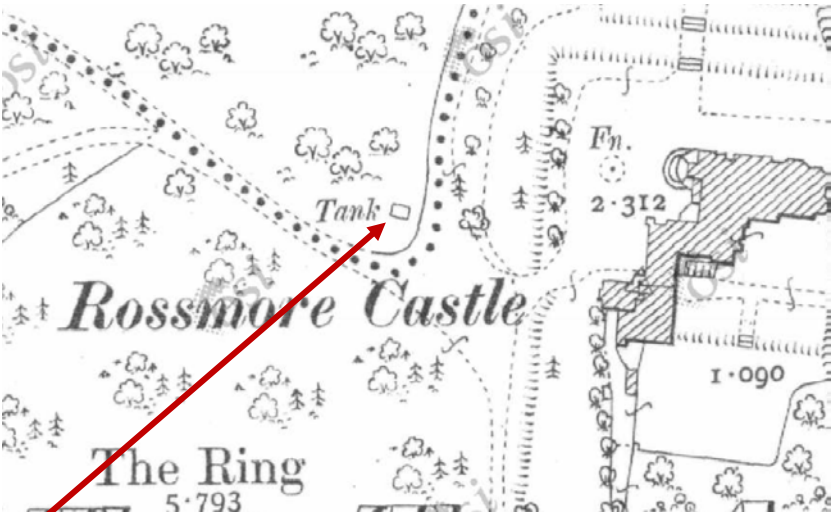
Tank shown as such on historic 25" OS Map

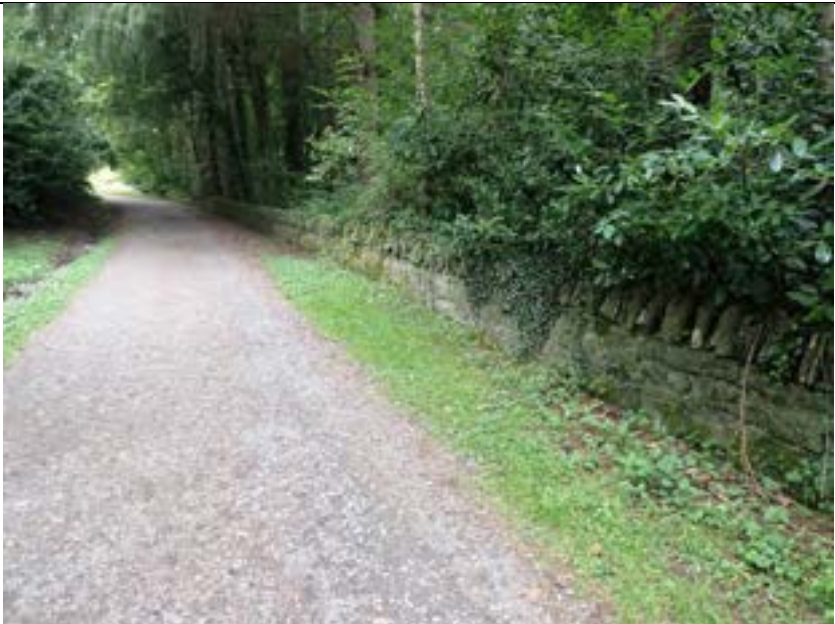
<p><b>16. Historic low stone walling</b></p>

<p>Low stone walling close to the site of the castle</p>
Coordinates	Concentrated in Corlattan
Townland	Concentrated in Corlattan (i.e. close to the castle) but examples could be present throughout the park
Description	<p>Aside from the perimeter wall and earthen/stone field boundaries, there is a network of mostly 19<sup>th</sup> low stone walling within the park. In addition to marking out areas and in certain locations providing a safety barrier, the walls would have functioned as decorative additions to the designed parkland.</p> <p>Low, predominately random rubble limestone walling, mostly located close to the castle. Copings observed include projecting coping and flat projecting coping.</p>
Condition	The condition of such walling varies from good to poor. However, overall, the walling appears to be in a reasonable condition. Caping stone walls with concrete and concrete pointing were observed.

Suggested Actions	<p><b>Survey</b>  Observation: Extent of internal walls and their conservation needs still unknown.  Action: A full survey of the demesne’s internal walls by a conservation engineer is required to quantify what remains and their condition.  Timing: Short term</p> <p><b>Vegetation</b>  Observation: Vegetation with root woody roots causing damage.  Action: Carefully remove any plants growing on the walls with woody roots (i.e. ivy, saplings). To remove large plants cut them off at the roots. To kill the roots, use a “cut-and-paint” technique: where the plant is cut and the cut surface is then painted with an appropriate herbicide. Fill resulting gaps in the wall as needed with appropriate lime mortar and limestone, to match surrounding.  Timing: Short term</p> <p><b>Repointing and possible grouting of walls</b>  Observation: Pointing required. Some wall cores may be vulnerable and missing substantial material.  Action: Much of the pointing in various walls is now missing or failing. This allows water into the structure and provides locations for vegetation growth.  Retain sound historic pointing. Where pointing has failed, rake out. Retain any pinning stones for later use. Remove vegetation matter and decayed mortar. Samples of decayed mortar should be analysed to guide replacement mortar. Repoint with lime mortar mix to match appearance of original. Use pinning stones and suitable replacement stones as required. Where existing concrete pointing is judged by a conservation engineer to be only causing no/minimal damage to the wall or its removal will cause more damage than it would solve, it should be retained. Only remove concrete pointing has been judged to be causing significant damage. Repoint with appropriate lime-based mortar. Subject to an inspection by a conservation engineer, grouting of sections of wall may be warranted.  Timing: Short term</p> <p><b>Rebuilding gaps in the masonry</b>  Observation: Missing masonry leading to a weakened wall and water ingress.  Action: Any gap should be filled with stonework preferably recovered from the site. Single fallen stones should also be reinserted. All stonework should be set in an appropriate lime mortar. Any localised rebuilding should be done to match known historic coursing and coping.  Timing: Short term</p> <p><b>Wall heads</b>  Observation: Exposed wall heads allowing water ingress to wall core.  Action: Remove all vegetation and accumulated humus from wall heads. Reset any dislodged stones in lime mortar. In areas where stone capping exists but individual stones or small sections of capping stones are now</p>

<p>missing, reinstate with matching stone and repair with lime mortar to match surrounding. Where large areas of no wall copings are present, mortar the wall top in appropriate lime mortar to shed water off the top. The flaunching should allow all water to easily fall off the top and not to puddle. Where concrete capping is deemed to be causing damage to the wall, remove concrete and flaunch with lime mortar or reinstate known traditional capping detail.</p> <p>Timing: Short term</p> <p><b>Leans and cracks</b></p> <p>Observation: Cracks and leans indicating possibly significant structural issues.</p> <p>Action: Where defects such as cracking or leaning is visible, obtain advice from a conservation engineer. Repairs should be carried out speedily, to halt continued degradation and resulting increase in costs.</p> <p>Timing: Short term</p>
Possible visitor experience actions	None
Protected Structure	No

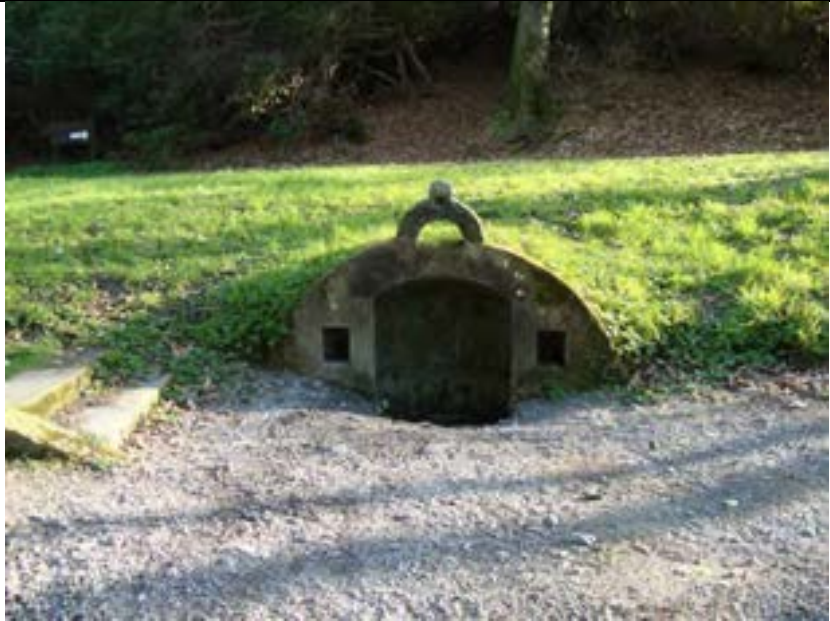
<b>17. Covered Well</b>	 
	Well when visited in August, 2021

Well as photographed by NIAH surveyor in 2012

Coordinates	54°13'39.5"N 6°59'52.9"W
Townland	Corlattan
Description	Semi-circular covered well, set in earthen mounding. Built c.1850, the well has an ashlar limestone façade and semi-circular chamber. The segmental-headed entrance is flanked by square-headed niches. There are two limestone steps to the east. In the historic 25" map the site is marked as 'Well'. Remnants of stone gully leading to nearby stream present. It is not marked in the first edition OS. According to the NIAH survey entry for the site, the existing well likely replaced an earlier version. By its appearance, it would have complemented Rossmore Castle. The well would have provided fresh drinking water.
Condition	Strongly built, the well is in overall good condition. Unfortunately, the half-ring to apex of façade recorded during the 2012 NIAH survey is now gone. Similarly, according to a worker on the site for several decades a set of steps in front of the well are also now gone. There is

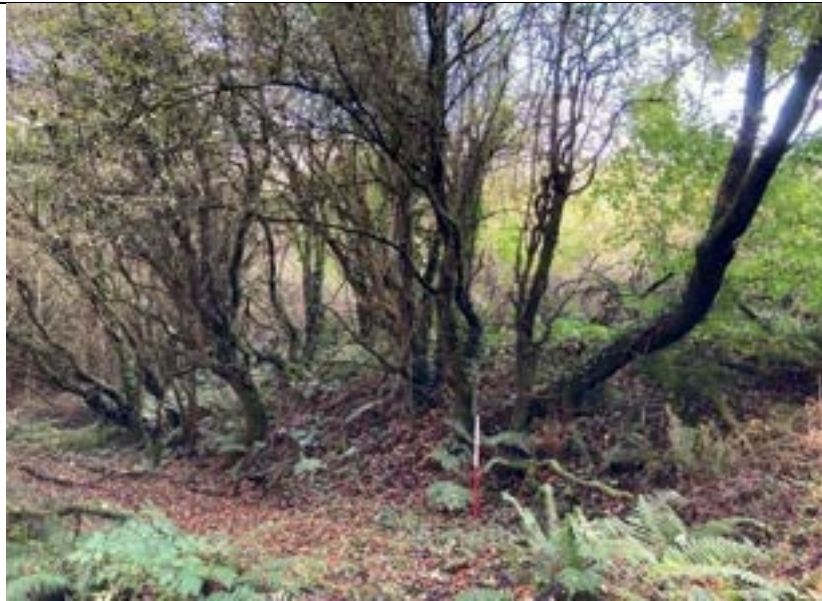
**18. Killycushil Ringfort**

Tree covered bank with shallow indication of ditch

Coordinates	54°13'42.0"N 7°00'14.2"W
Townland	Killycushil
Description	Raised circular area (diameter 39m N-S, 37.5m E-W) overlooking 19 <sup>th</sup> century man made lake 'Castle Lough'. Circular area now covered in trees and brambles. Bank (c.1.5m high) with some indication of ditch on exterior. Entrance gap (width of top 5.4m) at SSE is now blocked. Taken from Michael Moore 2018 survey for NMS.
Condition	Fair. The bank is still obvious. However, the ditch is now just a shallow dip before the bank. The interior is impenetrable due to vegetation. Natural tree growth is present throughout. The roots of these are likely to be disturbing subterranean archaeology. Although commercial forestry appears to be avoiding the main area of the tomb, planted trees are just a few metres from the ringfort. The roots

of these trees are possibly disturbing subterranean archaeology. Falling trees are likely to upturn archaeological remains.
Suggested Actions	<p><b>Trees</b></p> <p>Observation: Tree roots are likely to be disturbing archaeology. Falling trees are also a threat.</p> <p>Action: Carefully cut down and remove trees within the Ringfort, including likely area of ditch. After cutting down the vegetation with woody roots, treat root stumps with ecologically acceptable herbicide (make sure to seek expert advice on this matter). Allow roots to rot. The Department of Agriculture Forest Service guidelines on Forestry and Archaeology states that a 15m buffer zone should be created surrounding known archaeological sites (Dept. of Environment and Local Government and Coillte, n/d). This is not the case at the ringfort. Accordingly, all trees within 15m of the monument's edge should be cut down, removed and their roots remain to rot. Treat root stumps with ecologically acceptable herbicide (make sure to seek expert advice on this matter). Reseed any exposed areas with indigenous Irish grass.</p> <p>Under the current forestry and archaeology guidelines, once an operation is planned in an area, as part of the felling licence approval, an archaeological plan will be approved by an archaeologist in the Department of Agriculture Forest Service. All Coillte operators must complete training on environmental awareness. This approach significantly reduces the risk of damage being caused to archaeological sites during felling.</p> <p>Timing: Medium term</p>

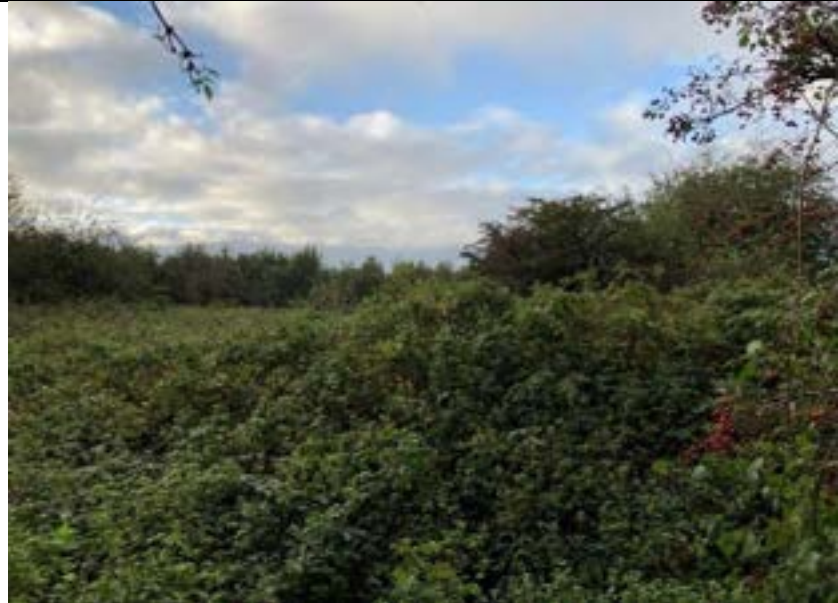
**19. Killydrutan Ringfort**

Interior of ringfort

SE. Internal area of the ringfort planted in coniferous forest in 1968. Site apparently harvested of coniferous forest.
Condition	Fair/poor condition, although this was difficult to ascertain due to the vegetation (predominately brambles). Most of the bank is still visually obvious. Where a ditch was visible, it appeared to be a shallow dip before a bank. Natural tree growth is concentrated on the bank. The roots of these are likely to be disturbing subterranean archaeology. Although current commercial forestry appears to be avoiding the main area of the tomb, planted trees are likely to be planted in what would have been the ringfort's ditch. The roots of these trees are possibly disturbing subterranean archaeology. Falling trees are likely to upturn archaeological remains. The planting of trees within the ringfort in 1968 is likely to have caused significant damage to the site's archaeology.

Suggested Actions	<p><b>Trees</b></p> <p>Observation: Tree roots are likely to be disturbing archaeology. Falling trees are also a threat.</p> <p>Action: Carefully cut down and remove trees from within the Ringfort, including likely area of ditch. After cutting down the vegetation with woody roots, treat root stumps with ecologically acceptable herbicide (make sure to seek expert advice on this matter). Allow tree roots to rot. Reseed bank where required with indigenous Irish grass. The Department of Agriculture Forest Service guidelines on Forestry and Archaeology states that a 15m buffer zone should be created surrounding known archaeological sites (Dept. of Environment and Local Government and Coillte, n/d). This is not the case at the ringfort. Accordingly, all trees within 15m of the monument's edge should be cut down, removed and their roots allowed to rot. Treat root stumps with ecologically acceptable herbicide (make sure to seek expert advice on this matter).</p> <p>Timing: Medium term</p>

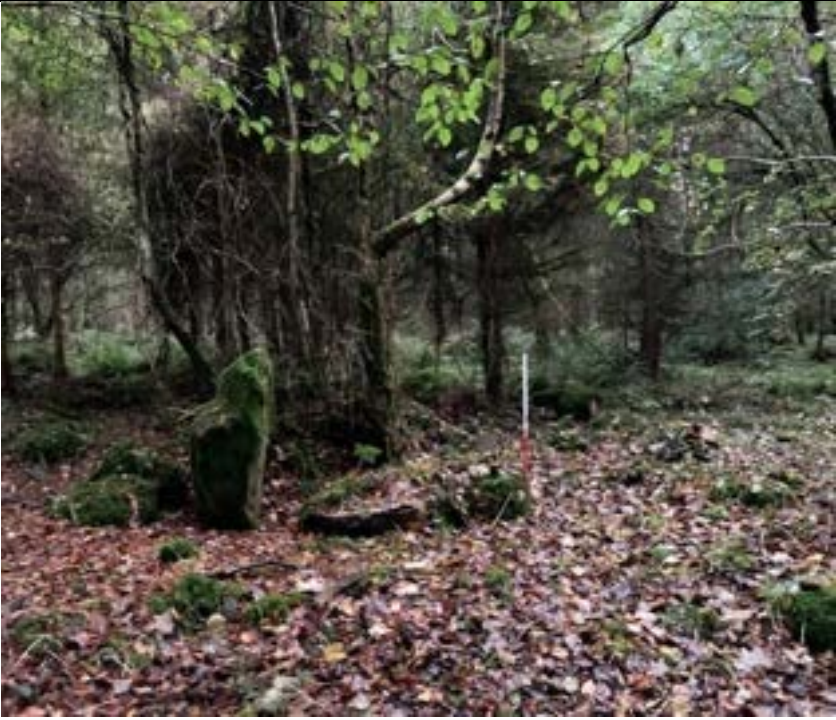
<p><b>20. Skeagarvey Megalithic tomb</b></p>

<p>Trees within area of tomb</p>
<p>Coordinates</p>	<p>54°13'52.3"N 6°59'10.3"W</p>
<p>Townland</p>	<p>Skeagarvey</p>
<p>Description</p>	<p>Likely to be a wedge tomb, this monument is composed of a gallery (L 2.5m) orientated NNW-SSE with two east side stones and a large south back stone. A low stone to east side of gallery possibly a buttress. Located in forest. Not marked on 1<sup>st</sup> edition OS Map or on the historic 25" OS Map.</p>
<p>Condition</p>	<p>Due to the overgrown nature of the site, it is difficult to fully appraise condition of the monument. Nonetheless, despite being robbed historically of much of its building material, the remaining stones appear in reasonable condition. There was evidence of anti-social behaviour with a campfire and rubbish located nearby, despite not being easy to access. The main area of the tomb is disturbed by natural woodland. The roots of these are likely to be disturbing subterranean archaeology and may disturb the foundations of the remaining standing stones. Although commercial forestry appears to be avoiding the main area of the tomb, planted trees are just a few metres from megalithic stones. The roots of these trees are possibly disturbing subterranean archaeology. There is also the possibility of trees falling on the remaining stones and causing damage.</p>

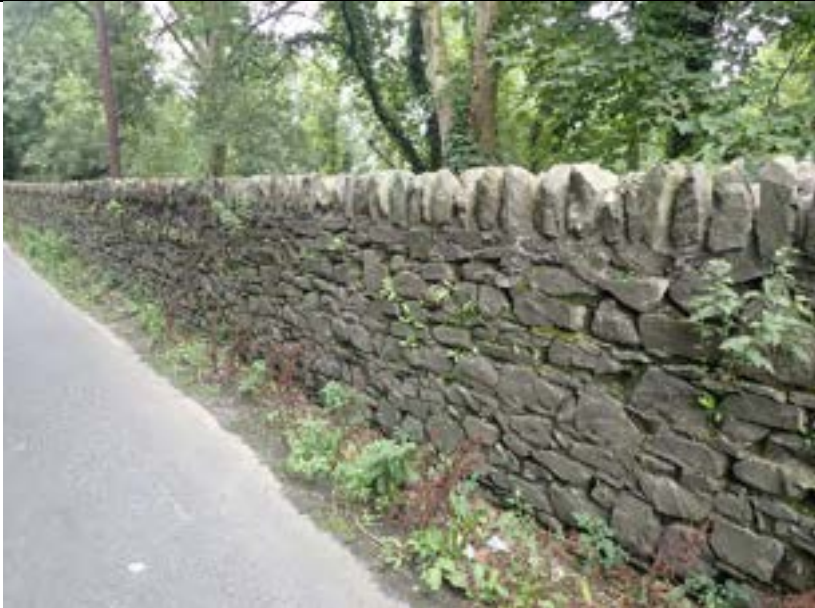
<b>21. Demesne wall</b>	  <p>Demesne wall to north of northwest gate (i.e. the main gate)</p>
-------------------------	--

Demesne wall running south of southeast gate
Coordinates	Throughout edge of park
Townland	Several townlands
Description	<p>Erected c.1830. When erected, the wall defined the limit of the estate and provided some security.</p> <p>At the north western entrance on the R189 (i.e. the main entrance), the wall is coursed, tooled, squared limestone with tooled sandstone copings. At the western gate (in private ownership), the wall is low, random rubble limestone. At the eastern entrance on the R188, the wall is roughly half the height of the the wall by the north west entrance. It is limestone, random rubble, roughly coursed. The section of the wall running north of the eastern gate is capped with concrete. The section of the wall running to the south is capped with limestone projection coping stones.</p>
Condition	<p>Albeit from a limited survey, the remaining standing sections appear to be mostly in reasonable condition. However, there are small sections of collapse along the R189, south of the main gate. There is evidence of some repair/rebuild There is also a large section along the R189 close to the junction with L16005 that appears to have been simply removed.</p> <p>There are also some incidences of inappropriate concrete capping. Incidences of concrete pointing are also visible.</p> <p>There is a significant amount of ivy on the wall head of the boundary wall running north from the northwest gate (i.e. main gate) and elsewhere. Sapling growth from wall heads was also observed.</p>

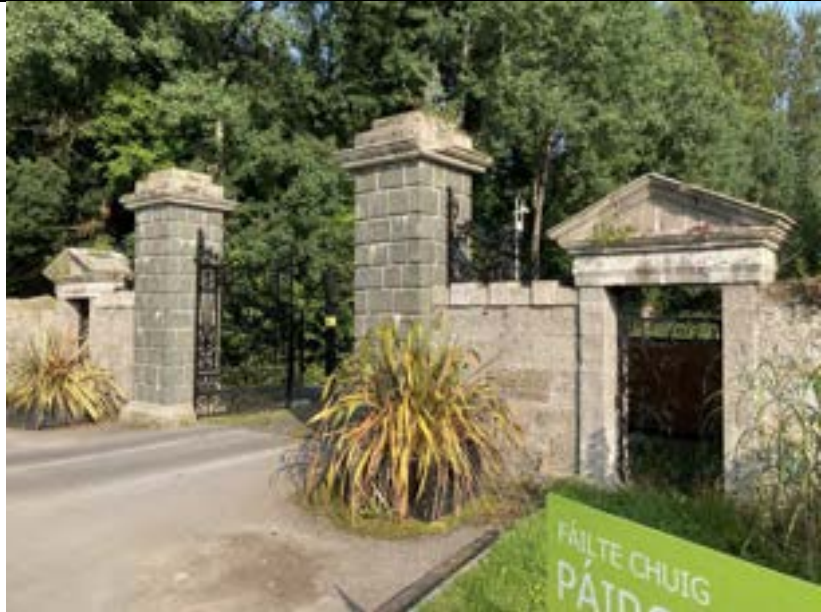
<p><b>22. Northwest Gate (i.e. main gate)</b></p>	 
	<p>Approach to main gate</p>

Main gate with vehicular and pedestrian entrances. Inappropriate planting in front of gate. Plants obscure the gate. The species have no known association with the historic estate.

Condition	<p>Overall, the cast iron gates are in good condition. The main area of concern was where iron entered stonework with corrosion being obvious. In only one area was this serious. Nonetheless, no leaning of the gates was noticeable.</p> <p>Some broken/missing ironwork was apparent.</p> <p>The stone pillars and openings, appear to be in overall good condition. However, inappropriate concrete pointing and repairs were leading to water ingress and stone damage. There was vegetation growth on the stonework ledges. Most of this is relatively benign, although at least one sapling was noted.</p> <p>Some stone cracking and broken stonework was observed.</p>
Suggested Actions	<p><b>Maintenance and painting</b></p> <p>Observation: Regular need to paint and inspect</p> <p>Action: Repaint at least once every five years. Inspect annually.</p> <p>During the inspection, clean the iron with a cloth and water (use a bristle brush if needed for soiling). Paint with two coats of appropriate oil-based paint.</p> <p>Where localised corrosion has set in, remove loose material with scraper, clean to a bright finish and feather the edges of the old paint</p>

<p>with abrasive paper. Treat derusted iron with rust neutralising inhibitor. Then paint area with 1-2 coats of zinc-phosphate primer, two layers of undercoat and two layers of topcoats. Final colour(s) used should match original paint scheme. Grease the pivot points to reduce wear. Timing: Short term</p> <p><b>Repairs to cast iron</b> Observation: Areas of cast iron are in need of repair. Action: Repair cracks less than 6mm thick using cold stitching. Pitting in rusted cast iron can be repaired using epoxy car-body filler. Clean metal, apply rust inhibitor, apply epoxy filler, shape and rub down with abrasive paper to match contour. Then prime and paint to match surrounding. For simple breaks in cast iron and the metal in reasonable condition, in situ arc-welding repair is usually possible. Only experienced blacksmith or welding service should undertake this. The weld should be continuous, ground flat, primed and painted. Timing: Short term</p> <p><b>Vegetation growth</b> Observation: Risk of vegetation with root woody roots causing damage tops of walls and piers. Action: Carefully remove any plants growing from tops of wall and piers. Gaps in pointing and stonework should be pointed with appropriate lime-based mortar. Consideration should be given to capping vulnerable stonework with lead. Where deemed appropriate, on the verticals of walling retain any vegetation that does not have woody roots. Timing: Short term</p> <p><b>Concrete pointing and repairs</b> Observation: Inappropriate concrete pointing and repairs causing damage to stonework and leading to water ingress. Action: Remove all concrete pointing and crack repairs and replace with appropriate lime-based mortar. Gaps in pointing should also be pointed with appropriate lime-based mortar. Where concrete has been used to replace broken stonework, remove and replace with cut stone to match profile of surrounding stonework. Fix with stainless steel dowels and point with appropriate lime-based mortar. Where broken stone fragments are visible replace with cut stone to match profile of surrounding stonework. Fix with stainless steel dowels and point with appropriate lime-based mortar. Timing: Medium term</p>

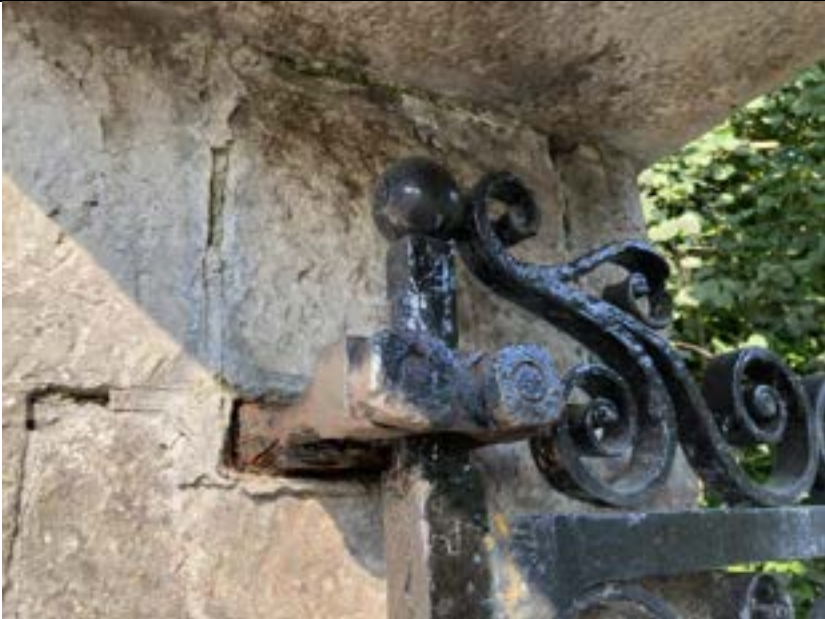
Vegetation growth on top of piers. Damaged stonework also visible.

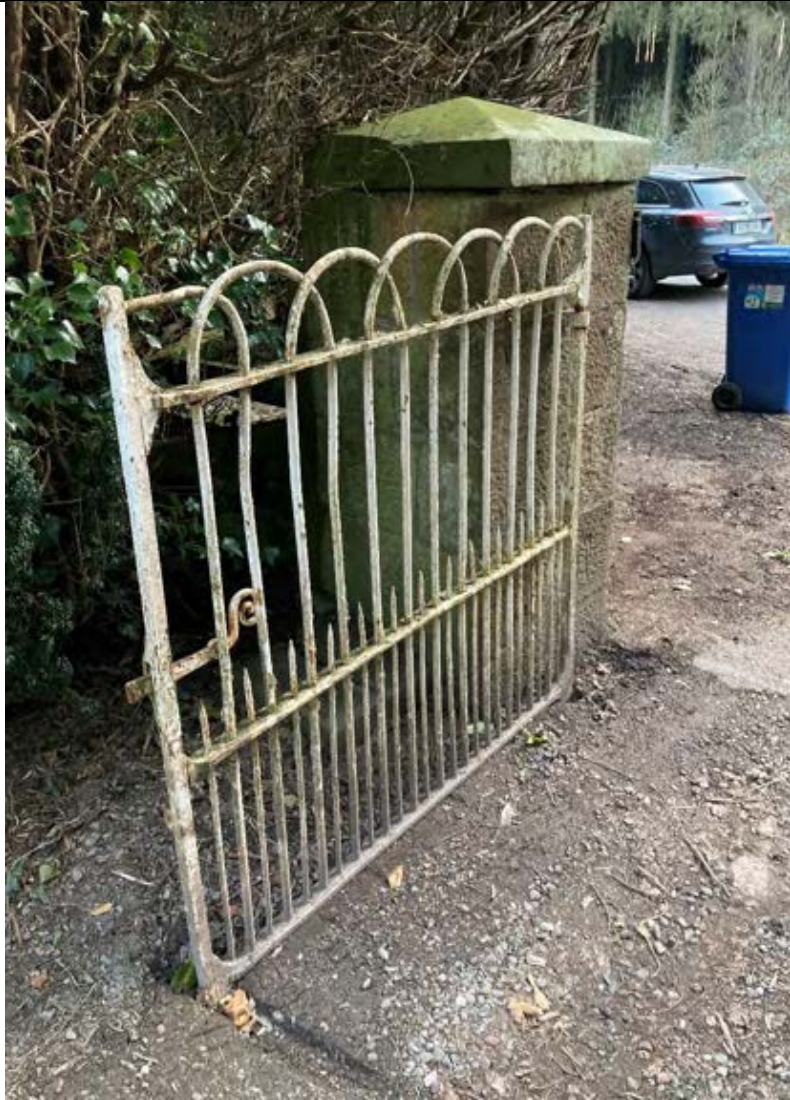
<p><b>23. West Gate</b></p>	  <p>Gate and pillars with lodge built c.1850 behind</p>
-----------------------------	--

Wrought iron gate

Coordinates	54°13'40.5"N 7°00'22.5"W
Townland	Clonavarn
Description	Freestanding gateway, at western entrance to former demesne of Rossmore Castle. Comprises pair of square-plan channelled dressed limestone piers to each side of vehicular entrance, with moulded cornices and pyramidal cappings, and supporting decorative double-leaf wrought-iron gate. Piers flanked by low random rubble limestone walling.
Condition	Overall, the gates and limestone piers are in good condition. There is some rust, but this is not significant. There is all some bending of bars but this appears to not be significantly impacting on the ability of the gates to function. The limestone piers are pointed in cement. Despite this, they appear in good condition.
Suggested Actions	<b>Maintenance and painting</b> Observation: Regular need to paint and inspect Action: Repaint at least once every five years. Inspect annually. During the inspection, clean the iron with a cloth and water (use a bristle brush if needed for soiling). Paint with two coats of appropriate oil-based paint.

<p>Where localised corrosion has set in, remove loose material with scraper, clean to a bright finish and feather the edges of the old paint with abrasive paper. Treat derusted iron with rust neutralising inhibitor. Then paint area with 1-2 coats of zinc-phosphate primer, two layers of undercoat and two layers of topcoats. Final colour(s) used should match original paint scheme. Grease the pivot points to reduce wear. Timing: Short term</p> <p><b>Vegetation management</b>  Observation: Danger of vegetation obscuring elements of the gates and piers.  Action: Trim vegetation during September - February.  Timing: Short term</p>
Possible visitor experience actions	Refer to this gate in the interpretation panel at the northwest gate (i.e. main gate).
Protected Structure	Yes Local 47
Record of Monuments and Places	No
Significance rating	Local
Category	Gates
Other notes	n/a
References	<a href="https://www.buildingsofireland.ie/buildings-search/building/41401306/rossmore-forest-park-killicushil-monaghan">https://www.buildingsofireland.ie/buildings-search/building/41401306/rossmore-forest-park-killicushil-monaghan</a>

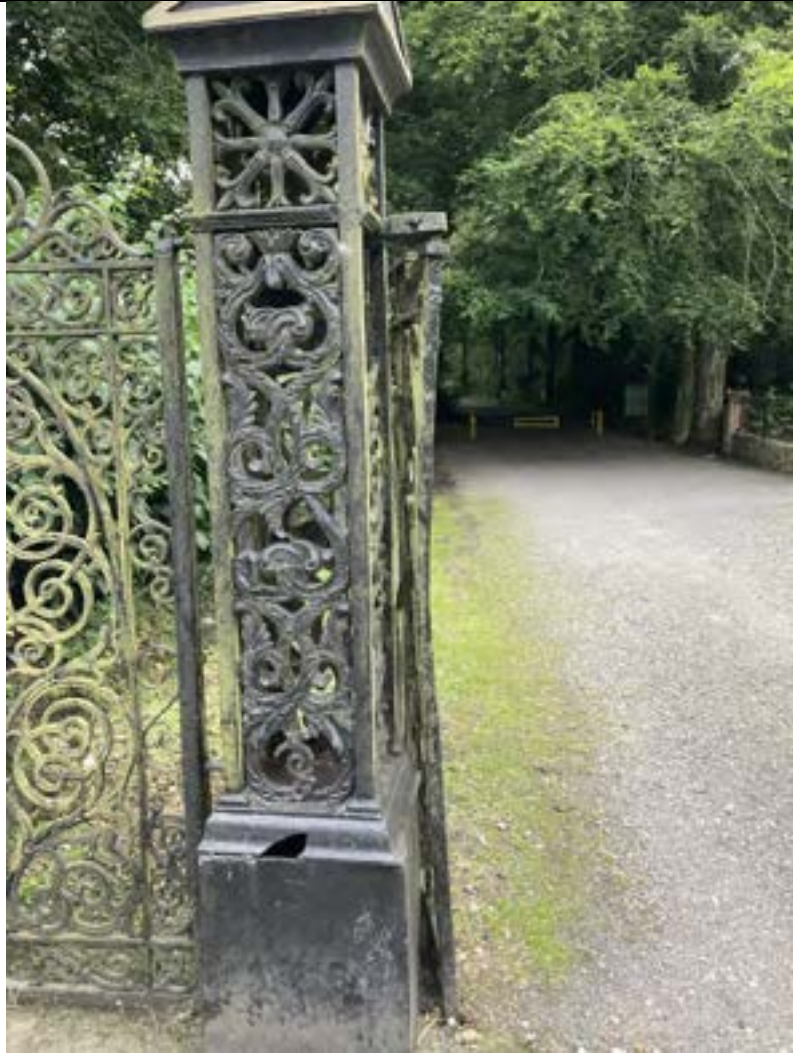
<b>24. Southeast Gate</b>	 
	View of gate looking into the park

Broken piece allowing water and debris into the structure. There is a noticeable bend in the gate. Was this caused by Mick Jagger?

Condition	<p>The southeast entrance to Rossmore Park is in a functional but poor condition. Aside from the large collapsed area of railing to the south of the gate, the ironwork throughout the gate and railing is in need of attention. Several components are broken off. It appears that the ironwork has not been painted for some time.</p> <p>The barrier in front of the pedestrian gate is visually intrusive and an inconvenience to cyclists.</p> <p>Outside the gate is frequently used for car parking. Across the road, the property owner has erected barriers to stop parking. It is likely that the collapsed railings were hit by a car.</p>
Suggested Actions	<p><b>Maintenance and painting</b></p> <p>Observation: Regular need to paint and inspect</p> <p>Action: Repaint at least once every five years. Inspect annually. During the inspection, clean the iron with a cloth and water (use a bristle brush if needed for soiling). Paint with two coats of appropriate oil-based paint.</p> <p>Where localised corrosion has set in, remove loose material with scraper, clean to a bright finish and feather the edges of the old paint with abrasive paper. Larger areas of corrosion may require dry abrasive cleaning or chemical stripping (please note: flame cleaning is not appropriate). Treat derusted iron with rust neutralising inhibitor. Then paint area with 1-2 coats of zinc-phosphate primer, two layers of undercoat and two layers of topcoats.</p> <p>Final colour(s) used should match original paint scheme.</p> <p>Grease the pivot points to reduce wear.</p> <p>Keep ground pivot free of dirt.</p> <p>Timing: Short term</p> <p><b>Repairs to cast iron</b></p> <p>Observation: Areas of cast iron are in need of repair.</p> <p>Action: Repair cracks less than 6mm thick using cold stitching. Pitting in rusted cast iron can be repaired using epoxy car-body filler. Clean metal, apply rust inhibitor, apply epoxy filler, shape and rub</p>

<p>down with abrasive paper to match contour. Then prime and paint to match surrounding.</p> <p>For simple breaks in cast iron and the metal in reasonable condition, in situ arc-welding repair is usually possible. Only experienced blacksmith or welding service should undertake this. The weld should be continuous, ground flat, primed and painted.</p> <p>Where possible, all repairs should take place on site.</p> <p>Timing: Short term</p> <p><b>Replacing missing elements</b></p> <p>Observation: Missing or heavily corroded cast and wrought ironwork</p> <p>Action: Missing and heavily corroded structural elements will need to be replaced. This is particularly important for any elements required for the structure's weathering. Accordingly, replacements will have to be ordered to match what would have been there originally. Budget permitting, decorative features that have been lost should also be replaced.</p> <p>Timing: Short term for pieces necessary for weathering of structure. Long term for purely decorative features</p> <p><b>Area of collapse</b></p> <p>Observation: A large section of the railing to the south of the gate has collapsed. The plinth and railings are still on site.</p> <p>Action: Reconstruct limestone plinth wall and repair the railings. Reuse as much of the fallen railings and plinth as possible.</p> <p>Timing: Medium term</p> <p><b>Concrete pointing and repairs</b></p> <p>Observation: Inappropriate concrete pointing and repairs causing damage to stonework. Gaps in pointing should also be pointed with appropriate lime-based mortar.</p> <p>Action: Remove all concrete pointing and crack repairs and replace with appropriate lime-based mortar.</p> <p>Where broken stone fragments are visible replace with cut limestone to match profile of surrounding stonework. Fix with stainless steel dowels and point with appropriate lime-based mortar.</p> <p>Timing: Medium term</p> <p><b>Mick Jagger damage</b></p> <p>Observation: The level of damage caused by Mick Jagger caused to the gates is unknown. These may not be the gates. He also may not have come to Rossmore.</p> <p>Action: Conduct more research on the Mick Jagger incident. If the damage he caused is identified, this should be retained unless it adversely undermines the functionality of the gates.</p> <p>Timing: Medium term</p> <p><b>Steel barrier in front of pedestrian entrance</b></p> <p>Observation: Steel barrier is visually intrusive.</p> <p>Action: Remove. If a barrier is deemed necessary, then it should be more in keeping with setting and suitable for use by cyclists.</p>

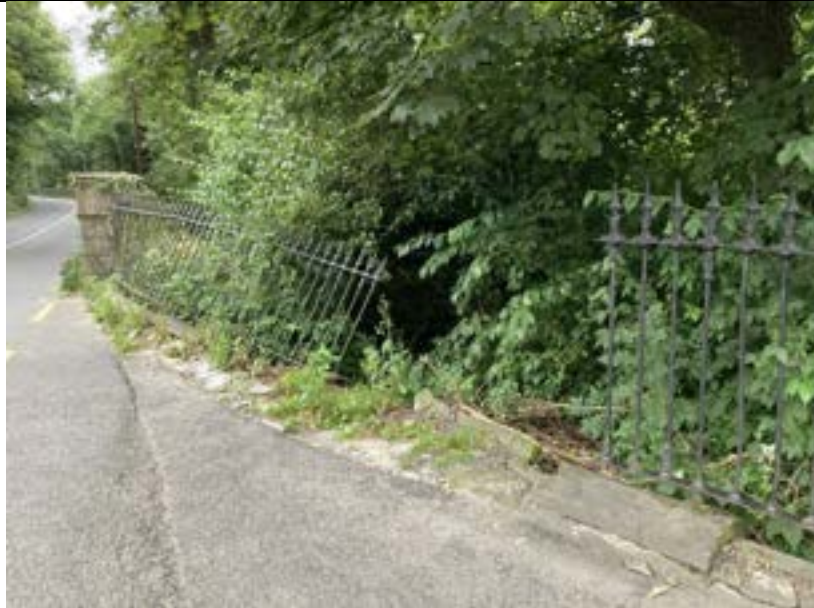
Area of collapse. Railings and plinth are still on site, albeit damaged.

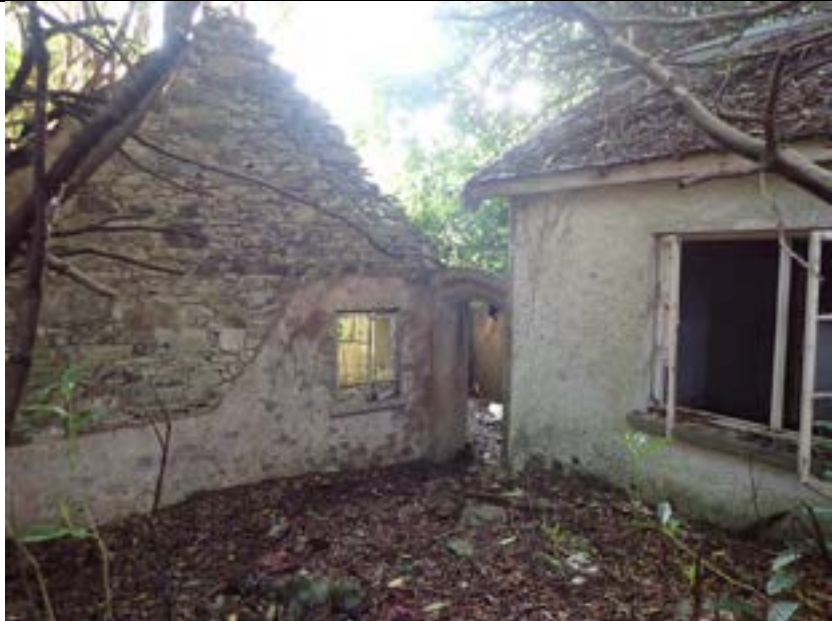
Exterior of cottage with outbuilding to left. Note carved limestone arch.

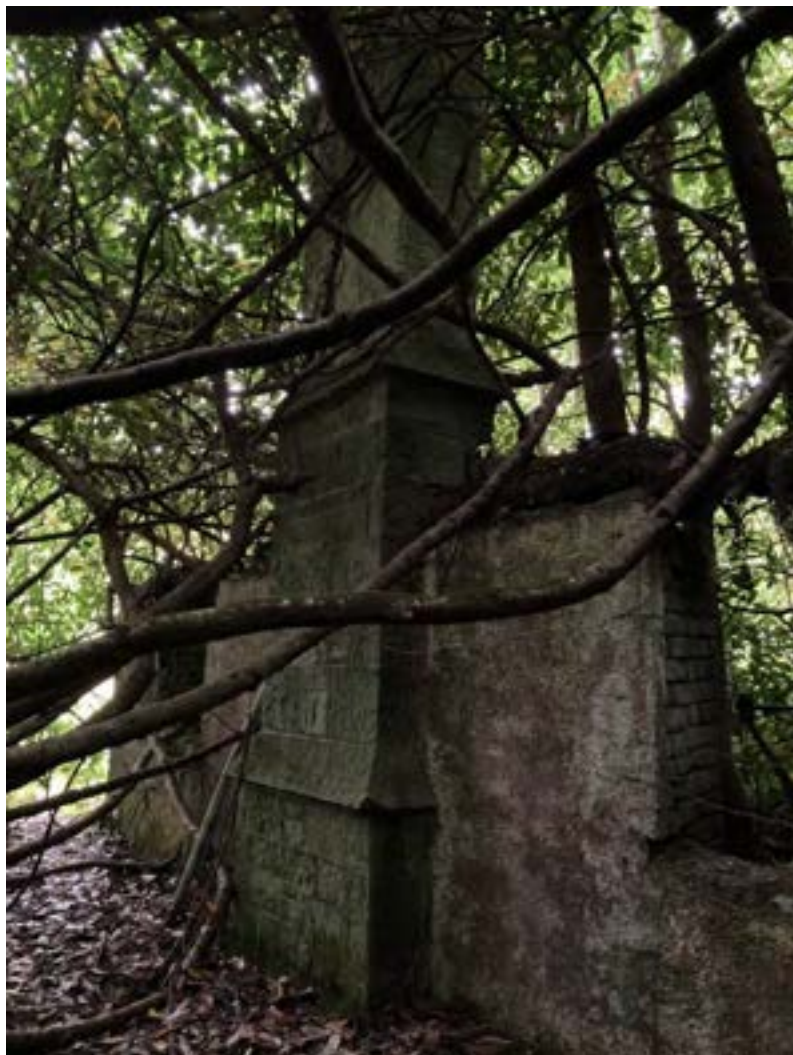
One of the two standing limestone chimney stacks

Condition	Very poor. The house was burnt in an IRA arson attack in May 1981. Areas of the site are dangerous to access. Sycamore, rhododendron and other vegetation has taken over the site. One of the standing limestone chimney stacks is in danger of collapse.
Suggested Actions	<p><b>Survey</b>  Observation: Full building condition survey and repair specifications required for the cottage and associated buildings.  Action: Due to the cottage's continued degradation, its heritage significance and strategic value, a complete building survey needs to be carried as a matter of urgency. On the team should be a conservation engineer and conservation architect (grade I or II). Following the report, a full programme of conservation and - where appropriate - restoration works should take place.  Timing: Immediately</p> <p><b>Access and interpretation</b>  Observation: This is one of the most interesting places in the park. Its reuse would animate the park as a whole and save the cottage from continued degradation.  Action: The cottage would greatly benefit from reuse. It is of strong social value. Well-designed interpretation would increase levels of appreciation for the site.  Timing: Long term</p>

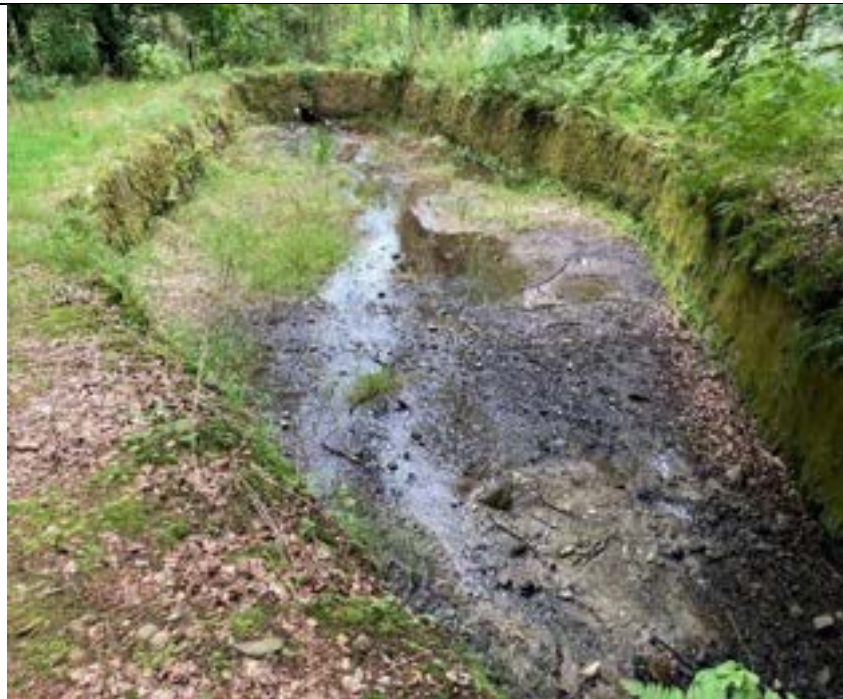
**26. Fish hatchery**

Image of the hatchery taken from beside the main water intake. The outtake is directly opposite from the intake. Outtake would originally have had an iron sluice gate.

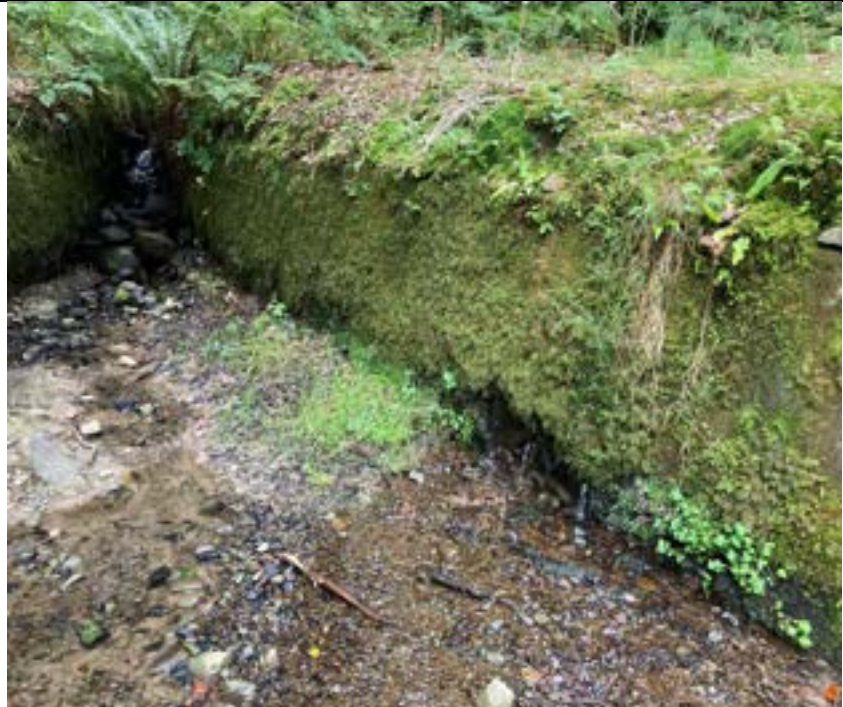
The main water entry point is visible on the left of the image. To the right water can be seen emerging from the base of the retaining wall. The wall is bulging out. The heavy moss growth also indicates that the area behind the plaster is saturated.

<p>The water flow into the hatchery comes from thick ceramic piping which is fed from water coming from Bartle’s Lough which is itself fed by water from Steenson’s Lough and Ardagh Lough. Bartle’s Lough, Steenson’s Lough and Ardagh Lough are all manmade.</p> <p>In plan, the hatchery resembles an stretched pentagon. The water enters via an opening at the south east apex and exits through an opening in the middle of the north west wall. The five retaining walls are composed of random rubble limestone. Both the walls and floor are plastered. There is no evidence of repairs.</p> <p>There are grooves at the western outlet, indicating that a sluice gate was once here.</p>
Condition	<p>Overall, the tank is in reasonable condition. Although the vast majority of the retaining walling is intact, there are areas of pressure from water pushing out at least one wall. This pressure is likely to increase during heavy rainfall. There is also the danger that water being retained behind plaster and within walls may damage the walls via frost thaw action. In certain sections the plaster has fallen from the walls, exposing the random rubble stonework which is beginning to deteriorate. There is significant debris (natural material washed into the hatchery). The level of damage this has done to the hatchery floor is unknown. Because there are no copings visible on the wall heads, they are exposed and vulnerable to weathering and vegetation growth. Trees located close to the retaining walls are a danger to the wall heads and are significant risk to the structural integrity of nearby retaining walls.</p>

Suggested Actions	<p><b>Survey</b></p> <p>Observation: The presence of a substantial flow of water behind at least one retaining wall requires an appropriate survey by a conservation engineer.</p> <p>Action: Conservation engineer to examine the retaining walls and ascertain the level of damage being done by water. Appropriate repair and water control measures are then to be specified. This may include repairing at least some of the piping coming from Bartle’s Lough to ensure in comes in where it is intended to.</p> <p>Timing: Short term</p> <p><b>Leans and cracks</b></p> <p>Observation: Cracks and bulges in retaining walls indicate significant structural issues.</p> <p>Action: Where defects such as cracking or leaning are visible, obtain advice from a conservation engineer. Repairs should be carried out speedily, to halt continued degradation and resulting increase in costs.</p> <p>Timing: Short term</p> <p><b>Wall heads</b></p> <p>Observation: Exposed wall heads allowing degradation of retaining wall.</p> <p>Action: The main objective of coping the wall heads is to prevent further degradation of the top of the walls. Accordingly, after repairing the uppermost masonry, a soft-caping approach may be taken. Soft-caping involves the use of appropriate grass sods on the wall tips to absorb rainfall and protect the wall surface. It is important to maintain the</p>

<p>sodding to ensure plants with woody roots grow. It may also be appropriate to remove all vegetation and accumulated humus from the structure's wall heads and mortar the wall top in appropriate lime mortar to shed water off the top. The flaunching should allow all water to easily fall off the top and not to puddle.</p> <p>Timing: Short term</p> <p><b>Trees</b></p> <p>Observation: Trees adjacent to the site are a risk to its built fabric.</p> <p>Action: Cut down and remove trees where roots are likely to be causing pressure to the retaining walls. Allow roots to rot. Treat root stumps with ecologically acceptable herbicide (make sure to seek expert advice on this matter). Any saplings within or close to the hatchery should also be removed.</p> <p>Timing: Short term</p>
Protected Structure	No
Record of Monuments and Places	No
Significance rating	Regional (category: technical)
Possible visitor experience actions	<p>The production of fish for stocking the lakes and later use as food and recreational fishing is a story that should be told through a well-designed interpretive panel complemented by an entry in an audio guide. Any panel should indicate the location of other parts of the fish hatchery (to the immediate east of Priestfield Lough). An accessway needs to be cleared to permit site visits. Furthermore, a simple fingerpost sign is required at the existing nearby trackway to indicate its location. Finally, as we are inviting visitors to look at the site, a safety assessment should be undertaken to understand the risks and plan appropriate measures which are sensitive to the site's heritage. For instance, this may include a well-designed handrail at the area of the hatchery closest to the main access point. The impact of the site's increased facilitation to visitors needs to be monitored and any necessary management actions taken.</p>

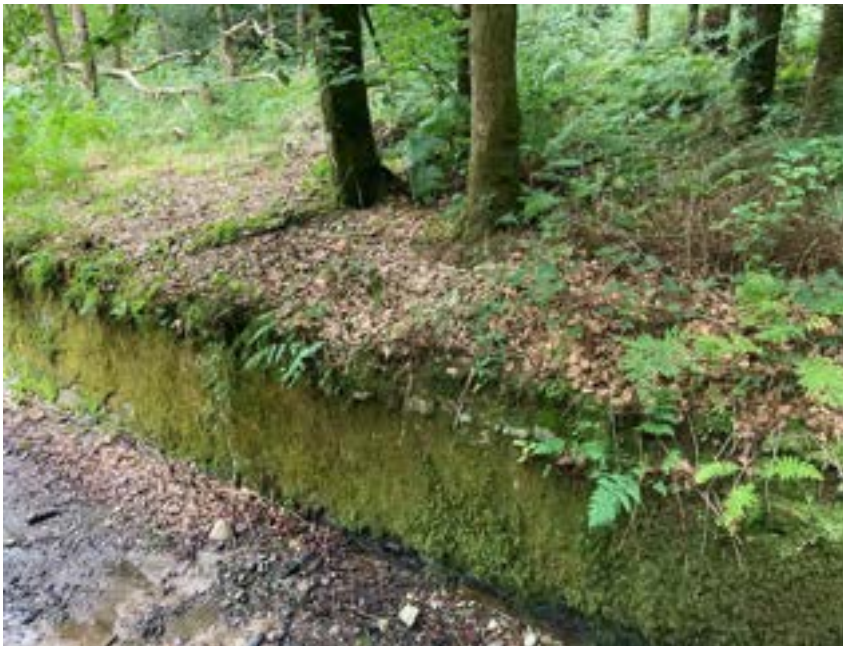
The roots from nearby trees are likely to be a significant risk to the structural integrity of nearby retaining walls.

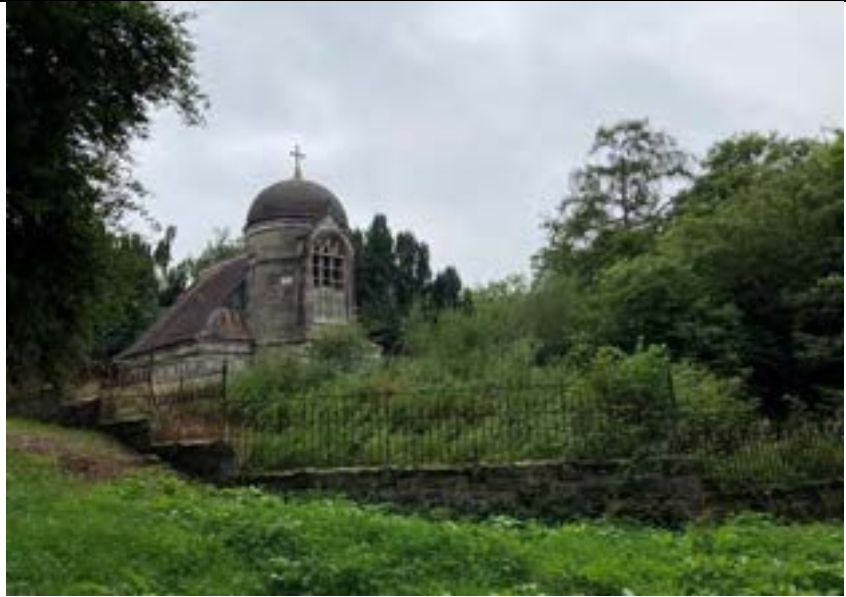
**27. Rossmore  
Mausoleum and  
Graveyard**

View of the mausoleum with the stained-glass windows no longer present

Condition	<p>Access to the site was not possible. Nonetheless, for a visual inspection outside of the railings several missing slates and at least one hole in the roof was visible. Apparently, a cause for this are golf balls from the adjacent golf course. The stained-glass windows are gone. Rain can now enter the structure through much of what was covered by the stained glass.</p> <p>The railings that form much of the site boundary appear to be in good condition.</p> <p>The adjacent high random rubble, limestone boundary wall was missing several stones. Much of the pointing was also gone. Towards the tops of the wall, repair work was evident. It was not clear but looking back over images it appears that inappropriate cement may have been used during those repair works. This require clarification.</p>
Suggested Actions	<p><b>Survey</b></p> <p>Observation: Out of date condition survey for a building that continues to degrade.</p> <p>Action: The most recent condition survey of the mausoleum is from early 2007 (Architectural Record and Research). Conservation work has taken place in the interim. Nonetheless, due to its continued degradation and the building’s national importance, a new survey needs to be carried as a matter of urgency. On the team should be a conservation engineer and grade 1 conservation architect. Following the report, a full programme of conservation and – where appropriate</p>

<p>– restoration works should take place. A survey of the graveyard and boundaries is also necessary to ascertain its conservation needs. Timing: Immediately</p> <p><b>Access and interpretation</b> Observation: According to the 2007 condition report of the mausoleum (ibid), dereliction/lack of use and vandalism are the key reasons for the building’s degradation. Action: The mausoleum would benefit from greater observation by those interested in the Park’s heritage. Increased visitation would improve observation, thereby reducing opportunities for vandalism and increasing the likelihood of building issues being noticed. As per family wishes, access inside the mausoleum should not be permitted. Accordingly, well-designed interpretation should be located outside the site, in a location that would not detract from its setting. Such interpretation would increase levels of appreciation for the site. Timing: Long term</p>

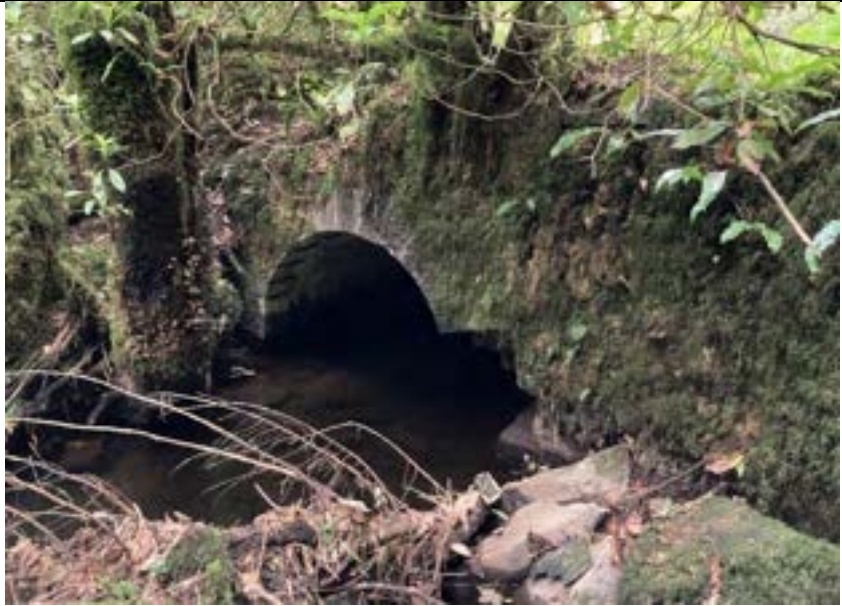
**28. Bridge**

Missing stones in arch and heavy vegetation growth is obvious

<p>Action: Carefully remove the any plants with woody roots. Insert appropriate stone infills and point with appropriate lime mortar as required. Timing: Short term</p> <p><b>Stone pointing</b> Observation: Failed/missing stone pointing is obvious Action: Replace failed pointing throughout the bridge and associated retaining walls with appropriate lime-based mortar. If possible and deemed to not be damaging to the structure, vegetation with non-woody roots (e.g. lichens, small ferns) should be retained. Timing: short term</p>
Possible visitor experience actions	None
Protected Structure	No
Record of Monuments and Places	No
Significance Rating	Regional (part of a set of three bridges) (categories: architectural, technical)
Category	Bridge
Other notes	Did not access under the bridge.
References	<a href="https://www.buildingsofireland.ie/buildings-search/building/41401311/rosmore-forest-park-cornaglare-monaghan">https://www.buildingsofireland.ie/buildings-search/building/41401311/rosmore-forest-park-cornaglare-monaghan</a>

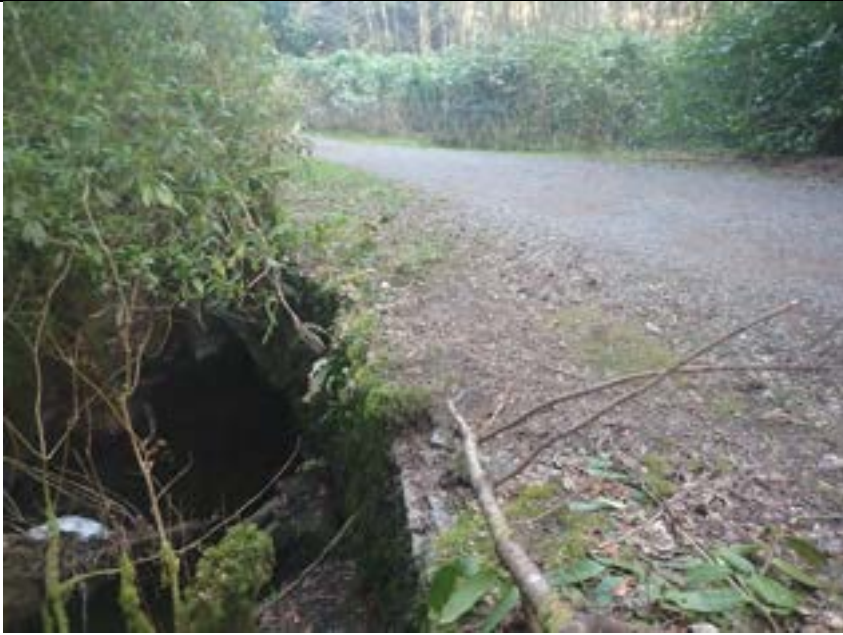
Missing and loose stones in arch. Failed pointing in spandrels.
