# Rossmore Forest Park Built Heritage Conservation Management Plan

## 1.1 Introduction

The objective of this document is to provide heritage advice on the appropriate conservation and management of the built heritage assets in Rossmore Forest Park. This report was jointly commissioned by Cavan County Council and Monaghan County Council. It is an action of the Rossmore Masterplan.

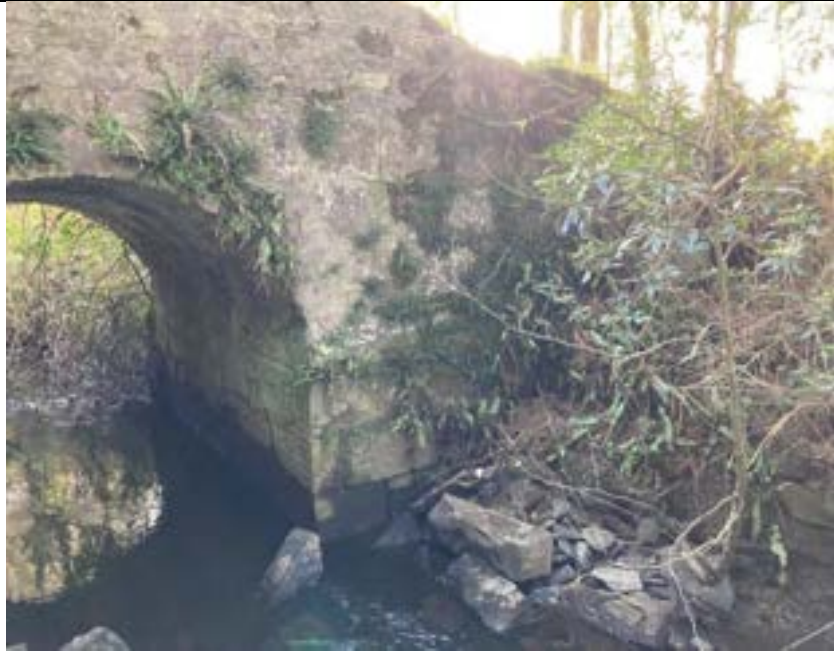
<p><b>29. Bridge</b></p>	  <p>View of bridge</p>
--------------------------	--

Parapet stones rest by the stream. Tree growing from retaining stone wall.

Coordinates	54°13'19.4"N 7°00'01.2"W
Townland	Corlattan/Kilnamaddy
Description	'Masonry road bridge, constructed c.1850, to east of Priestfield Lough, having round arch with rendered gauged-brick voussoirs and intrados, coursed rubble limestone spandrel walls and parapet walls.' Taken from NIAH entry.
Condition	Good overall condition. Little cracking observed. No sagging of the arch was noticeable. Concrete repairs evident throughout. Several parapet stones rest on the bank of the stream. Integrity of the brick needs inspection by a conservation engineer. Some pointing missing from between brickwork was observed. Ivy and other plants with

woody roots growing from parapets. At least one tree was growing from associated riverbank retaining stone wall.
Suggested Actions	<p><b>Survey</b>  Observation: The structural integrity of the arch needs to be examined.  Action: Inspection required from a conservation engineer to diagnose any issues and propose solutions.  Timing: Immediate</p> <p><b>Woody vegetation</b>  Observation: Vegetation with woody roots likely to cause damage  Action: Carefully remove the any plants with woody roots. Insert appropriate stone infills and point with appropriate lime mortar as required.  Timing: Short term</p> <p><b>Stone pointing</b>  Observation: Failed/missing stone pointing is obvious  Action: Replace failed pointing throughout the bridge and associated retaining walls with appropriate lime-based mortar. Similarly, replace cement pointing judged to be causing damage to the structure with appropriate lime-based mortar. If possible and deemed to not be damaging to the structure, vegetation with non-woody roots (e.g. lichens, small ferns) should be retained. Conduct lime mortar analysis to inform mortar specification.  Timing: Short term</p> <p><b>Rebuilding parapet</b>  The northern parapet wall is seriously denuded. The southern parapet is covered in ivy and other vegetation.  Action: Rebuild the northern parapet wall back to its original height using traditional materials and methods. Where possible, reuse materials lying on the riverbank. The rebuild is to match coursing of remaining parapet.  Once ivy has been removed from the southern parapet, it is to be repaired to its original configuration using traditional materials and methods. Conduct lime mortar analysis to inform mortar specification.  Timing: Short term</p> <p><b>Concrete pointing</b>  Observation: Considerable amount of concrete is obvious on the bridge.  Action: The immediate removal of the concrete may cause more damage than it solves. However, over time the analysis of this may change. Should that happen, the concrete pointing should be removed and replaced with appropriate lime-based mortar  Timing: Long term</p>

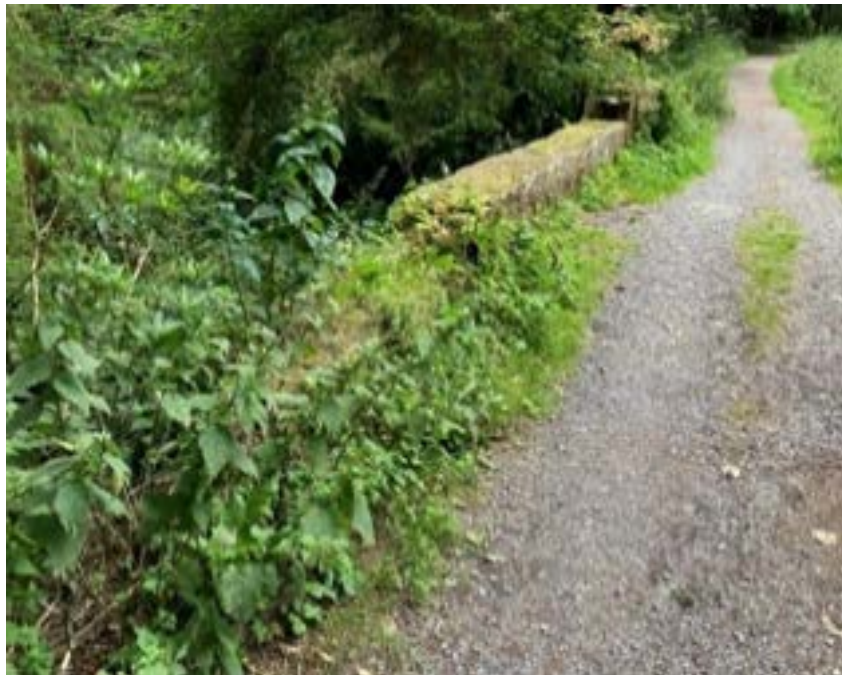
Much of the north parapet has been demolished

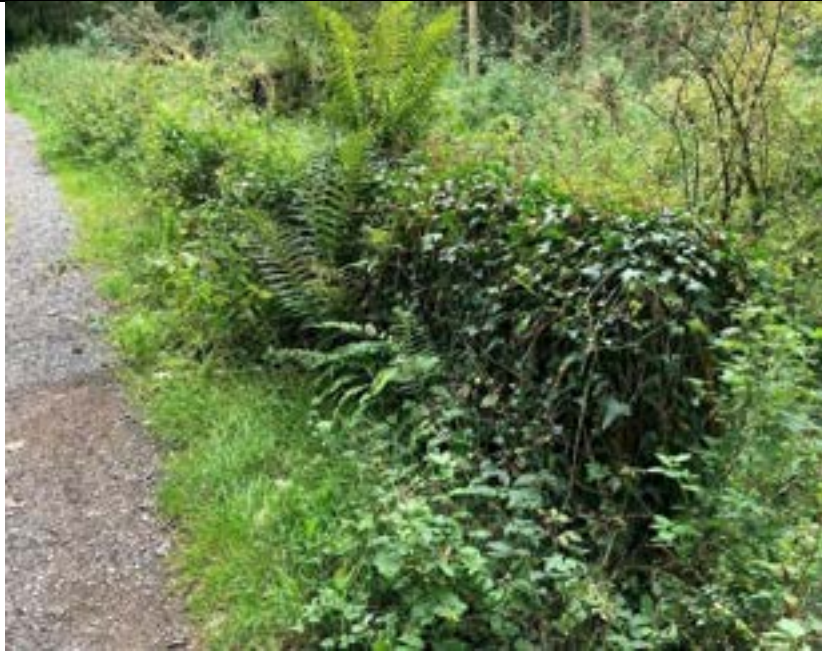
Southern parapet wall is covered in vegetation

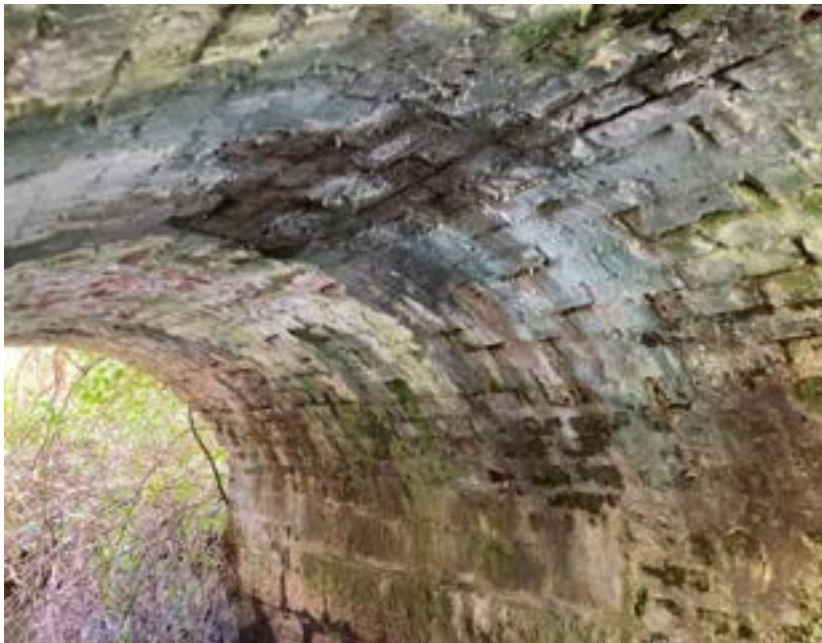
Brick underside of arch

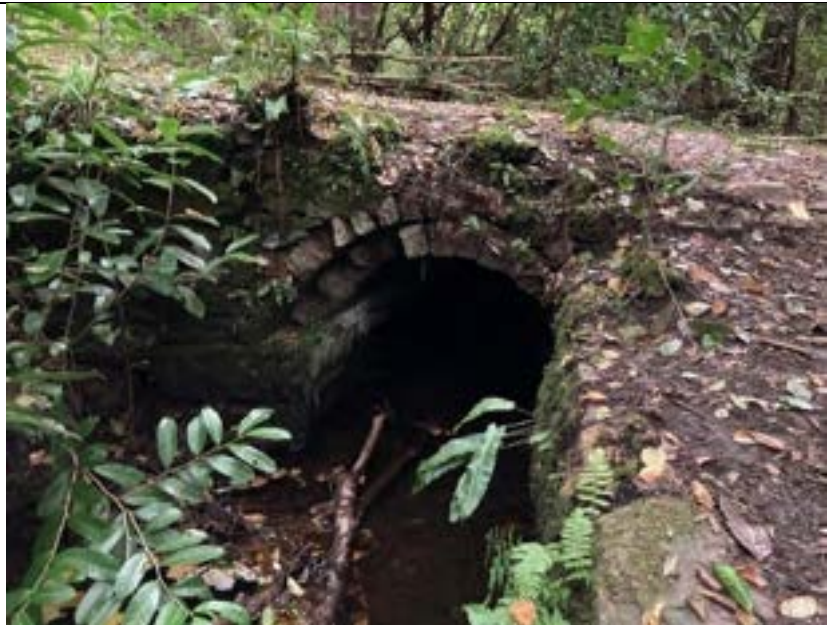
East side of bridge. No handrail present.

are limestone random rubble. Cast iron sluices. There is also a circular brick lined well.
Condition	<p>The bridge is in poor condition with missing brick voussoirs on both the east and west sides of the single arch. Other voussoirs appear to be loosening. Vegetation with woody roots is growing from the bridge. Pointing has been lost throughout the bridge. This has allowed water ingress. There is no parapet present for those walking over the bridge. Some of the masonry in the channels was loosening. Areas of pointing had also failed. Cast iron sluice gates are unable to move.</p> <p>Limestone quayside at Priestfield Lough appears to be in reasonable condition.</p> <p>With the exception of the trackway, the site area has a dense covering of rhododendron and other vegetation making inspection difficult.</p>
Suggested Actions	<p><b>Structural issues</b></p> <p>Observation: Several bricks from the bridge arch have popped out. Others appear to be loosening. The engineer should also examine any conservation needs in the adjacent channels and well.</p> <p>Action: Inspection required from a conservation engineer to diagnose the issues and propose solutions.</p> <p>Timing: Immediate</p> <p><b>Handrails</b></p> <p>Observation: The bridge has no parapet.</p> <p>Action: Install robust and reversible handrail on both sides of the bridge. Handrails to be appropriate to setting and heritage value of bridge.</p> <p>Timing: Immediate</p> <p><b>Woody vegetation</b></p> <p>Observation: Vegetation with woody roots likely to cause damage</p> <p>Action: Carefully remove the any plants with woody roots. Insert appropriate stone or brick infills and point with appropriate lime mortar as required.</p> <p>The rhododendron in the area needs to be controlled to permit adequate management of the site.</p> <p>Timing: Short term</p> <p><b>Stone and brick pointing</b></p> <p>Observation: Replace failed pointing throughout the bridge, associated retaining walls and channels and quayside with appropriate lime-based mortar. If possible and deemed to not be damaging to the structure, vegetation with non-woody roots (e.g. lichens, small ferns) should be retained. Conduct lime mortar analysis to inform mortar specification.</p> <p>Timing: Short term</p>

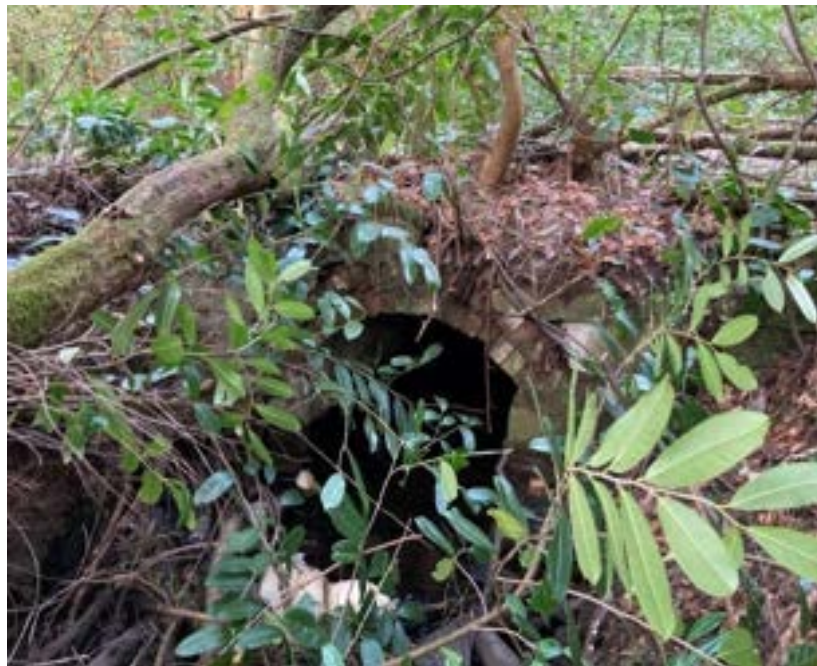
West side of bridge

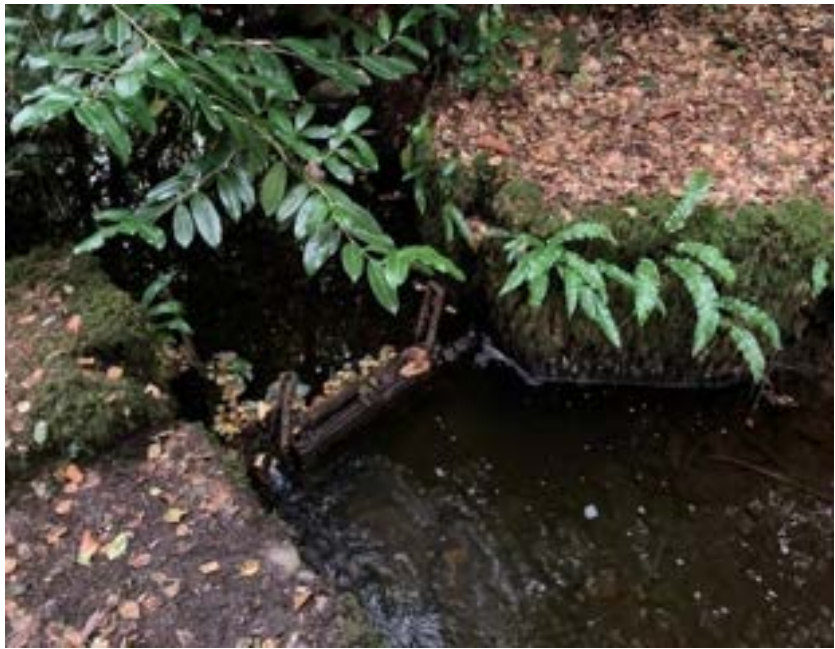
Cast iron sluice gate

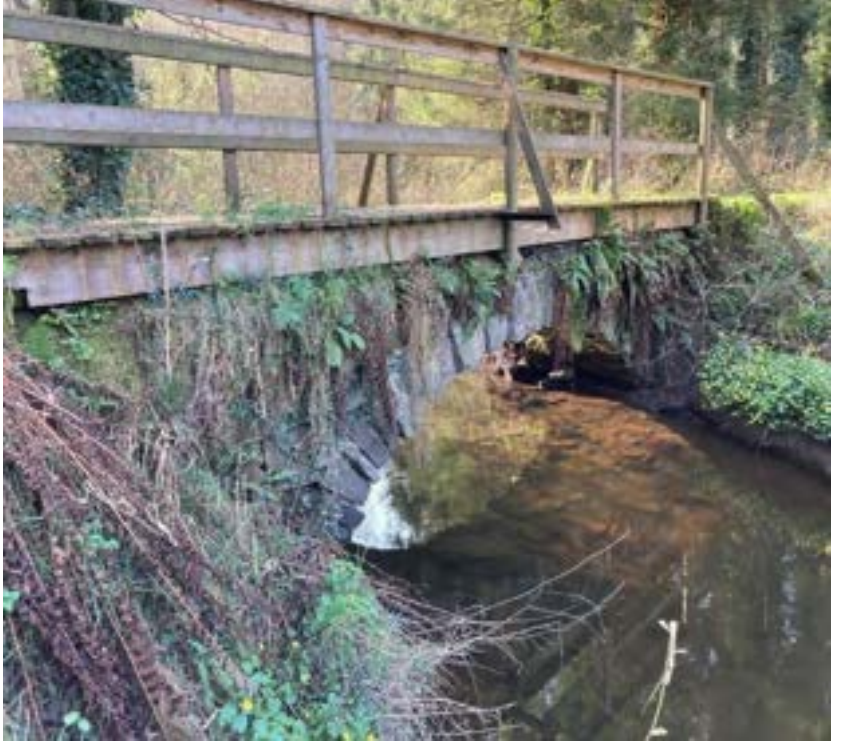
<p>General view of bridge</p>

<p>rubble limestone spandrel walls, and recent unhewn timber handrail to carriageway.’ Taken from NIAH entry.</p>
Condition	<p>Possibly poor. Engineer survey is required to ascertain. There is a heavy vegetation growth throughout this small bridge. Pointing has been lost throughout the bridge. This has allowed water ingress. Water may also be penetrating past the timber walkway into the arch.</p>
Suggested Actions	<p><b>Structural issues</b>  Observation: Heavy vegetation growth and loss of pointing possibly loosening stonework.  Action: Inspection required from a conservation engineer to diagnose the issues and propose solutions.  Timing: Immediate</p> <p><b>Vegetation</b>  Observation: Excessive vegetation likely to cause damage  Action: Carefully remove vegetation likely to be causing damage and/or obscuring inspection. Insert appropriate stone infills and point with appropriate lime mortar as required.  Timing: Short term</p> <p><b>Stone pointing and grouting</b>  Observation: Replace failed pointing throughout the bridge with appropriate lime-based mortar. Conduct lime mortar analysis to inform mortar specification. Grouting of the structure may also be required if deemed so by conservation engineer.  Timing: Short term</p>

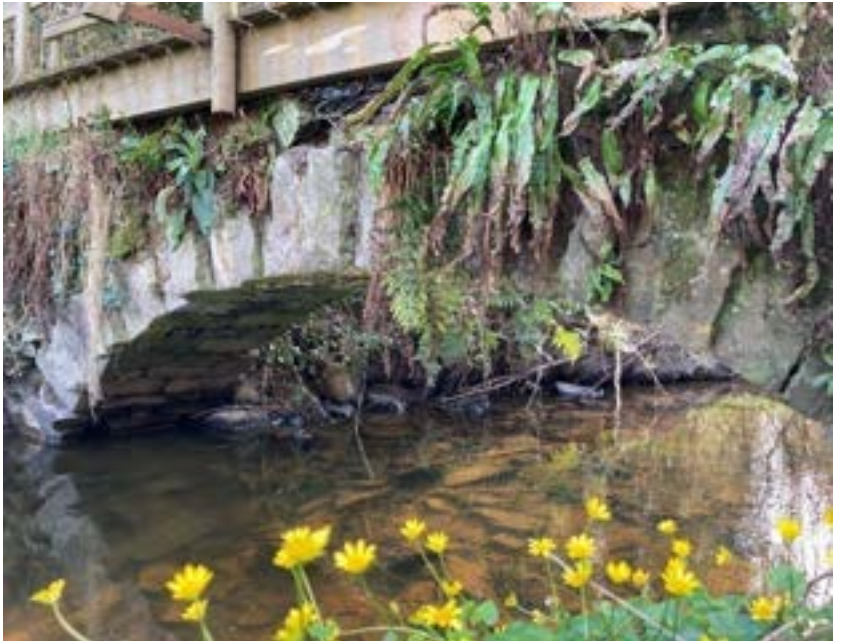
<p>View of underside of arch</p>
<p>Coordinates</p>	<p>54°13'22.1"N 6°59'56.3"W</p>
<p>Townland</p>	<p>Corlattan/Kilnamaddy</p>
<p>Description</p>	<p>'Rubble masonry footbridge, built c.1800, to south-west of walled garden, with rubble limestone voussoirs to round arch, coursed</p>

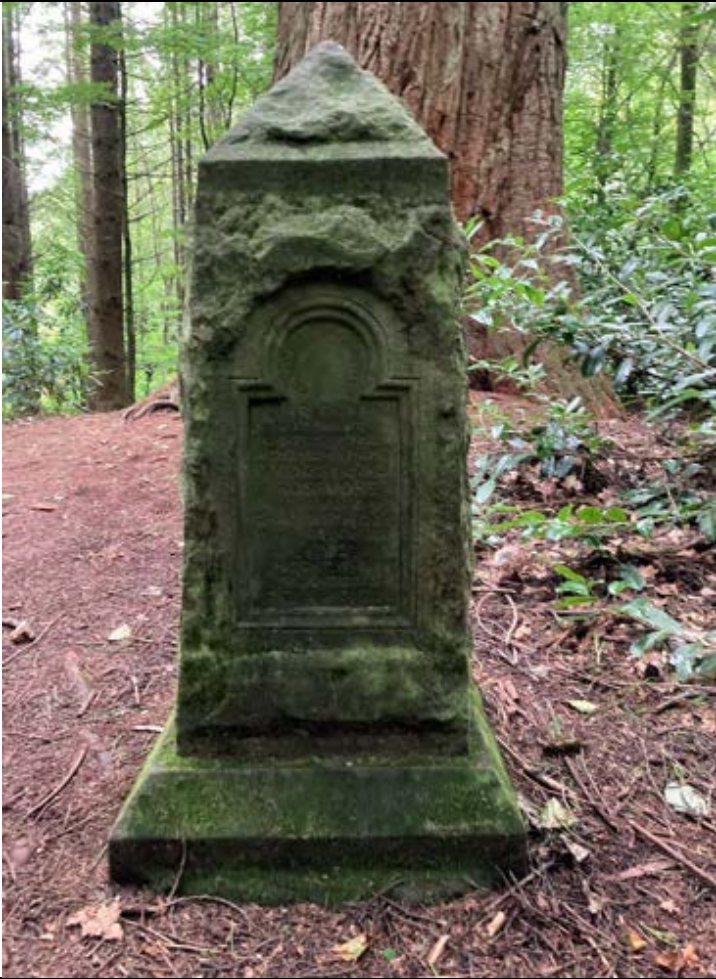
<p><b>32. 1862 Giant Redwood memorial</b></p>

<p>Coordinates</p>	<p>54°13'15.5"N, 7°00'02.9"W</p>
<p>Townland</p>	<p>Cornaglare</p>
<p>Description</p>	<p>Stone marker commemorating the 1862 planting of a Giant Redwood (Sequoia) tree by Lord Rossmore. Simple granite pillar with rough pyramidal top, positioned on stone plinth. Incised carved letters on one face only. The redwood still survives and can be seen behind the marker in the photo above. At 44m high, it is the tallest tree in Monaghan (Fennell, 2013). Trees had become a competitive sport for prominent landowners in 19<sup>th</sup> century Ireland. Giant Redwoods were the most prized (ibid).</p>
<p>Condition</p>	<p>Very good condition. Although some of the letters are difficult to read, overall, the marker is in very good condition.</p>
<p>Suggested Actions</p>	<p><b>Cleaning</b> Observation: Managing vegetation on the memorial Action: If appropriated treated, granite memorials can have a long lifespan with little maintenance required (Snow, 2013). There may be the temptation to remove the green algae on the stone. This should not be done. Inappropriate cleaning may damage the stone with little gain, as the green algae will likely soon return. Consequently, the only cleaning permitted on the marker should be the careful removal of moss or other excess vegetation with a stiff natural bristle or nylon brush (not wire) or wooden spatula. Warm water may be used with the bristle brush if necessary. If gaps are discovered in the pointing between the column and plinth, repoint with appropriate lime-based</p>

<p>mortar. Any new vegetation growth (e.g. saplings, brambles) in immediate vicinity of the monument which could obscure or damage the it should be carefully removed. Timing: Medium term</p> <p><b>Legal Protections</b> Observation: The redwood behind the memorial is of sufficient heritage significance to receive protection as a tree of special amenity value. Action: Include the redwood on the list of trees of special amenity value in the next County Development Plan. Timing: Medium term</p>
Possible visitor experience actions	The 1862 Redwood memorial together with the nearby Cray and Mafeey tree markers and Brigid Westenra marker further away have the potential to give visitors insight into the park's social history. This could be done through a well-designed interpretive panel in a discrete location close to the redwood. The panel would provide information and show the location of the Cray, Mafeey and Brigid Westenra stones. The marker in Corlattan for the Giant Redwood should also be mentioned.

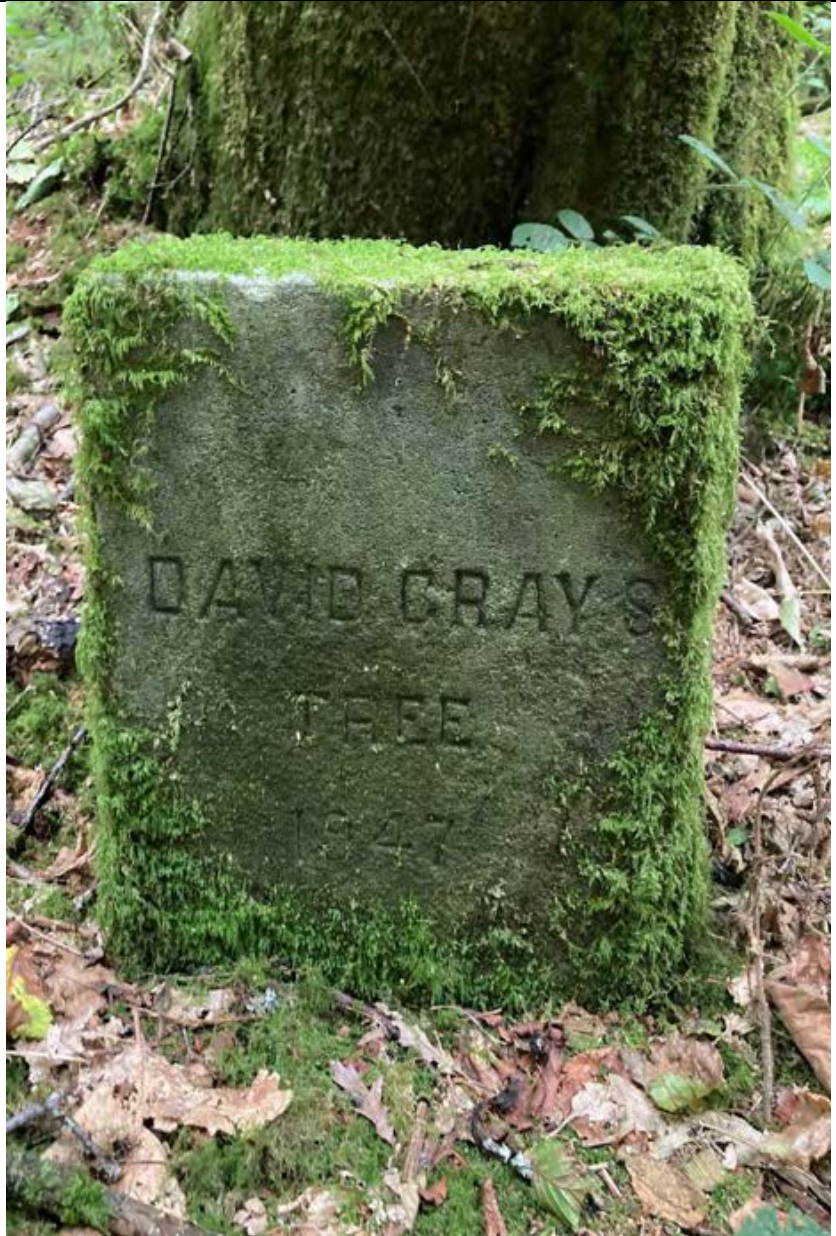
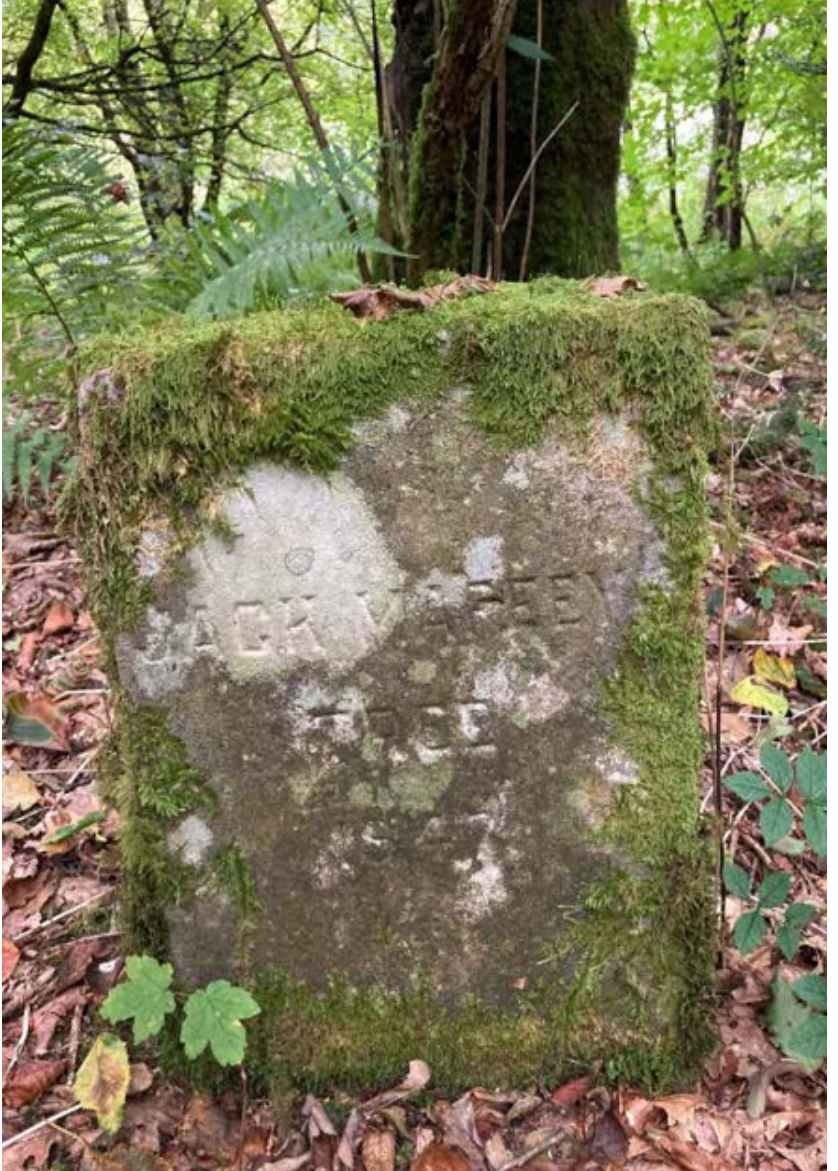
33. Cray and Mafeey tree markers

Coordinates	54°13'16.0"N 7°00'08.8"W
Townland	Cornaglare
Description	Two simple stone markers: 'Jack Mafeey Tree 1947' and 'David Cray's Tree 1947'. Limestone, rectangular cut slabs with writing on one face. According to a person who had worked for several decades at Rossmore, both Mafeey and Cray were ambassadors.
Condition	Good condition. Moss growth on both with sapling and brambles visible in immediate vicinity of Jack Mafeey stone.
Suggested Actions	<p><b>Cleaning</b></p> <p>Observation: Managing vegetation on the memorials</p> <p>Action: There may be the temptation to totally clean both stones. This should not be done. Inappropriate cleaning may damage the stone with little long-term gain. Consequently, the only cleaning permitted on both markers should be the careful removal of moss or other excess vegetation with a stiff natural bristle or nylon brush (not wire) or wooden spatula. Warm water may be used with the bristle brush if necessary.</p> <p>Timing: Medium term</p>

<p><b>Vegetation with woody roots</b>  Observation: Over the long-term, the sapling and brambles in the immediate vicinity of the Jack Mafeey stone have the potential to dislodge it.  Action: Carefully weed out the sapling and brambles. The earlier this is done, the better. Monitor for regrowth.  Timing: Short term</p> <p><b>Additional research</b>  No information on Jack Mafeey or David Cray was easily available.  Action: Conduct research on Jack Mafeey or David Cray.  Timing: Long term</p>
Possible visitor experience actions	The 1862 Redwood memorial together with the nearby Cray and Mafeey tree markers, other redwood marker and Brigid Westenra tree marker have the potential to give visitors insight into the park's social history. This could be done through a well-designed interpretive panel in an appropriate location close to the redwood. The panel would provide information and show the location of the Cray and Mafeey stones. The location of Brigid Westenra stone and other redwood marker would also be shown.

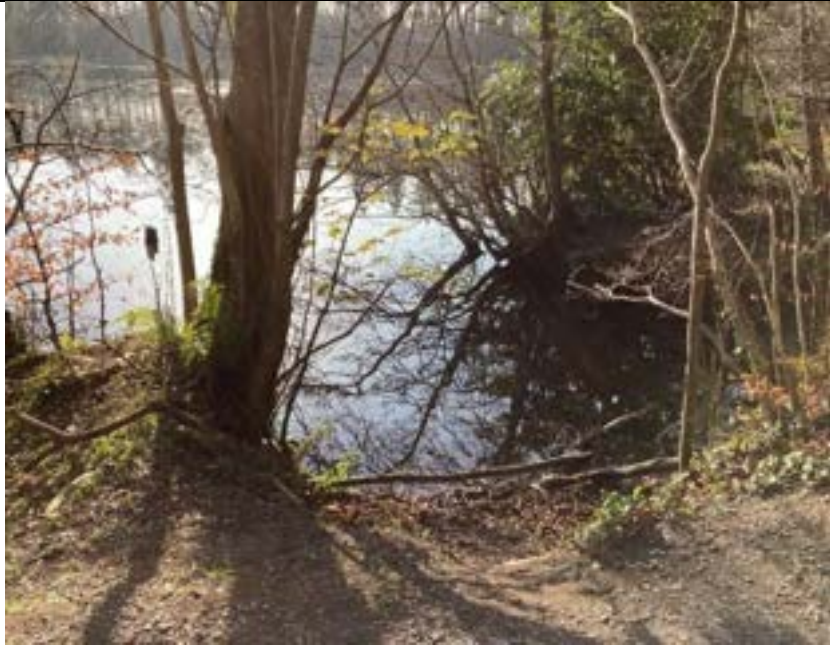
View of boathouse looking out into Priestfield Lough. Vertical timber visible in the lake is probably associated with the Boat House.

Leslie, the boathouse at Priestfield Lough provided direct access to the lake.
Condition	Very poor. Only low random rubble limestone footings remain of the boathouse. There is one vertical timber visible in the lake.
Suggested Actions	<b>Consolidation of remains</b> Observation: Remaining stonework being disturbed by tree growth. Action: Remove semi mature trees that are pushing out the remaining walls. Reset loose stones and bind with appropriate lime-based mortar. Growth of saplings on or near the wall remains should be monitored and any saplings removed as required. Timing: Medium term
Possible visitor experience actions	Site would suit a well-designed and discretely located interpretive panel focusing on the boathouse and its function as a place where the estate's family could row out onto the lake and fish.
Protected Structure	No
Record of Monuments and Places	No
Significance Rating	Local

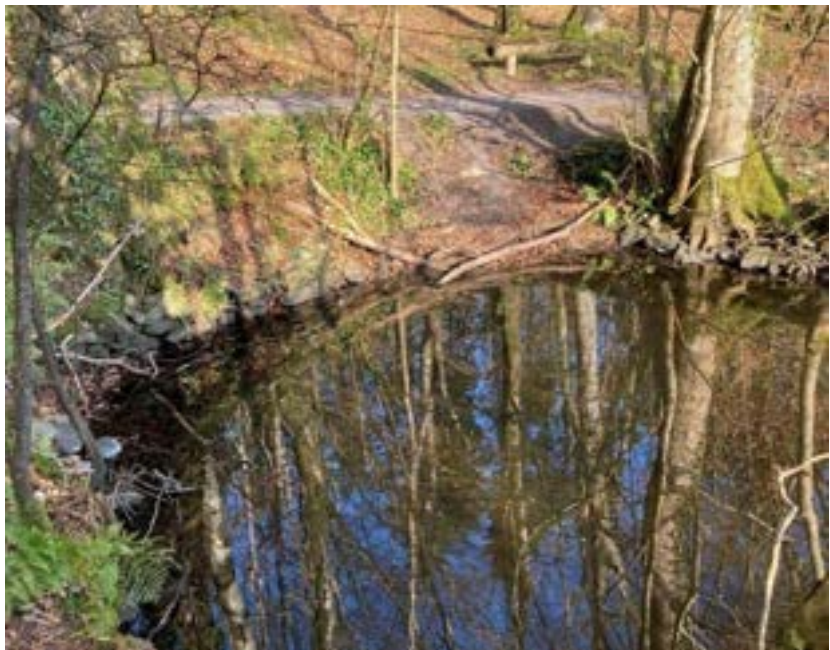
View of boathouse stone foundations/footings.

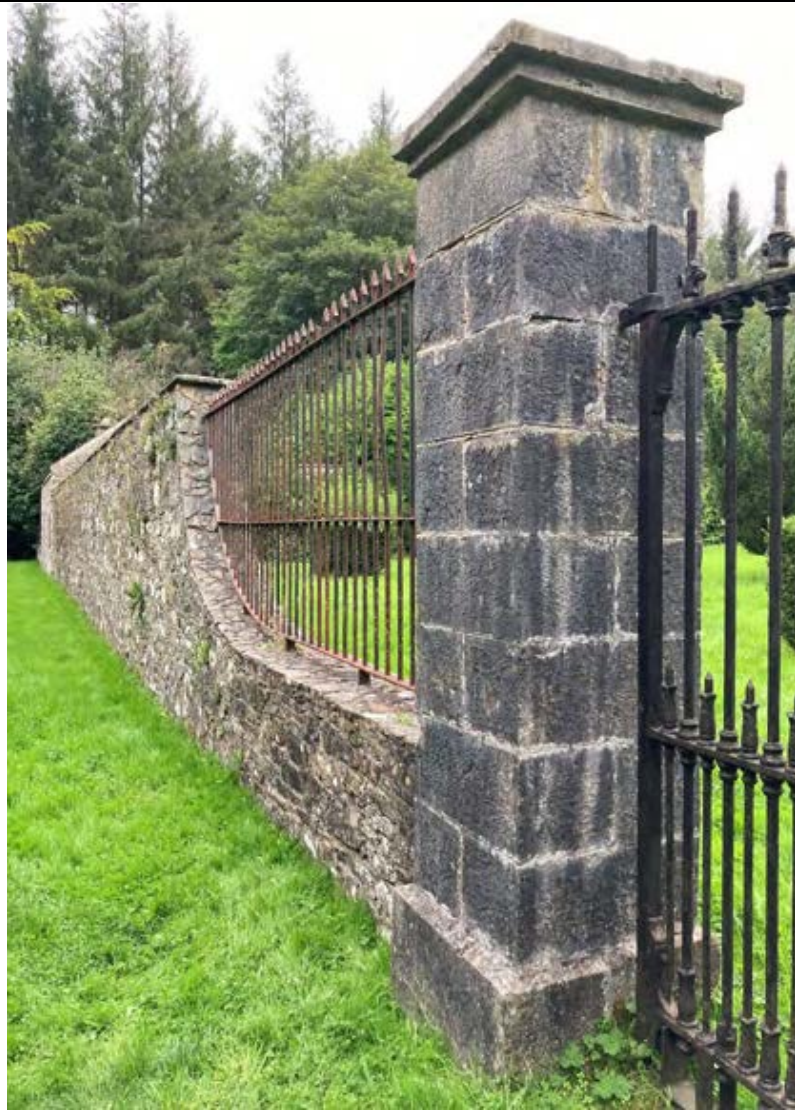
The railings and gate differ significantly

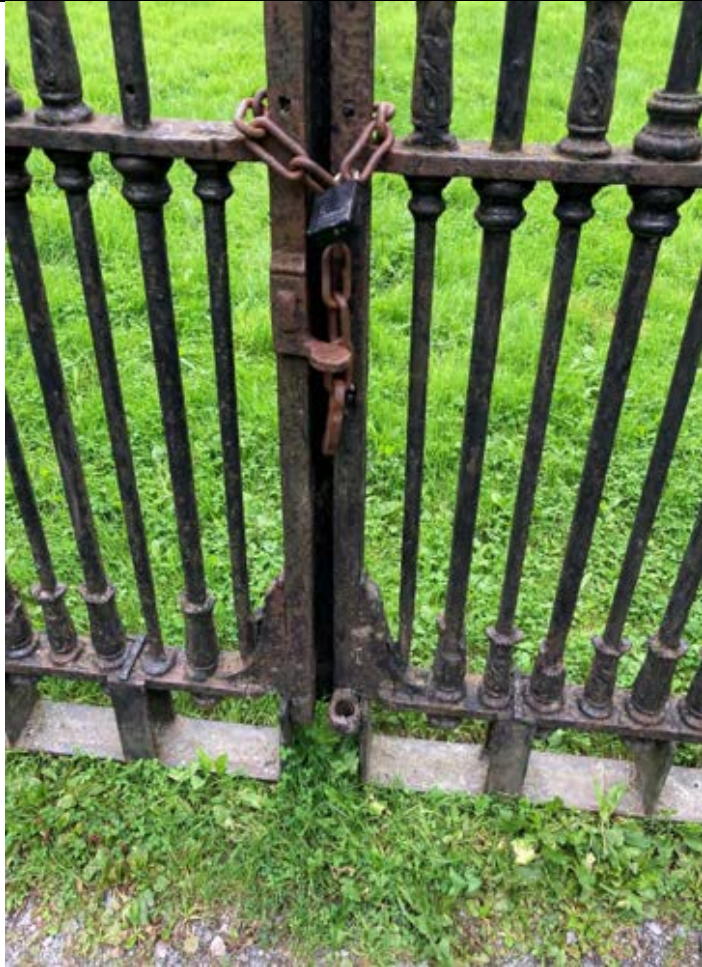
The gates are missing various decorative elements. The latch is also partially missing. Later steel additions have been added at the base.

Townland	Corlattan
Description	Walled garden built c.1830. 'Gateway broken through c.1860. Cut limestone piers to centre of south elevation either side of cast-iron vehicular gate, flanked by cast-iron railings, with arrow-head finials, on low plinth, rising to meet full height of garden wall... The symmetrical gated entrance to the south was intended to be appreciated approaching from the Yew Walk, which was planted south of the garden in the mid-nineteenth century, and it is likely the gated entrance may also date from this time.' Taken from NIAH entry. According to a worker on the site for several decades the current gates are from Dartree Estate. In front of the gates was a font that was demolished and filled in in the later half of the 20 <sup>th</sup> century.
Condition	Overall, the cast iron gates are in good condition. No leaning of the gates was noticeable. Some broken/missing decorative ironwork was apparent. Corrosion was also noticeable on some of the bars. The stone pillars and walls for the railings appear to be in overall good condition. However, there was inappropriate concrete pointing and repairs in the piers and bases for the railings. This may be leading to water ingress and stone damage. Some lime staining was noticeable.

Suggested Actions	<p><b>Maintenance and painting</b></p> <p>Observation: Regular need to paint and inspect</p> <p>Action: Repaint at least once every five years. Inspect annually. During the inspection, clean the iron with a cloth and water (use a bristle brush if needed for soiling). Paint with two coats of appropriate oil-based paint.</p> <p>Where localised corrosion has set in, remove loose material with scraper, clean to a bright finish and feather the edges of the old paint with abrasive paper. Larger areas of corrosion may require dry abrasive cleaning or chemical stripping (please note: flame cleaning is not appropriate). Treat derusted iron with rust neutralising inhibitor. Then paint area with 1-2 coats of zinc-phosphate primer, two layers of undercoat and two layers of topcoats.</p> <p>Final colour(s) used should match original paint scheme.</p> <p>Grease the pivot points to reduce wear.</p> <p>Keep ground pivot free of dirt.</p> <p>Timing: Short term</p> <p><b>Repairs to cast iron</b></p> <p>Observation: Areas of cast iron are in need of repair.</p> <p>Action: Repair cracks less than 6mm thick using cold stitching. Pitting in rusted cast iron can be repaired using epoxy car-body filler. Clean metal, apply rust inhibitor, apply epoxy filler, shape and rub down with abrasive paper to match contour. Then prime and paint to match surrounding.</p> <p>For simple breaks in cast iron and the metal in reasonable condition, in situ arc-welding repair is usually possible. Only experienced blacksmith or welding service should undertake this. The weld should be continuous, ground flat, primed and painted.</p> <p>Timing: Short term</p>

<p><b>Replacing missing elements</b>  Observation: Missing or heavily corroded cast and wrought ironwork  Action: Missing and heavily corroded elements will need to be replaced. This is particularly important for any elements required for the structure's weathering. Accordingly, replacements will have to be ordered to match what would have been there originally. Budget permitting, decorative features that have been lost should also be replaced.  Timing: Short term for pieces necessary for weathering of structure. Long term for purely decorative features</p> <p><b>Use of cement</b>  Observation: Extensive cement has been used in the stone piers and bases for the railings. This is likely to be causing damage to the wall.  Action: Replace cement pointing with appropriate lime mortar. Conduct lime mortar analysis to inform mortar specification.  Timing: Medium term</p>
Possible visitor experience actions	Refer to story of the gate as part of the wider interpretation concerning the walled garden and Yew Walk. Refer to this gate in the interpretation panel at the northwest gate (i.e. main gate).

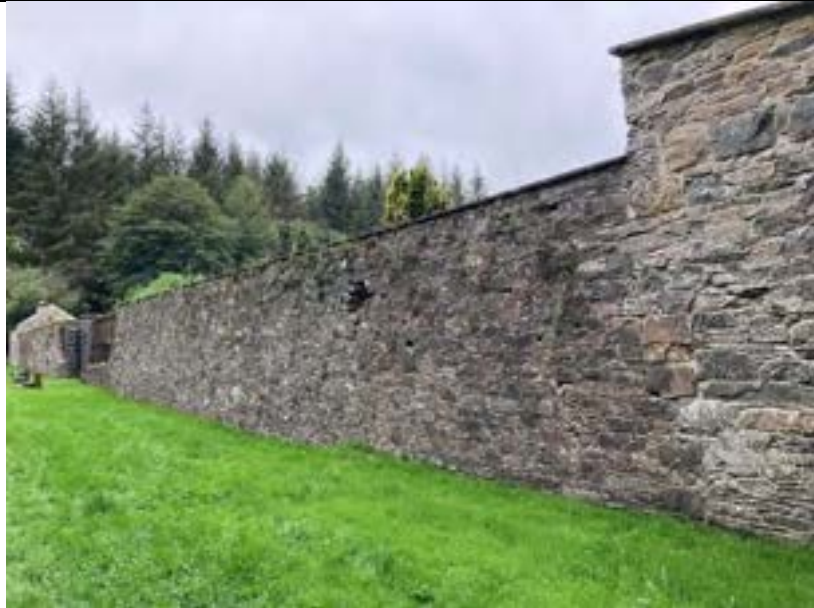
Southeast wall with main entrance. Several missing stones in the wall are visible.

Condition	<p>Little of the plant varieties that once grew in the garden still exist now.</p> <p>The random rubble limestone enclosure wall is in overall good condition. However, missing stones, failed pointing and concentrations of ivy growth were observed.</p> <p>Throughout the surveyed enclosure wall, associated buildings and other low walling, a high amount of concrete pointing was observed. The extensive use of cement has been to both the advantage and detriment of the walls. Although in the short term it had halted further degradation and vegetation growth, over time, it is leading to cracking caused by the cement being harder than the stone. This in turn is providing ledges for vegetation growth and access points for water. Water is also being retained within the wall. Concrete capping slabs were also observed.</p> <p>At the two storey, pitched roof structure a large crack was observed. However, the slate roof appeared in good condition.</p>

<p>Action: Carefully remove the any plants with woody roots. Insert appropriate stone infills and point with appropriate lime mortar as required. Timing: Short term</p> <p><b>Stone pointing</b> Observation: Failed/missing stone pointing is obvious. Action: Replace failed pointing throughout the bridge and associated retaining walls with appropriate lime-based mortar. Similarly, replace cement pointing judged to be causing damage to the structure with appropriate lime-based mortar. If possible and deemed to not be damaging to the structure, vegetation with non-woody roots (e.g. lichens, small ferns) should be retained. Conduct lime mortar analysis to inform mortar specification. Timing: Short term</p> <p><b>Missing stones</b> Observation: In certain locations walls are missing stones Action: Infill sections of missing stonework with matching. Take care to match existing coursing. Samples of existing mortar should be analysed to guide replacement mortar. Timing: Short term</p> <p><b>Concrete slab capping</b> Observation: The walls are capped with concrete slabs. Action: Remove concrete capping and replace with flat capping slabs of natural stone. Samples of existing mortar should be analysed to guide replacement mortar. Timing: Medium term</p>

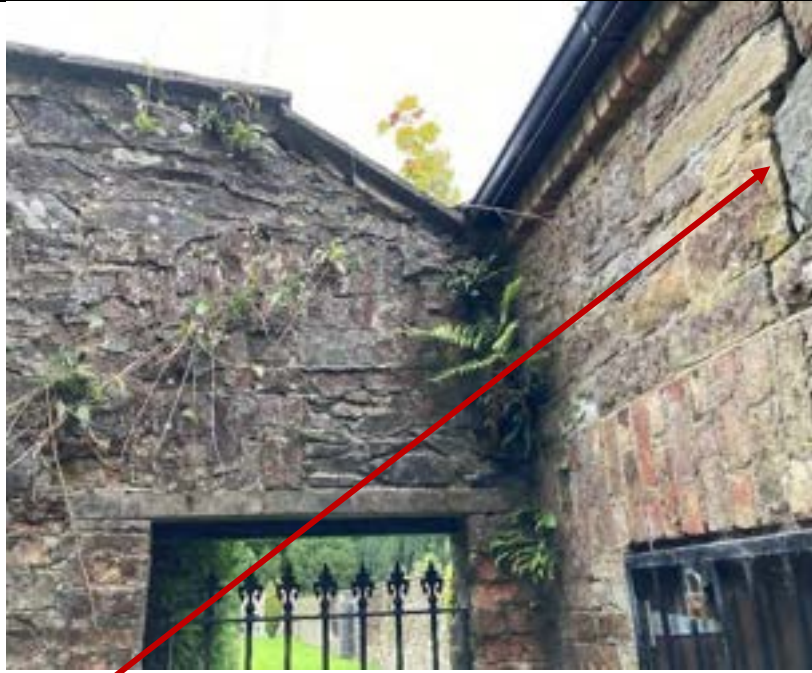
Large crack visible on two storey, pitched roof structure. Concrete pointing and capping also visible on the garden wall.

Suggested Actions	<p><b>Survey</b></p> <p>Observation: A complete structural survey by a conservation engineer is to be carried out. As part of the survey, the large crack noticed in the two-storey pitched roof structure should be inspected.</p> <p>Action: Inspection required from a conservation engineer to diagnose any issues and propose solutions.</p> <p>Timing: Short term</p> <p><b>Woody vegetation</b></p> <p>Observation: Vegetation with woody roots likely to cause damage.</p>

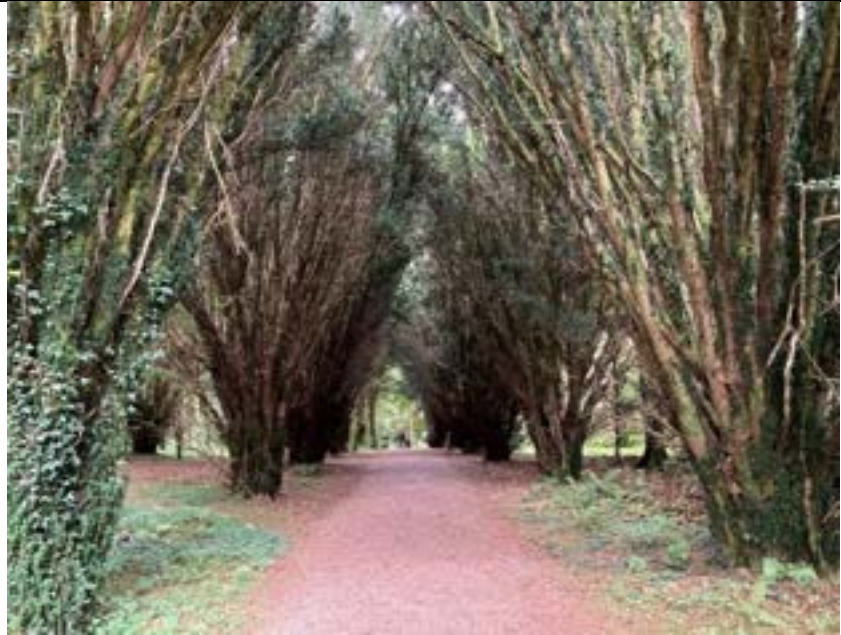
Ivy growth on the Yew

<p>Many of the trees have ivy growing on top of them. Ivy can act as a sail that breaks their branches. There also in direct competition with other trees nearby. Most of these neighbouring trees were planted by the Westensras or the state. There are also trees that have naturally germinated close to the Yew. In addition, to competing for nutrients and space, neighbouring trees may also cause direct damage Yews if they were to fall on them. However, although there is the risk of neighbouring trees falling onto Yew, the wholesale removal of trees may expose the Yew to greater wind forces.</p>
Suggested Actions	<p><b>Arborist survey</b>  Observation: Although Yews may be very long lived, the health of the Yews at Rossmore needs to be monitored to guide their management.  Action: Arborist with experience in ancient trees to survey the Yews every five years and advise on management.  Timing: Short term</p> <p><b>Ivy growing on the Yew trees</b>  Observation: Ivy can act as a sail that breaks the branches of the Yew trees. Although ivy does have habitat value, especially during winter, the presence of ivy on the yews in Rossmore is detrimental to the survival of the yews.  Action: Control ivy growth on the Yew trees. Be careful not to damage Yew branches. Any work is to be done from September to February.  Timing: Short term</p> <p><b>Neighbouring trees</b>  Observation: Neighbouring non-Yew trees competing for nutrients and space with the Yew. May also be a direct risk of collapse onto Yew.  Action: Obtain advice from an arborist with experience in ancient trees on the strategic removal of neighbouring trees judged to be negatively impacting onto the Yew.  Timing: Short term</p> <p><b>Growth management</b>  Observation: Yews often spread out. Limbs that touch the ground may take root. This aids stability.  Action: The best policy is non-intervention with as little pruning as possible (Ball, 2014). Only prune to abate structural defects or control branches seriously impinging on the walkway. This should only be done by a tree surgeon with experience managing ancient trees. No trees are to be pollarded, lopped or topped.  Timing: Medium term</p> <p><b>Compaction</b>  Observation: Yews have shallow roots. The presence of a path and compaction caused by visitors may cause damage. Climbing may also cause damage.</p>

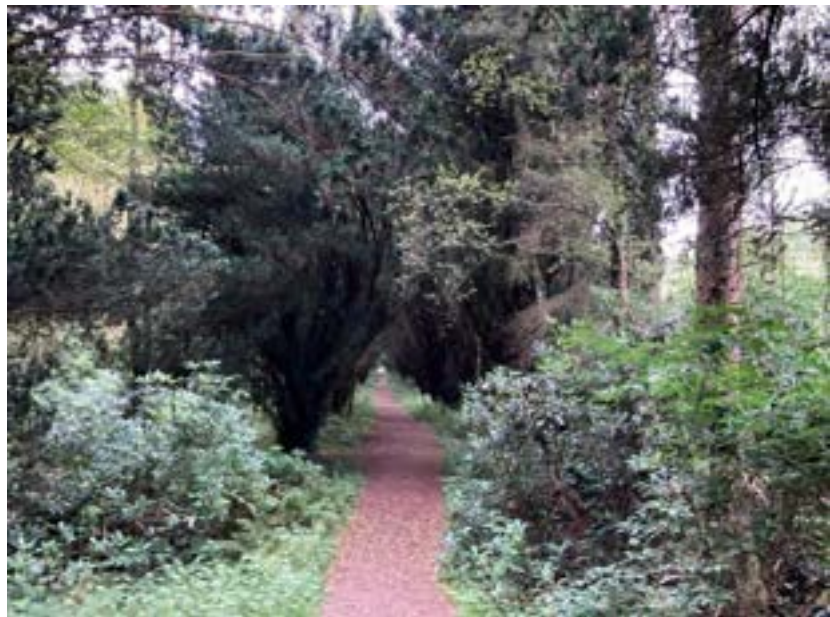
The Yew are in competition with trees planted by the Westenras and the state. There are also trees that have naturally germinated close to the Yew.

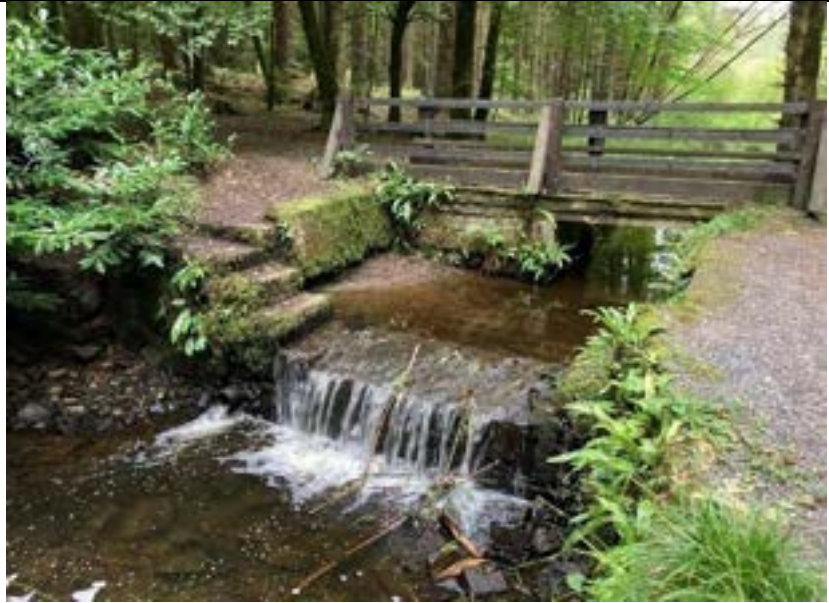
Weir just upstream from the dam. Vegetation growth and water erosion visible on retaining walls

Suggested Actions	<p><b>Survey</b>  Observation: The presence of substantial flow of water requires an appropriate survey by a conservation engineer.  Action: Conservation engineer to examine all walling, including the dam and ascertain the level of damage being done by water and vegetation. Appropriate repair and water control measures are then to be specified.  Timing: Immediate</p> <p><b>Ram drum</b>  Observation: Rare Ram drum still in situ and requires survey from conservation engineer.  Action: Conservation engineer to survey ram drum and immediate surroundings to provide advice on future conservation. A key question to be answered is if the ram drum can be conserved on site or is best moved to a location such as Monaghan County Museum or the proposed new visitor/interpretive centre for the park.  Timing: Short term</p> <p><b>Vegetation</b>  Observation: Risk of vegetation with woody roots causing damage.  Action: Carefully remove any plants with woody roots (i.e. ivy, saplings) either on or close to the structure that is currently causing or likely to cause damage. To remove large plants cut them off at the roots. To</p>

<p>kill the roots, use a “cut-and-paint” technique: where the plant is cut and the cut surface is then painted with an appropriate herbicide. Fill resulting gaps in the wall as needed with appropriate with appropriate mortar. Where deemed possible and appropriate, retain any vegetation that does not have woody roots. Ensure that site is not overwhelmed by vegetation. Timing: Short term</p> <p><b>Managing debris obstructing access</b> Observation: Excessive debris on or close to the dam and ram making surveying and repair works difficult. Action: Any debris impeding inspection of ram and dam should be removed, with hand tools if necessary. This will also facilitate maintenance. Timing: Short term</p> <p><b>Repointing</b> Observation: Pointing required. Action: Much of the pointing in various walls is now missing or failing. This allows water into the structure and provides locations for vegetation growth. Retain sound historic pointing. Where pointing has failed, rake out. Retain any pinning stones for later use. Remove vegetation matter and decayed mortar. Samples of decayed mortar should be analysed to guide replacement mortar. Repoint with lime mortar mix to match appearance of original. Use pinning stones and suitable replacement stones as required. Where existing concrete pointing is judged by a conservation engineer to be only causing no/minimal damage to the wall or its removal will cause more damage than it would solve, it should be retained. Only remove concrete pointing has been judged to be causing significant damage. Repoint with appropriate lime-based mortar. Timing: Short term</p> <p><b>Rebuilding gaps in the masonry along the quays</b> Observation: Missing masonry leading to a weakened quay wall and water ingress which in turn pushes out more stonework. Action: Any gap should be filled with stonework preferably recovered from the site. Single fallen stones should also be reinserted. All stonework should be set in an appropriate lime mortar. Any localised rebuilding should be done to match known historic coursing and coping. Area behind the wall should be infilled with material to match surrounding. Timing: Short term</p> <p><b>Rebuilding gaps in the masonry in freestanding walls</b> Observation: Missing masonry leading to a weakened freestanding walls and water ingress which in turn pushes out more stonework. Action: Any gap should be filled with stonework preferably recovered from the site. Single fallen stones should also be reinserted. All stonework should be set in an appropriate lime mortar. Any localised rebuilding should be done to match known historic coursing and coping.</p>

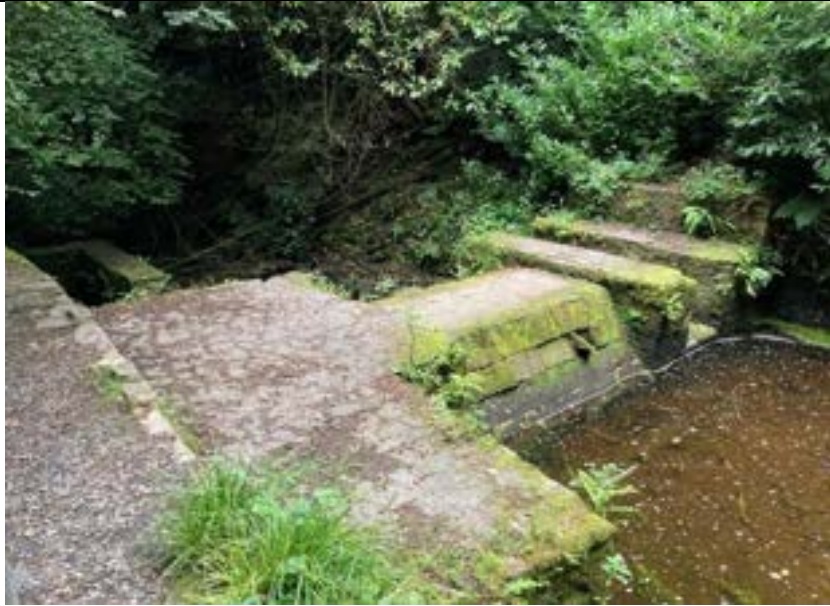
Dam with dislodged ashlar stones

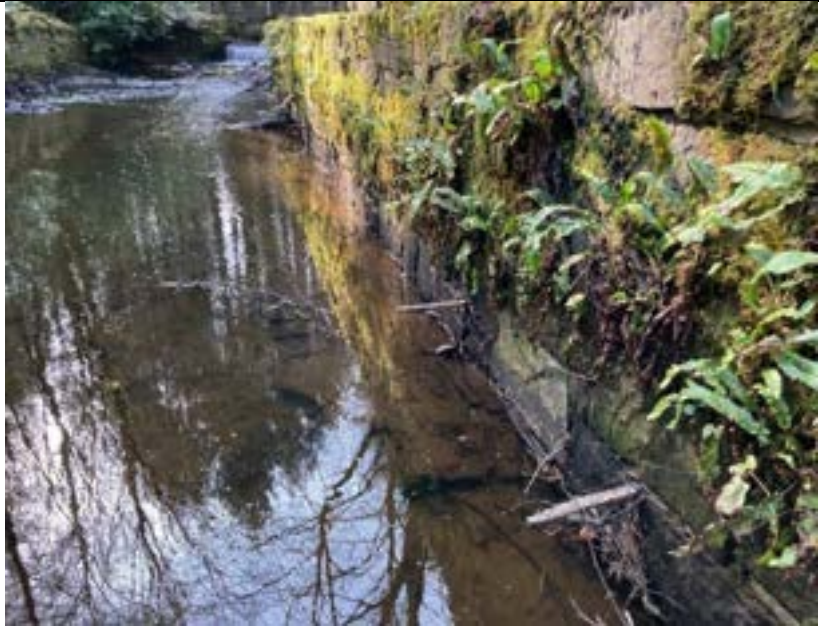
Iron brackets for piping

<p>Subject to an inspection by a conservation engineer, grouting of sections of wall may be warranted. Timing: Short term</p> <p><b>Maintenance and painting of brackets and gate</b> Observation: Regular need to paint and inspect gate and brackets Action: Repaint at least once every five years. Inspect annually. During the inspection, clean the iron with a cloth and water (use a bristle brush if needed for soiling). Paint with two coats of appropriate oil-based paint. Where localised corrosion has set in, remove loose material with scraper, clean to a bright finish and feather the edges of the old paint with abrasive paper. Larger areas of corrosion may require dry abrasive cleaning or chemical stripping (please note: flame cleaning is not appropriate). Treat derusted iron with rust neutralising inhibitor. Then paint area with 1-2 coats of zinc-phosphate primer, two layers of undercoat and two layers of topcoats. If known, final colour(s) used should match original paint scheme. Otherwise, another historically appropriate colour should be used. Grease the pivot points of the gate to reduce wear. Ensure brackets are securely fitted to quay walling. Timing: Short term</p> <p><b>Legal Protections</b> Observation: The hydroelectricity and water pumping scheme at Rossmore exhibits more than enough technical sophistication to warrant the listing of all its main elements (dam/ram, engine house, tank) as a protected structure Action: Include the dam/ram as a protected structure in the next County Development Plan. Timing: Medium term</p>
