# Rossmore Forest Park Built Heritage Conservation Management Plan

## 1.1 Introduction

The objective of this document is to provide heritage advice on the appropriate conservation and management of the built heritage assets in Rossmore Forest Park. This report was jointly commissioned by Cavan County Council and Monaghan County Council. It is an action of the Rossmore Masterplan.

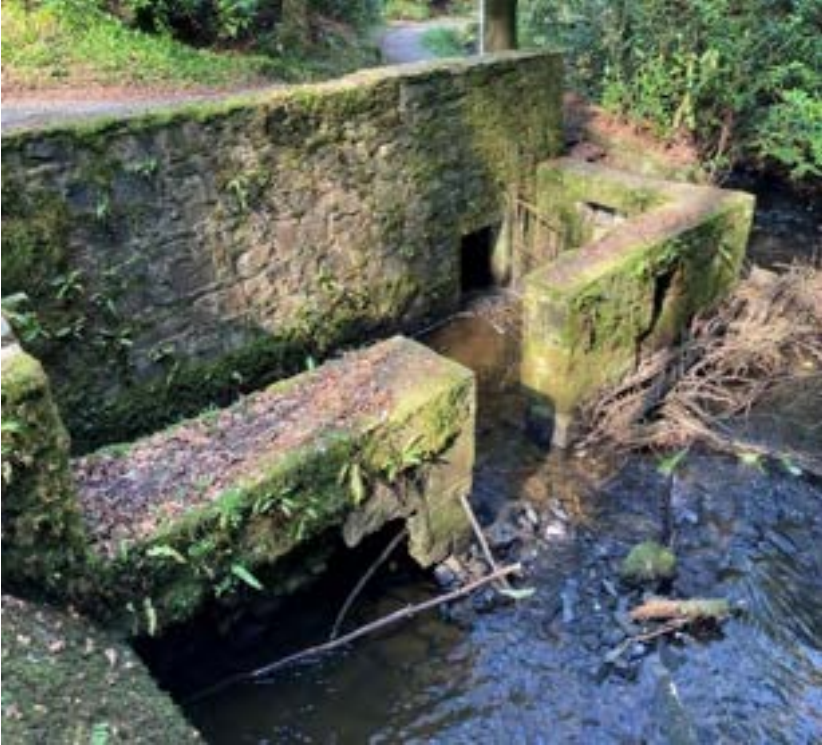
Ram drum is still present. Simple gate still survives. Area contains a large amount of debris.

Severe degradation of walling caused by water erosion
Coordinates	54°13'24.2"N 6°59'44.4"W
Townland	Kilnamaddy/Corlattan
Description	<p>As the the 19<sup>th</sup> century progressed, so did the water needs of big houses such as Rossmore Castle. In order to provide sufficient water for baths, laundries and toilets, a larger scale intervention was needed. In the case of Rossmore Castle, the answer was a hydraulic dam and ram (Carson, 2009).</p> <p>'Hydraulic dam and ram, constructed c.1880. No longer in use. Coursed rubble and cut limestone walls to channel to south of concrete, hemispherical dam wall, and to walls of channel leading to drop to lower level of river to east. Coursed rubble limestone walls to north-east containing square-headed opening with wrought-iron gate in abutment wall. Associated hydraulic ram (not accessible at time of survey) believed to be contained within abutment wall. Rubble stone steps to lower level of river from north-east bank. Series of former sluice gates from west and south-west. Coursed rubble sluice wall, some with socket for timber sluice gate, some with remains of wrought-iron sluice gate fixings. Dam located to south-east of remains of Rossmore Castle and walled garden, on bend of river flowing from west to north.</p> <p>The hydraulic dam and ram are located to the east of the remains of Rossmore Castle and are marked on the 1908 Ordnance Survey map as 'Hydraulic Ram'. Rossmore Park, now in the ownership of Coillte, is arguably one of the most interesting demesne complexes in the county of Monaghan. The demesne also contains gates and lodges, a mausoleum, bridges, walled garden, and wells. In addition, the park has the remains of some pioneering engineering features, many named on the 1908 map, including a pumping works, a gas works, and of course this hydraulic dam and ram, used for generating</p>

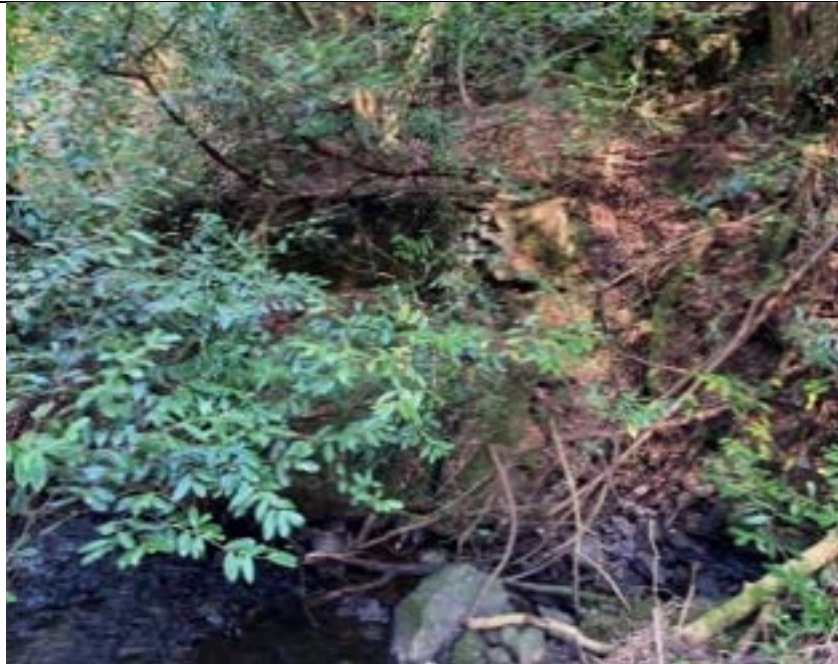
The beginnings of the mill race. Photo taken from dam.  
Taken from dam, beginning of mill race. Section missing that connected with stream.

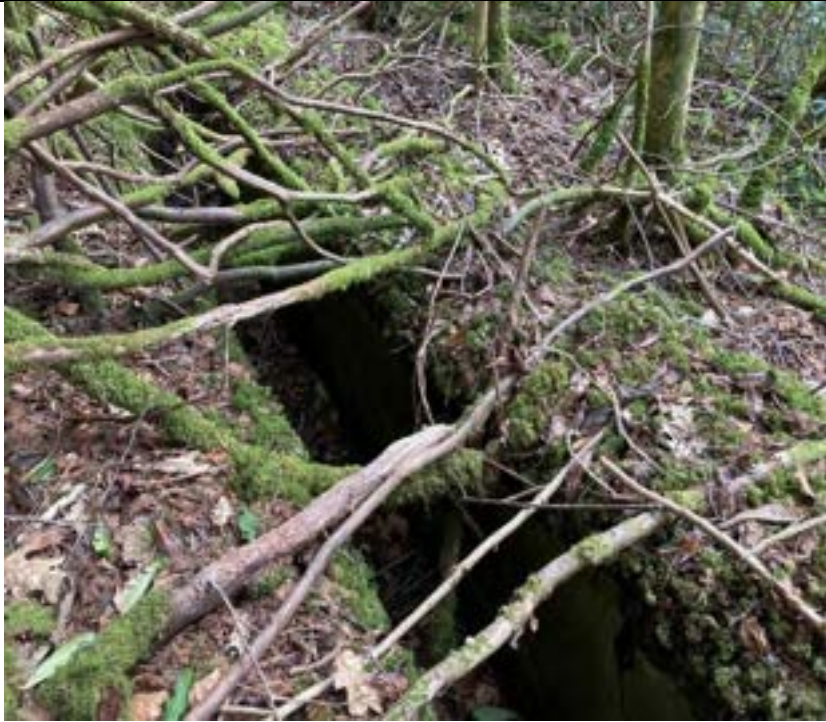
Inside the mill race are rendered walls

<p>failed. This showed that the race was of random rubble masonry construction. The exposed areas were degrading.</p>
Suggested Actions	<p><b>Survey</b>  Observation: The interaction between historic render and stonework requires attention by a conservation engineer. Due to access issues, only small amount of the mill race was surveyed.  Action: A full survey of the structure by a conservation engineer is required to assess condition and specify a full programme of appropriate repairs.  Timing: Short term</p> <p><b>Managing debris and vegetation obstructing access</b>  Observation: Excessive vegetation and debris on or close to the mill race making surveying and repair works difficult.  Action: Any debris or plant growth impeding inspection of the mill race should be removed, with hand tools if necessary. This will also facilitate maintenance.  If cleaning of render is eventually deemed necessary, the only cleaning permitted on the marker should be the careful removal of moss or other excess vegetation with a stiff natural bristle or nylon brush (not wire) or wooden spatula. Warm water may be used with the bristle brush if necessary.  Timing: Short term</p> <p><b>Vegetation</b>  Observation: Vegetation with root woody roots causing damage.  Action: Carefully remove any plants with woody roots (i.e. ivy, saplings). To remove large plants cut them off at the roots. To kill the roots, use a "cut-and-paint" technique: where the plant is cut and the cut surface is then painted with an appropriate herbicide. Fill resulting gaps in the wall as needed with appropriate mortar, limestone, and render to match surrounding. Where deemed possible and appropriate, retain any vegetation that does not have woody roots.  Timing: Short term</p> <p><b>Legal Protections</b>  Observation: The hydroelectricity and water pumping scheme at Rossmore exhibits more than enough technical sophistication to warrant the listing of all its main elements (dam/ram, mill race, engine house, tank) as a protected structure  Action: Include the mill race as a protected structure in the next County Development Plan.  Timing: Medium term</p>

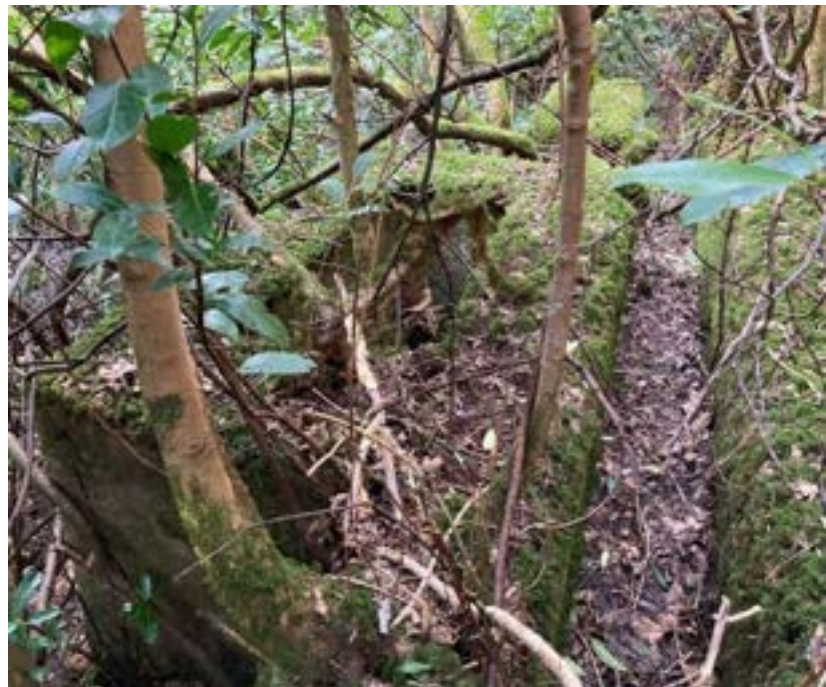
Roughly half way along the mill race is this structure. A previous long-term worker on the site speculated that it could have been the location of another ram associated with pumping water.

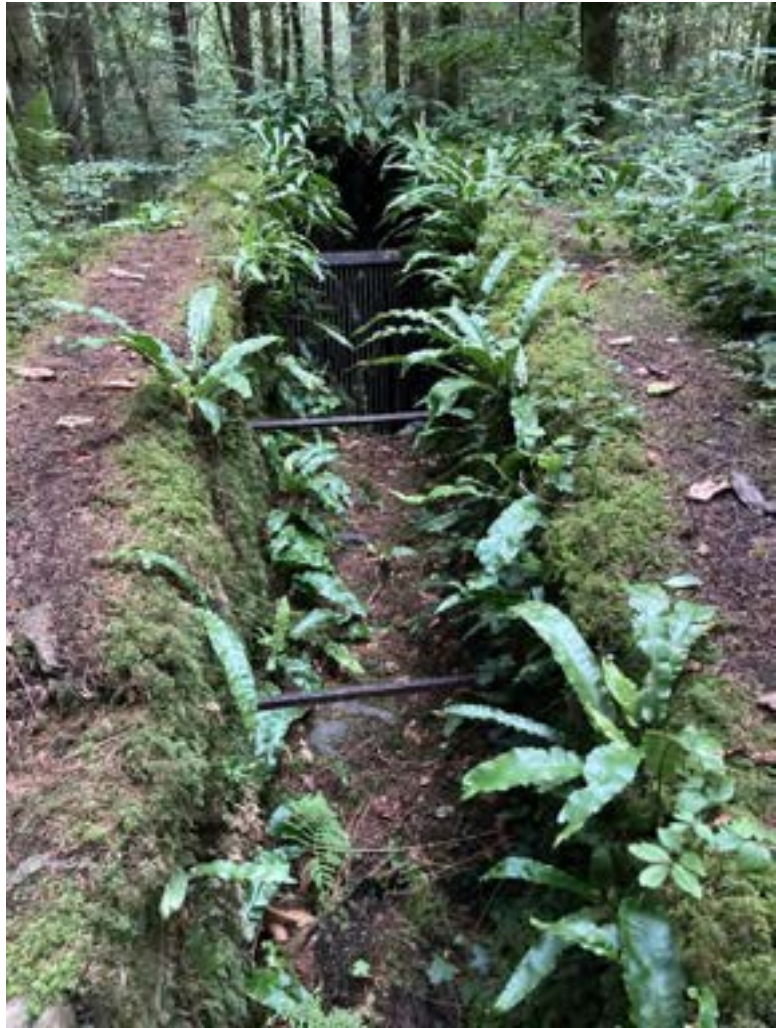
Iron bars and screed

<p>of the north west wall. The screed separated debris from the water. The water then flowed down an iron pipe and fed the turbine at the engine house. Remnants of a circular iron pipeline were found during the survey for this report going in the direction of the pump house. Interestingly, the pipe from the tanks to the Engine House is not indicated on the historic 25" OS map. Located in woodland.</p> <p>An interesting second hand story told by someone who had worked at the site for several decades was about when the power failed a local boy having to go and clear debris from the screed in the tank to ensure there was a flow to the turbine below.</p>
Condition	<p>Good. The random rubble walls appear in good condition. The metal ties and screed are still intact. The large metal pipe is severely degraded. It is possible that much of the piping to and from the tank was removed for scrap. The wall core towards the southeast end is exposed with some minor collapse visible. There is significant vegetation growth at the wall heads and interior of the walls. Some cracking was also visible in the rendered walls.</p>

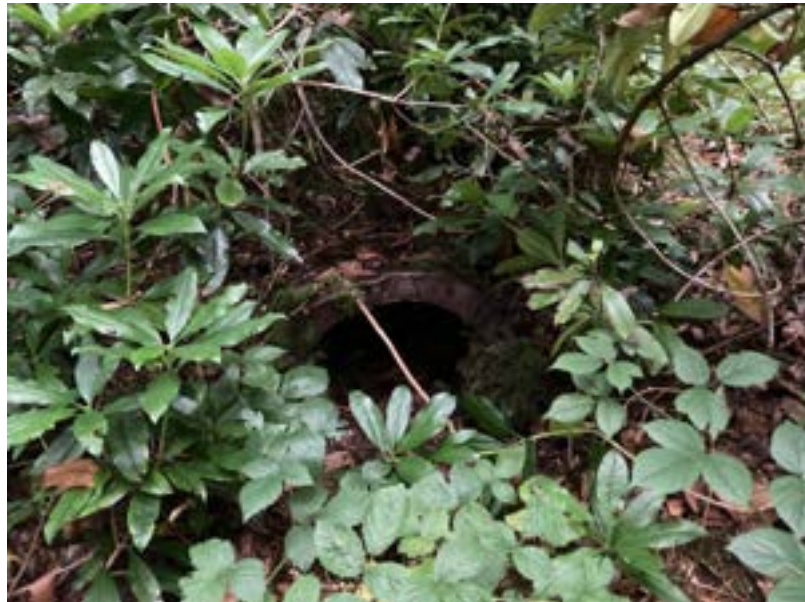
Rendered walls with cracking and vegetation growth

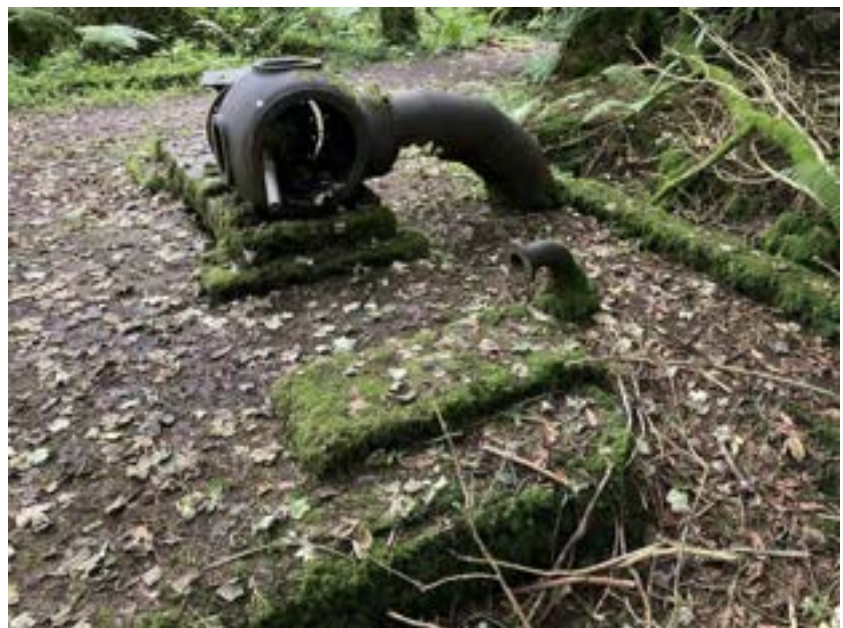
Pumping machinery in detail

Suggested Actions	<p><b>Painting the machinery</b></p> <p>Observation: External of exposed machinery requires protection through painting.</p> <p>Action: Clean the metal with a cloth and water (use a bristle brush if needed for soiling). Paint with two coats of appropriate oil-based paint. Where localised corrosion has set in, remove loose material with scraper, clean to a bright finish or as best as reasonably possible. Treat derusted iron with rust neutralising inhibitor. Then paint area with 1-2 coats of zinc-phosphate primer, two layers of undercoat and two layers of topcoats.</p> <p>Final colour(s) used should match original paint scheme or historically appropriate scheme. Repaint at least every 5 years.</p> <p>Timing: Short term</p> <p><b>Machinery</b></p> <p>Observation: The machinery is exposed to the elements. Some of the machinery is corroding. Although painting will provide some protection, something more comprehensive is required.</p> <p>Action: Create a well-designed, architecturally contemporary protective structure over the existing machinery. This structure should also be used as a place to interpret the machinery and the whole of the hydroelectric scheme.</p> <p>Timing: Short term.</p> <p><b>Vegetation</b></p> <p>Observation: Vegetation obscuring features. Risk of vegetation with woody roots damaging the engine house.</p> <p>Action: Carefully remove any plants with woody roots (i.e. ivy, saplings). To remove large plants cut them off at the roots. To kill the roots, use a “cut-and-paint” technique: where the plant is cut and the cut surface is then painted with an appropriate herbicide. Fill resulting gaps in the wall as needed with appropriate with appropriate mortar.</p>

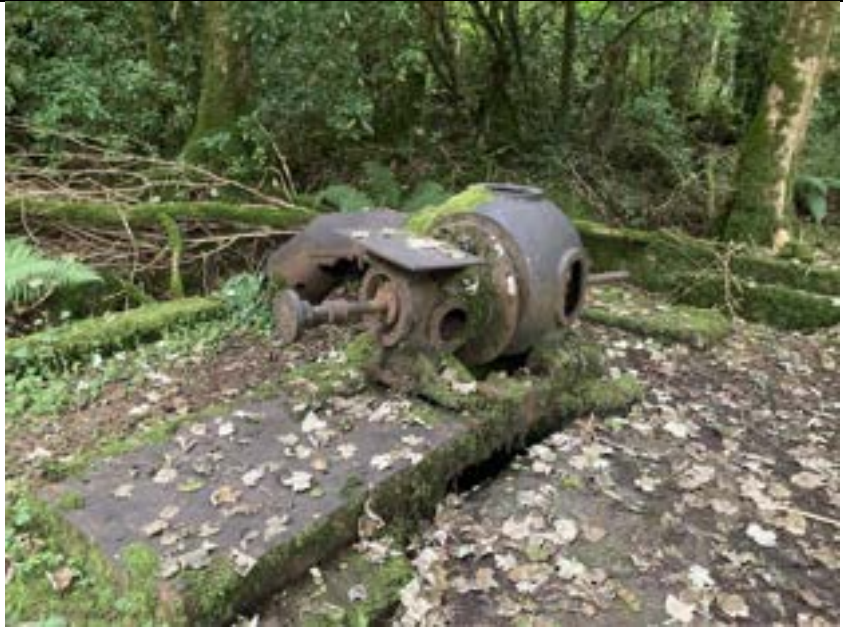
Pumping machinery in detail. Note corrosion on underside of large pipe which carried water from the tank to the south east up on the hill

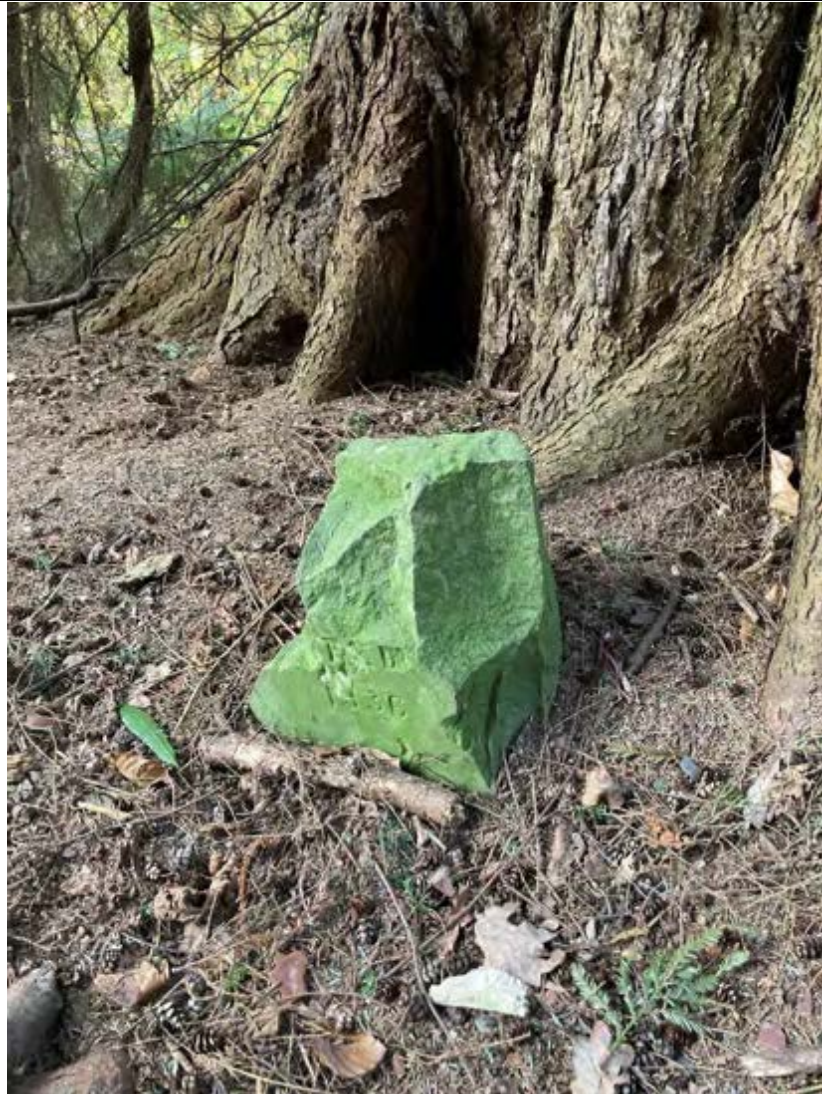
Smashed stone

Stone with associated tree immediately behind
Coordinates	54°13'36.0"N 6°59'41.3"W
Townland	Kilnamaddy
Description	Modest tree marker honouring Brigid Westenra (b.1928). Smashed. There is some fragmentary lettering and a date of 1936. Brigid was the daughter of the 6 <sup>th</sup> Baron Rossmore. Marker associated with pine tree immediately behind.
Condition	Poor. Apparently, the marker was deliberately smashed by someone. The fragments are not present nearby. The remaining marker is in reasonable condition.
Suggested Actions	<p><b>Managing debris and vegetation</b></p> <p>Observation: Managing vegetation and debris on or close to the memorial.</p> <p>Action: This is a maintenance action. The memorial should be monitored annually for the growth of vegetation and accumulation of debris. Any debris or plant growth in danger of obscuring the marker should be removed with hand tools if necessary to ensure that the marker is visible for visitors and accessible for inspection. If cleaning is eventually deemed necessary, the only cleaning permitted on the marker should be the careful removal of moss or other excess vegetation with a stiff natural bristle or nylon brush (not</p>

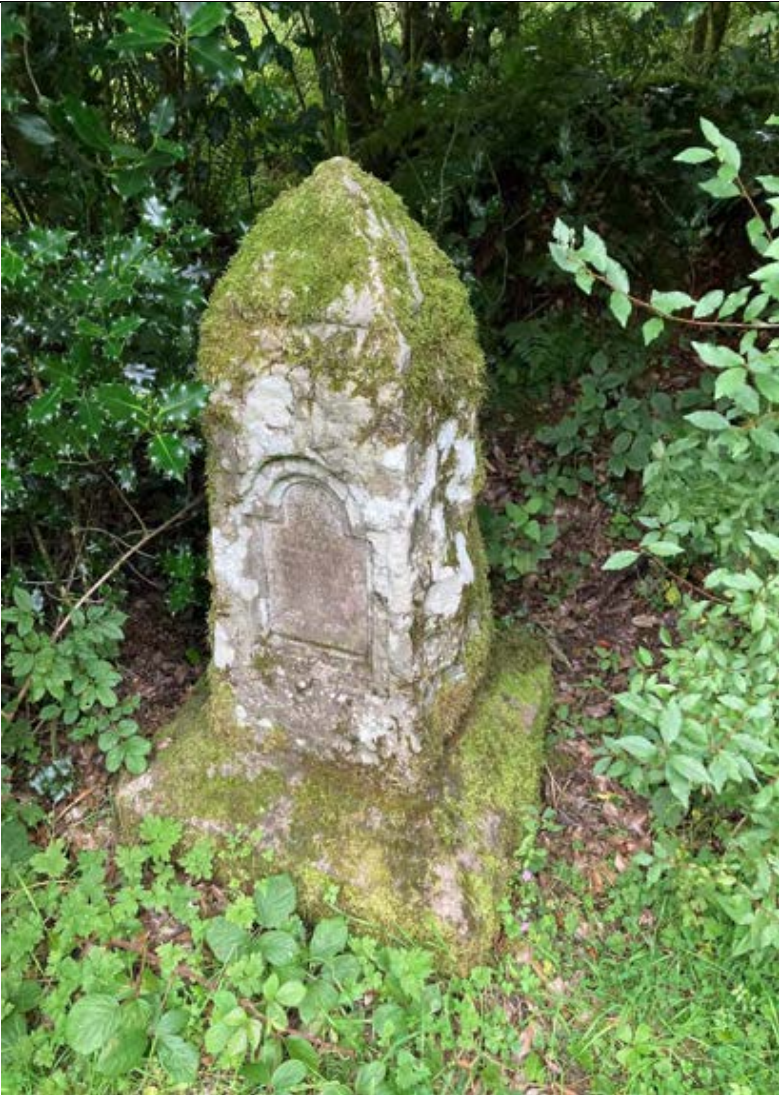
<p><b>44. Giant Redwood marker</b></p>

<p>The marker could easily become fully hidden from view by vegetation growth</p>
Coordinates	54°13'22.3"N 6°59'56.0"W
Townland	Corlattan
Description	Stone marker commemorating the planting of a Giant Redwood tree. Simple granite pillar with rough pyramidal top, positioned on stone plinth. Incised carved letters on one face only. The redwood no

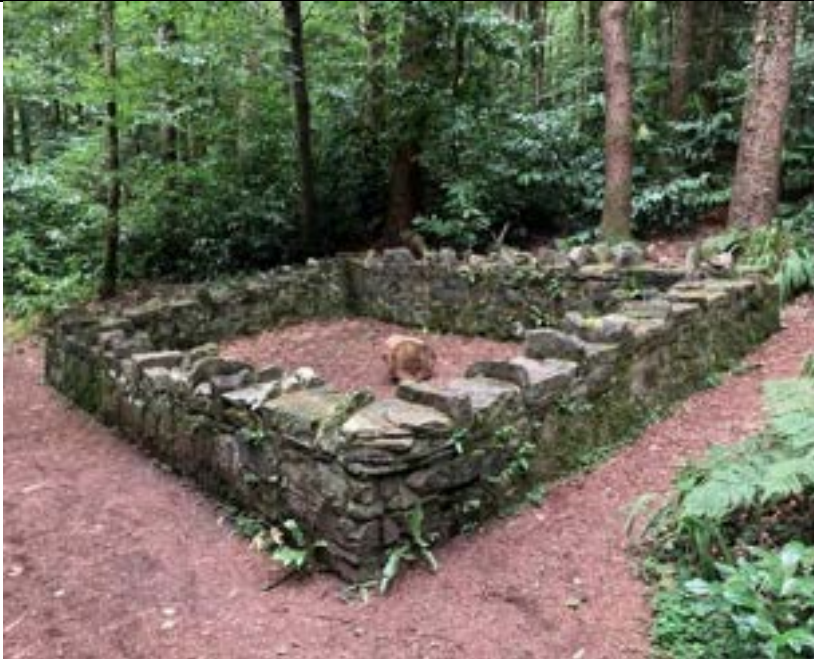
<p>Simple wall surrounds area of pet burials</p>
Coordinates	54°13'27.9"N 6°59'59.9"W
Townland	Corlattan
Description	Pet Cemetery for pets of the estate owners. Simple rectangular random rubble stone wall enclosing an area of pet burials.
Condition	Good overall condition with some area of disturbed stonework. Cement pointing used throughout.
Suggested Actions	<p><b>Enclosure wall</b></p> <p>Observation: Concrete pointing used in wall.</p> <p>Action: Remove cement pointing and replace with appropriate lime-based mortar. If possible and deemed to not be damaging to the structure, vegetation with non-woody roots (e.g. lichens, small ferns) should be retained.</p> <p>Reinstate any loose stonework and bed in appropriate lime-based mortar. Conduct lime mortar analysis to inform mortar specification.</p> <p>Timing: Medium term</p>
Possible visitor experience actions	The site would benefit from a well-designed and discretely located interpretive panel discussing the importance of pets to the estate's owners and the existence of pet cemeteries in estate grounds throughout Ireland.
