PROPOSED CHARLES GAVAN DUFFY PLACE

Rev	Issue Date	Description	App
Status: PLANNING			
Client: Monaghan County Council			
Project: Dublin Street South			
Drawing: Development to East Edge of CGDP Proposed Floor Plans & Elevation			
Scale: 1:100 @ A0			
McAdam ENHANCING LOCAL COMMUNITIES			
Contact Details		16 Montgomery House 478 Castleberg Road Belfast, BT5 6BQ	T: 028 9040 2000 E: admin@mcadamdesign.co.uk www.mcadamdesign.co.uk
Drawn: mcc Date: 23/11/23	Checked: eh Date: 23/11/23	Approved: mcc Date: 23/11/23	
Project Number: A2156	Drawing Number: 200-102	Revision: -

Design Statement - Architecture

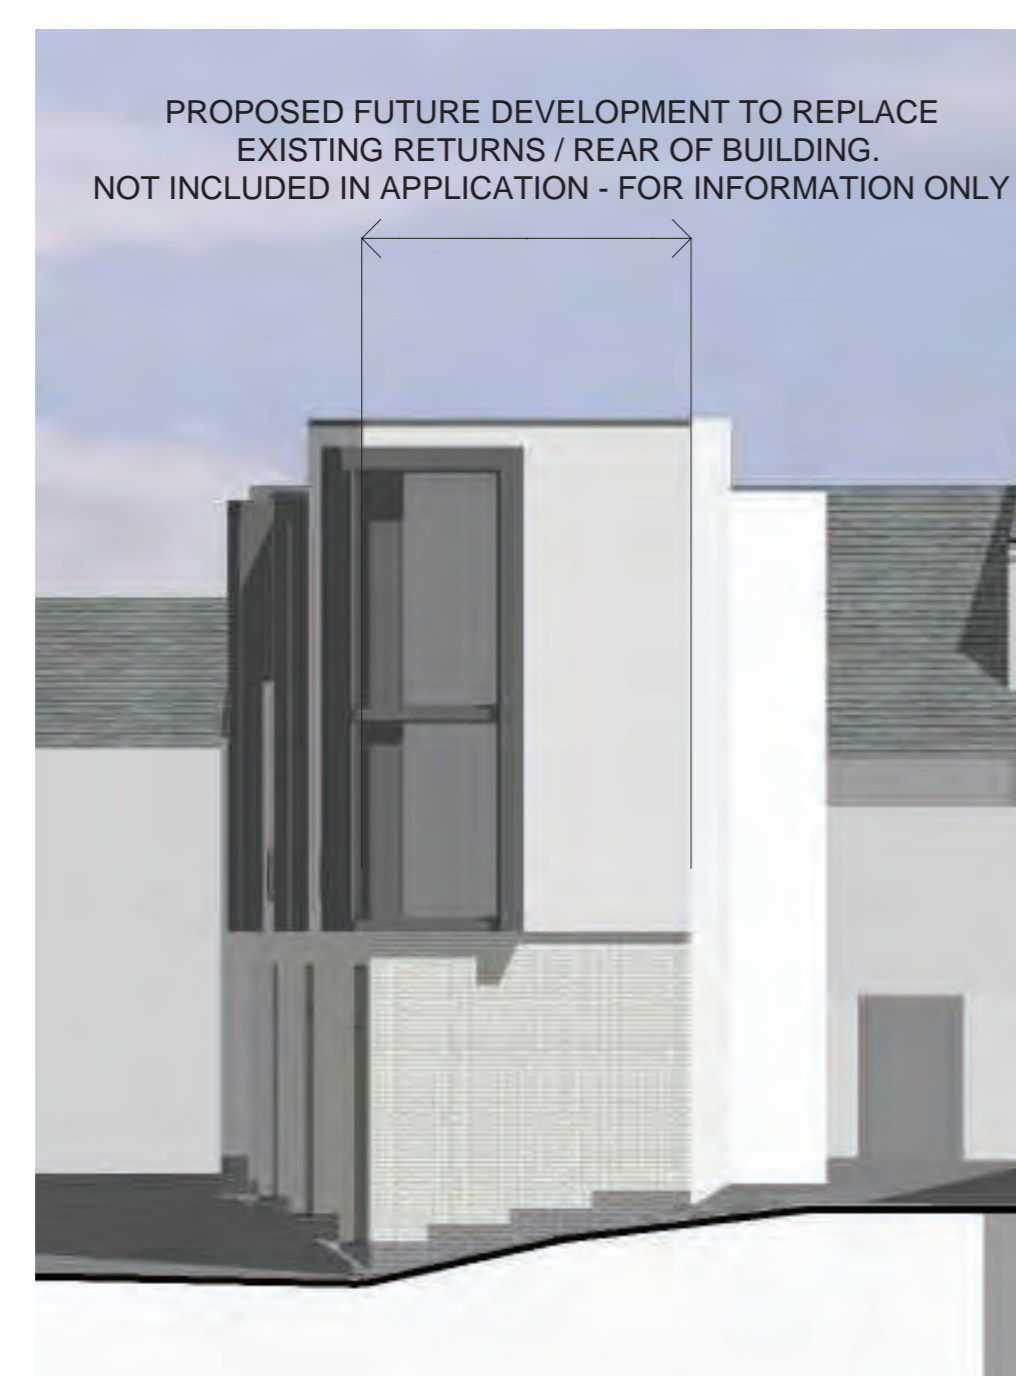
PROPOSED SOUTH ELEVATION
SCALE 1:100

PROPOSED FUTURE DEVELOPMENT TO REPLACE EXISTING RETURNS / REAR OF BUILDING. NOT INCLUDED IN APPLICATION - FOR INFORMATION ONLY

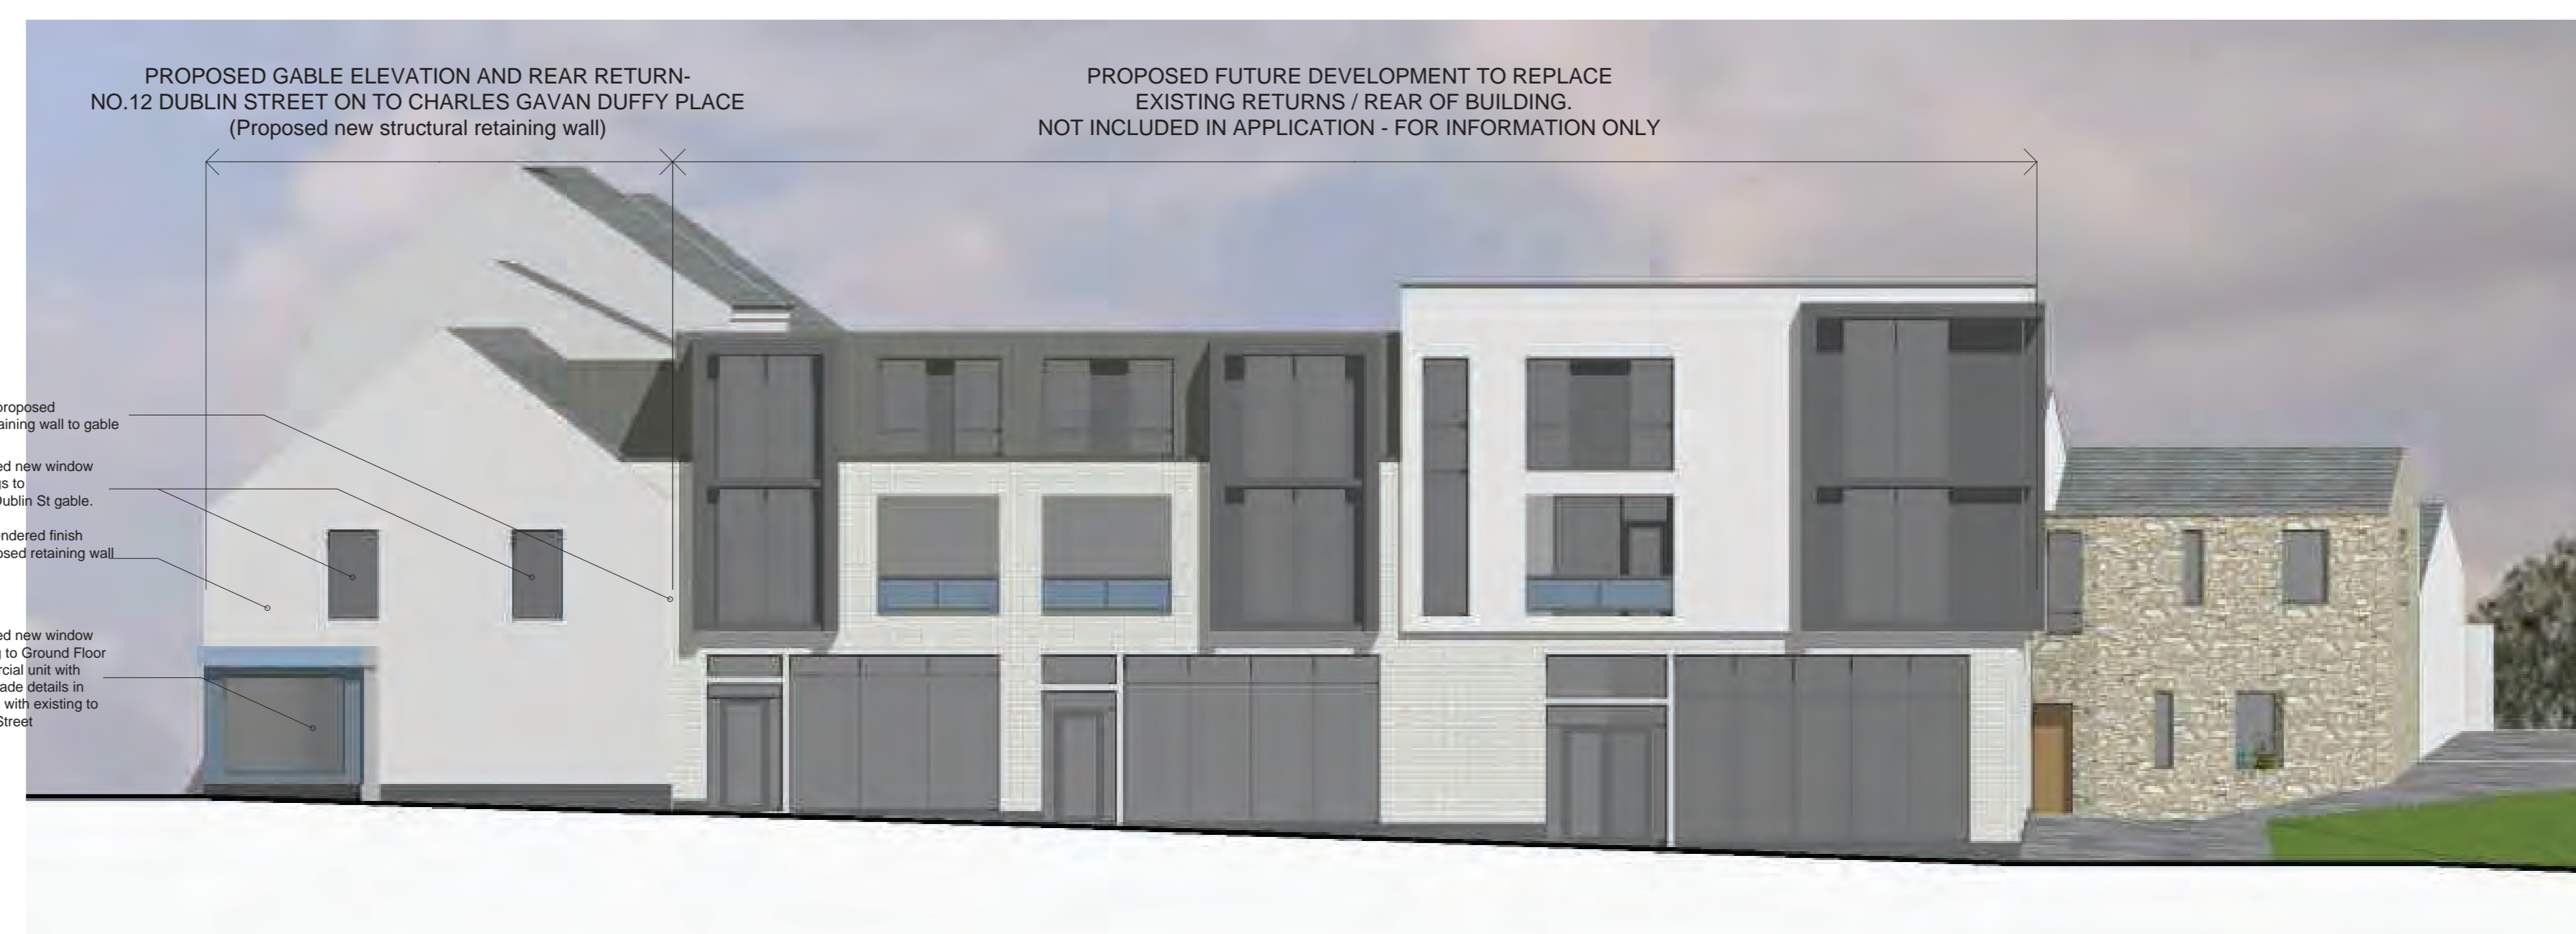
PROPOSED WEST ELEVATION
SCALE 1:100

PROPOSED GABLE ELEVATION AND REAR RETURN- NO.12 DUBLIN STREET ON TO CHARLES GAVAN DUFFY PLACE (Proposed new structural retaining wall)

End of proposed new retaining wall to gable
Proposed new window openings to gable, No.12 Dublin St gable
New floorboard finish to proposed retaining wall
Proposed new window opening to Ground Floor commercial unit with new facade details in keeping with existing to Dublin Street

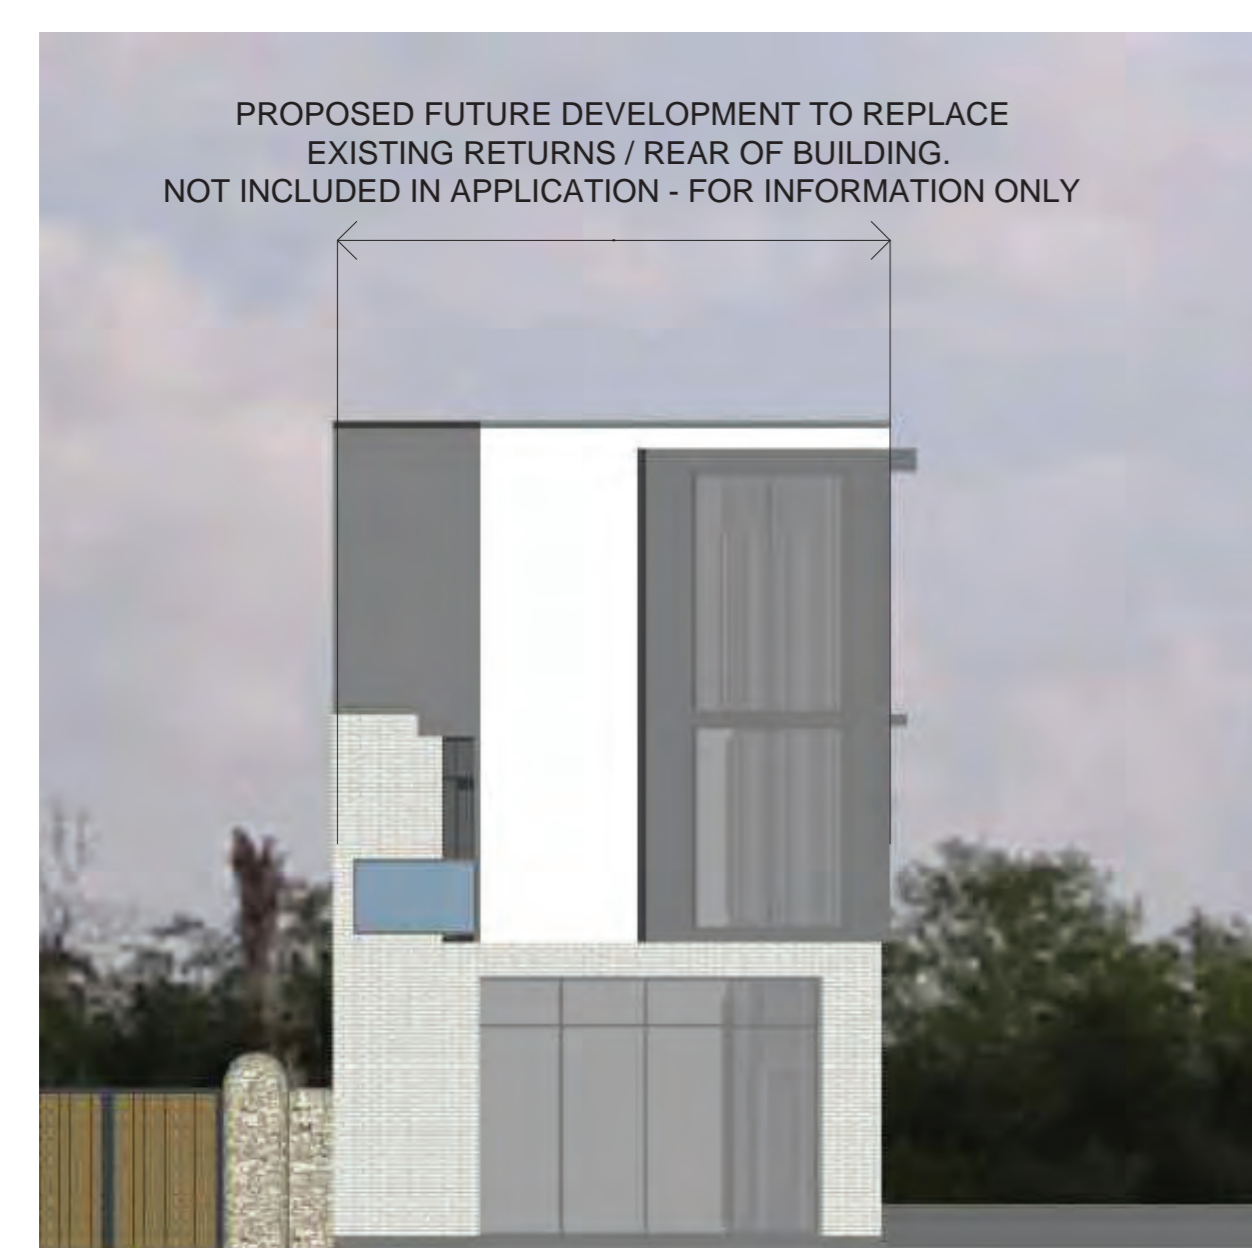
PROPOSED SOUTH ELEVATION
SCALE 1:100

- Render finish to new gable retaining wall
- Proposed new opening to First Floor Level
- Proposed recessed panel of timber panelling
- Proposed new entrance door to access First Floor Apartment.
- New roof structure to replace existing slate pitched roof, sides clad with standing seam jointed pre-patented zinc sheet
- Existing window opening retained with new window installed
- New retaining structure faced with light grey wirecut facing brick
- New commercial shopfront to No. 7 Dublin Street
- New shopfront window and door set in brick opening

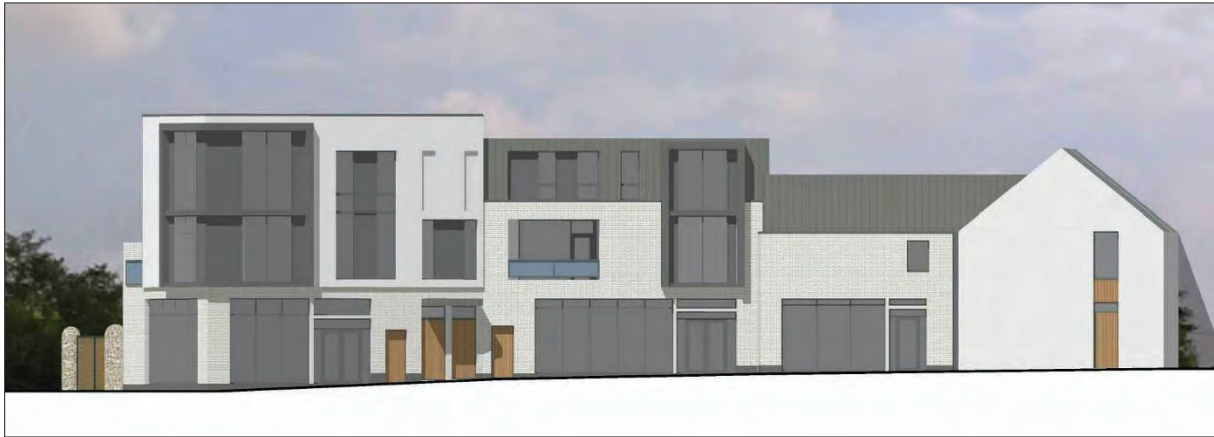
Proposed Elevations – Complimentary Contemporary Expression

Selection of high-quality durable materials with a palette of complimentary light neutral tones including:

- Light grey smooth wirecut clay facing brick.
- Mid-grey powder coated aluminium windows and shopfronts.
- Light toned render
- Mid grey pre-patinated zinc standing seam cladding.
- External doors in warm toned vertical hardwood strips

- Flat roof structure with vertical face clad in pre-patinated standing seam zinc panels to replace existing slate pitched roof.
3. New 3 Storey infill to replace existing 2 storey return structure set back from adjacent above to follow ownership boundary – brick façade to ground and first floors with shopfront ‘punched opening’. 2nd floor clad in pre-patinated standing seam zinc panels. Flat roof structure

4. New 3 Storey corner infill to replace existing single storey shed structure at different angle to adjacent above –ground floor brick façade with dual aspect with shopfront ‘punched openings’. 2 storey rendered façade to 1st and 2nd floors. Flat roof structure

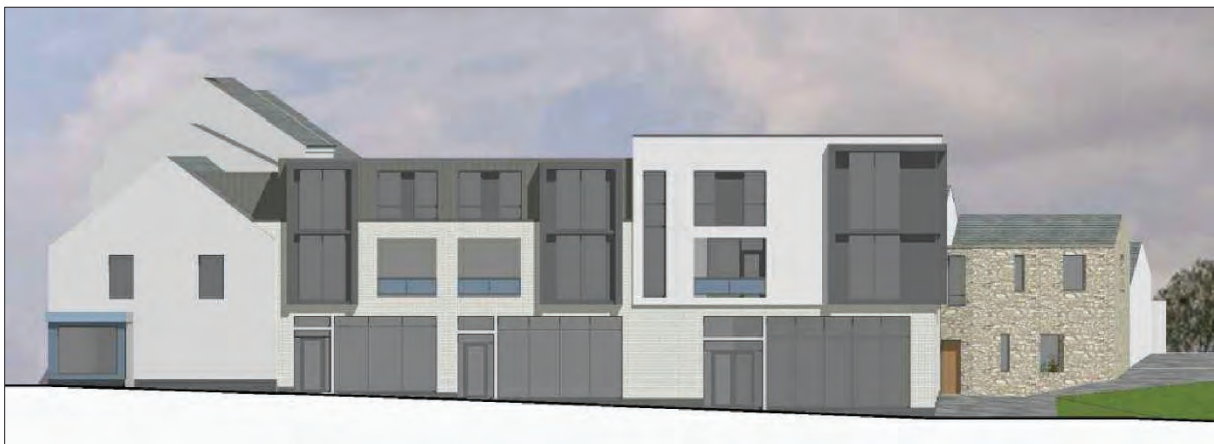
Proposed Elevations to East Edge of CGDP

The design approach to the eastern edge of CGDP is identical to the western albeit the terrace frontage is made up of 3 distinct components instead of 4.

In essence the new CGDP will be ‘book ended’ to Dublin Street by new retaining walled gables to the existing buildings either side of the new ‘opening’ and to the new Church Walk by 3 storey contemporary ‘gateway’ developments with rendered upper floors, punched openings and expansive double height corner glazed elements.

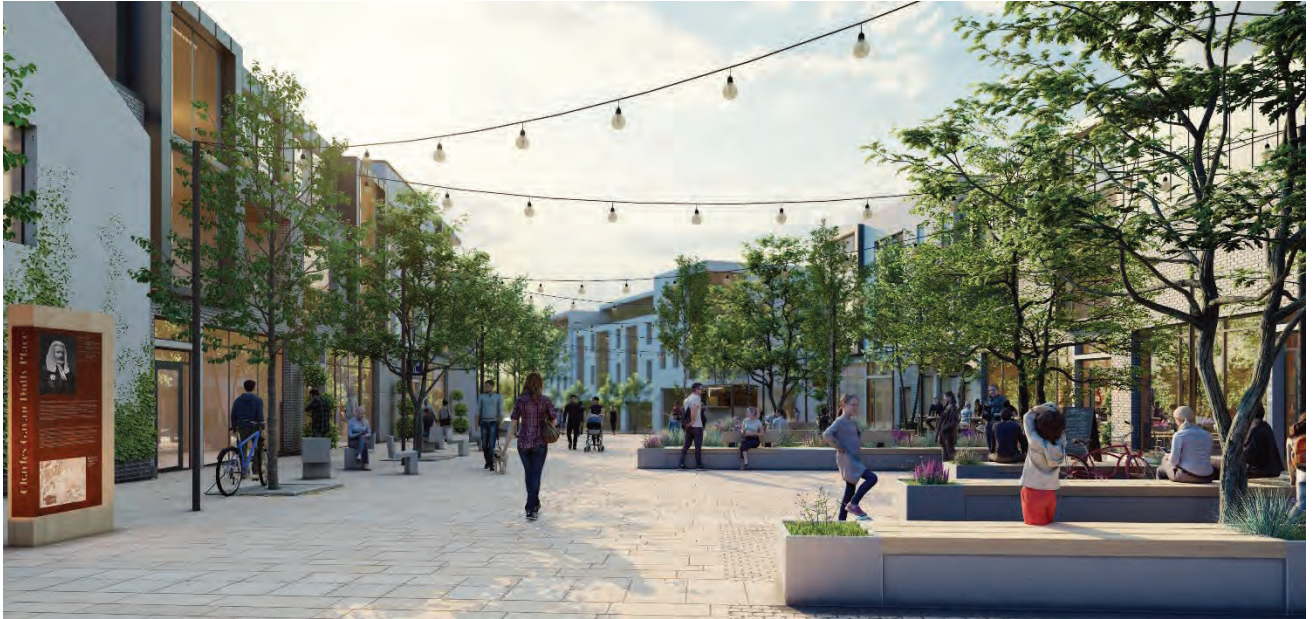
Visualisation showing proposals for Charles Gavan Duffy Place.

Charles Gavan Duffy Place will be a new fully pedestrianised public space connecting Dublin Street through to its 'backland' areas, opening up new sites for development and enhancing pedestrian linkages throughout this area. The new public space is formed by the demolition of existing structures fronting Dublin Street and their associated 'backland' areas. The proposals focus on fully pedestrianised high quality public realm, encouraging activity, social interaction and providing connections into a new reimagined urban place. New building frontages to the north and south provide a strong urban form, bringing animated edges and natural surveillance to the new space.

Charles Gavan Duffy Place will benefit from a southerly orientation and will increase light onto Dublin Street. This area is intended as a multi-use space that can host events, open-air markets, pop-up commercial/retail uses, or occasional festivals. Vehicular access will be restricted to deliveries to commercial premises and waste collection for residential and commercial units. The proposed space creates a new setting and enables new opportunities for future infill development and reuse / adaptation of existing underutilised buildings on either side of the new space, creating opportunities for new commercial and residential activity. The Dublin Street Regeneration Plan 2017 suggested this area might be known as 'Charles Gavan Duffy Place'. It is proposed that this space will be dedicated to Charles Gavan Duffy, in recognition of his historical connections to this area, with aspirations to provide an appropriate high quality 'totem' information sign commemorating Charles Gavan Duffy.

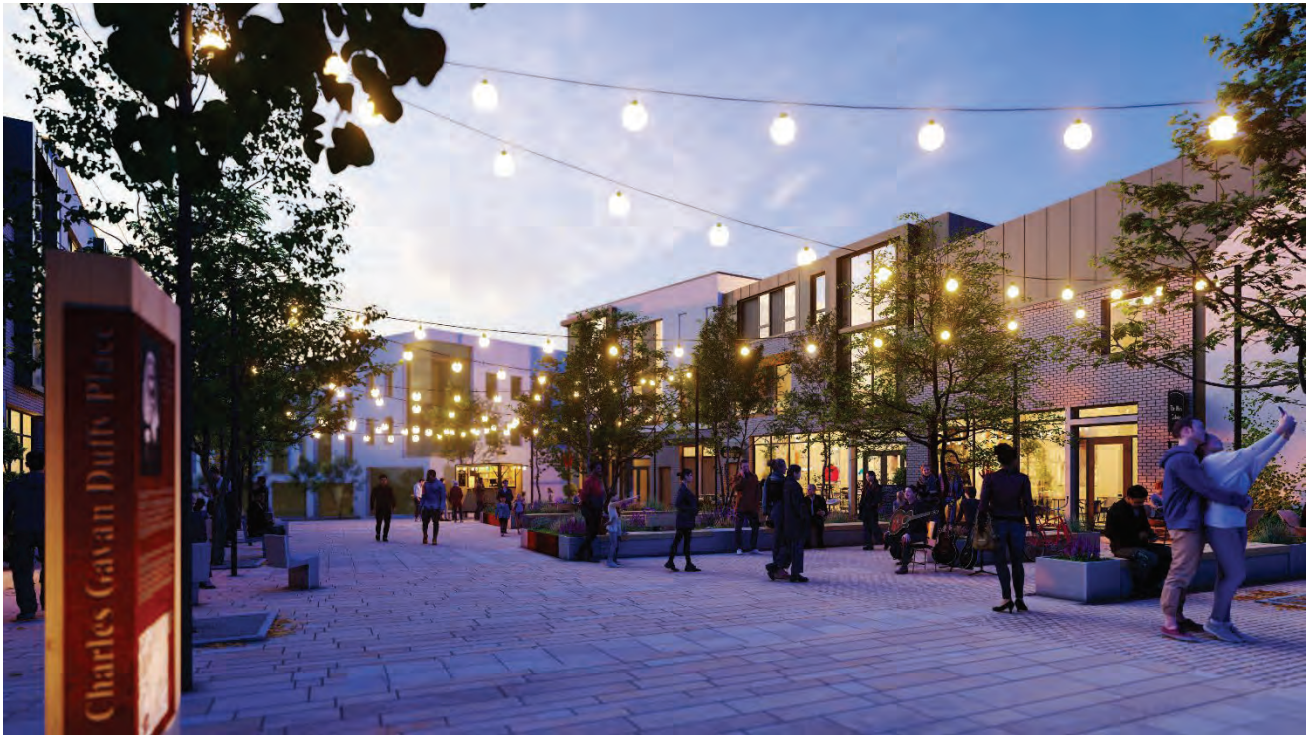
Charles Gavan Duffy Place will be defined through warm toned natural stone paving, using a variety of surface textures and unit sizes to add detail and interest. This warmer toned paving will complement the surfaces used within the streets and alleyways, but will be unique within the area, marking Charles Gavan Duffy Place as an important space for Monaghan. Mature tree planting, raised planters and seating elements provide spatial definition, introducing edges for people to sit against and creating zones along the edges for café / bar spill out. The raised planters will contain a range of multistem trees, shrubs, ornamental grasses, perennials, and bulbs to provide seasonal colour and variety, and to enhance biodiversity. Lighting is provided throughout including 'catenary' lighting strung between carefully placed columns. This assists in creating a welcoming environment after dark and creates a human scale 'ceiling' within Charles Gavan Duffy Place.

Catenary lighting in Charles Gavan Duffy Place enhancing the environment after dark and providing a unique space within Monaghan's Town Centre.

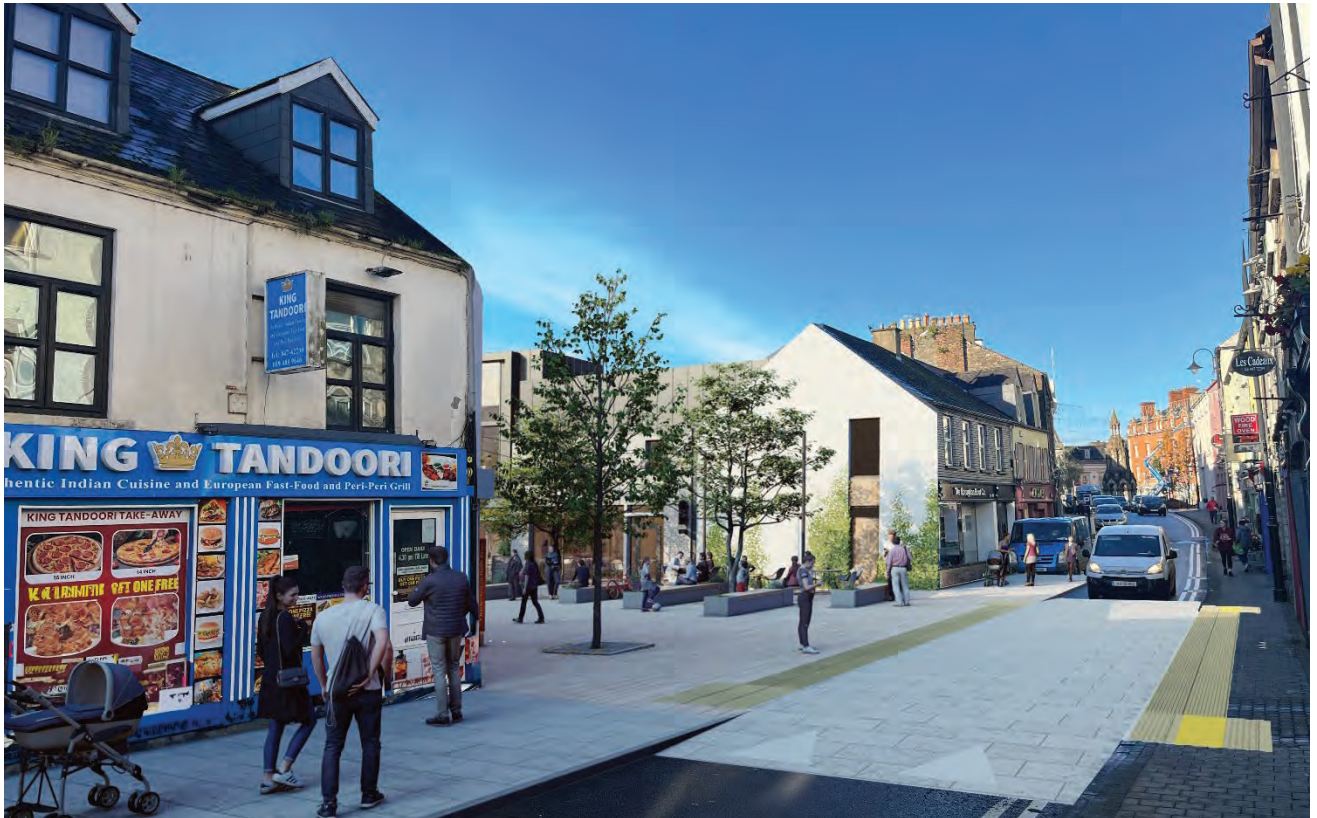
The interface between Charles Gavan Duffy Place and Dublin Street. The materials for Dublin Street are ultimately proposed to coordinate with the wider Town Centre. The warm toned paving of Charles Gavan Duffy Place will push out into Dublin Street to clearly mark its thresholds and promote it as a new urban space.

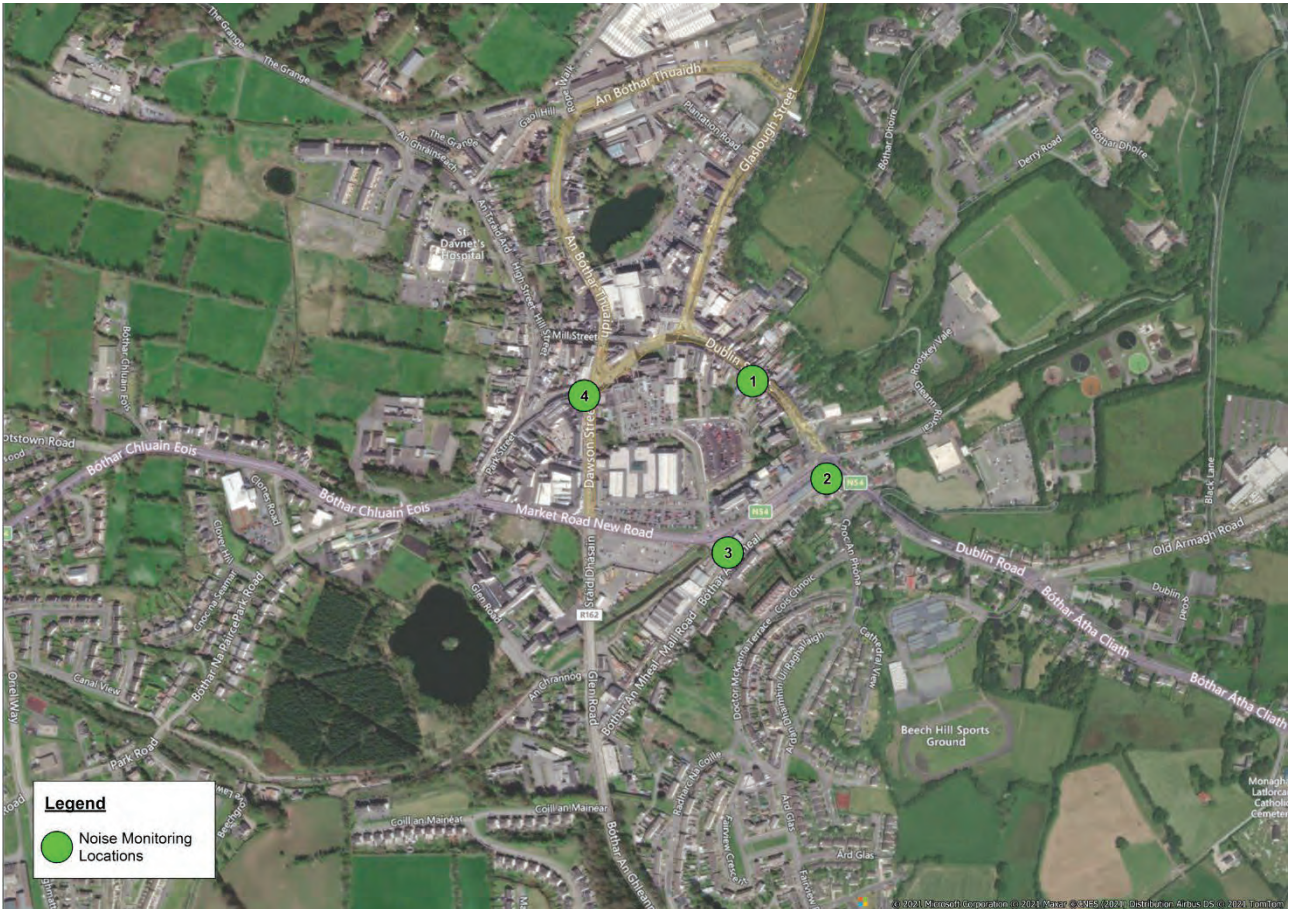
Figure 4.A.1: Noise Monitoring Locations

As the proposed development site is an open area it is not possible to set up and leave noise monitoring equipment operating unattended for an extended period of time. Therefore, to be representative of existing noise sources RPS have undertaken attended noise monitoring for both daytime and night-time at 4 locations as detailed in Figure 4.A.1 above.

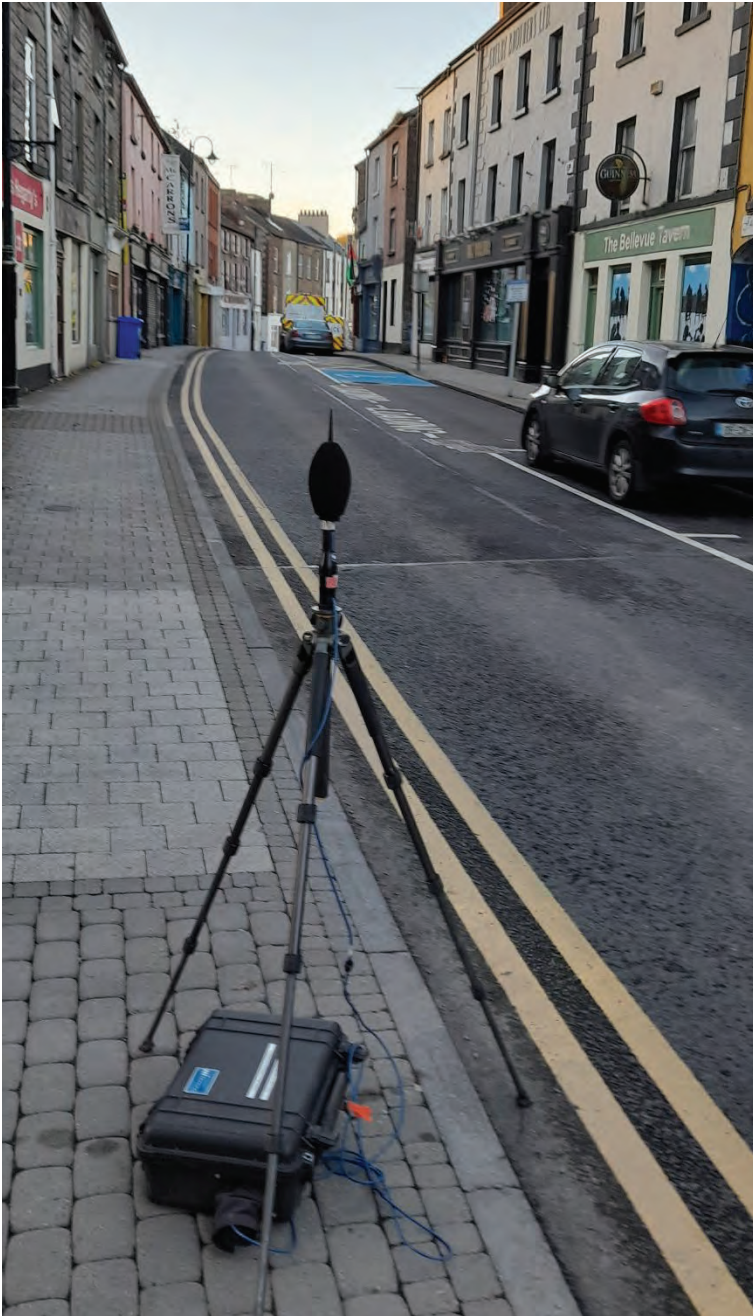
Photograph 4A.1: Photograph of Noise Monitoring Location 1

A photograph of the noise equipment set up at NML1 is shown in photograph 4A.1 below.

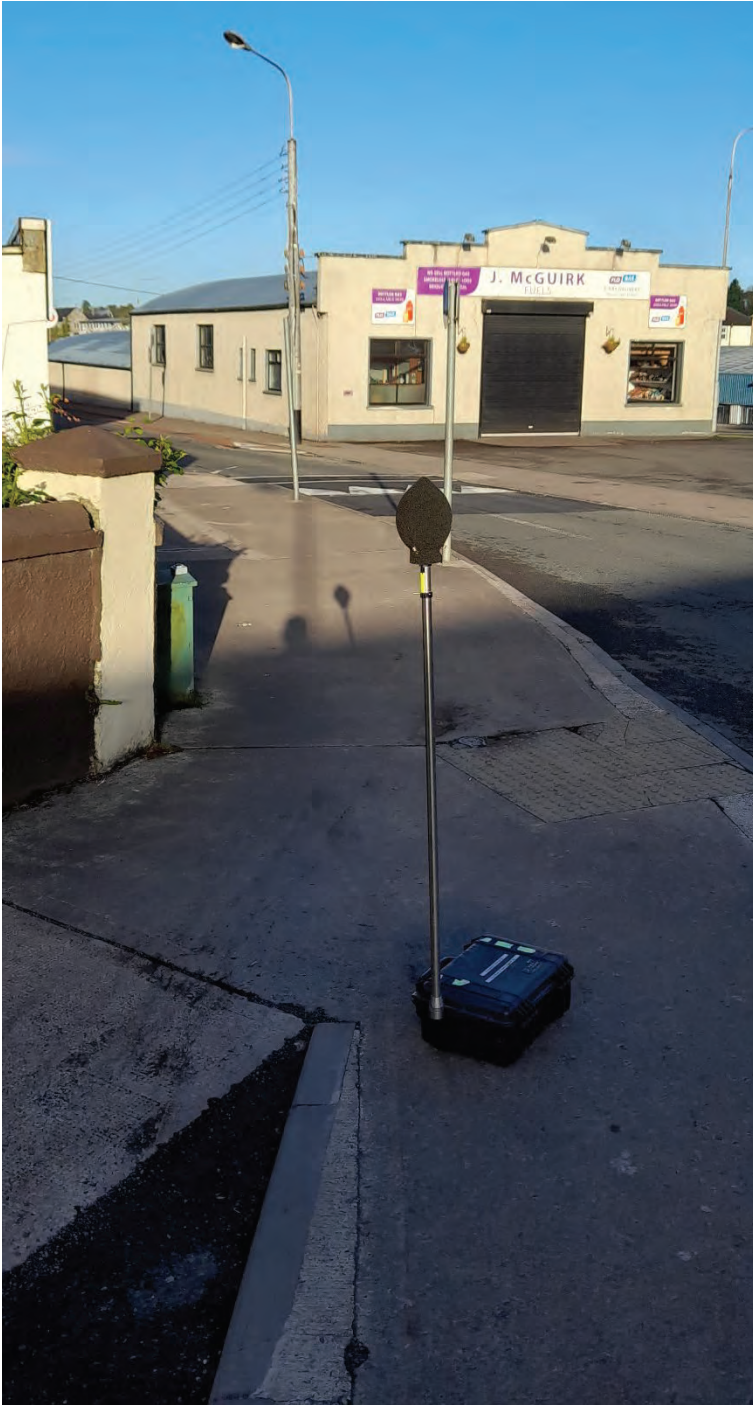
Photograph 4A.2: Photograph of Noise Monitoring Location 2

NML2 was located close to residential properties at Old Cross Square and Rooskey Vale, to the eastern boundary of the proposed redevelopment site.

A photograph of the noise equipment set up at NML2 is shown in photograph 4A.2 below.

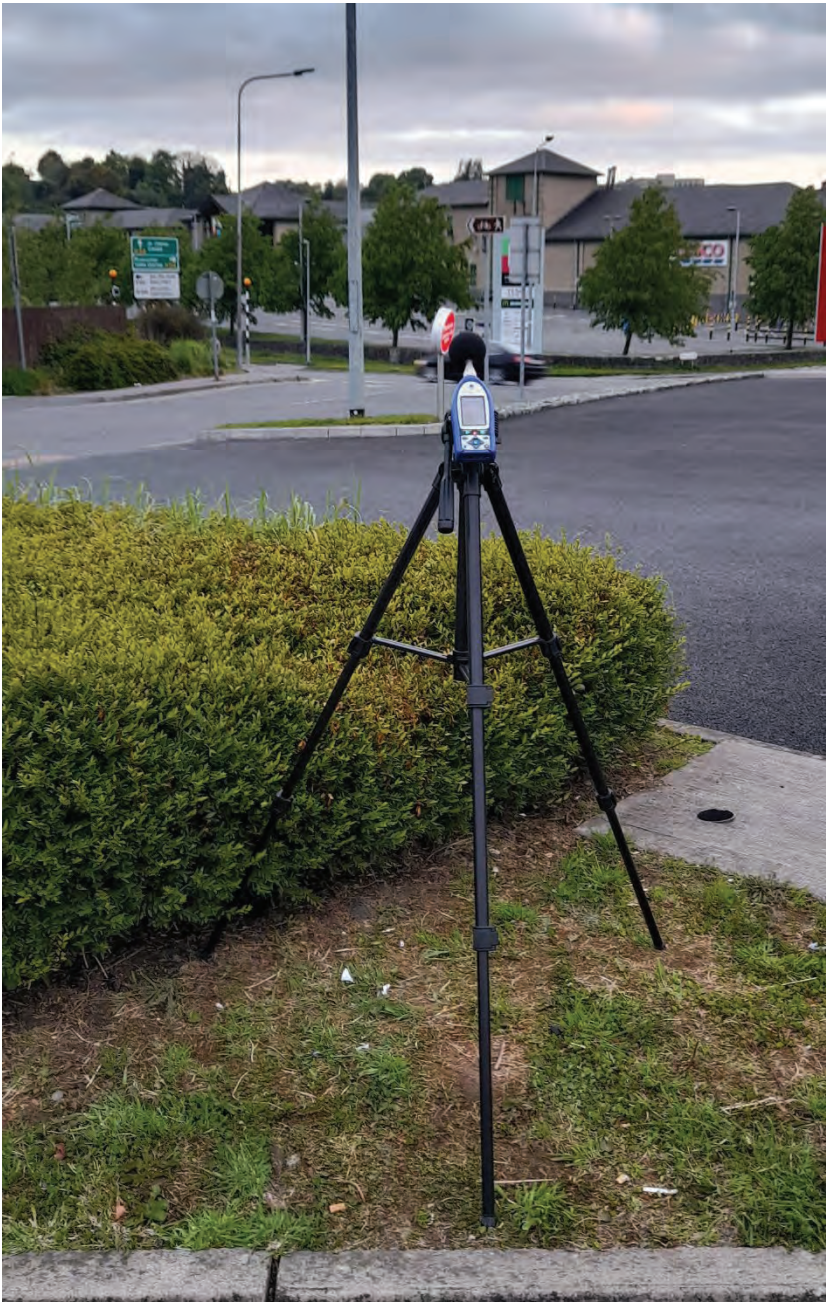
Photograph 4A.3: Photograph of Noise Monitoring Location 3

NML3 was located at to the southern boundary of the proposed redevelopment site at Castle Road. This location is representative of the existing residential properties on Broad Road and Canal Street. These are the closest residential properties to the operational phase of the proposed road realignment.

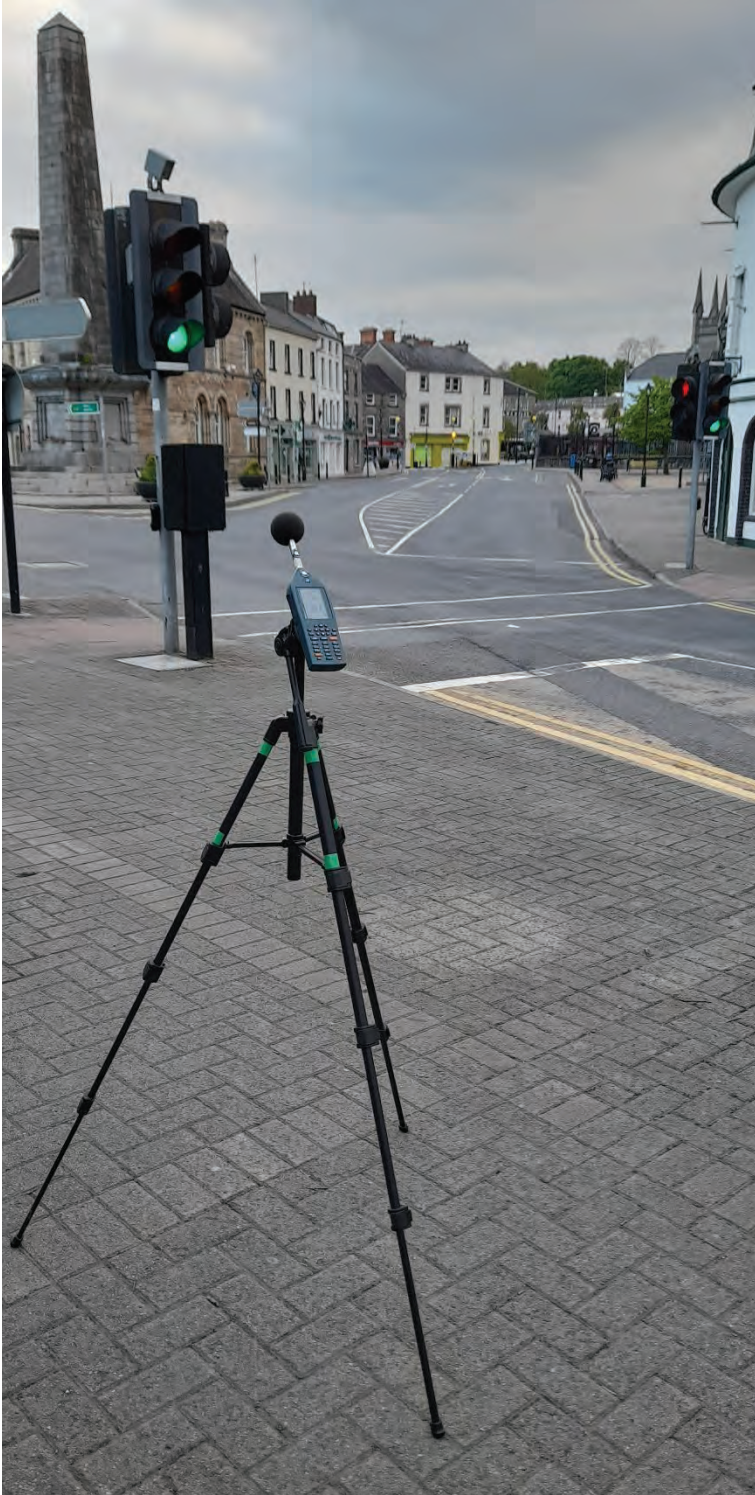
Photograph 4A.4: Photograph of Noise Monitoring Location 4

NML4 was located close to residential properties along Dawson Street to the western boundary of the proposed redevelopment site.

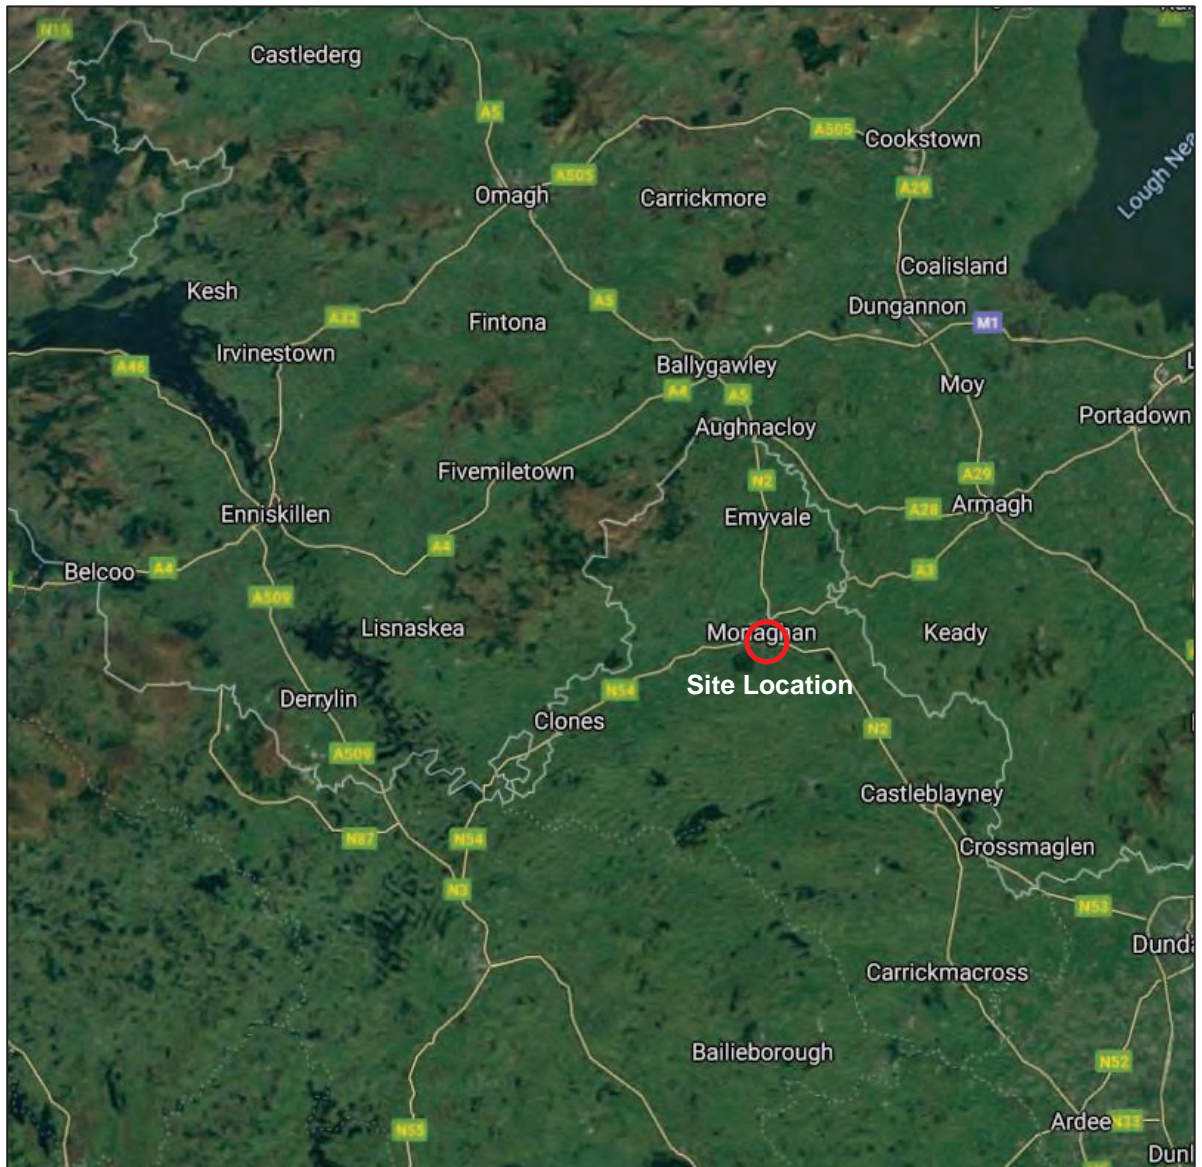
Figure 2.1 Site Location

As shown in Figure 2.1, the site is located within the central core of Monaghan Town centre in the Republic of Ireland, approximately 6.90km from the Northern Ireland border.

The site is located at Irish grid reference 267304 Easting, 333645 Northing.

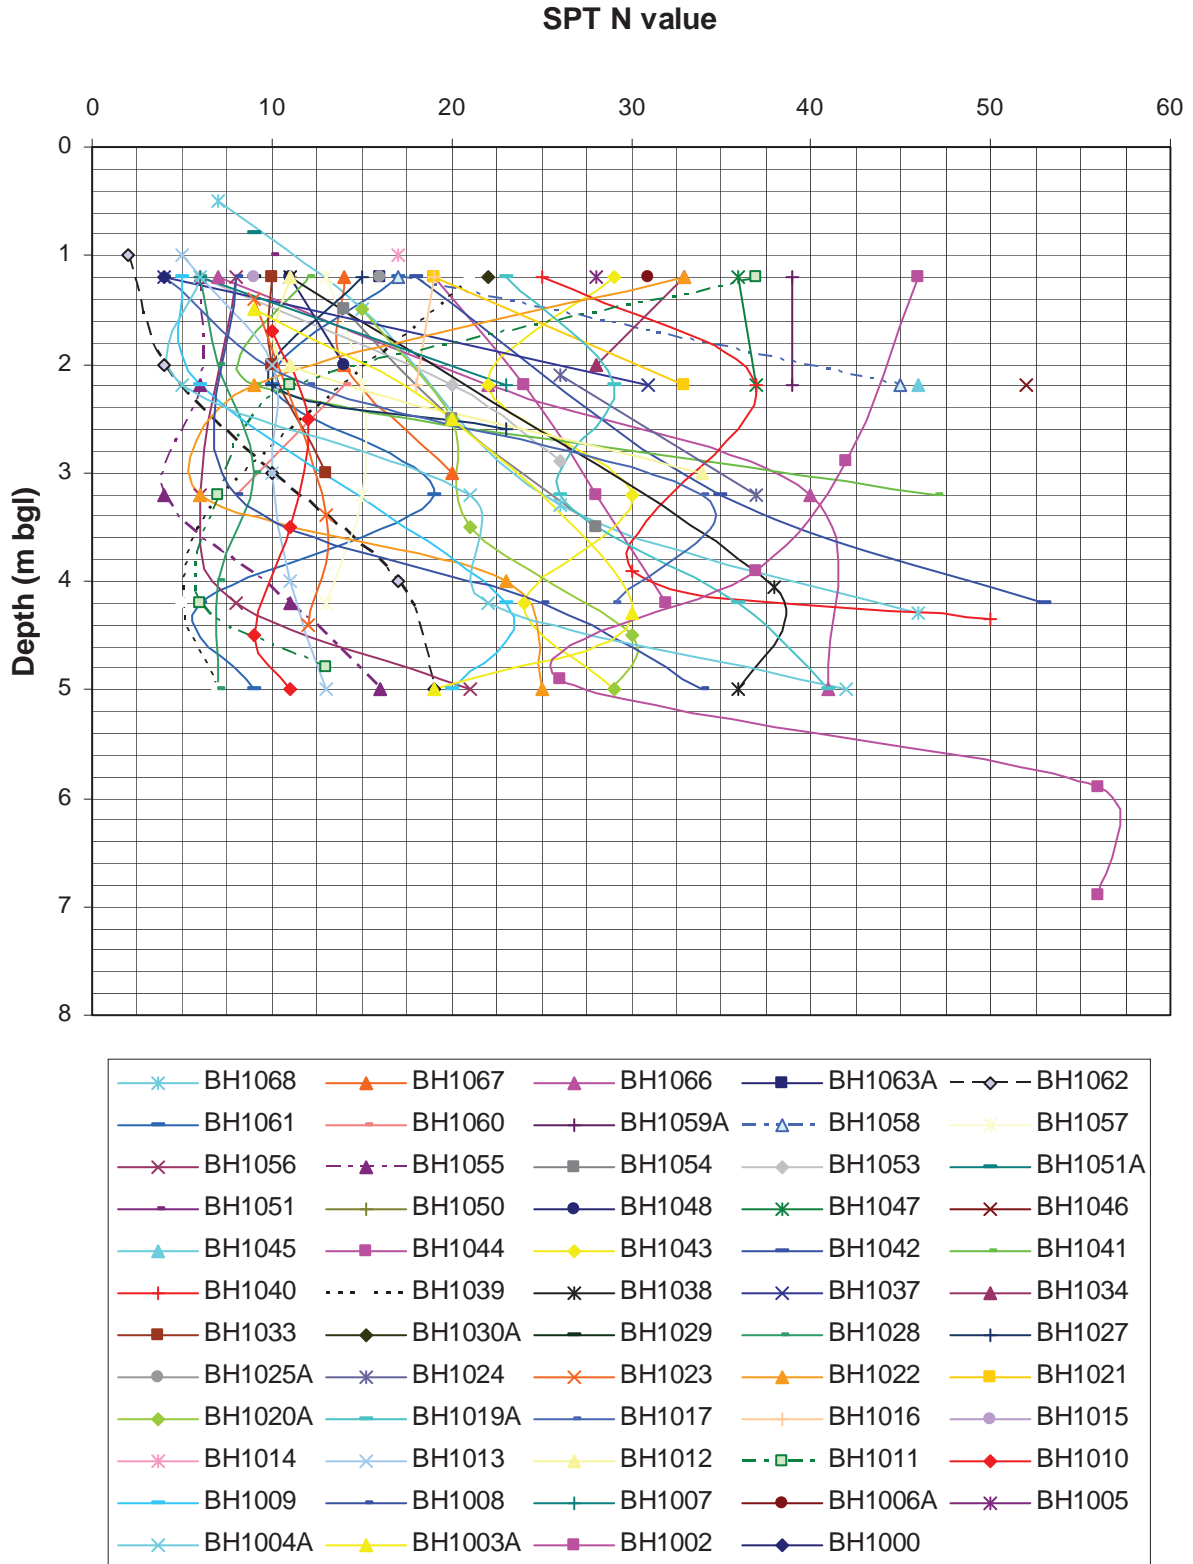
The distribution of Standard Penetration Test, SPT N values with depth is presented graphically below for cable tool boreholes (BH1000).

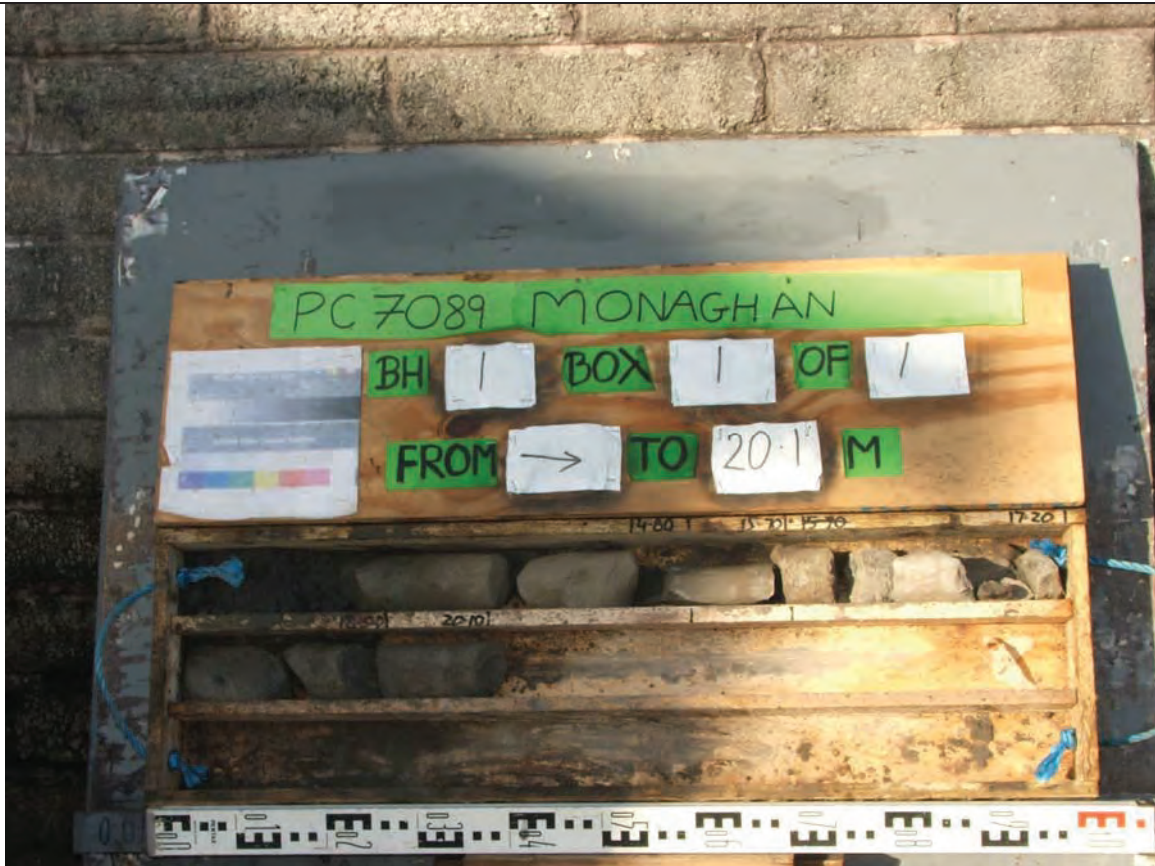
BHR1

Rotary Core Photographic Record
