PROPOSED CHARLES GAVAN DUFFY PLACE

Rev	Issue Date	Description	App
Status: PLANNING			
Client: Monaghan County Council			
Project: Dublin Street South			
Drawing: Development to East Edge of CGDP Proposed Floor Plans & Elevation			
Scale: 1:100 @ A0			
McAdam ENHANCING LOCAL COMMUNITIES			
Contact Details		16 Montgomery House 478 Castleberg Road Belfast, BT5 6BQ	T: 028 9040 2000 E: admin@mcadamdesign.co.uk www.mcadamdesign.co.uk
Drawn: mcc Date: 23/11/23	Checked: eh Date: 23/11/23	Approved: mcc Date: 23/11/23	
Project Number: A2156	Drawing Number: 200-102	Revision: -

Design Statement - Architecture

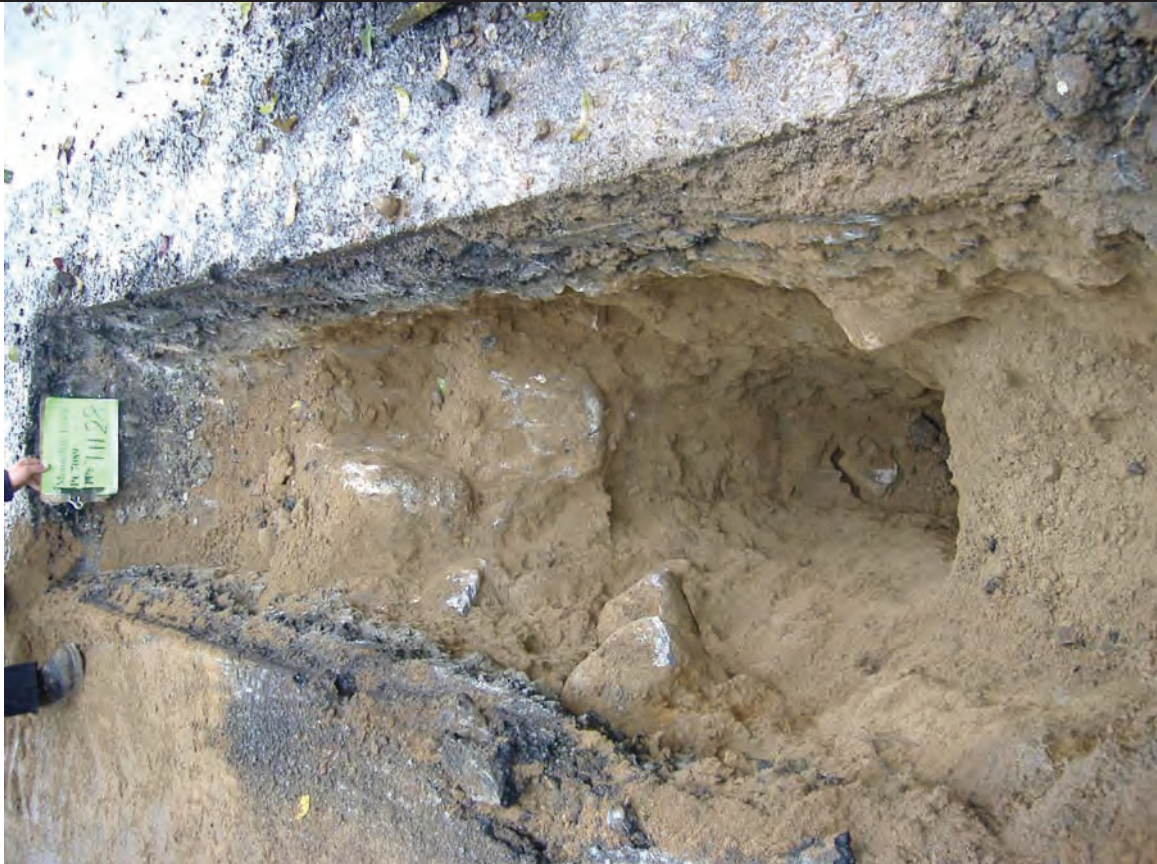
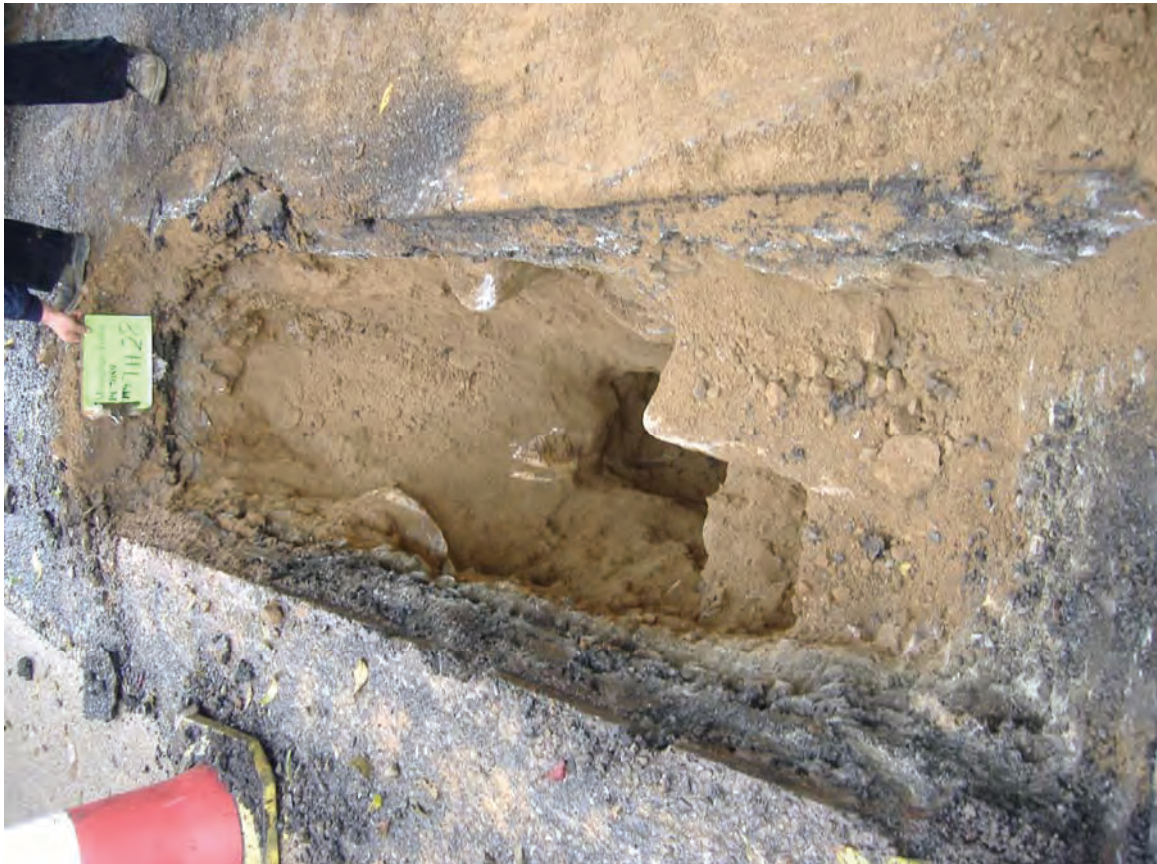
Trial Pit Number: TP28

Trial Pit Photographic Record

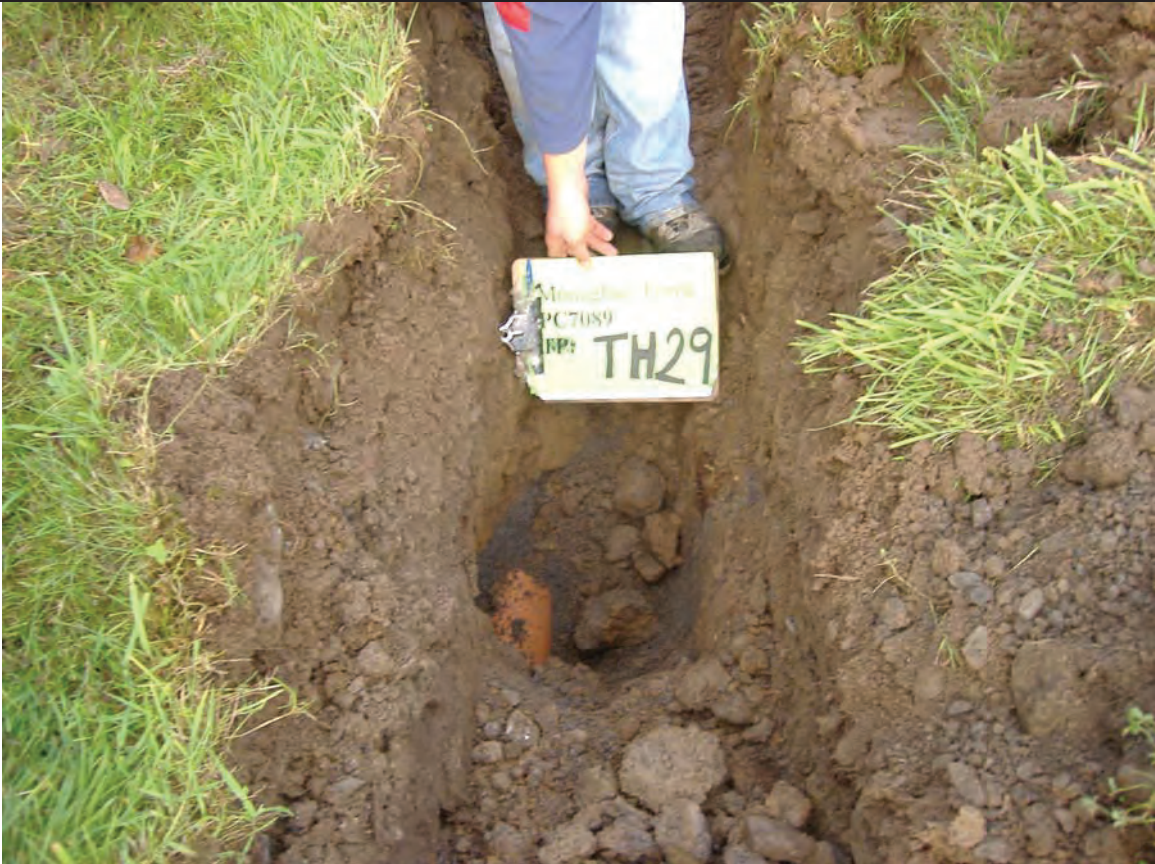
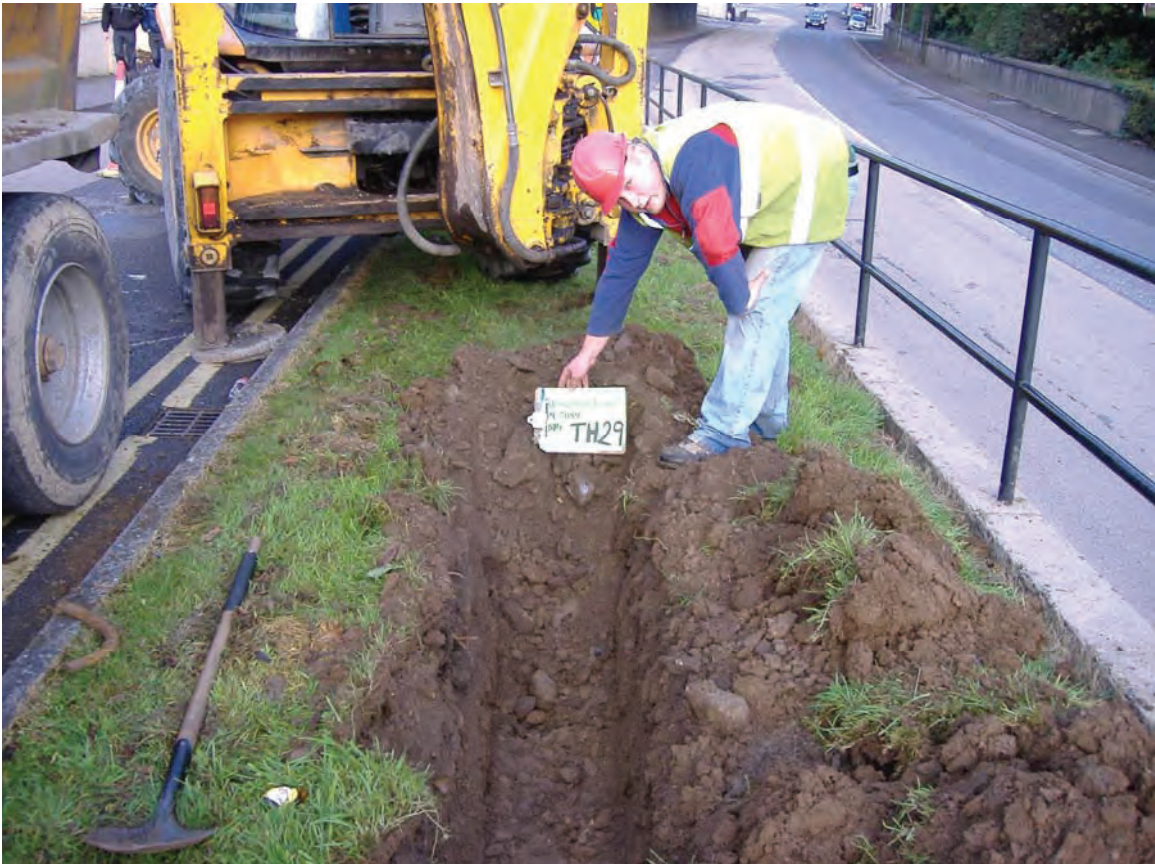
Trial Pit Number: TP29

Trial Pit Photographic Record

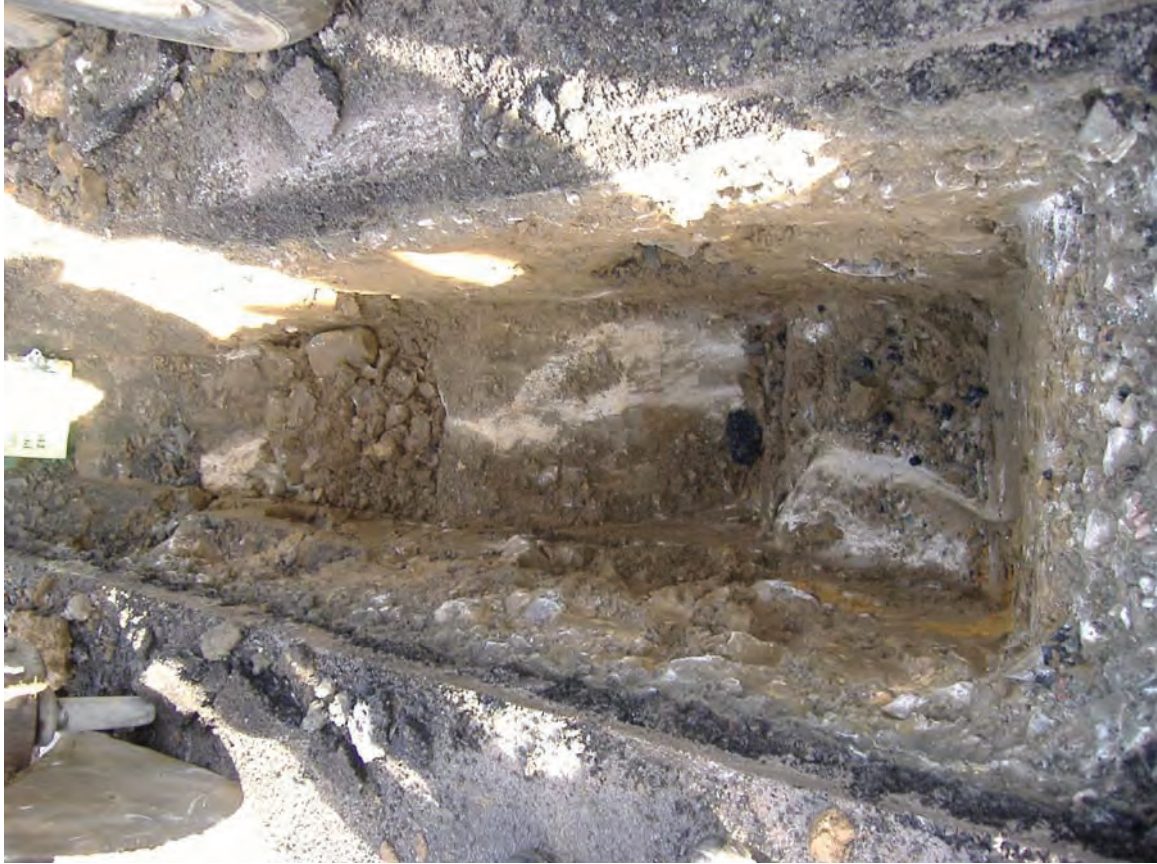
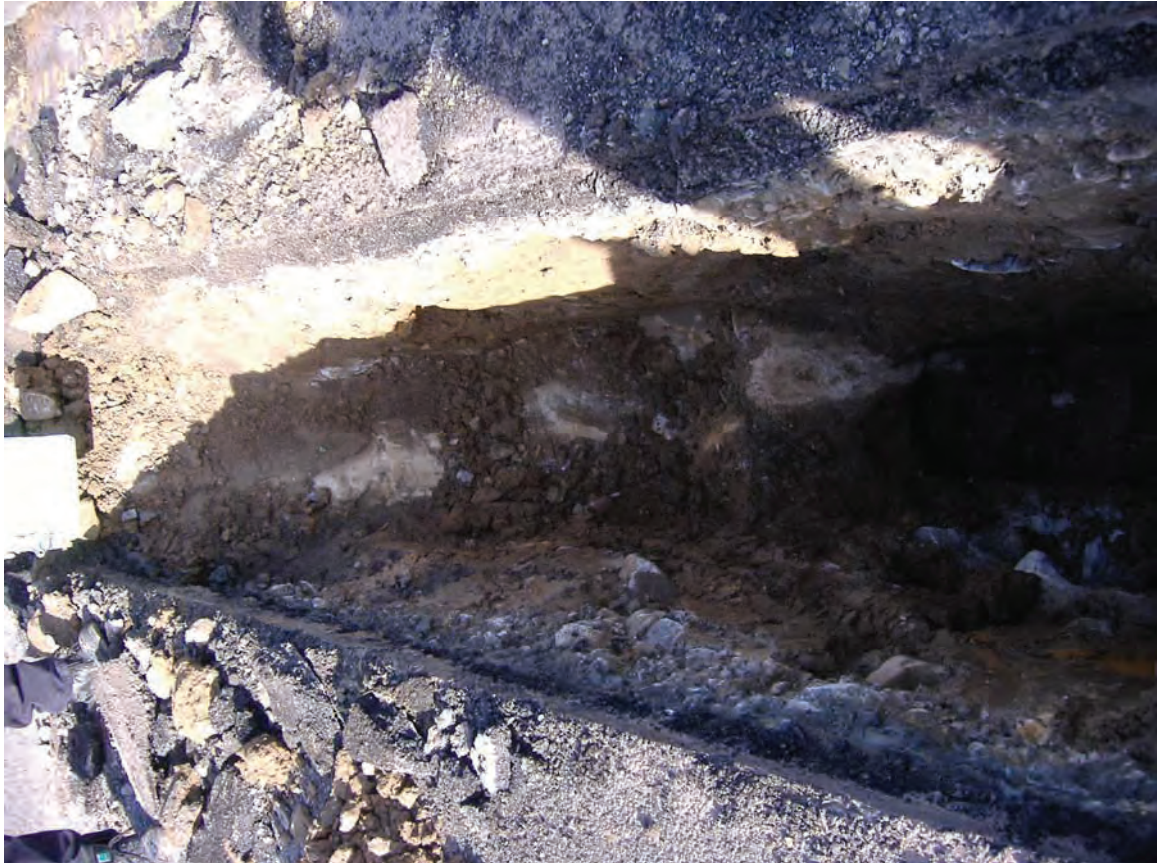
Trial Pit Number: TP29A	Project Monaghan Town Collection Network Project No PC7089 Carried Out T. J. O'Connor & Associates, Consulting Engineers	
--------------------------------	--	--

Trial Pit Photographic Record

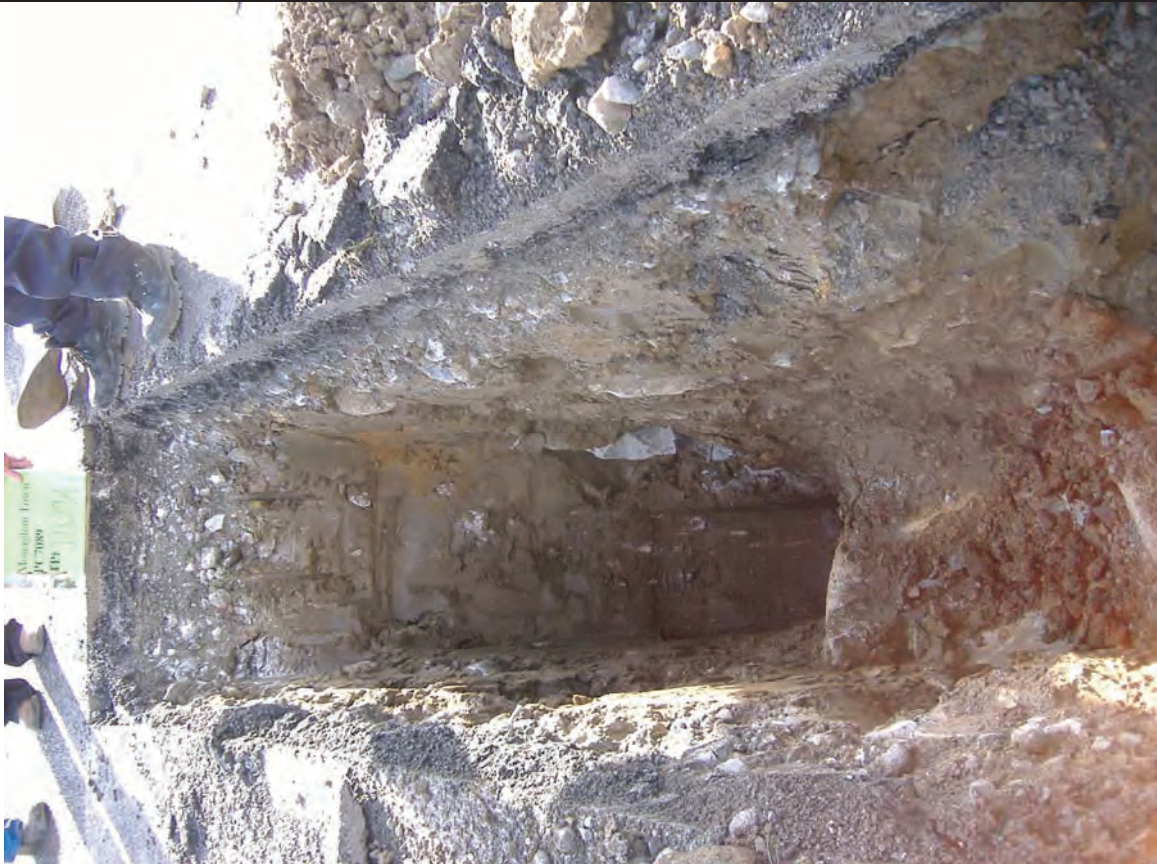
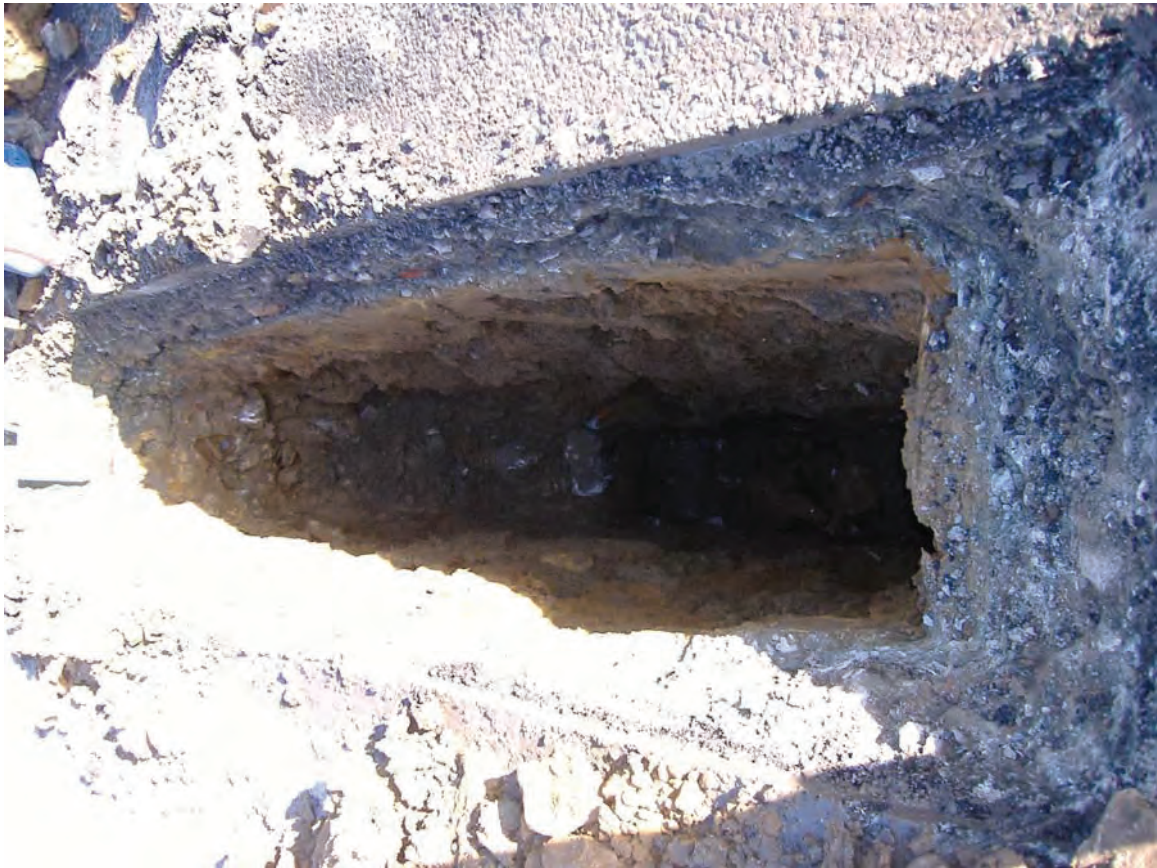
Trial Pit Number: TP29A	Project Monaghan Town Collection Network Project No PC7089 Carried Out T. J. O'Connor & Associates, Consulting Engineers	
--------------------------------	--	--

Trial Pit Photographic Record

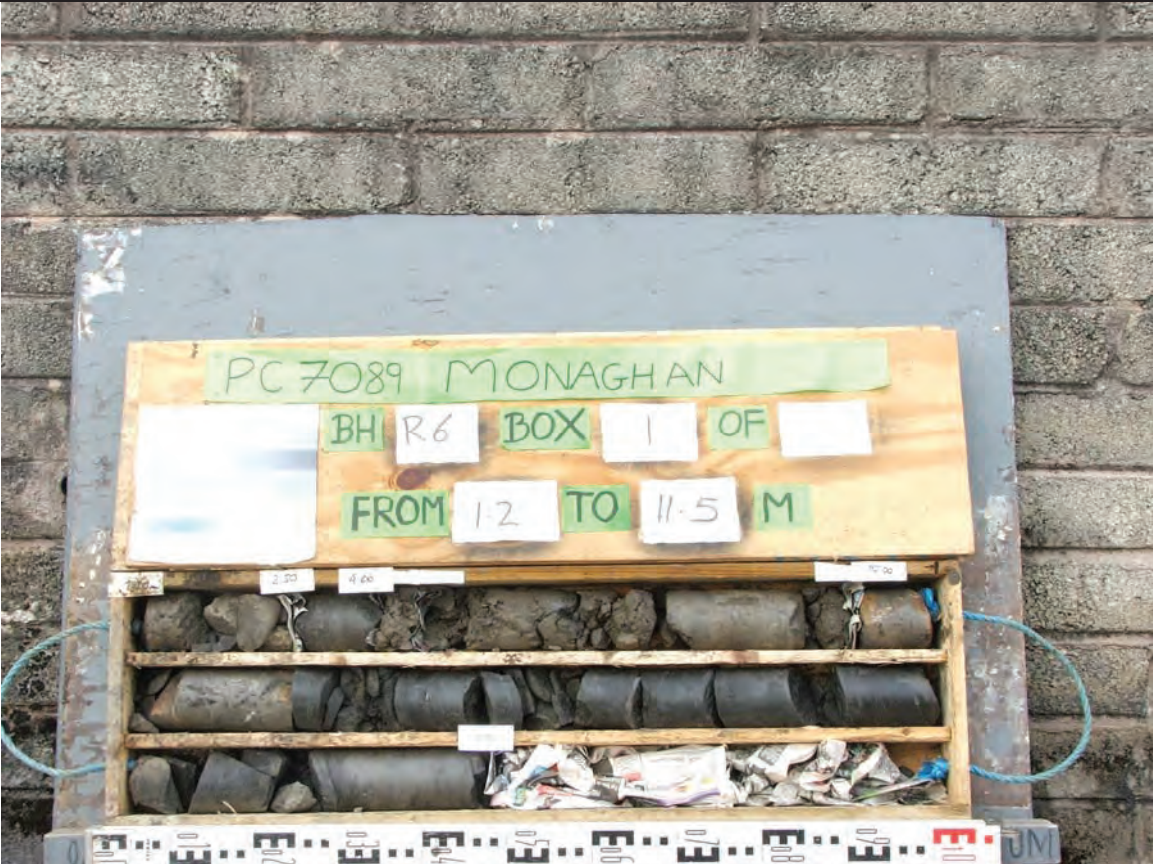
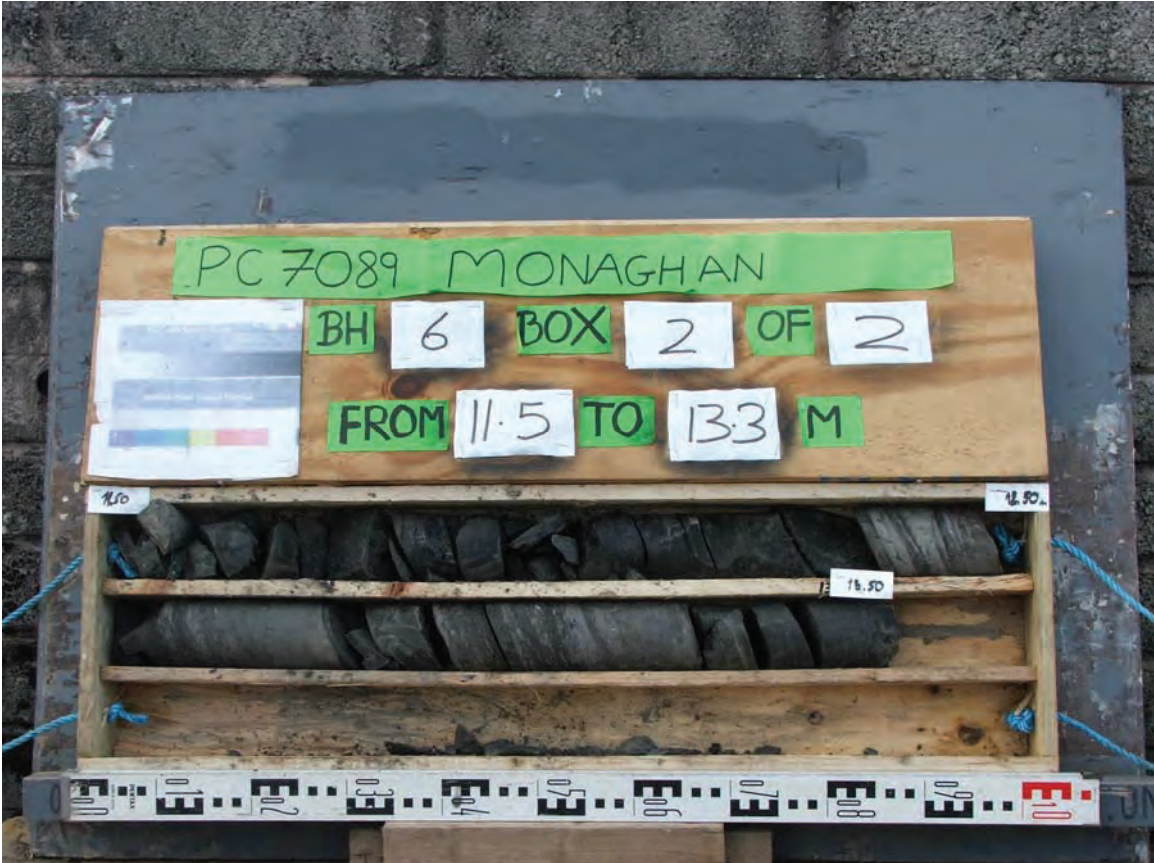
BH06

Rotary Core Photographic Record

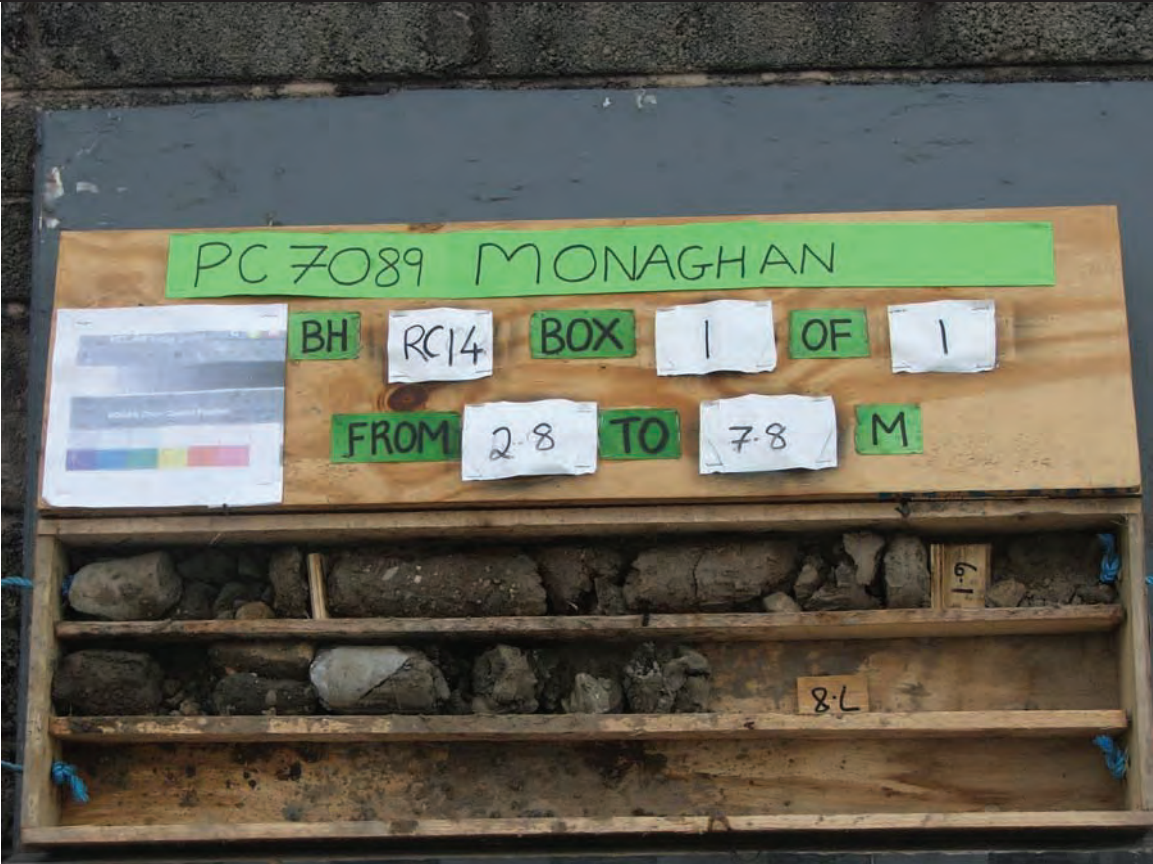
Rotary Borehole Number: BH14	Project Monaghan Town Collection Project No Network PC7089 Carried Out for T. J. O'Connor & Associates, Consulting Engineers	
-------------------------------------	---	--

Rotary Core Photographic Record

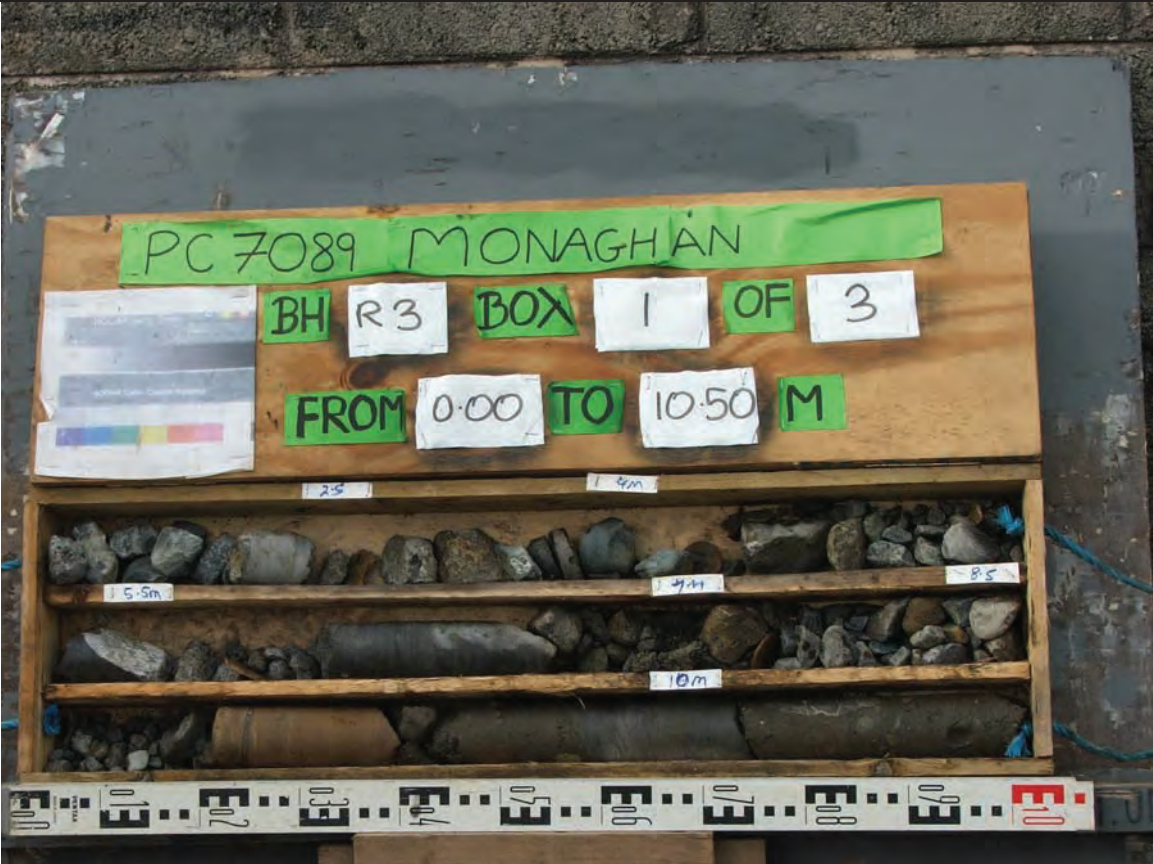
<p>Rotary Borehole Number: BHR03</p>	<p>Project: Monaghan Town Collection Network Project No: PC7089 Carried Out for: T. J. O'Connor & Associates, Consulting Engineers</p>	
---	--	--

Rotary Core Photographic Record

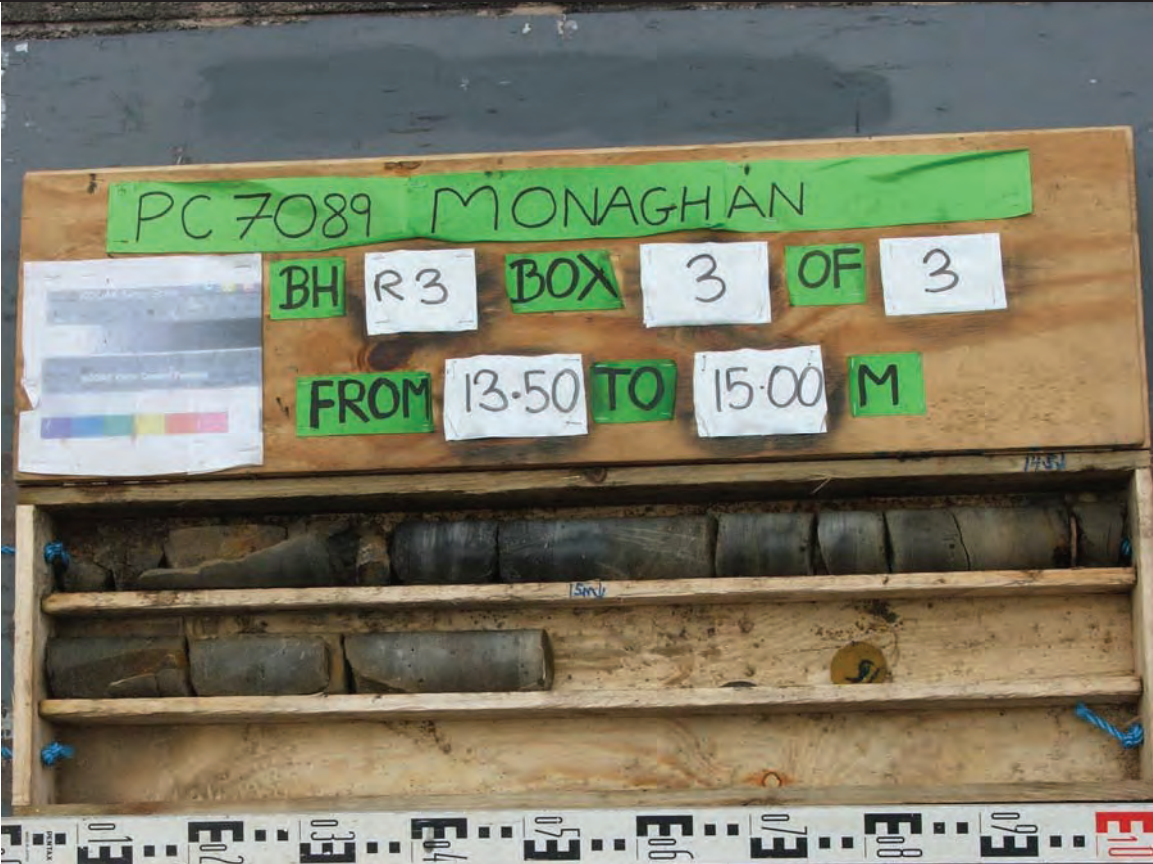
Rotary Borehole Number: BHR03	Project Monaghan Town Collection Project No Network PC7089 Carried Out for T. J. O'Connor & Associates, Consulting Engineers	
--------------------------------------	---	--

Rotary Core Photographic Record

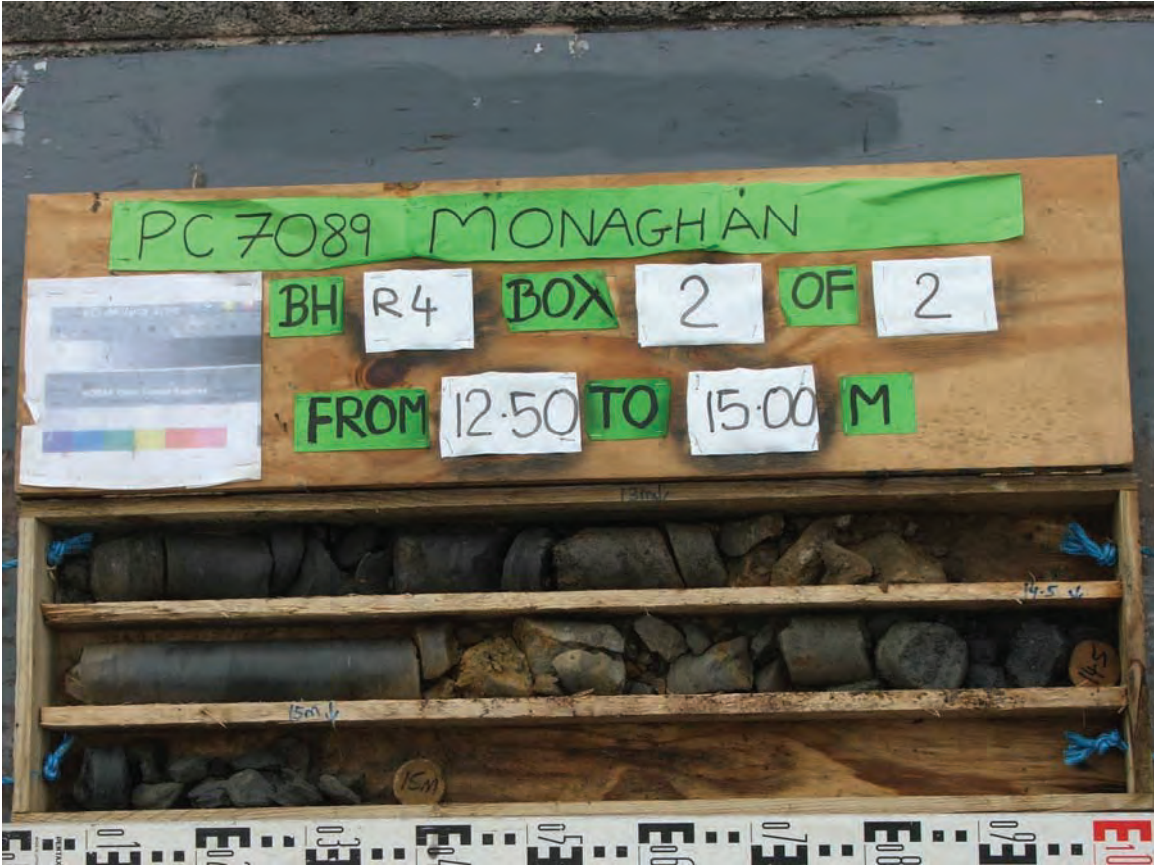
Rotary Borehole Number: BHR04	Project Monaghan Town Collection Network Project No PC7089 Carried Out for T. J. O'Connor & Associates, Consulting Engineers	
--------------------------------------	---	--

Rotary Core Photographic Record

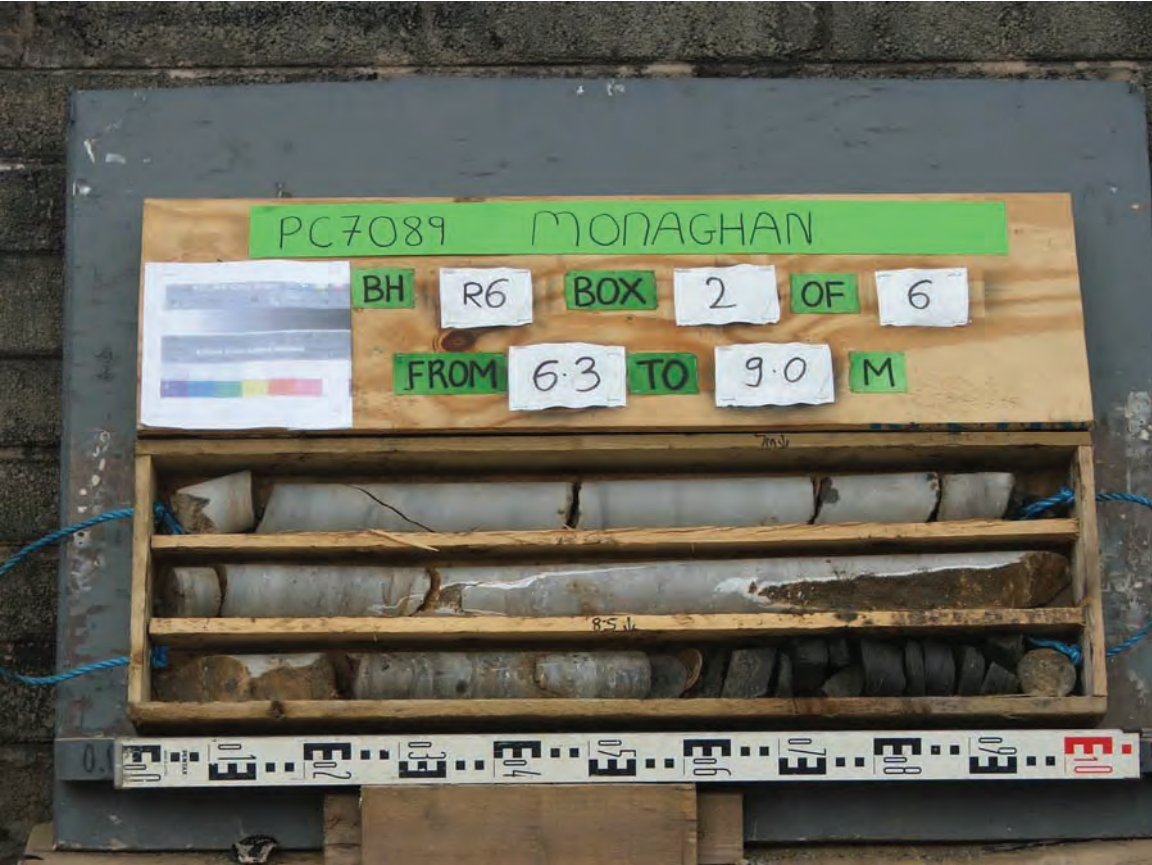
BHR06

Rotary Core Photographic Record

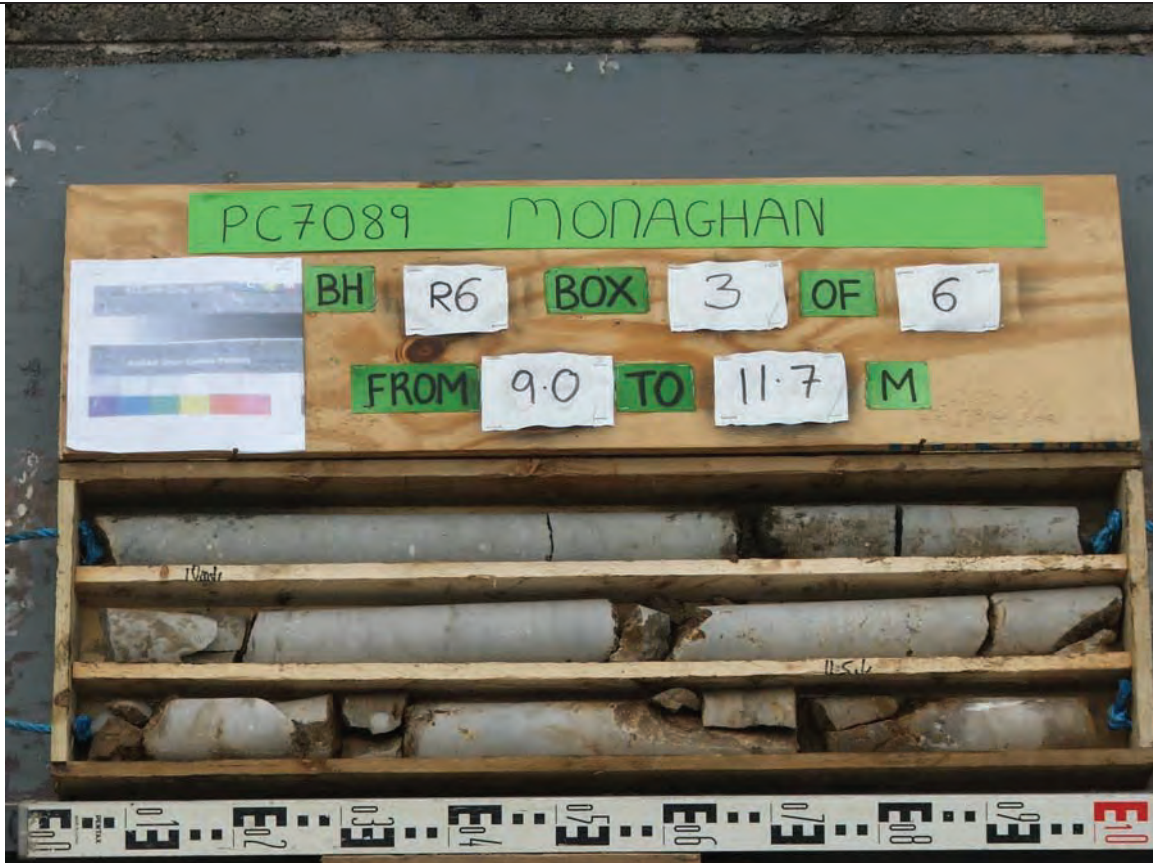
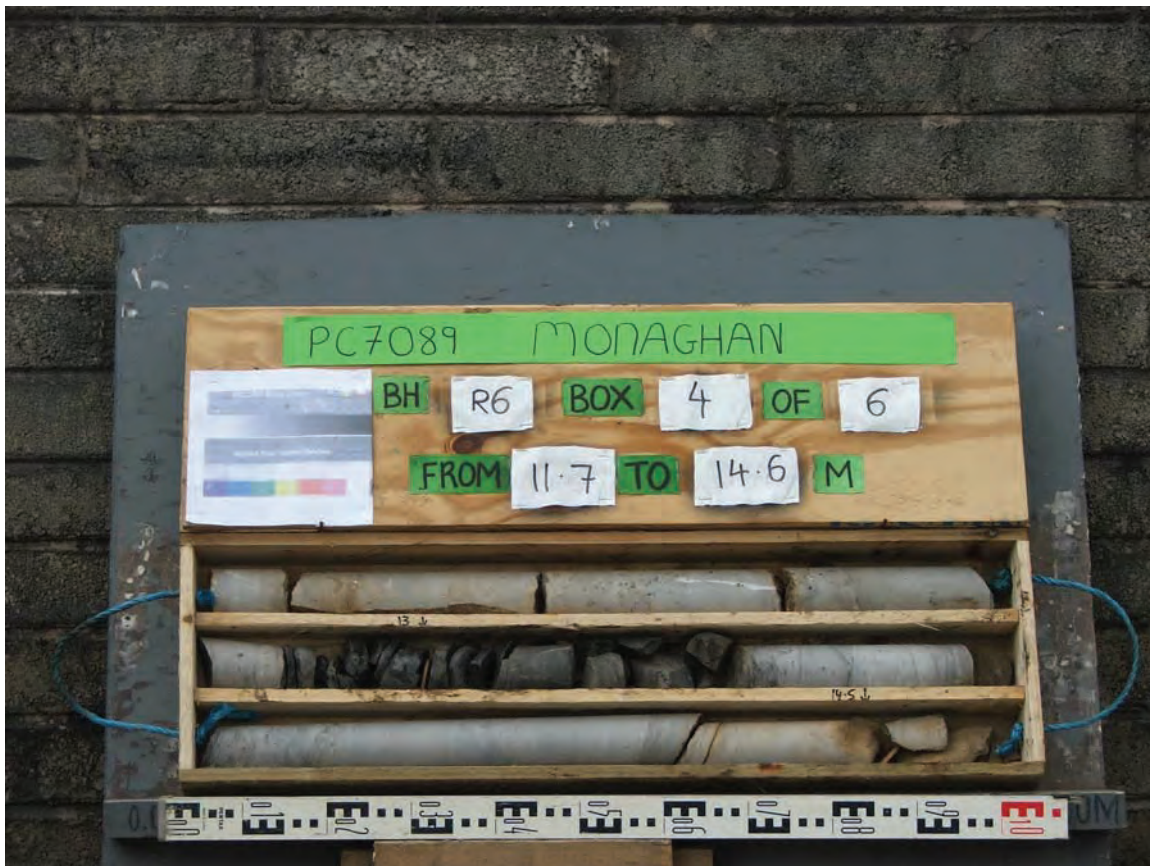
Rotary Borehole Number: BHR06	Project Monaghan Town Collection Network Project No PC7089 Carried Out for T. J. O'Connor & Associates, Consulting Engineers	
--------------------------------------	---	--

Rotary Core Photographic Record

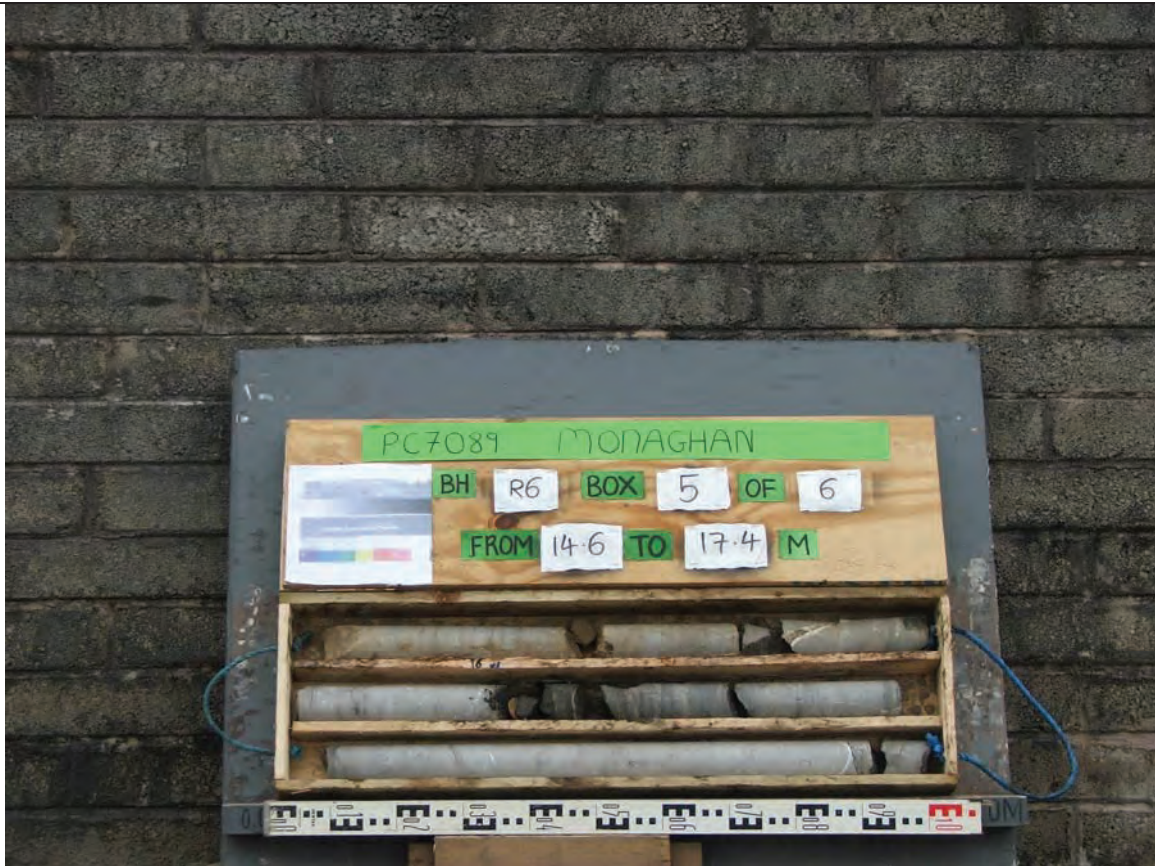
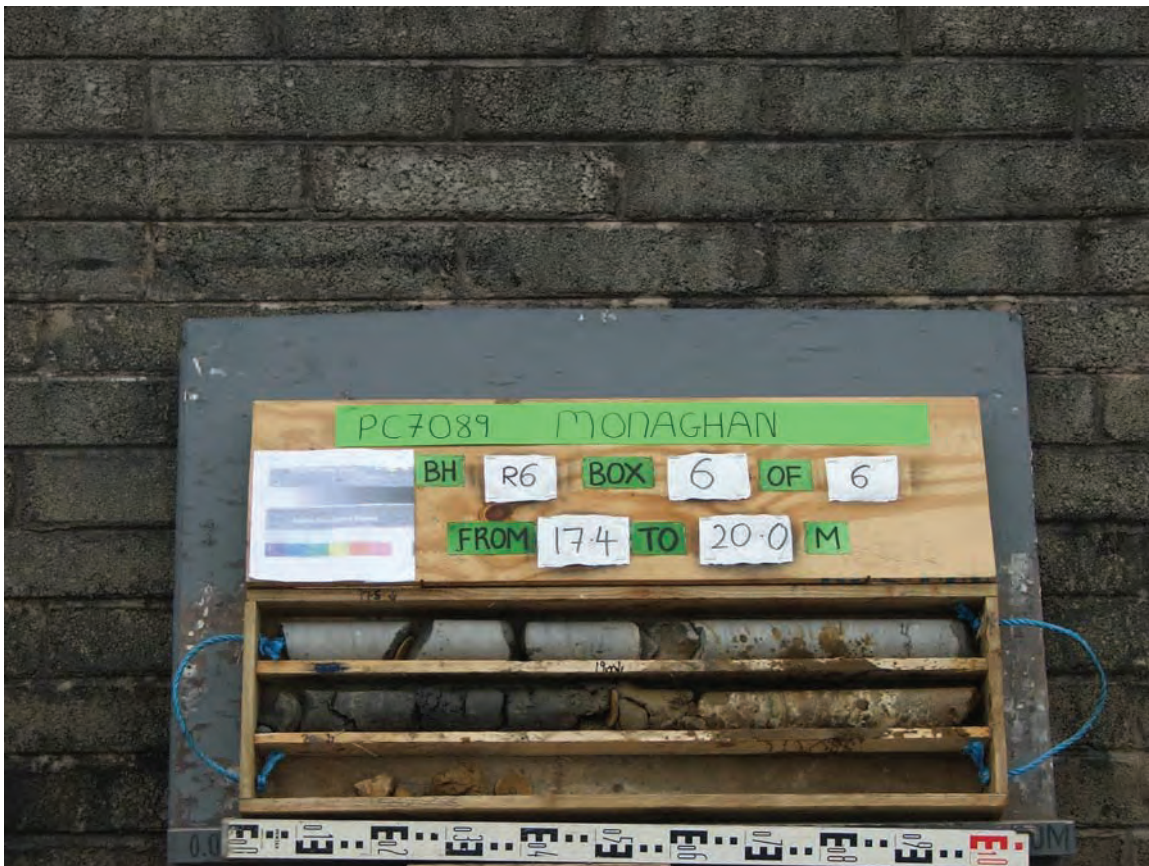
Rotary Borehole Number: BHR06	Project Monaghan Town Collection Network Project No PC7089 Carried Out for T. J. O'Connor & Associates, Consulting Engineers	
--------------------------------------	---	--

Rotary Core Photographic Record

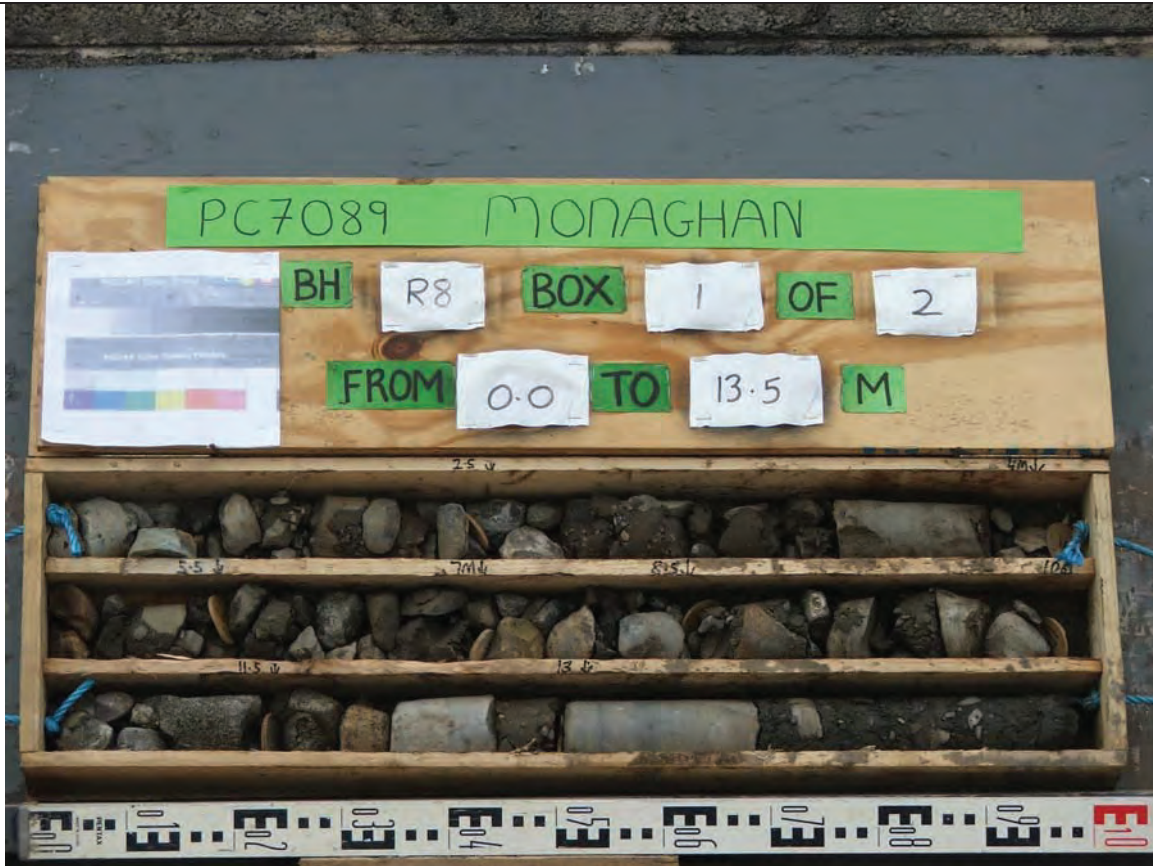
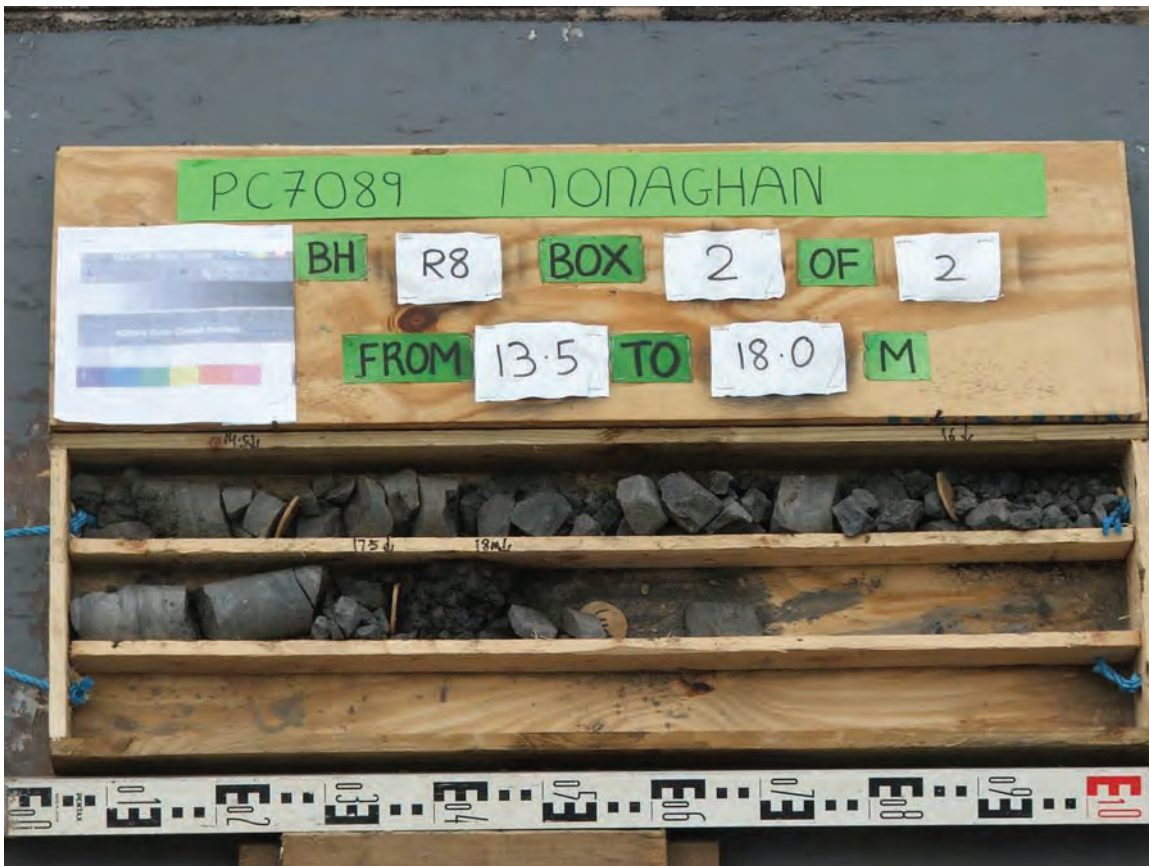
Rotary Borehole Number: BHR08	Project Monaghan Town Collection Network Project No PC7089 Carried Out for T. J. O'Connor & Associates, Consulting Engineers	
--------------------------------------	---	--

Rotary Core Photographic Record
