PROPOSED CHARLES GAVAN DUFFY PLACE

Rev	Issue Date	Description	App
Status: PLANNING			
Client: Monaghan County Council			
Project: Dublin Street South			
Drawing: Development to East Edge of CGDP Proposed Floor Plans & Elevation			
Scale: 1:100 @ A0			
McAdam ENHANCING LOCAL COMMUNITIES			
Contact Details		16 Montgomery House 478 Castleberg Road Belfast, BT5 6BQ	T: 028 9040 2000 E: admin@mcadamdesign.co.uk www.mcadamdesign.co.uk
Drawn: mcc Date: 23/11/23	Checked: eh Date: 23/11/23	Approved: mcc Date: 23/11/23	
Project Number: A2156	Drawing Number: 200-102	Revision: -

Design Statement - Architecture

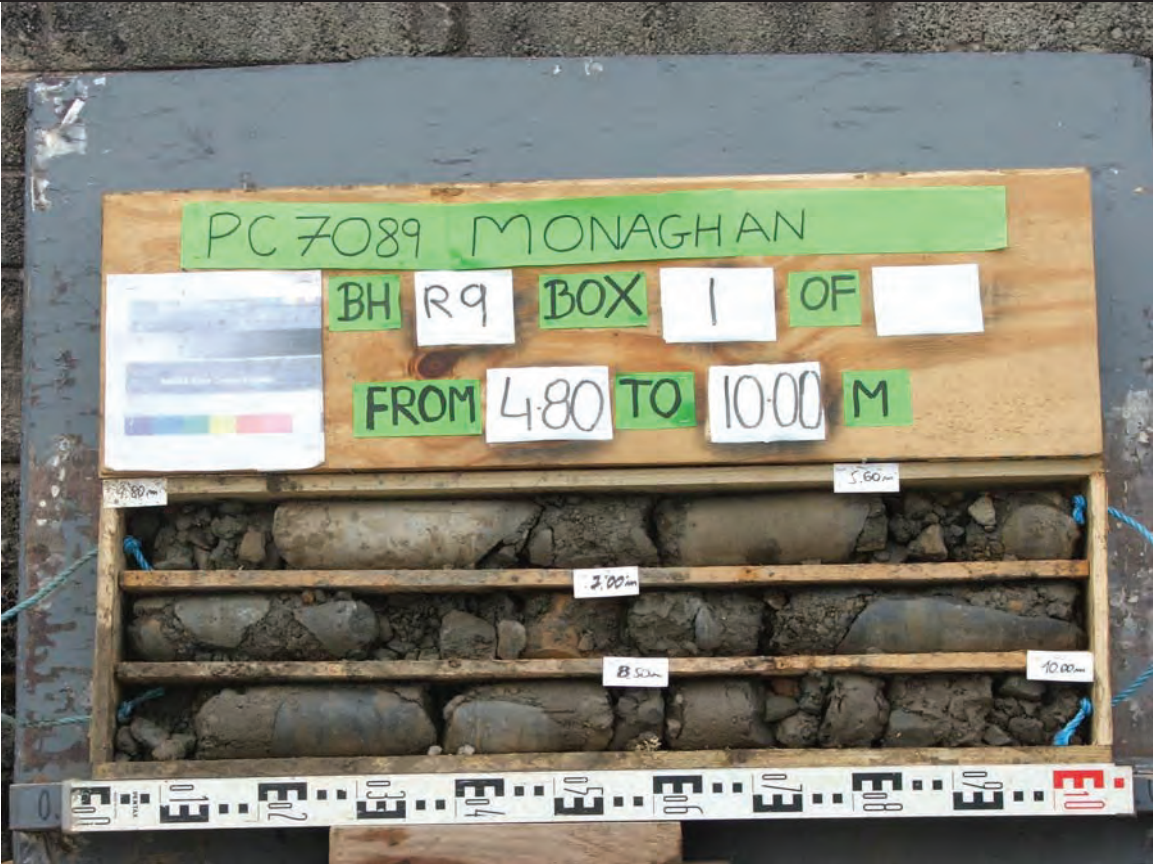
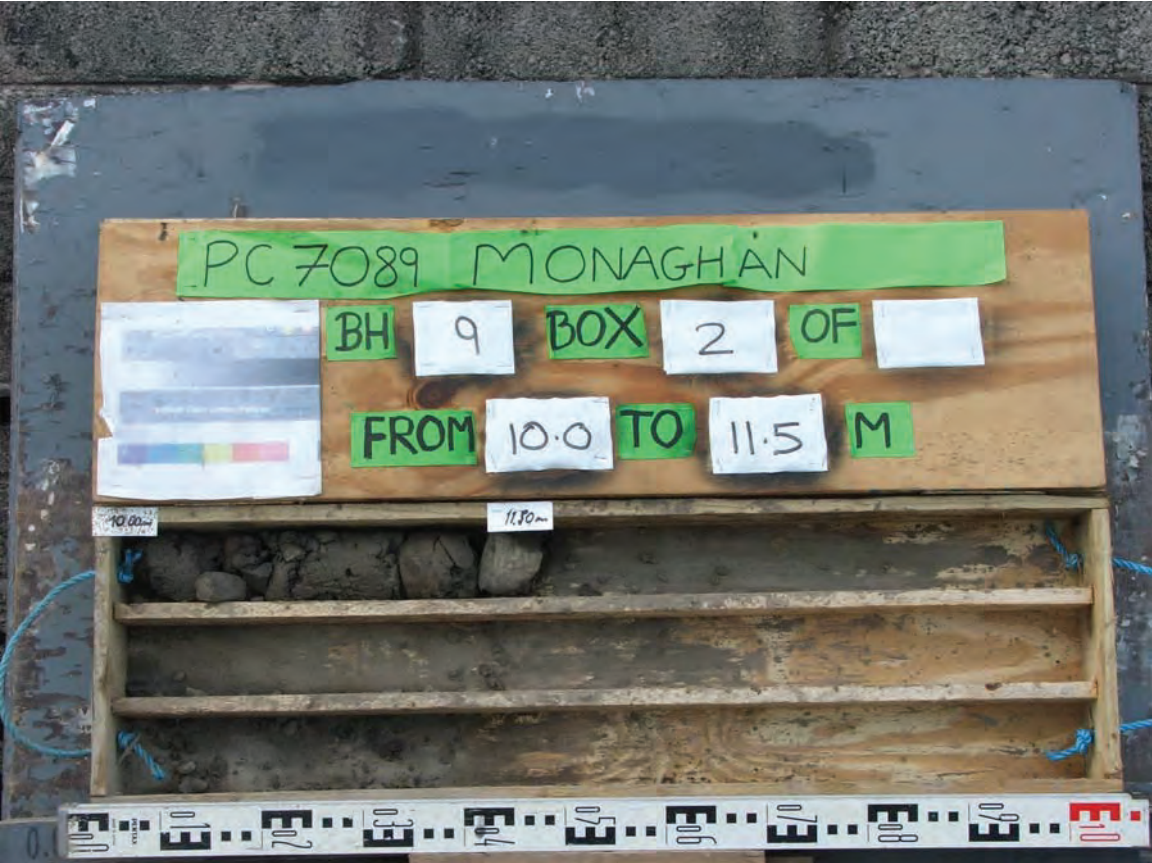
BHR09

Rotary Core Photographic Record

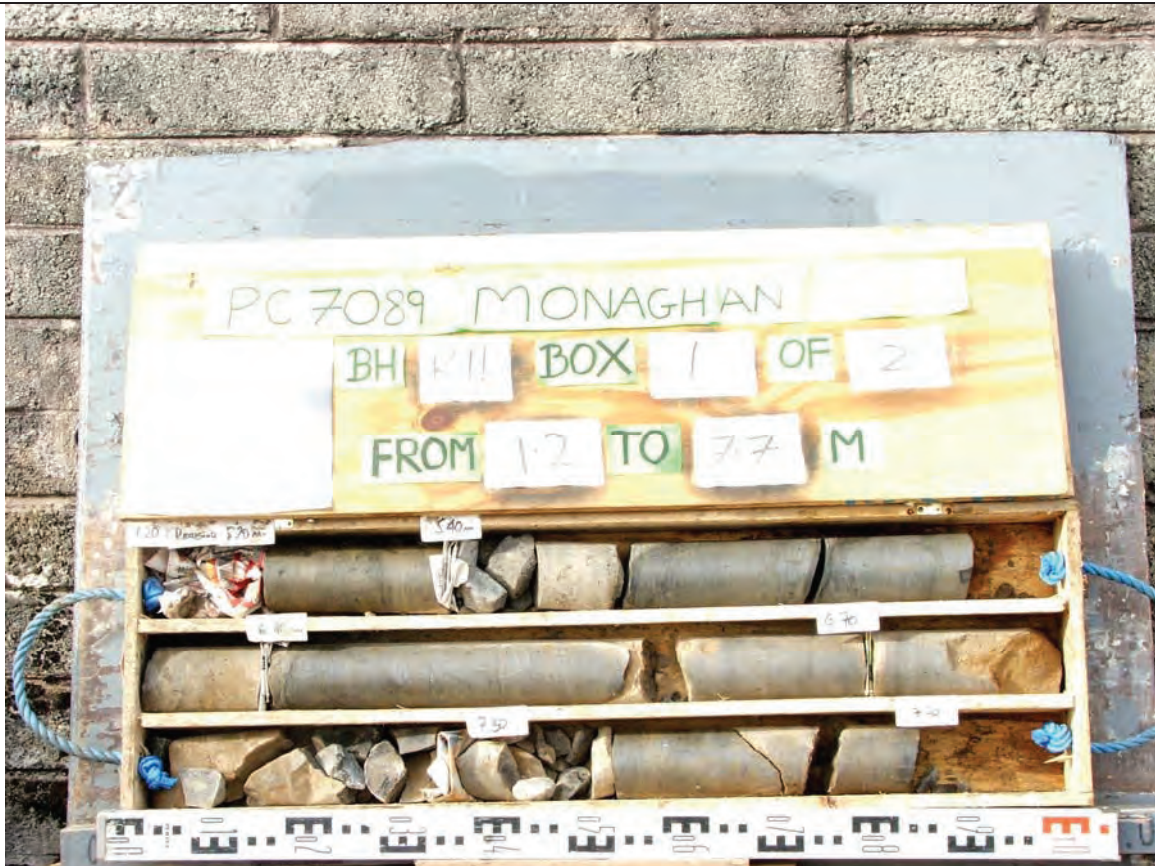
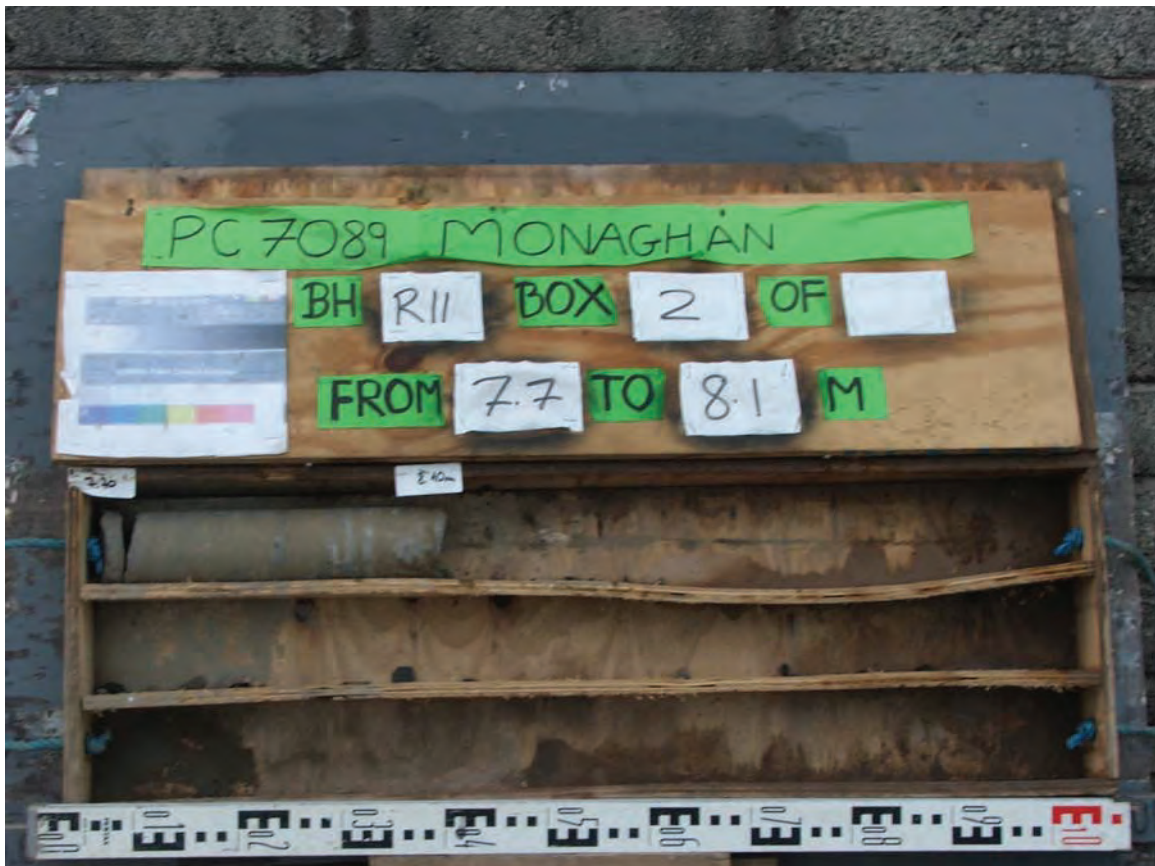
BHR11

Rotary Core Photographic Record

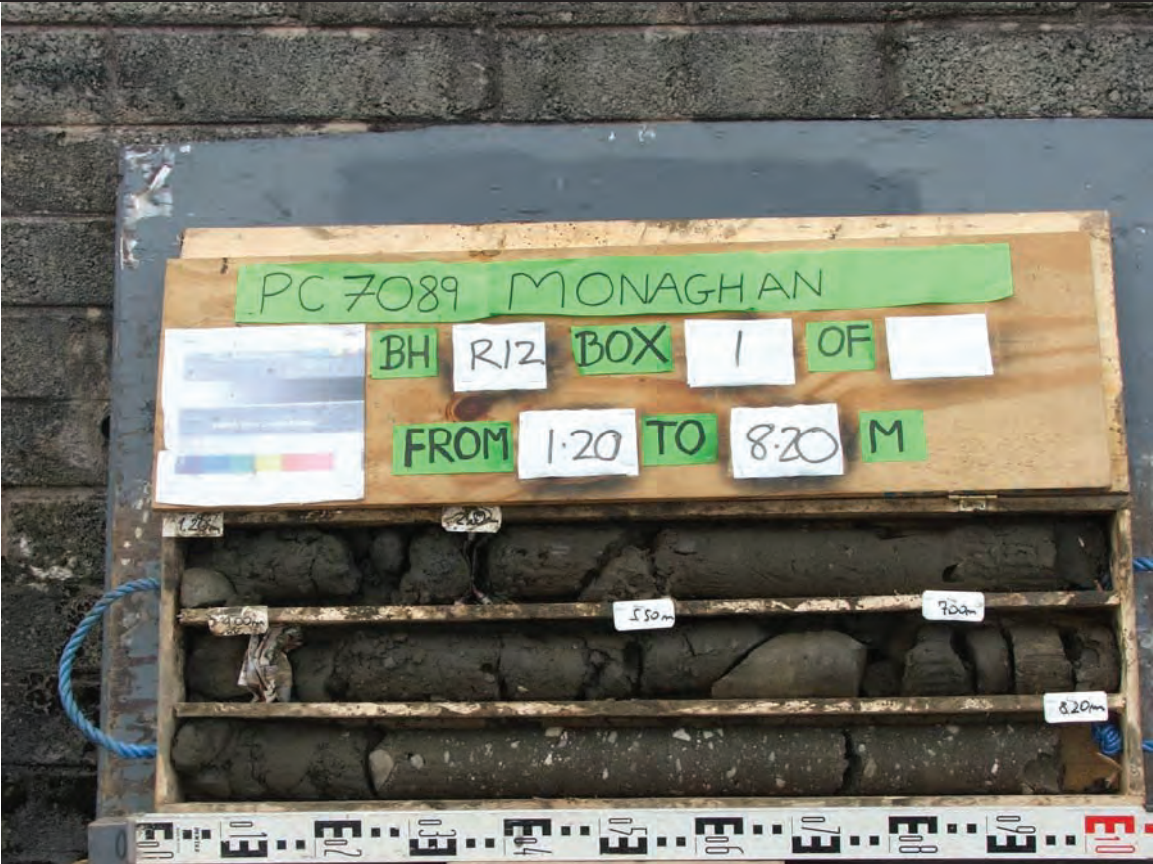
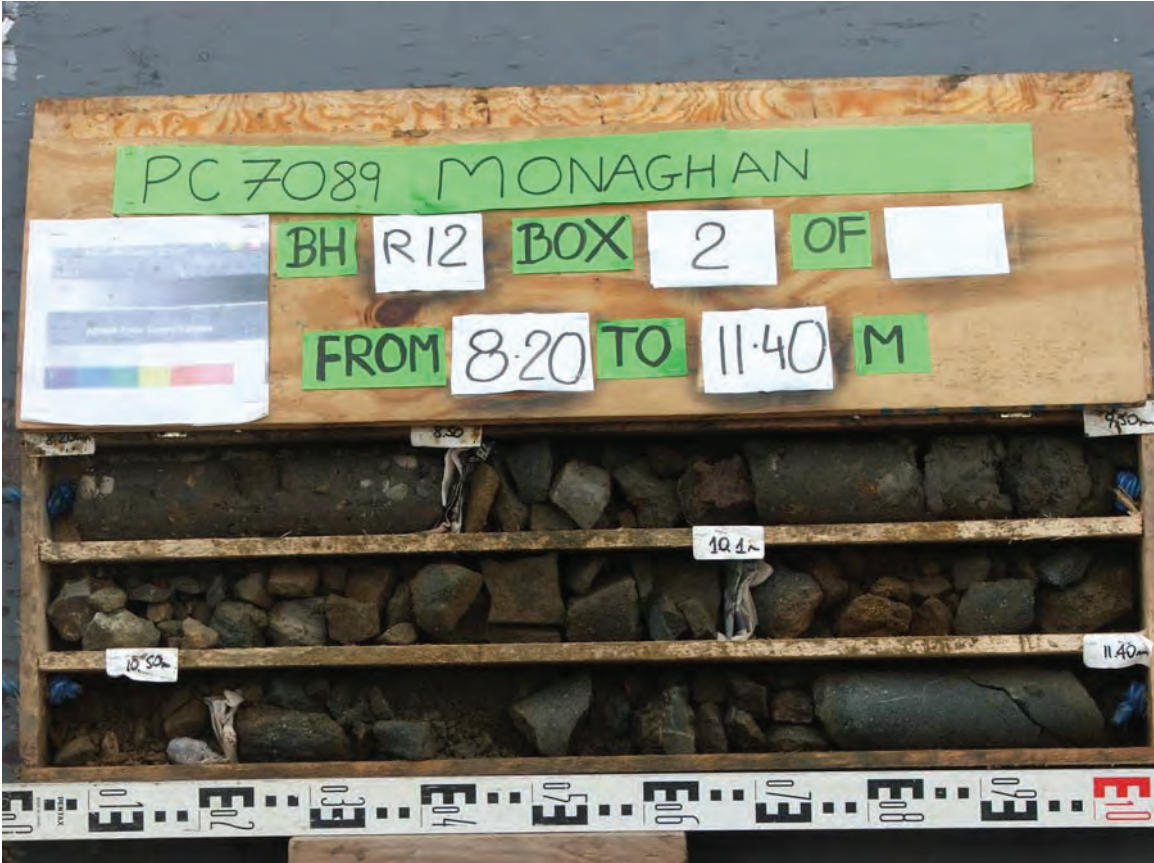
Rotary Borehole Number: BHR12	Project Monaghan Town Collection Network Project No PC7089 Carried Out for T. J. O'Connor & Associates, Consulting Engineers	
--------------------------------------	---	--

Rotary Core Photographic Record

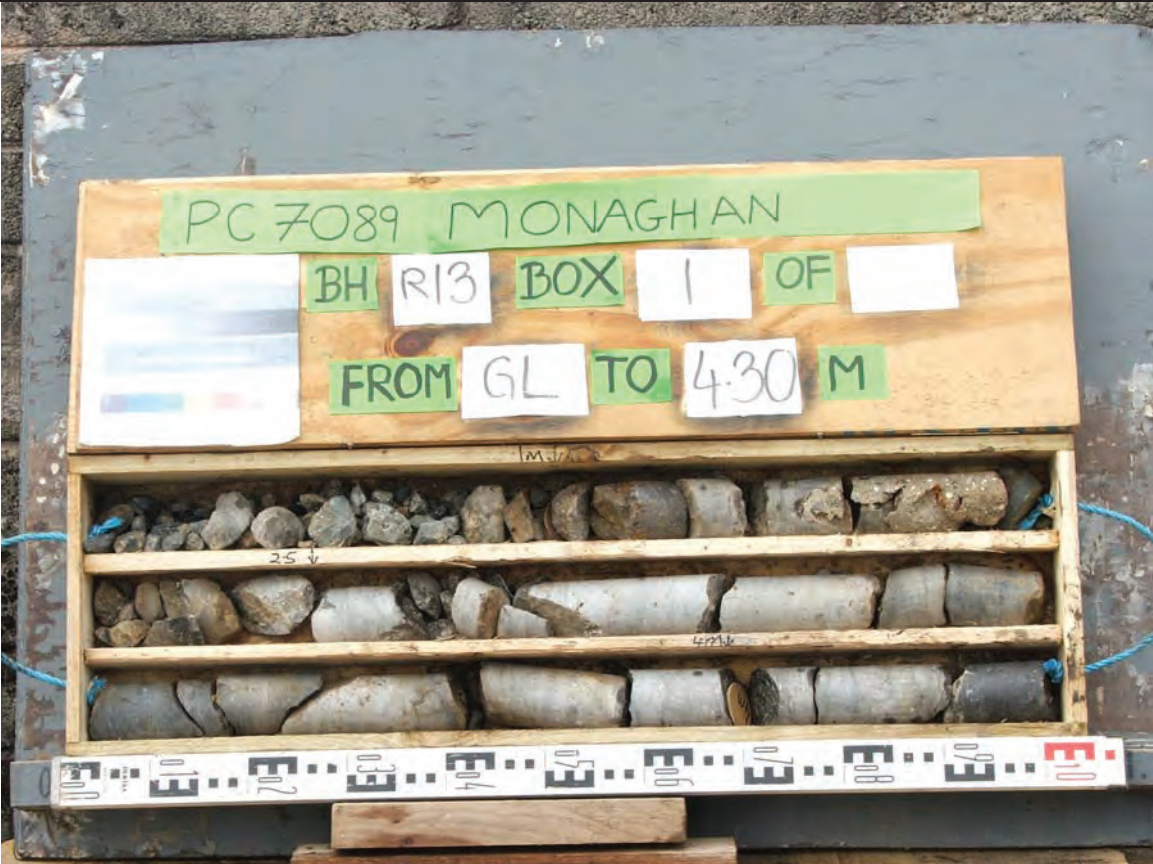
Rotary Borehole Number: BHR13	Project Monaghan Town Collection Project No Network PC7089 Carried Out for T. J. O'Connor & Associates, Consulting Engineers	
--------------------------------------	---	--

Rotary Core Photographic Record

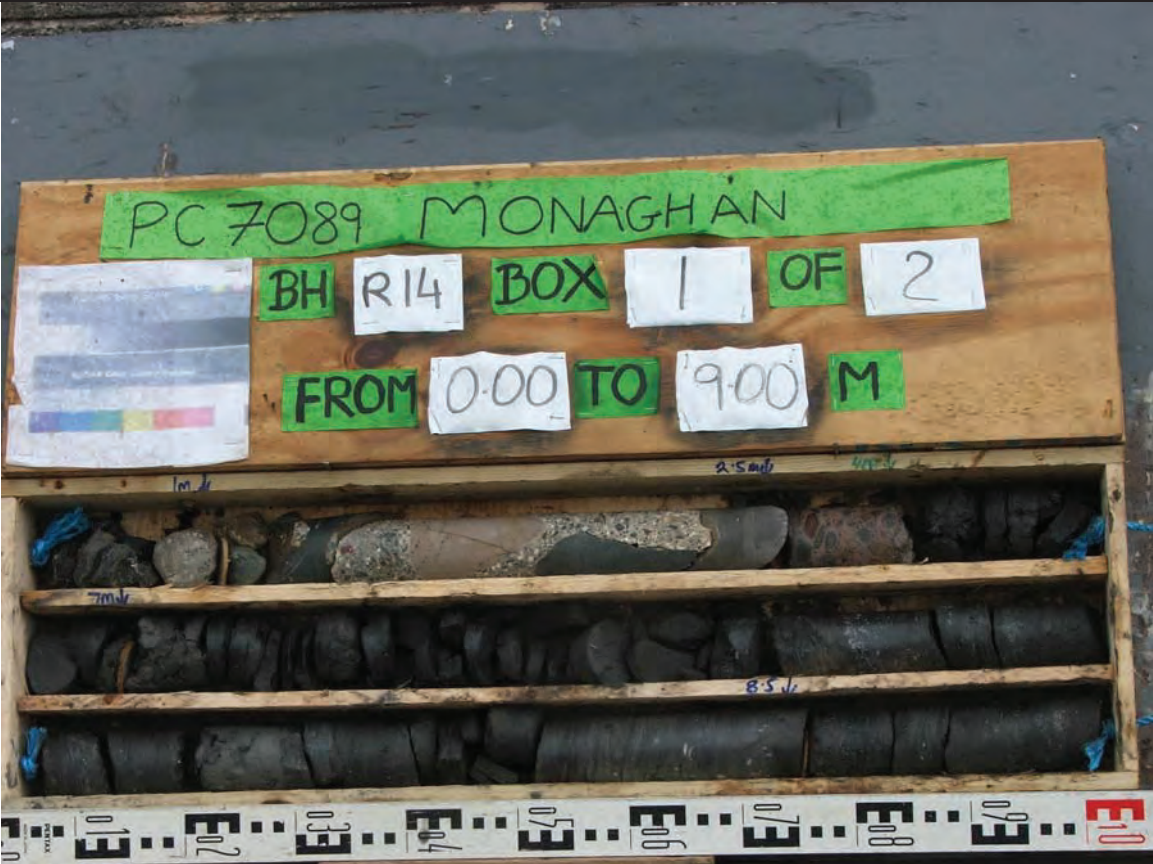
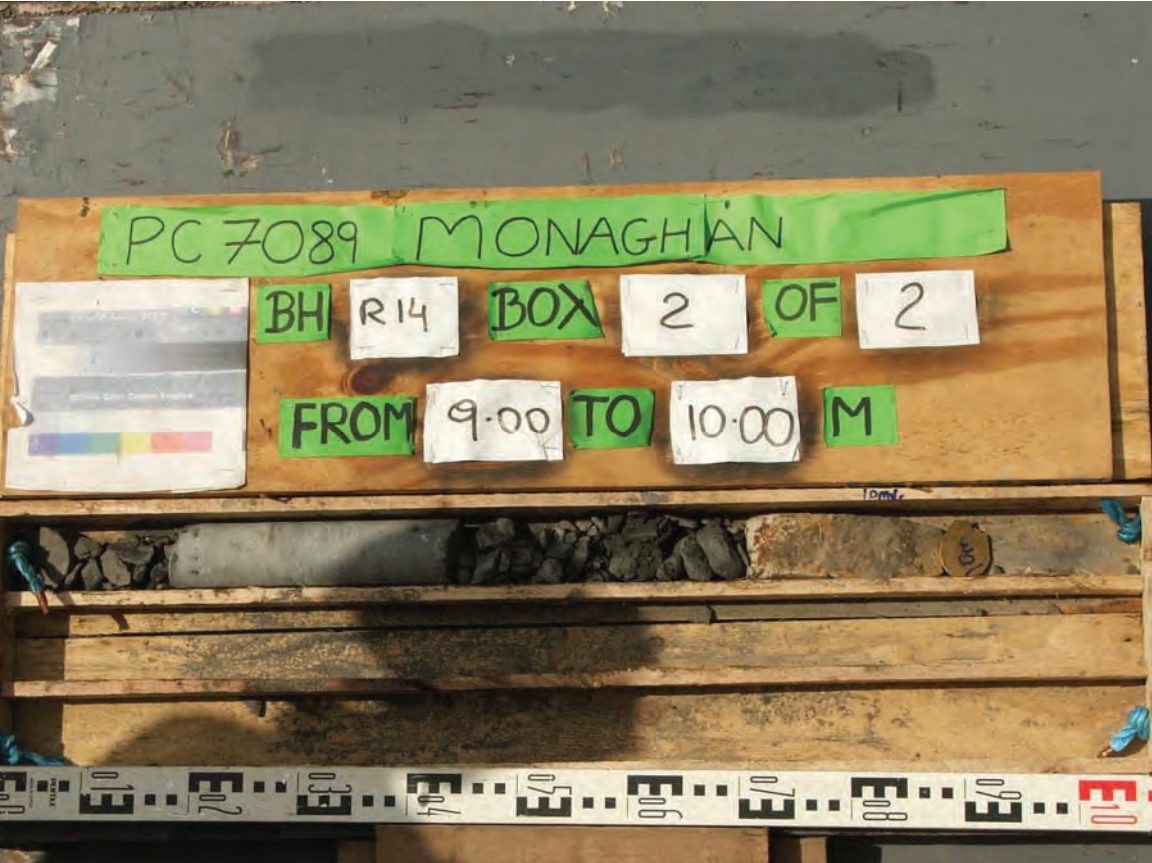
Rotary Borehole Number: BHR14	Project Monaghan Town Collection Project No Network PC7089 Carried Out for T. J. O'Connor & Associates, Consulting Engineers	
--------------------------------------	---	--

Rotary Core Photographic Record

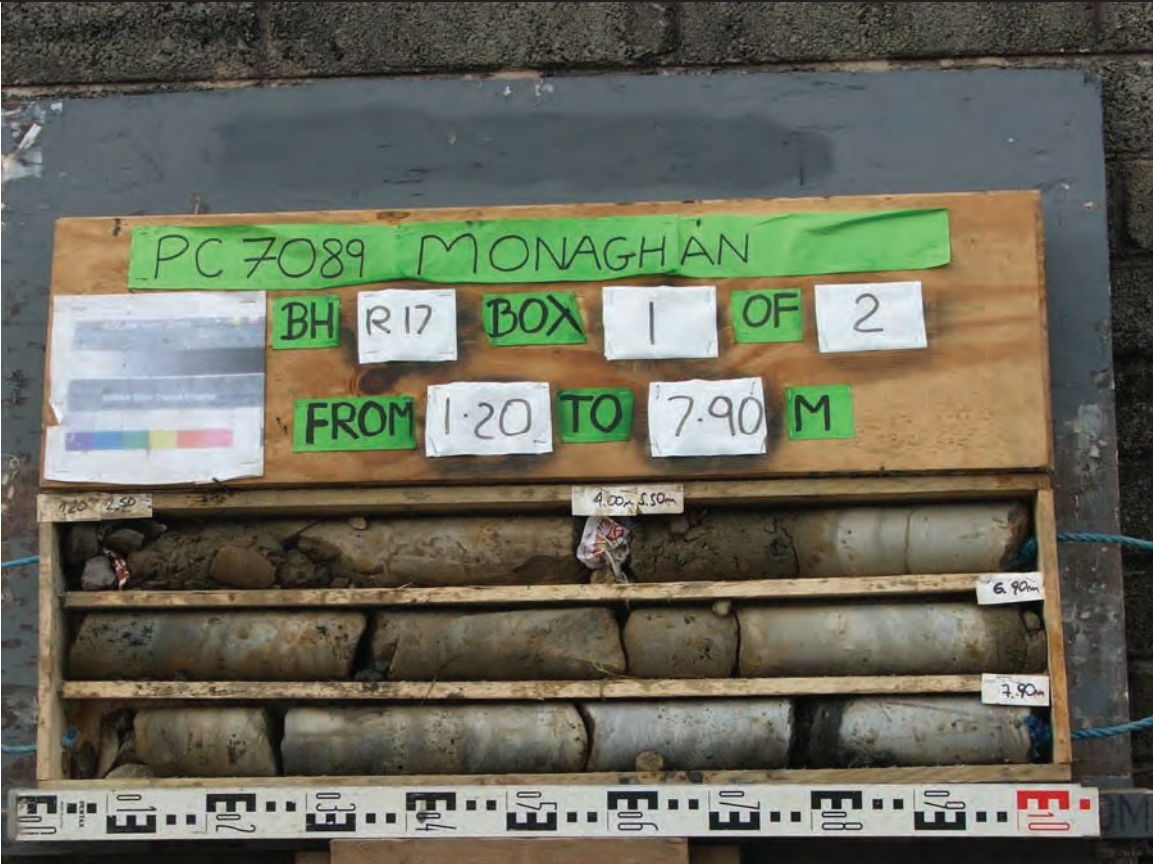
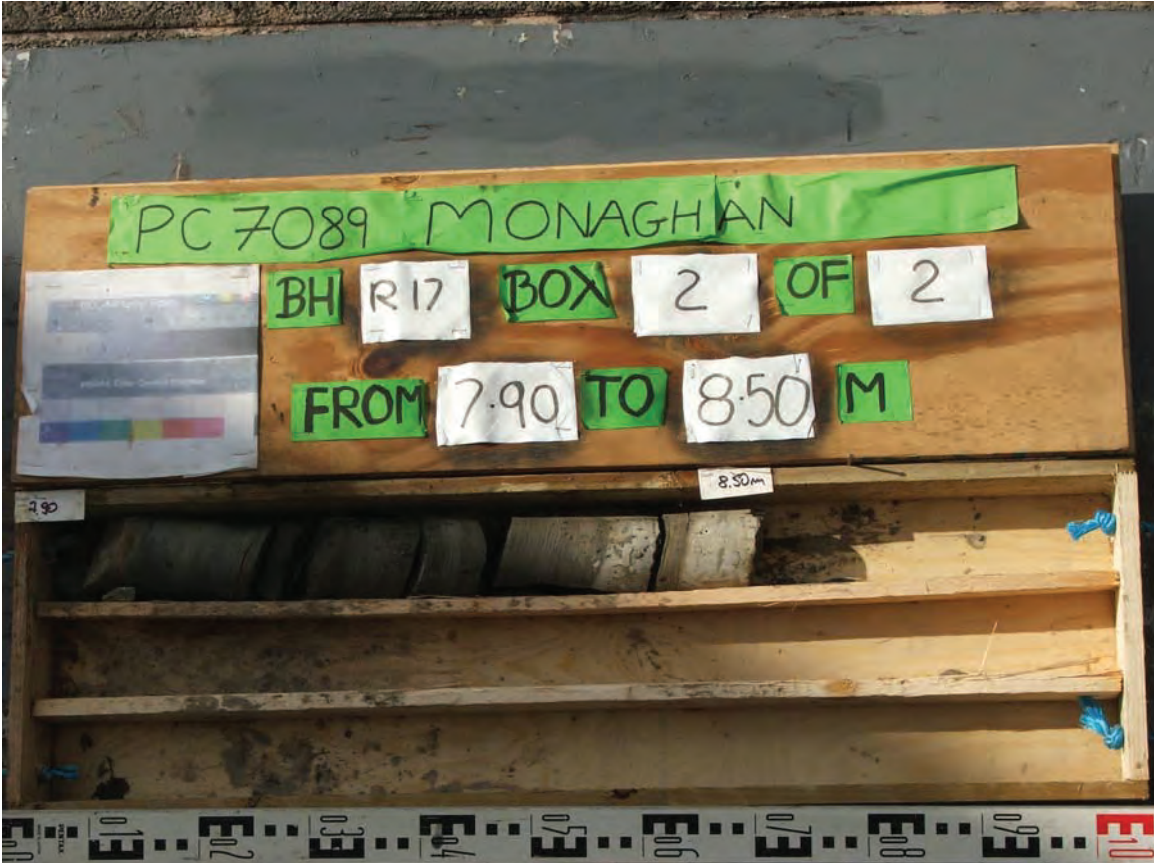
Rotary Borehole Number: BHR17	Project Monaghan Town Collection Network Project No PC7089 Carried Out for T. J. O'Connor & Associates, Consulting Engineers	
--------------------------------------	---	--

Rotary Core Photographic Record

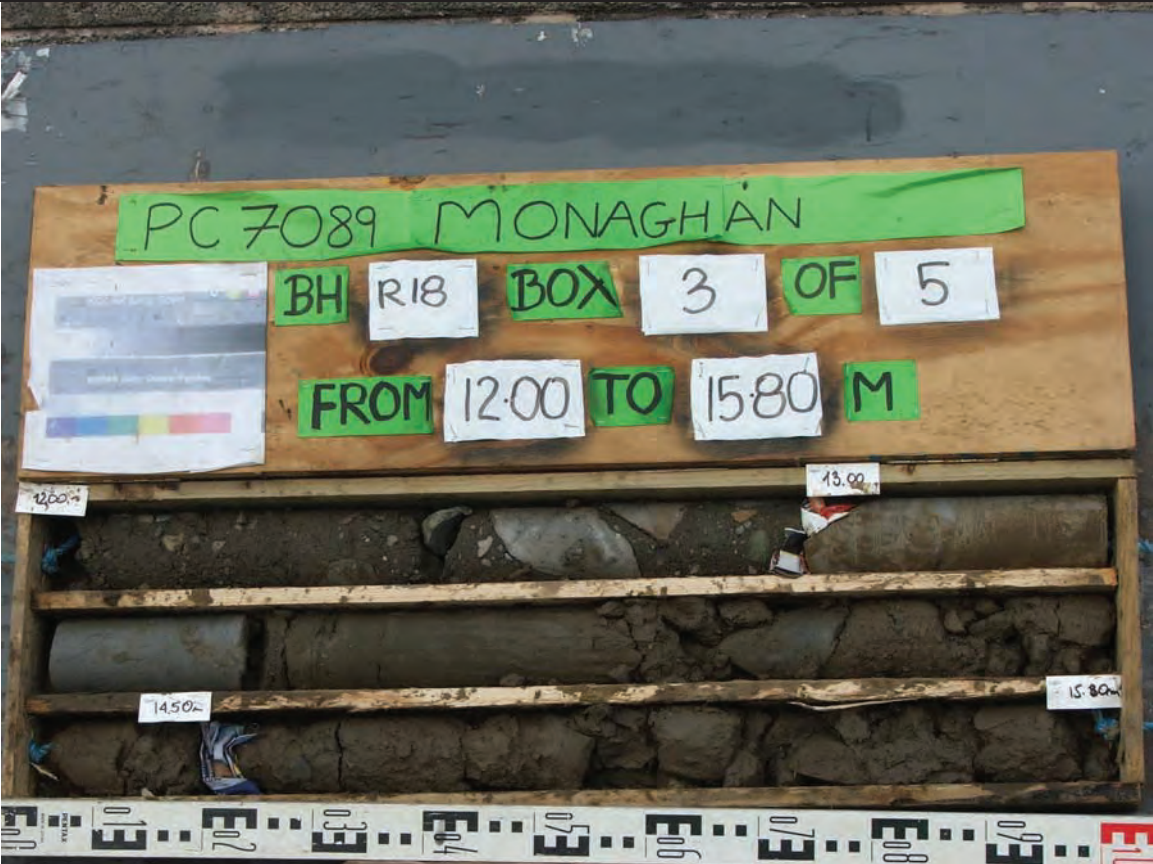
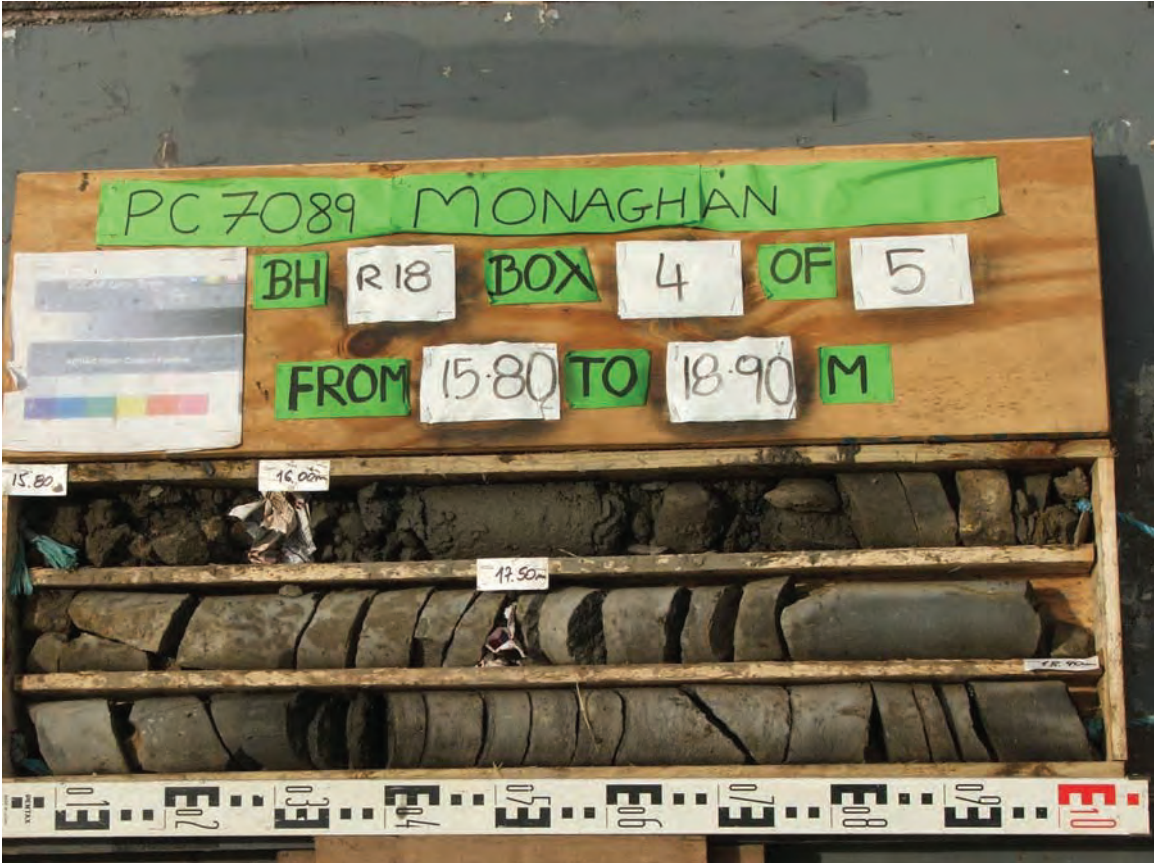
BHR18

Rotary Core Photographic Record

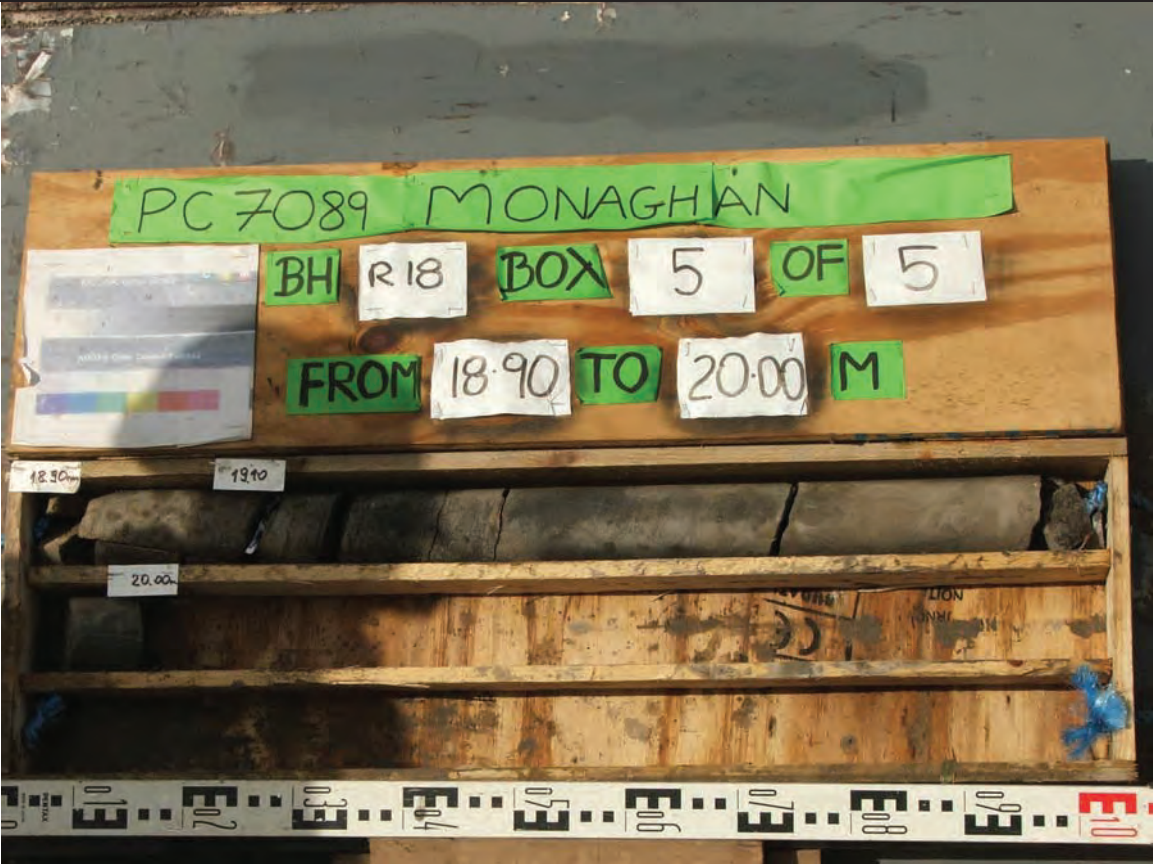
Rotary Borehole Number: BHR18	Project Monaghan Town Collection Project No Network PC7089 Carried Out for T. J. O'Connor & Associates, Consulting Engineers	
--------------------------------------	---	--

Rotary Core Photographic Record

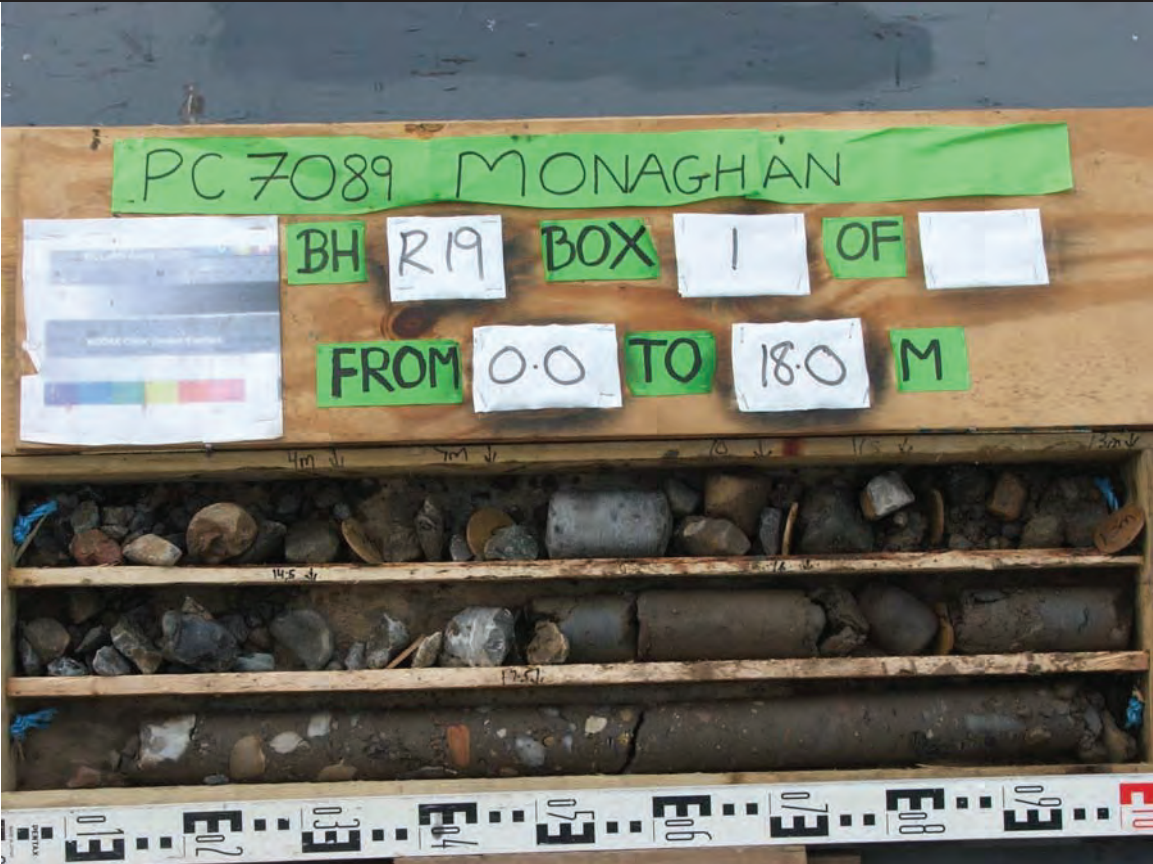
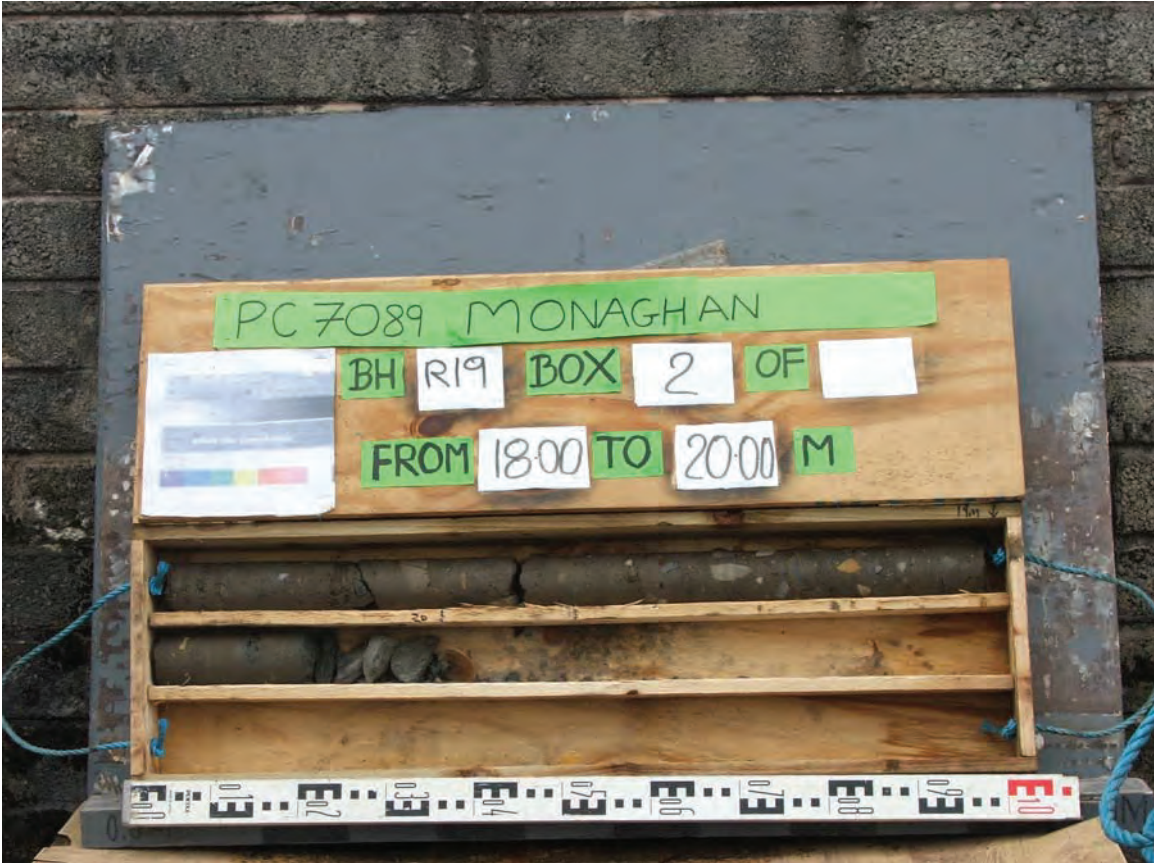
Rotary Borehole Number:	BHR19	Project Project No Carried Out for	Monaghan Town Collection Network PC7089 T. J. O'Connor & Associates, Consulting Engineers
-------------------------	-------	--	---

Rotary Core Photographic Record

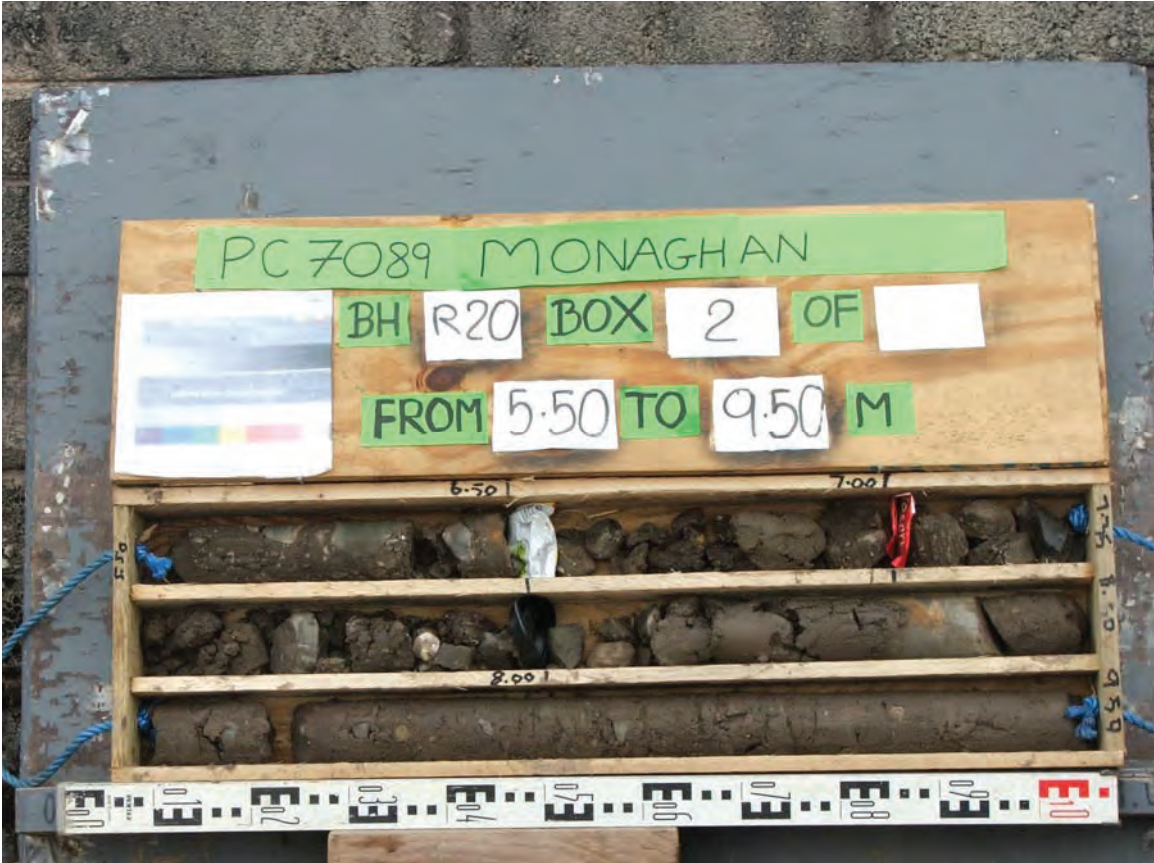
Rotary Borehole Number: BHR20	Project Monaghan Town Collection Project No Network PC7089 Carried Out for T. J. O'Connor & Associates, Consulting Engineers	
--------------------------------------	---	--

Rotary Core Photographic Record

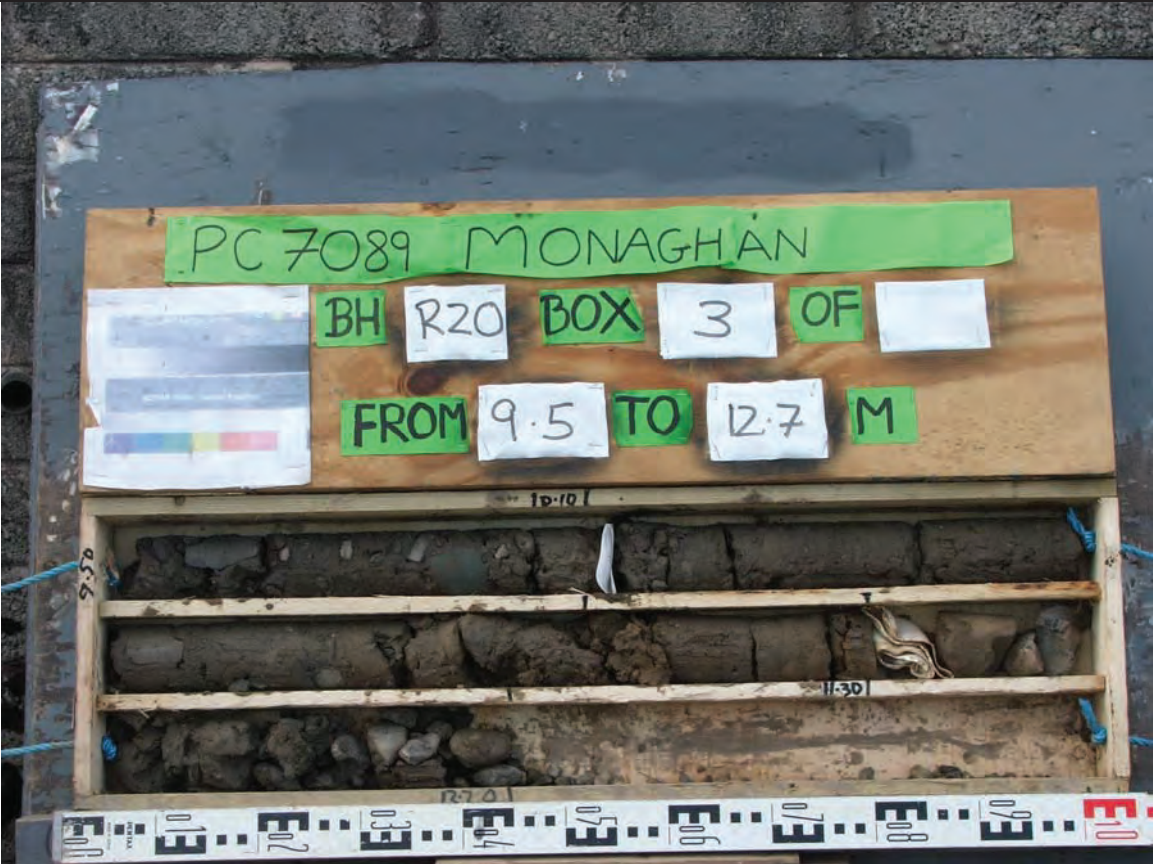
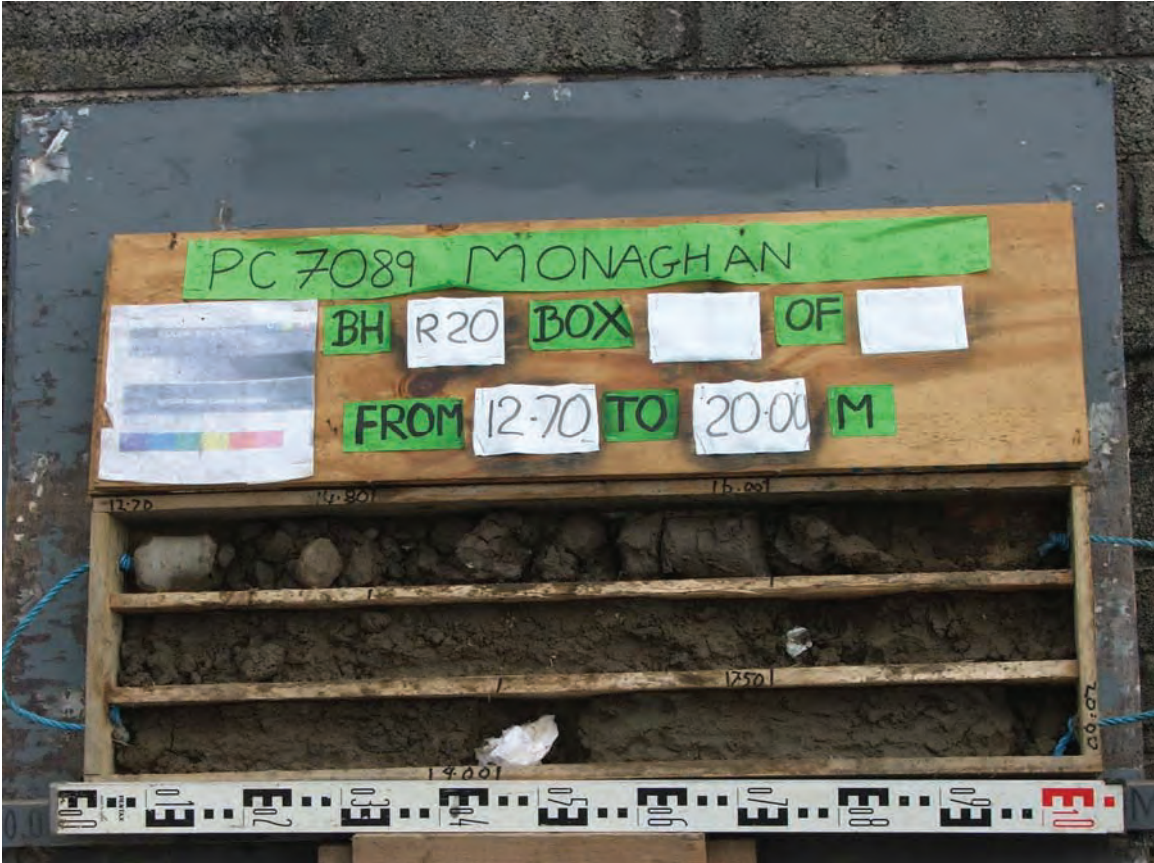
Rotary Borehole Number: BHR20	Project Monaghan Town Collection Project No Network PC7089 Carried Out for T. J. O'Connor & Associates, Consulting Engineers	
--------------------------------------	---	--

Rotary Core Photographic Record

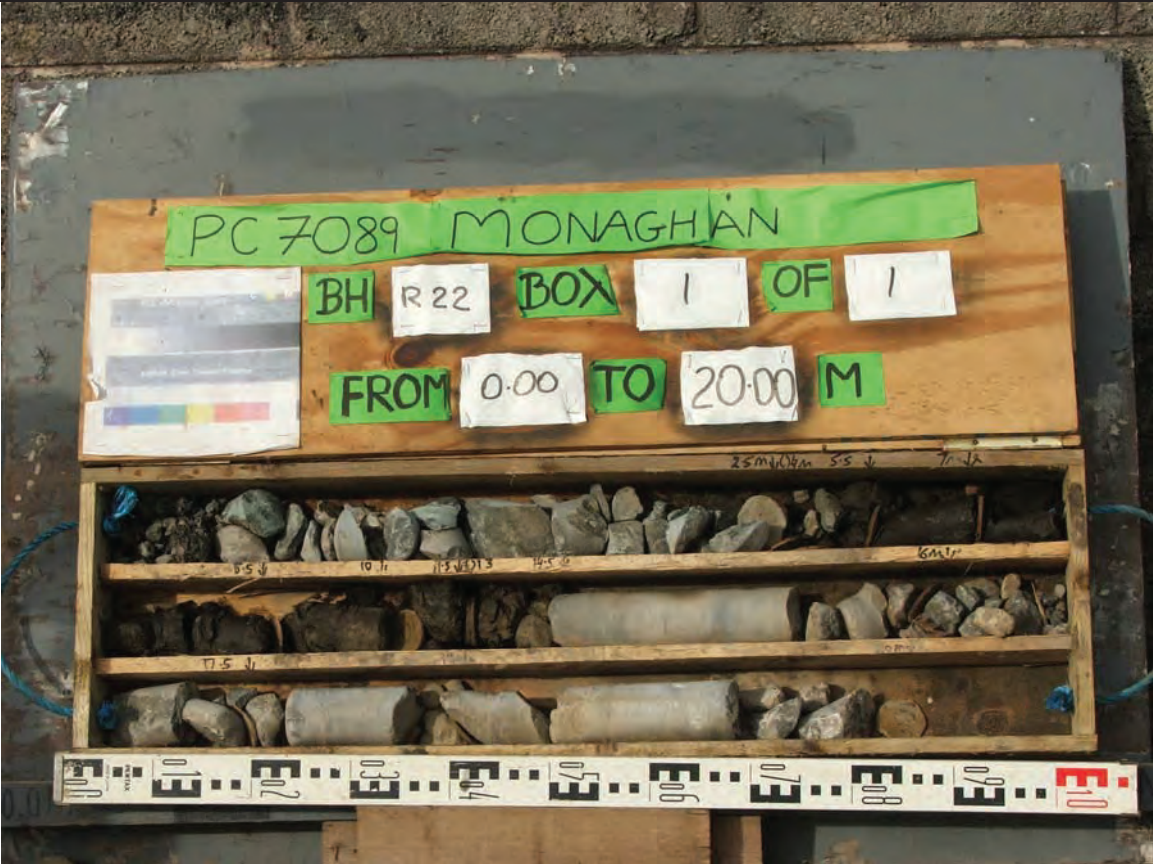
Rotary Borehole Number: BHR22	Project Monaghan Town Collection Network Project No PC7089 Carried Out for T. J. O'Connor & Associates, Consulting Engineers	
--------------------------------------	---	--

Rotary Core Photographic Record
