GEOTECHNICAL BORING RECORD

Appendix 3 - Trial Pit Records

Regeneration Scheme in Monaghan Town: Phase 1 South Dublin Street and Backlands

Stage 1 Road Safety Audit

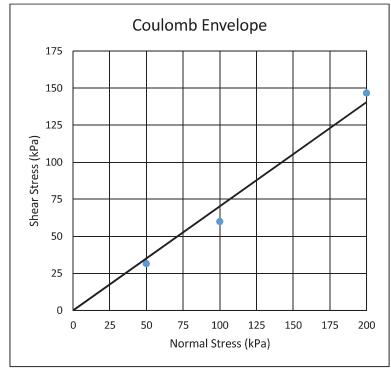
c' (kPa) 0 φ' (degrees) 35

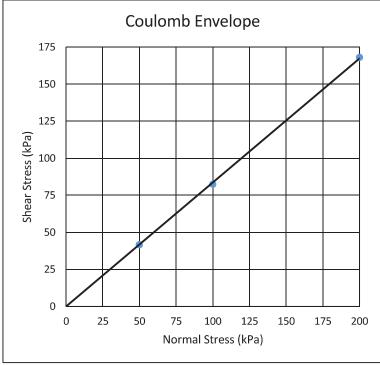
c' (kPa) 0 φ' (degrees) 40

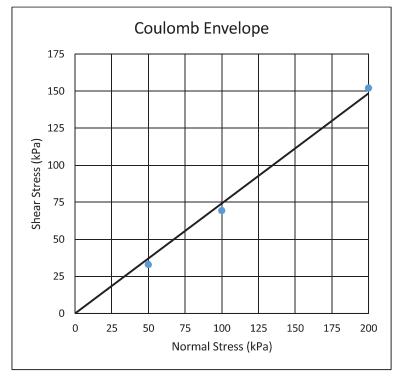
c' (kPa) 0 φ' (degrees) 37

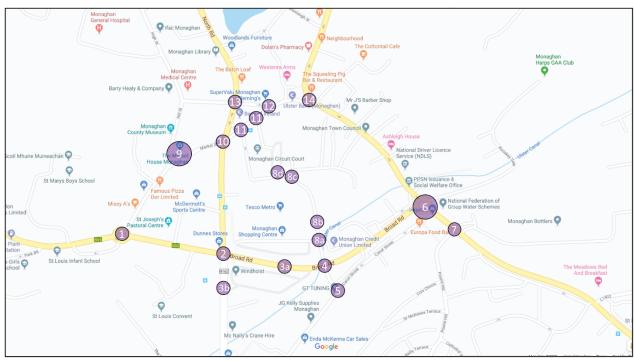
Figure 3.1 - Location of Junction Turning Counts and Queue Surveys

| J. No. | Junction Name |
| 1 | N54 Clones Road / Market Road / Park Street roundabout |

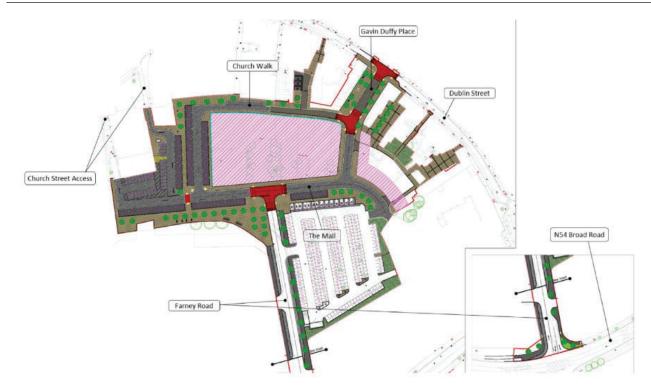
Figure 2-1: Scheme extents

The scheme extents are shown in Figure 2-1. The proposed works comprise:

It is intended the large area at the centre of the development hatched in purple will be reserved as a future development site with vehicular access intended on Church Walk. It is intended there will be a 60mm high kerb upstand between the natural stone paving within the carriageway and the footpaths on Church Walk. It is also proposed to relocate the existing recycling bins to the southern corner of the carpark adjacent to Farney Road.

The existing streets within the scheme extents comprise footpaths and carriageways with a number of narrow and inconsistent pedestrian facilities. The existing speed limit within the scheme extents is 50km/h. The surrounding land uses are predominantly commercial and retail.

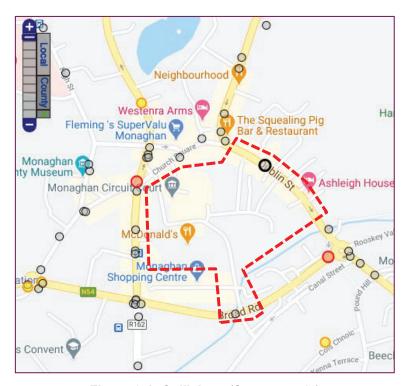
Figure 3-1: Collisions (Source: rsa.ie)

One minor injury collision occurred on Dublin Street in 2011 and involved a pedestrian.

One minor injury collision occurred on N54 Broad Road in 2014 and involved a pedestrian. This collision occurred in close proximity to the existing pedestrian crossing.

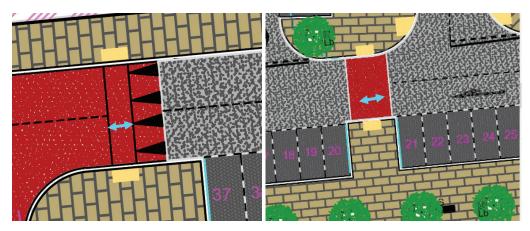
If insufficient width is provided on the raised ramps, pedestrians could slip down the sloped ramp into waiting vehicles, resulting in possible personal injuries.

Sufficient width should be provided on the raised pedestrian crossings.

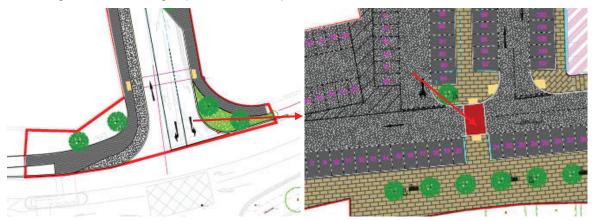
If insufficient visibility at the junctions is provided, it could lead to a driver pulling out in front of an oncoming vehicle, resulting in possible side impact collisions.

Sufficient visibility splays should be provided at junctions.

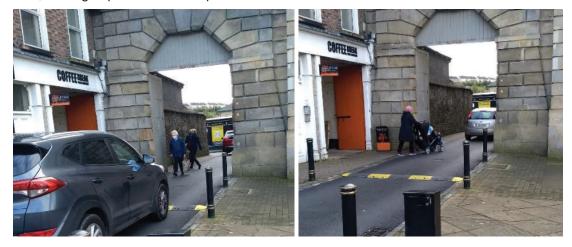
Drivers entering the arch from Church Square may not expect a pedestrian to be in the carriageway in this location, especially drivers unfamiliar with the area or during poor visibility conditions. There is a risk that pedestrians may enter the carriageway in front of an oncoming vehicle, leading to possible vehicle-pedestrian collisions.

Improved pedestrian facilities should be provided on the Church Street Access.

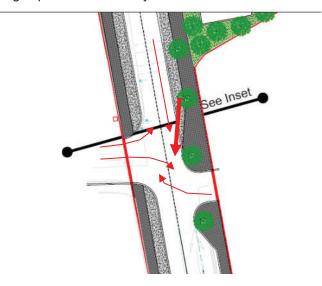
Cyclists who fail to observe all of the vehicle movements may enter the traffic lane in front of an oncoming vehicle resulting in possible vehicle-cyclist collisions.

The southbound cycleway should be terminated in a safe location.

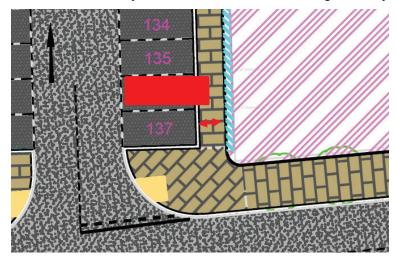
If vehicles overhang the footpath, mobility impaired pedestrians may choose to travel within the carriageway in this location where they are at an increased risk of being struck by a vehicle.

Sufficient footpath width should be provided behind perpendicular parking bays.

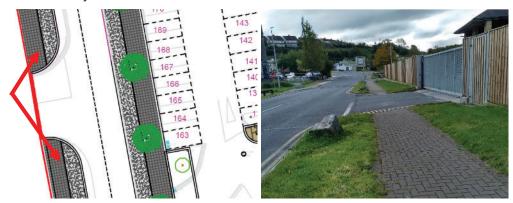
It is unclear if there is sufficient visibility provided to approaching pedestrians or cyclists for drivers existing the access due to the high fence. Insufficient visibility to pedestrians or cyclists crossing the commercial access could lead to a reduced reaction time for drivers and possible vehicle-pedestrian or vehicle-cyclist collisions.

Sufficient visibility to pedestrians and cyclists should be provided for drivers exiting the access.

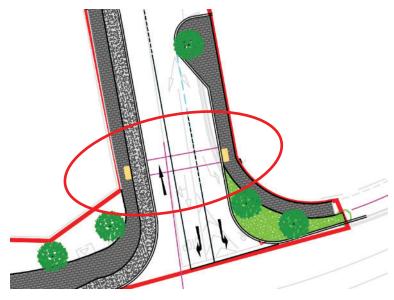
Additionally, pedestrians making the crossing will also be required to descend/ascend a full height kerb at the traffic edge of the cycleway.

A safer pedestrian crossing alternative should be provided of Farney Road.

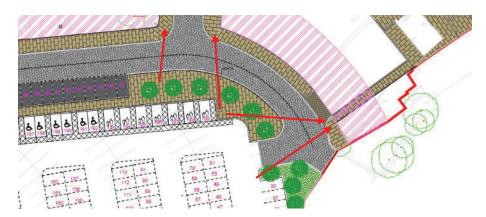
If pedestrians cross The Mall in an unsafe location it could lead to trip incidents resulting in possible personal injuries.

Pedestrian crossings should be provided of the Mall in appropriate locations.

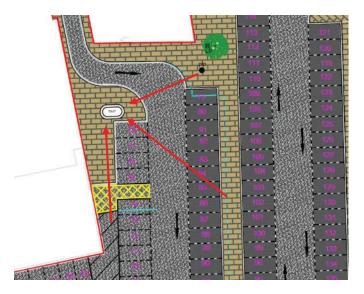
If appropriate access to the toilet is not provided, pedestrians ascending or descending the kerb could trip resulting in possible personal injuries.

Appropriate access for pedestrians should be provided to the public toilet.

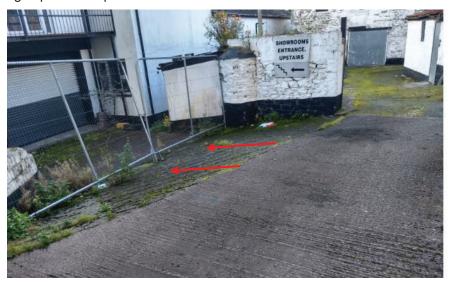
If the steep gradient is retained mobility impaired pedestrians may have difficulty traversing the slope leading to possible trip or fall incidents.

An appropriate gradient should be provided at the eastern Dublin Street link to the property accesses.

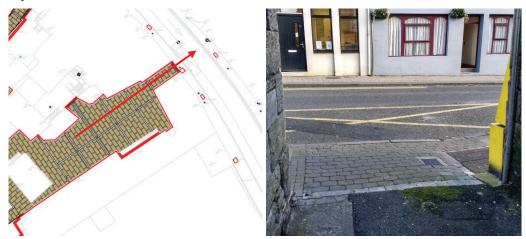
There is a risk visually impaired pedestrians may not appreciate the end of the footway if the low kerb is retained and inadvertently step into the carriageway on Dublin Street, where they could be struck by a vehicle.

Sufficient guidance for visually impaired pedestrians should be provided as to the termination of the footpath at the end of the pedestrian links to Dublin Street.
