Report No. 14537.R02

November 2007

## MAGHEROSS, CARRICKMACROSS, CO MONAGHAN

### CONSERVATION MANAGEMENT STRATEGY

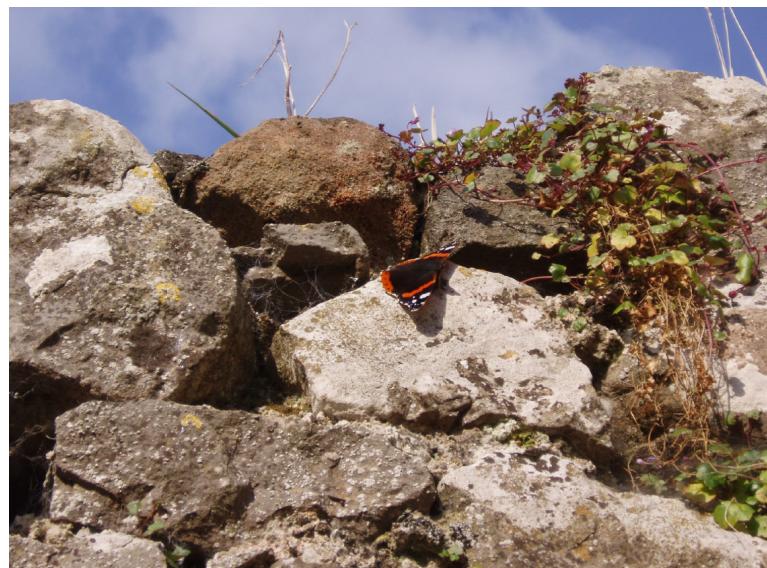
Fig. 6 Graveyards, especially those set in urban areas, can be important oases for wildlife

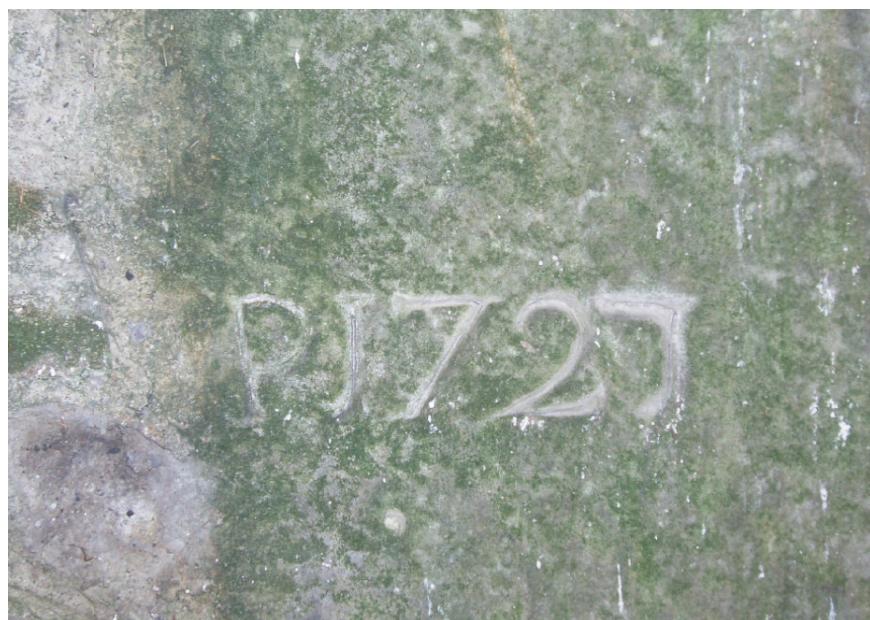
Fig. 11 Some of the graffiti within the tower is historically significant

Action 14 Generally, the inside of the tower needs tidying, particularly to remove the waste generated by pigeons. However, care should be taken to protect some of the graffiti (Fig. 11) which is now in itself historically significant.

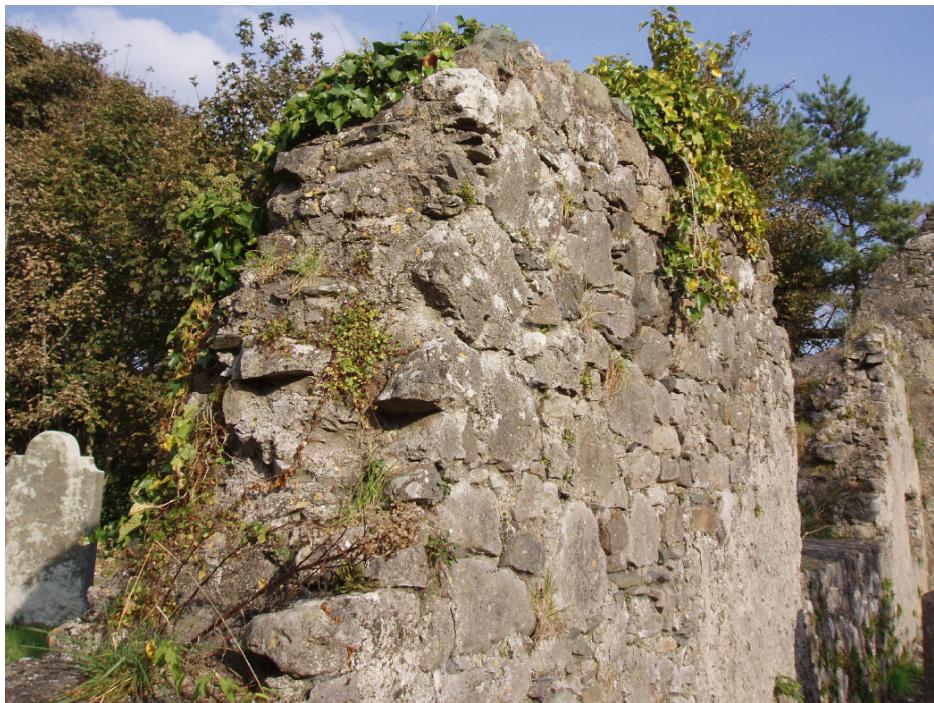
Fig. 20 Detail of the north wall of the church

than removal of ivy in the manner outlined above (Figs 19 and 20).

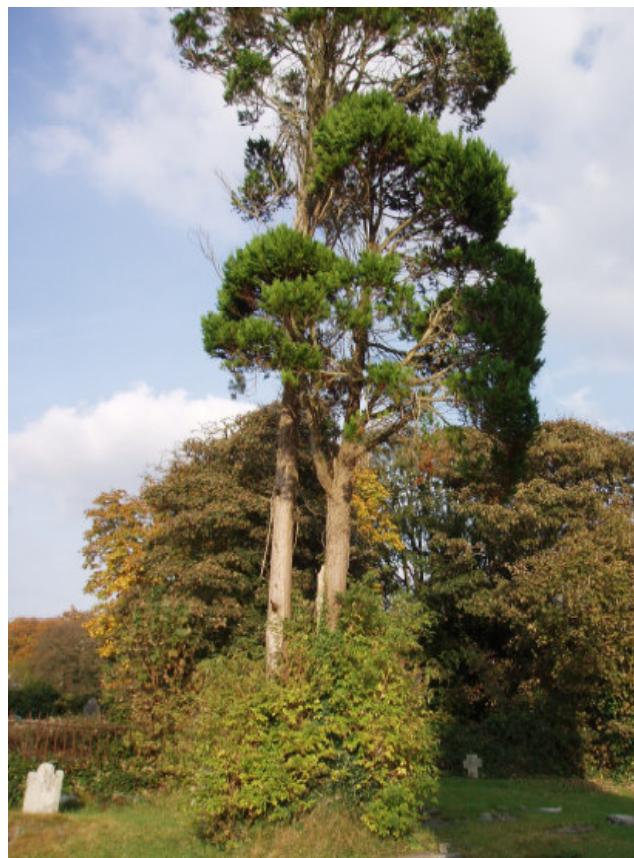
Mature trees enhance the appearance of graveyards and provide a habitat for wildlife (Fig. 21). As with most graveyards, Magheross contains a number of yews, one of which is listed in Monaghan County Council's Draft Development Plan 2007-2013. However, tree and shrub roots are potentially damaging to any masonry, particularly where trees are growing close to the masonry fabric. A regime of regular pruning should be maintained, and over-mature trees replaced as necessary (after consultation with Monaghan County Council's Heritage Officer).

Fig. 21 The graveyard is home to a number of mature trees which contribute to its character

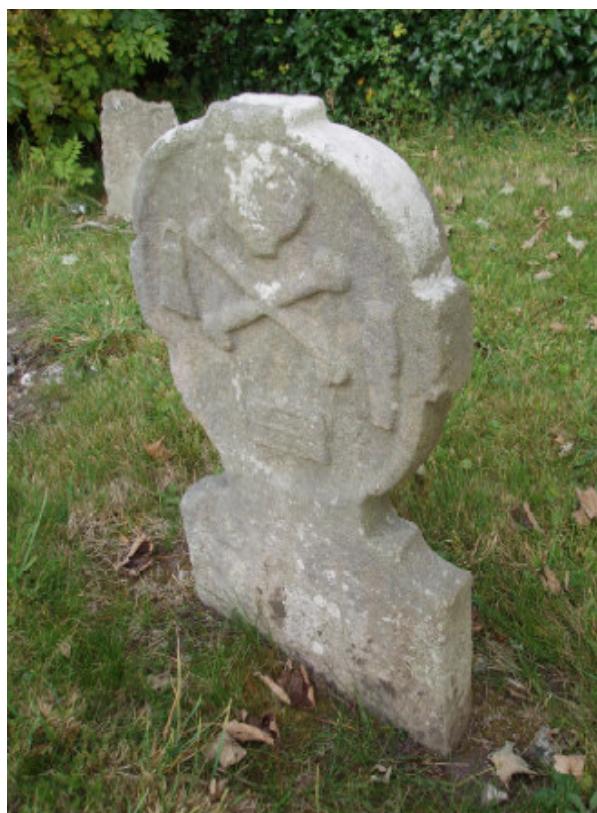
The majority of the gravestones appear to be in good repair and are easily accessible (Fig. 24). Some, however, have sustained damage in antiquity, and this is especially true of some of the grave slabs (Figs 25 and 26). Whilst this damage is unfortunate, repairs would be expensive and they are consequently thought to be unnecessary at this time.

Fig. 24 Most of the grave markers are in good repair

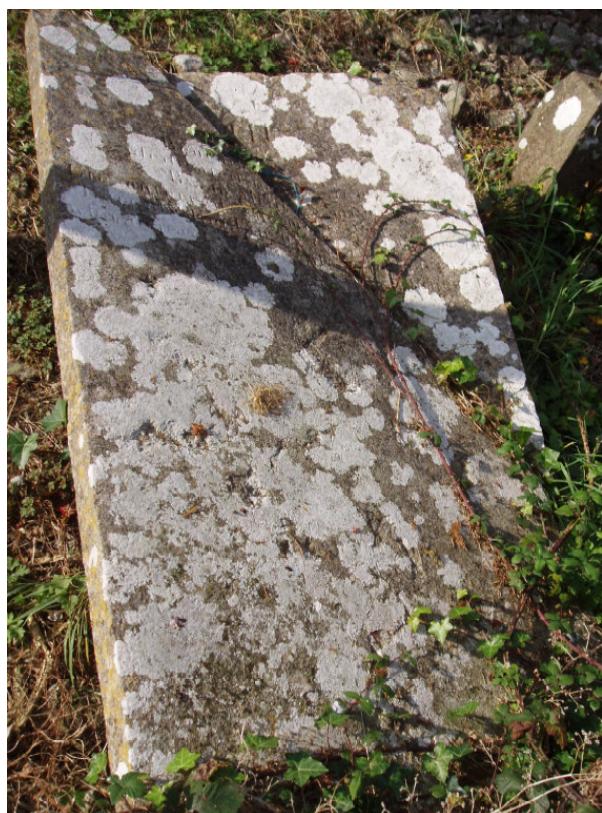
Moss and lichen also add to the character of graveyards (Fig. 27). Some lichens damage stonework, and it might be beneficial to consult a lichenologist to ascertain whether the lichens are benign or not. Mosses are generally sympathetic to gravestones and should only be removed if there is clear evidence that the growths are having a detrimental effect on the integrity of the stone.

Fig. 27 Mosses and lichen can enhance the character of graveyards

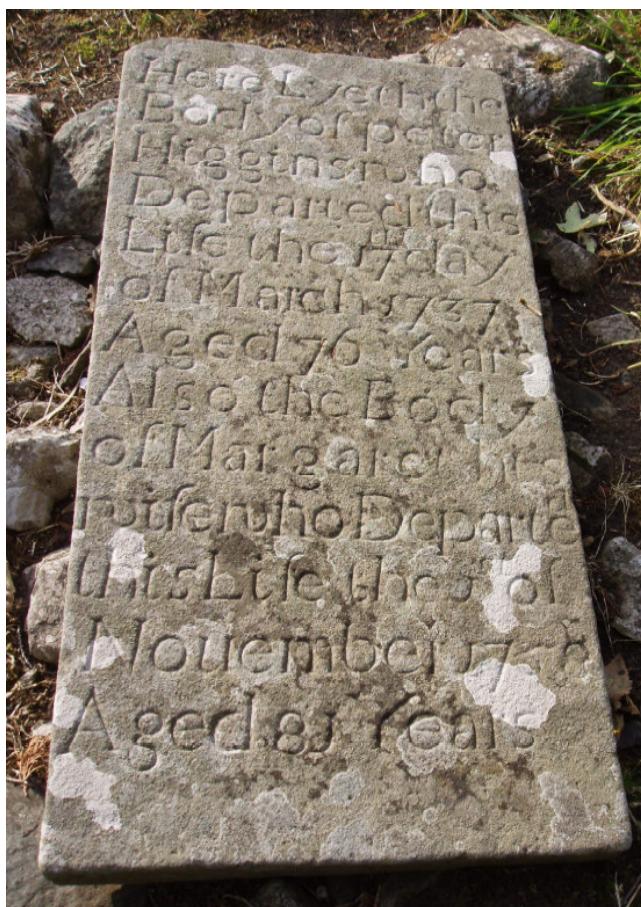
Fig. 28 The fine inscriptions on some of the grave markers are susceptible to damage from weathering

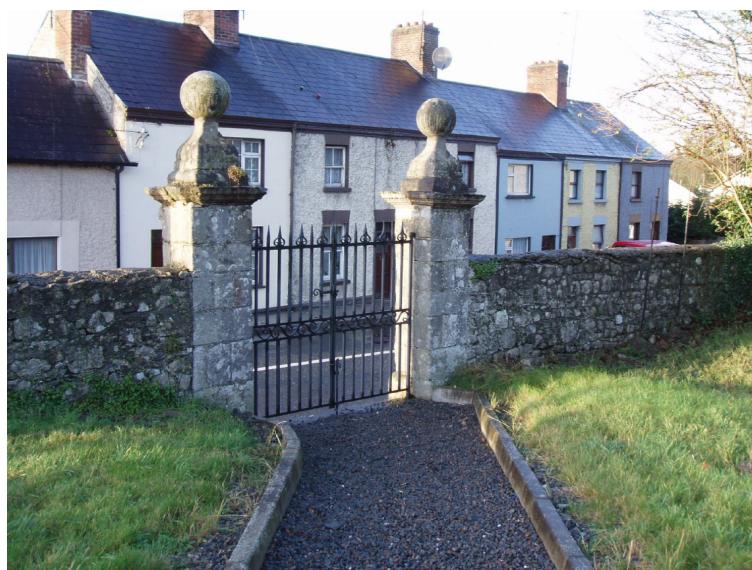
Fig. 46 The entrance gate to the site is in good order
