Temple Moyle, Lattonfasky, Co. Monaghan
Conservation Plan

Temple Moyle, Lattonfasky, Co. Monaghan Conservation Plan

Monuments: MO024-034001 Church & MO024-034002 Graveyard

Our Ref: 2021_53

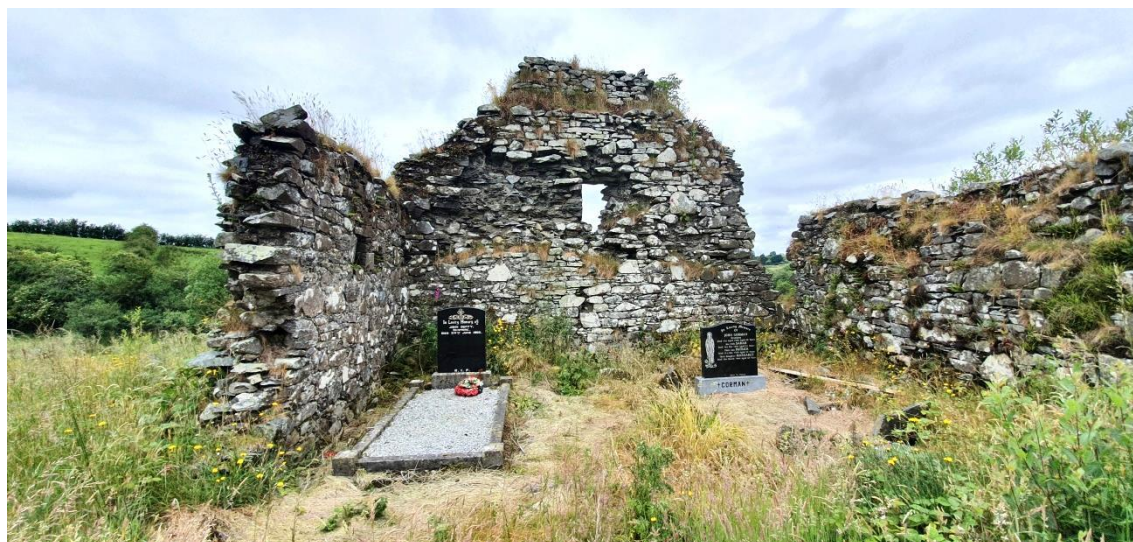
One of the modern gravestones marked John Duffy, buried 1969, belongs to the local blacksmith locally known as Johnny Stephen (Plate 9). Johnny Stephens forge is now a ruined stone building located at the top of the hill near the entrance to the approaching laneway. It is not known why Johnny Stephen was granted the privilege of being buried within the chapel. Mr McEntee remembers accompanying someone to a different blacksmith's forge as a child and witnessing the blacksmith give the cure to his companion (the cure of what is unclear). It was very common for blacksmiths to have the cure, particularly if the 'patient' drank the water from the forge. It is possible the water did in fact have healing properties due to the high levels of iron within it. This healing ability, along with their standing within the community as a necessary craftsman would have caused blacksmiths to be held in high regard. It is not known if Johnny Stephen himself had the cure and as a result was held in high esteem but it is very unusual for him to have been granted a position within the chapel walls. It is especially curious as he had no family. It is worth noting that throughout the graveyard and even within the chapel itself there are grave markers comprising of iron crosses made from reused cartwheels, it is possible Johnny Stephen made these grave markers and perhaps this was the reason he was granted the respect of burial within the chapel.

Plate 9: Two modern graves within the western end of the chapel one marked John Duffy (left) and one John Gorman (right)

It is said that the 'Night of the 'Big Wind' on the 6th of January 1839 was the highest the level of the lake ever rose to and the fish were blown out of the lake and scattered around the shore. Finally, local tradition recounted by Peadar Connolly tells of a prophesy stating that on the day of a funeral the western gable wall (which currently appears unstable, Plate 34) will collapse on the mourners gathered and kill many people. We will be recommending that wall is stabilised before the next funeral.

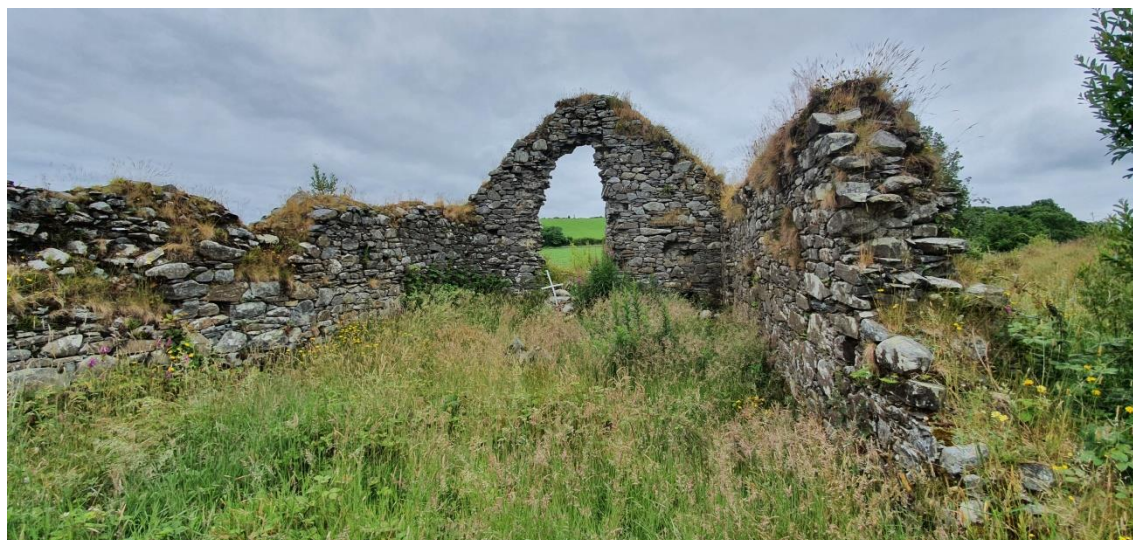
Plate 12: Eastern interior of chapel, Facing E

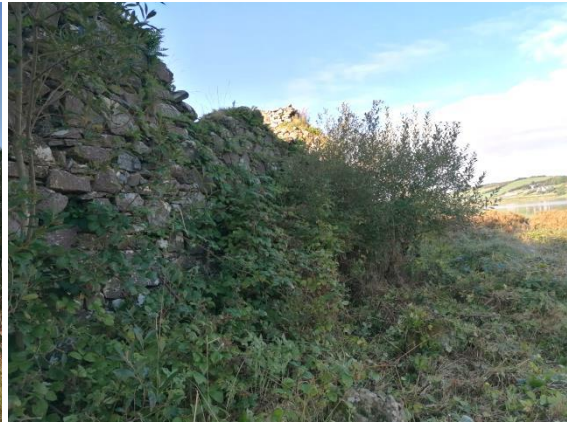
Plate 13 (L): Landscaping work gets underway at eastern gable of chapel, facing S
Plate 14 (R): The northern face of the chapel was extremely overgrown, facing W

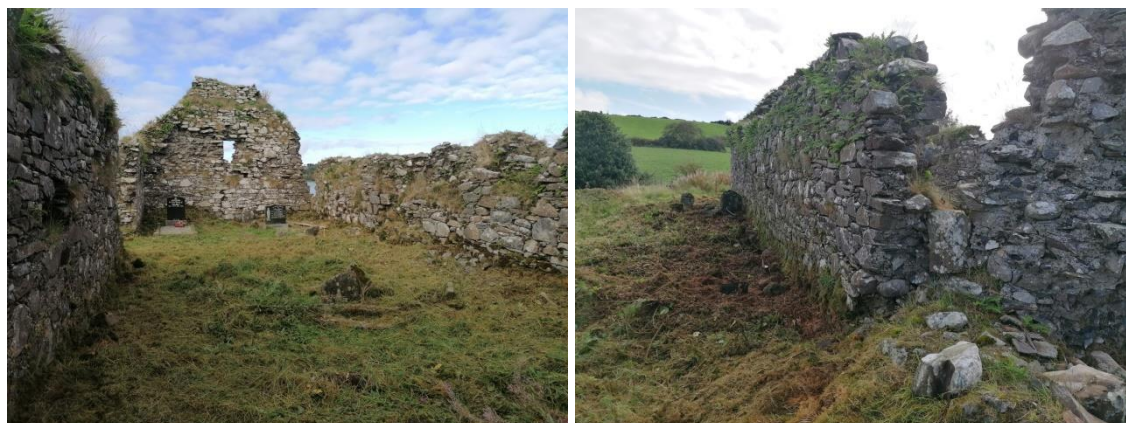
Plate 19 (L): Landscaping work completed, western interior of chapel, Facing W

Plate 20 (R): Landscaping work complete, northern wall and collapsed NW corner stone heap, Facing SE

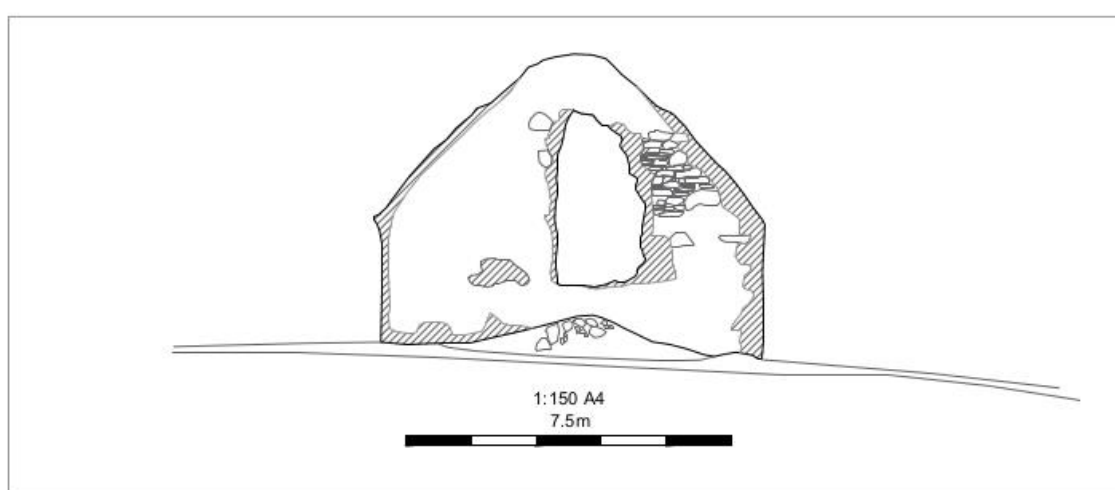
Figure 14: East Elevation (exterior)

Across the east wall and all across the chapel, grass and ferns can be noted growing between stones. Grass is particularly prominent across the bottom of the window opening and along the top of the wall itself. Roots of grass and ferns are unlikely to cause great damage and it is advised not to remove them. Tall grass, shrubs and small trees in the form of ash and sloe were growing in this area. They were removed during the landscaping works. A large tree stump is present near the window opening on the interior of the chapel. It appears to be some decades old and was manually cut 0.50m from the ground. The root systems of this large tree are likely to have penetrated to some depth and could have added to the destabilisation of this wall (Plate 24).

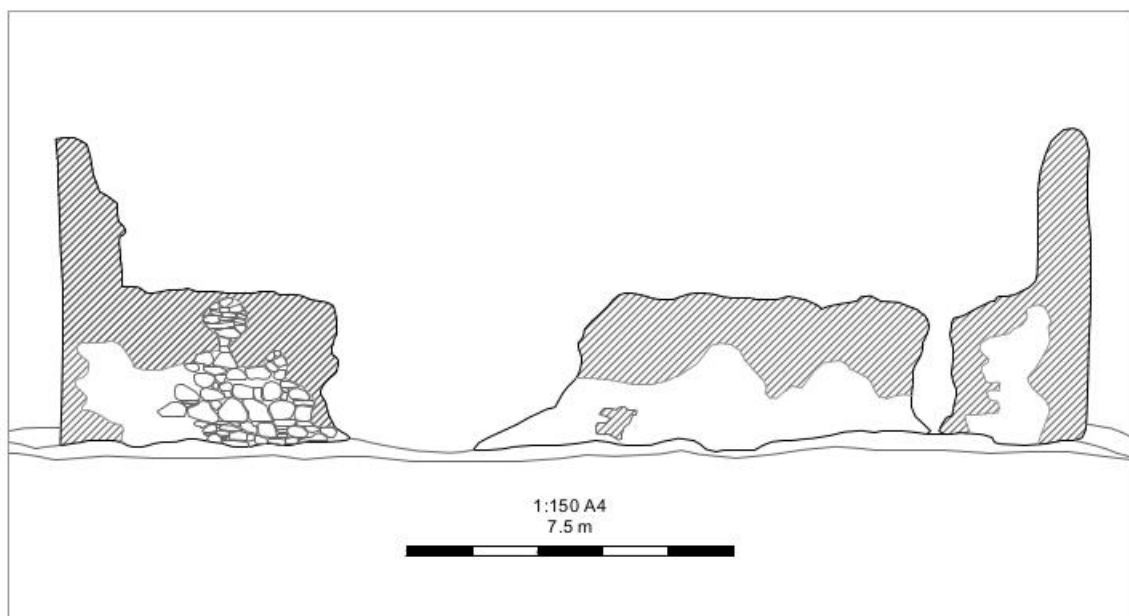
Figure 15: South elevation (exterior)

The key issues affecting the south elevation are:

- Collapse of the stones within the small window opening leading to lack of support and destabilisation of the top of the wall. This has resulted in a complete section of the wall collapsing.
- Brambles were noted growing through the wall in multiple places. All have been snipped during landscaping but are at risk of regrowth from the ground up.
- The collapse of the doorway has led to severe collapse of the western side of this elevation.
- Loss of mortar on the corners of the building, the top of the wall and certain patches along the wall face is leading to weathering of mortar resulting in further dislodgement of stones particularly around the area of the collapsed doorway.
- Beam-holes have been noted on the interior face but corbels which once supported the gallery have been removed.
- External wall face has fallen away over a substantial portion of the wall.

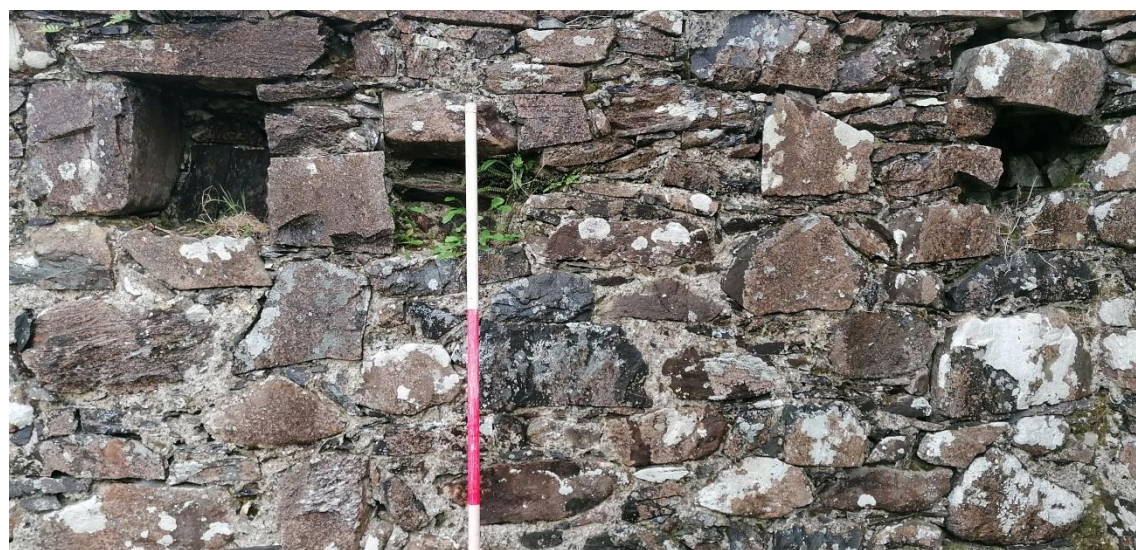
Plate 30: Inner face of south wall, towards the western side. Three beam-holes or empty slots that once held corbel stones for a wooden gallery

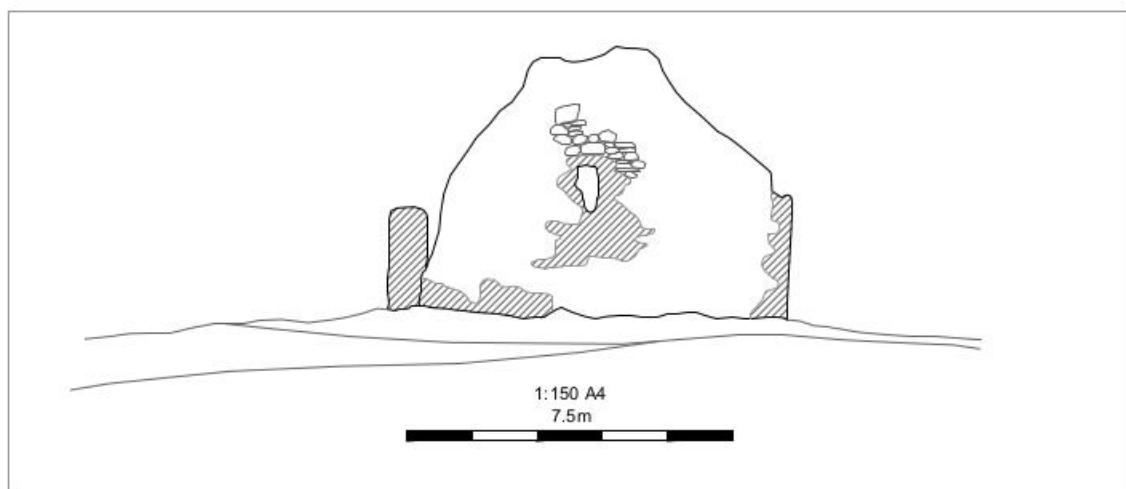
Figure 16: West elevation (exterior)

The is aligned NNE/SSW, with a small window high in the wall opening onto the gallery. It stands to a maximum height of c.6.25m but is in a poor state of repair. The NW corner has completely collapsed. The corner and lower northern section of the wall has become undermined by erosion and collapse. As a result the western gable wall no longer has any contact with or support from the northern wall and has a dangerous westward tilt away from the northern wall. Although the locals say it has stayed in this position for many years it would appear to be unstable (Plate 34). There are two decorated/inscribed stones on the external face of the western gable (Plate 5 & 6). These are described in detail in section 2.1.

The internal wall face is heavily eroded with large parts of the central area collapsed. The window, which is situated c.2.60m above ground measures max c.1m high x c.0.50m wide. The window is similar to the others in that it has splayed and faced edges, although with an apparently simple flat lintel. This window is higher than both the window in the east and south walls in order to open onto the original wooden gallery. Possible evidence for the gallery can also be found on this wall in the form of two (possibly three) holes representing removed corbel stones which would have supported the gallery beams (Plate 35).

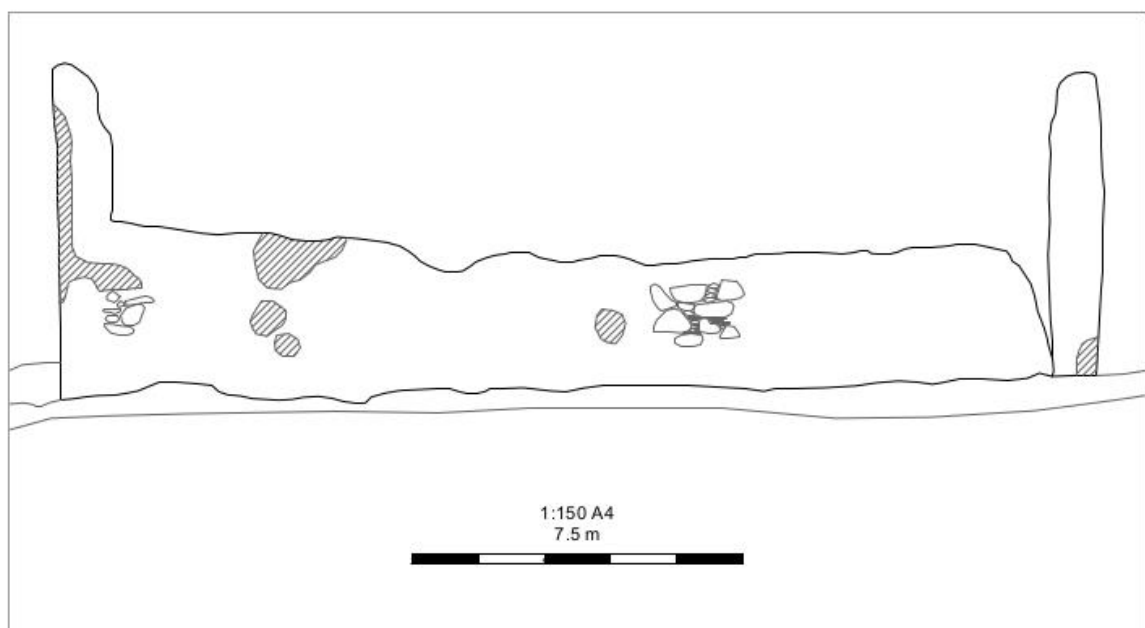
Figure 17: North Elevation (Exterior)

The external face of the north wall is the best preserved wall of the chapel (Plate 37 & 38). It is aligned ENE/WSW and was densely covered and obscured by saplings and brambles prior to the landscaping works (Figure 17, Plate 14 & 20). Both the NW and NE corners have suffered from partial erosion and collapse. Brambles had grown through the wall in this location and were snipped during the landscaping works. It is likely that some of the damage seen on the exterior and interior face of the north elevation are as a result of the brambles.

The key issues affecting the north elevation are:

- The mortar is eroding from between the stones in both corners, along the top of the wall and in small patches on the interior and exterior face this is resulting in partial collapse and loss of stones.
- Grass and ferns are obscuring the stones on the inner face of the wall
- Brambles are growing thickly along the wall, they were cut back during landscaping but will continue to grow in spring, they were recorded growing through the wall and snipped in those locations. It is possible the brambles could cause further damage to the walls.
- A decorated/ engraved stone was recorded on the interior face of the wall.

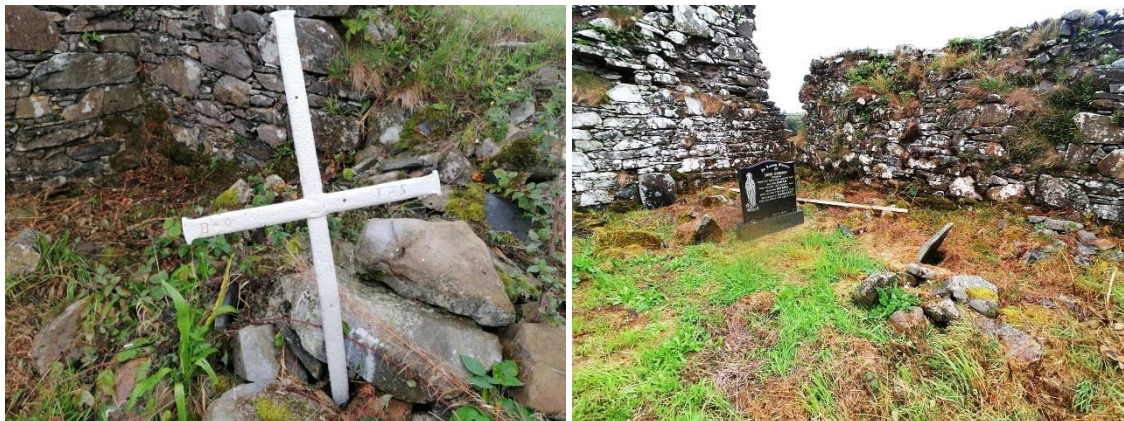
There are two modern gravestones, a head stone dating to the 18th century, an undated white Iron cross and multiple erect thin stone slabs which are unmarked within the chapel. The cross, made out of cartwheels, is said to mark the grave of two priests. The southernmost modern headstone marks John Duffy, dated 1969 while the northernmost modern headstone marks John Gorman and his family. Photos taken no earlier than 2003 suggest this grave is a recent addition to the chapel.

Plate 39: Painted white iron cross within chapel

Plate 40: Modern gravestone with 18th C gravestone behind it and unmarked headstones in front and beside within chapel

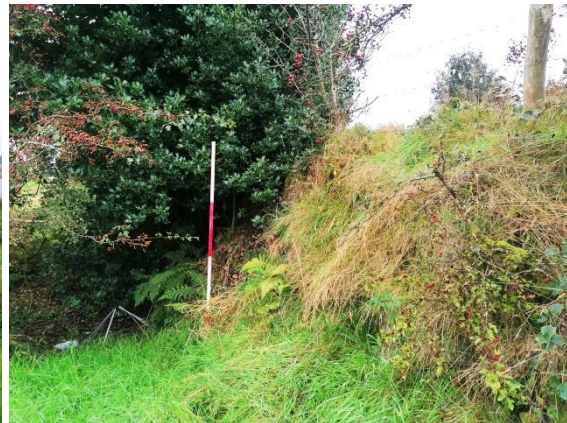
The entrance to the graveyard, located in its northern corner, is flanked by two large, square pillars measuring c.2m tall x c.1m wide. These appear to be of modern construction as they are held together with concrete but they are sympathetically designed and complement the chapel stonework well. Both piers have a large growth of ferns on the top and are covered in lichen. The gates themselves are iron with a wrought iron design at the centre (Plate 41).

The earthen bank which surrounds most of the graveyard emerges from the southernmost pier and runs SE. It is not built into to the pier and does not fully abut it which suggests this is perhaps the original bank and the pillar is a more recent addition (Plate 42). The bank is c.1.7m high x c.1.5m wide. Closer inspection revealed it to be a very overgrown and in places partially collapsed wall or stone faced bank. It appears to be constructed with the same stone type as the chapel, no cement was noted on inspection (Plate 43). To the rear (west) of the northernmost pier is a collapsed wall of similar construction to the pier running ENE/WSW measuring c.0.75m wide x 0.35m high x c.35m long. The wall abuts the pier and is likely to be contemporary with it. It is possible the wall truncates part of the northern section of the graveyard (Plate 44).

Plate 41 (L): Entrance gate to graveyard, note 2m high bank to left and the gap between the pillar and the bank

Plate 42 (R): Outer bank surrounding the graveyard, Facing SE

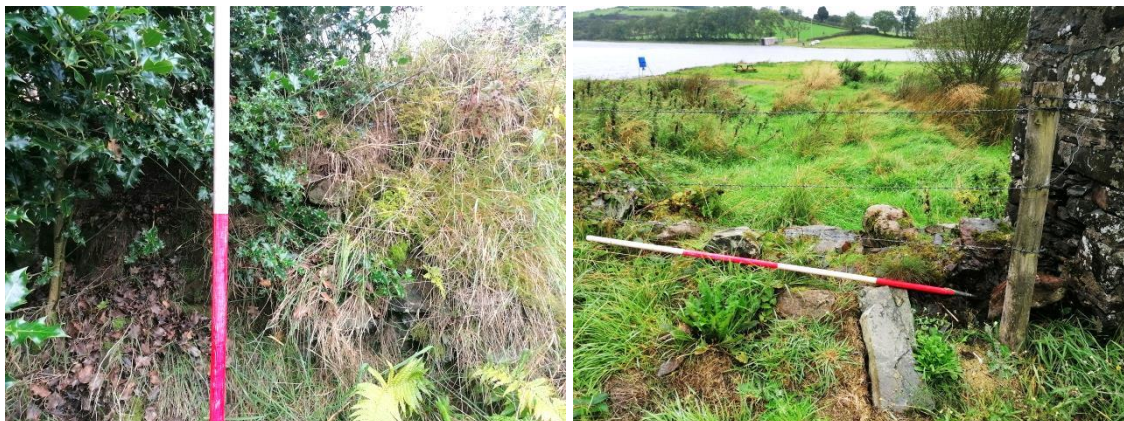
Plate 43 (L): Detail of outer bank, note the stone wall hidden beneath moss, grass and ferns
Plate 44 (R): Wall running SSW from the gate post

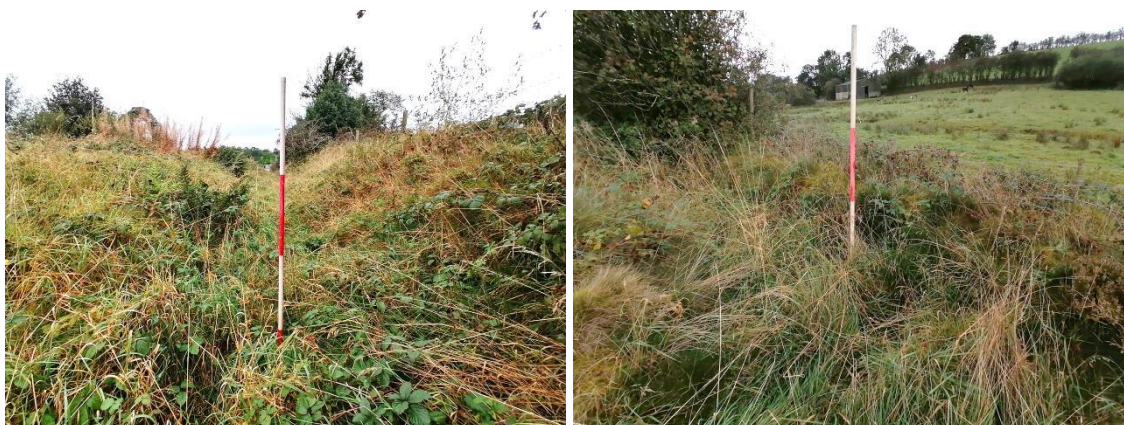
The graveyard comprises an internal ditch and bank which encloses a natural rise in the bedrock. The ditch is particularly noteworthy along the northern and eastern sides with a max width of c.2m and depth of c.1.5m. This ditch becomes more shallow and narrow as it passes along the south and western sides.

Plate 45 (L): Wide internal ditch to east of graveyard, bank on left, graveyard and chapel on left, facing north
Plate 46 (R): Narrow and shallow ditch and bank to SW of graveyard, facing SW

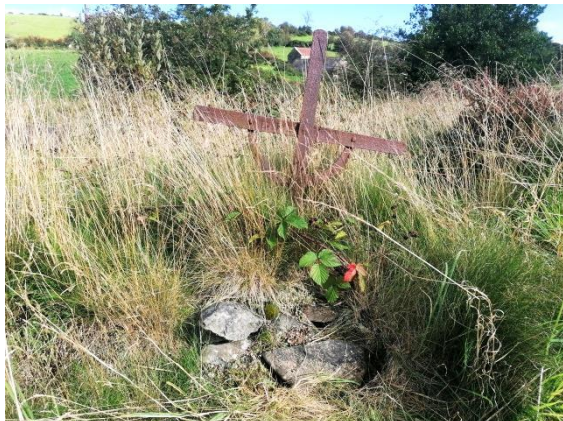
reported that burials in this graveyard were sometimes dug in 'every direction as the rock allows' instead of the standard E/W alignment (Shirley 1879, 349). As a result the main method for burying in this graveyard involved of partial interment and entombing the shallow grave or partially exposed body with stones in long low cairns (Plate 47). This method of burial was noted in many places across the graveyard. In one area towards the SE end of the graveyard, the grass had been cut and well maintained by the family of the deceased. This exposed a family plot which had been used for generations. As a result of the repeated entombment with low cairns in this area the family plot can be seen as a low square mound (Plate 48).

Plate 47 (L): An example of stones piled on top of the body as a result of the bedrock preventing grave excavation

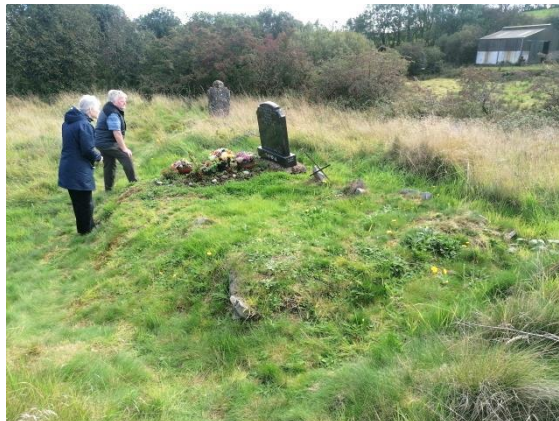
Plate 48 (R): An example of a raised family plot as a result of generations of stone entombment

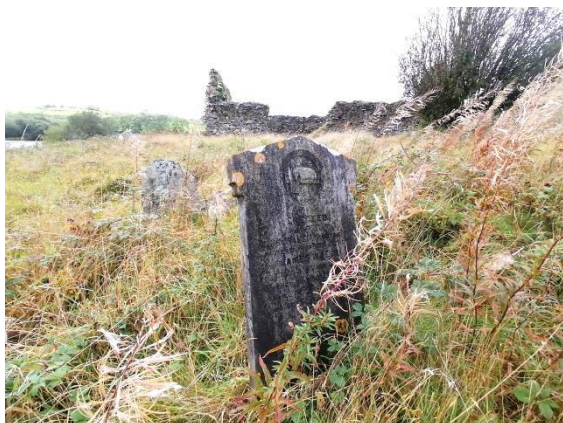
There are a variety of grave markers within the graveyard. Modern black and white marble and concrete engraved gravestones mark relatively modern burials across the site. Two are located within the chapel itself. There are engraved headstones dating from the 18th century onwards (Plate 49-50). They take the form of the small simple headstones, large rectangular recumbent slabs and a few upright decorated stone. There are also iron crosses, some of which were made from reused cart wheels, which were utilised as grave markers across the graveyard. One iron cross within the chapel is said to mark the burial place of two priests (Plate 39).

Plate 49 (L): A decorated headstone in the foreground with a plain un-inscribed gravestone in the background

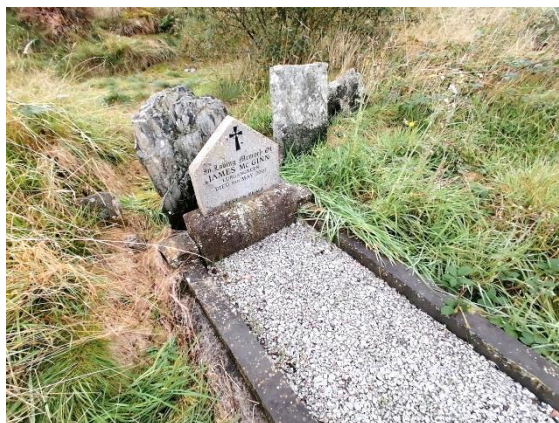
Plate 50 (R): Most recent head stone (2007) with older un-inscribed headstones behind it

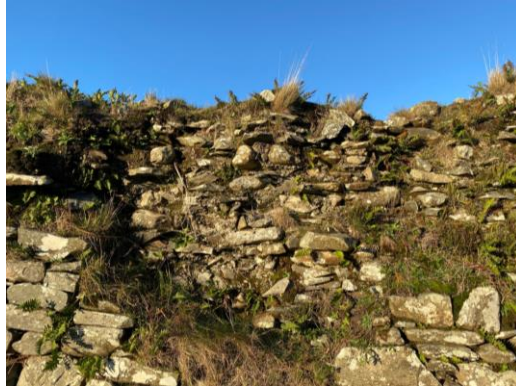
Large sections of the outer structural stone skin to the south wall have become removed for the wall and resulted in a significant weakening of the wall.

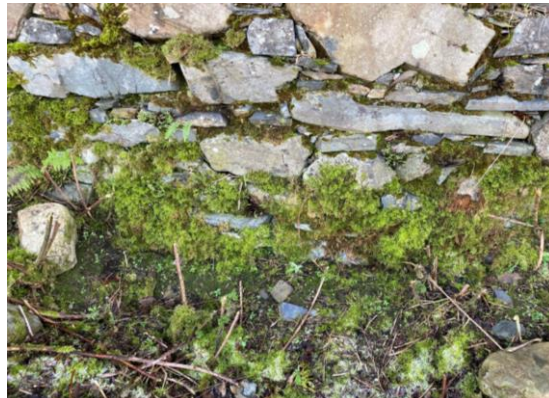
The foundations to the north facing wall have become exposed in a number of locations which leaves the foundations open to and susceptible to deterioration.
