1.0 INTRODUCTION

Layde Consulting was appointed by Carlin Planning Ltd to undertake a series of bat activity surveys and potential roost assessments for a proposed Regeneration Scheme within Monaghan town, extending to lands at the rear of Dublin Street North. This report summarises the key findings in relation to identified bat species within the study area and provides further recommendations as necessary.

1.1 Site Overview & Development Proposals

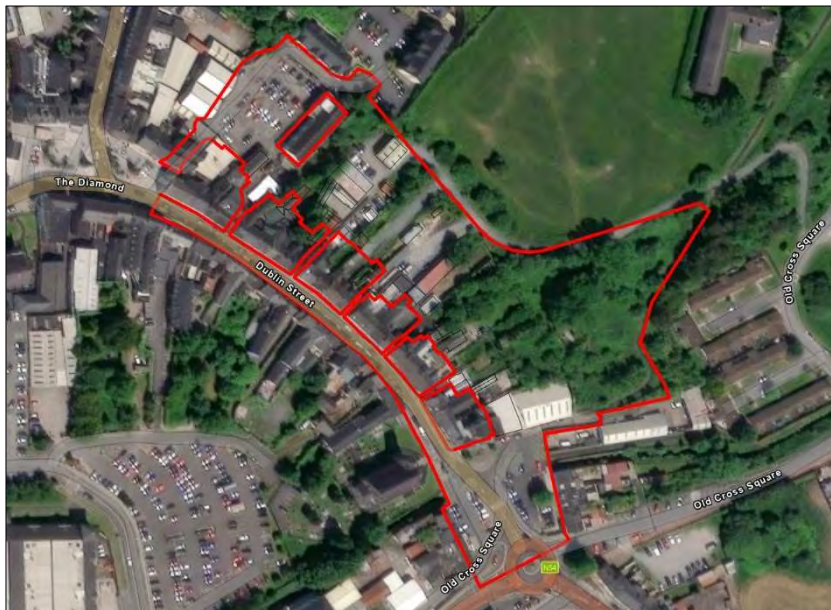
Figure 1- Proposed development area, lands to the rear of Dublin Street North

The proposed development area (herein termed the 'site') incorporates lands to the rear of Dublin Street North, Monaghan (see Figure 1), and comprises of a mix of urbanised areas, external residential amenity areas, commercial land, and derelict lands comprising of scrub and treelines along St. Davnet's Row and the Old Infirmary. Under the development proposals it is intended to regenerate the site by demolishing the existing buildings within the site, and constructing a new public access road, car parking and event space, and also enabling the provision of future development plots for commercial and residential uses. As a result, the development proposals also include the removal of vegetation and ground cover, as required, and grading cut/fill works. The proposals also include all necessary infrastructure provisions such as drainage and utilities, paving, surfacing and landscaping.

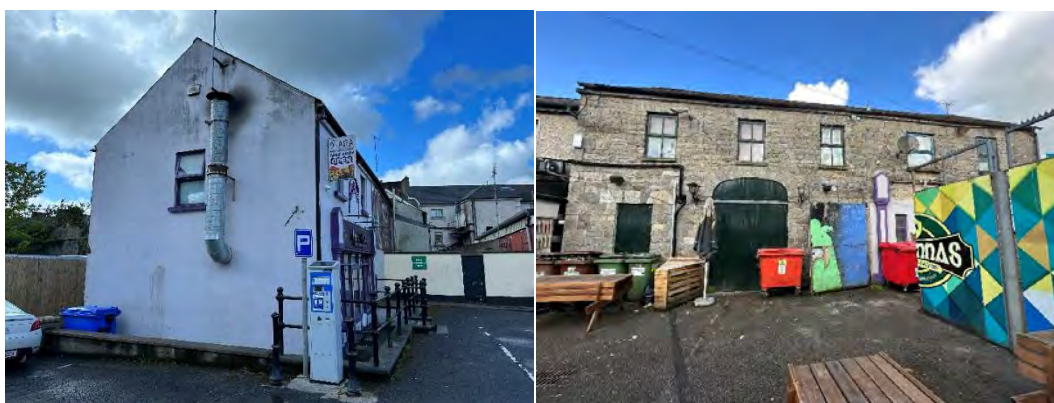
Photoplate 1 & 2 – Gable and front facade of Building No.62c

An inspection was carried out for the outside of the property, which is currently used as a commercial hot food takeaway at ground floor level, and store / staff facilities at first floor level (see Photoplates 1 & 2). Other than a crack on the exterior plasterwork along the external gable end (facing towards The Diamond car park), there were no obvious PRF's that would likely be used for roosting bats. On inspection of the external plasterwork along the gable end, the damage is only superficial and is unlikely to be used even by an individual opportunistic bat. An external service hole is provided for pipework, but it appears to be robustly blanked off, with little opportunity for ingress. Therefore, the site was considered to have negligible bat roost suitability.

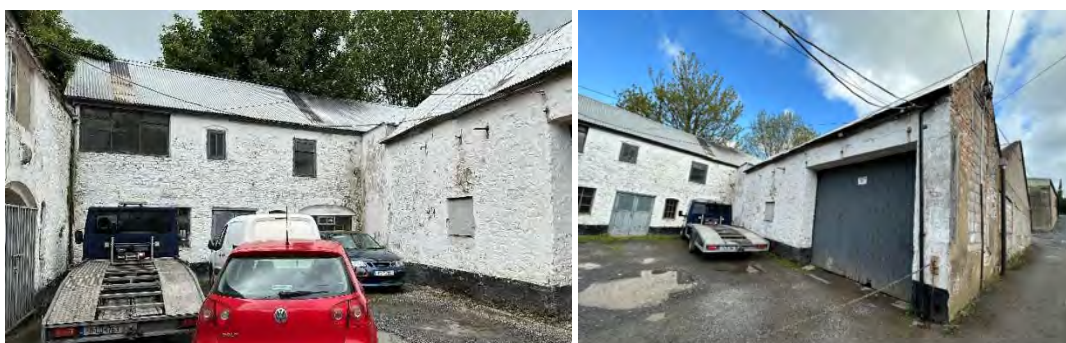
Photoplate 3 & 4 – Front façade of Building No.56b & 54d.

Internal building inspections were carried out on the 20th August 2024 with the property owner present, and no evidence of bat roost activity was recorded. Externally, bat roost potential was considered to be low, given that a number of small voids and cracks were identified between blockwork and the roof, for all three building facades facing into the lane (eastward) and also along the northern façade (Photoplates 3 – 5). It is noted that the voids do not penetrate through to the inside of the building, as noted during the internal inspection.

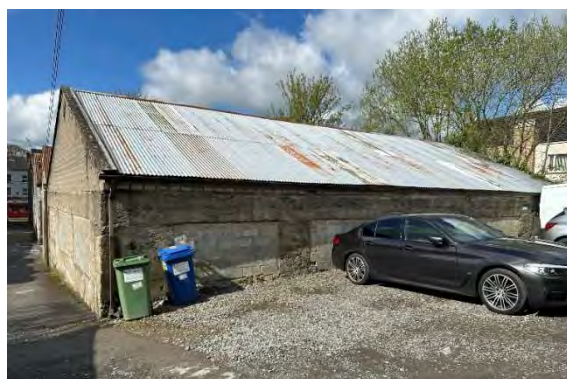
Photoplate 5 – Northern façade of Building No.54e.

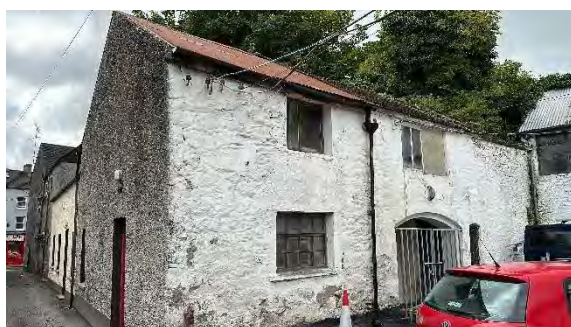
Photoplate 6 –Building No.55c adjoining No.54c.

Building No.55c is currently vacant and was previously used as a store. Unfortunately, the owner of the building had recently deceased during the survey period, and no access could be gained to inside the building. Externally, the rear of the building could not be inspected, due to antisocial behaviour within the vicinity of Buildings 59d, 59c and 57c, all of which openly link onto the rear of 55c. However, the front façade of Building 55c (see Photoplate 6) was considered to have low potential for bat roost, given that PRFs were identified in the form of small cracks on the external stone work and plaster, along with openings of pipework etc.

Building 54c was lying vacant during the initial survey on the 17th July 2023, however the building was being renovated for habitable living in August 2024. An internal inspection was granted for inside the building and roof space with the building contractor present during the internal inspection, which adjoins Buildings 54b and 55b (considered further below). The internal building structure was in good repair, with no evidence of ingress, and no evidence of bat roost activity was recorded in part of the building. This includes the shared roof space between the adjoining buildings.

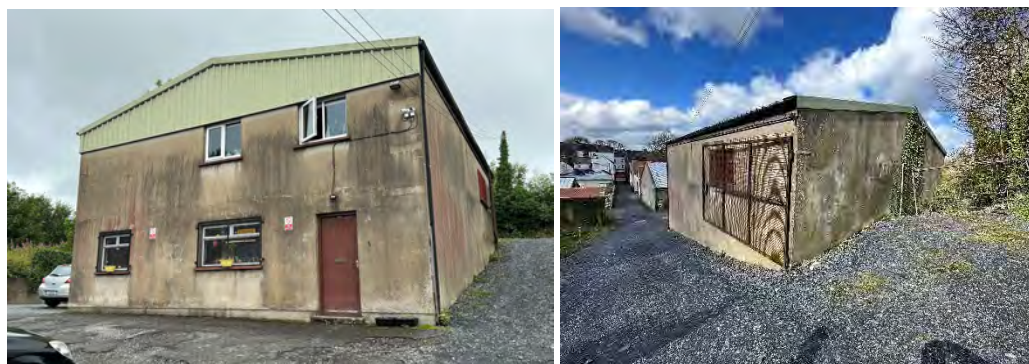
Photoplate 7 & 8 –Building No.54f front and rear views.

Access to inside Building No.54f could not be gained. The ground floor is currently used as a commercial premises, and the first floor level is used for residential purposes (see Photoplate No.7 & 8). The building is in good repair, with no obvious PRFs or evidence of bat activity around the building. Therefore, bat roost potential was considered to be negligible.

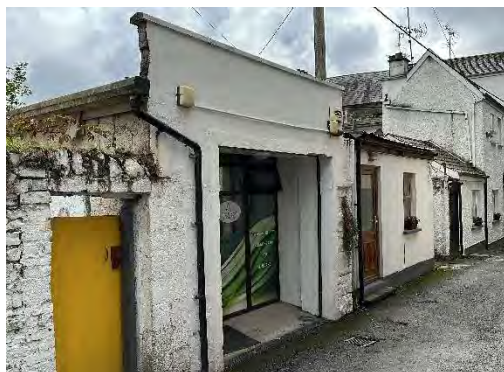
Photoplate No.9 – Front façade of Building No.52d

Building No.52d and 51d adjoin onto each other. The first property is used as a commercial hairdresser unit which has been recently renovated (see Photoplate 9) and has no obvious PRFs or evidence of bat activity around the building. As such the potential for bat roost was considered to be negligible. The second building (No.51d) is used as a storeroom for a commercial property which faces onto Dublin Street (Suzanne Michaels).

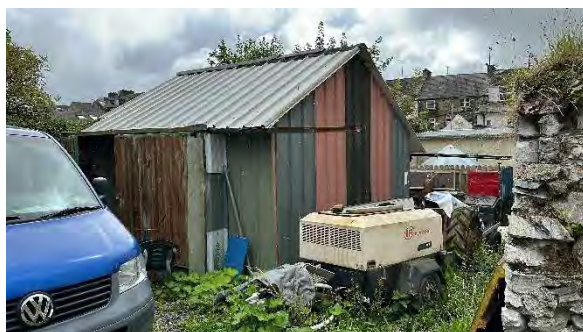
Photoplate No.10 – View of Building No.52e.

This building is currently used as a private garage (see Photoplate No.10), and permission was granted from the owner to internally inspect the building for bat roost activity on the 20th August 2024. No evidence of bat activity was recorded inside the building. In terms of PRFs, the building was considered to have low bat roost potential, therefore bat activity surveys were initially carried out on the 18th July 2023, and also on the 21st August 2024. Buildings facades were monitored during both survey periods by 2No. personnel, with the exception of the rear façade which could not be gained access to, and no bat activity or emergence was recorded for the building as summarised below in Table 5.

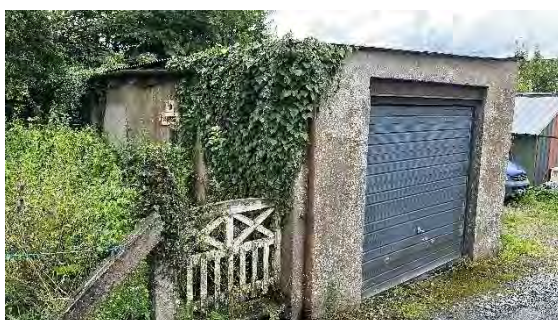
Photoplate No.11 – Building No.52f.

Building No.52f is used as a residential garage, and the owner could not be contacted to gain permission for inspecting the inside of the building. Externally the site was inspected on the 18th July 2023 and on the 20th August 2024 for PRF's, with a number of potential openings visible between the blockwork wall structures and the metal roofing (see Photoplate No.11), and potential ivy ingress into the building structure. Further inspection of the gaps (where accessible) indicated that cement pointing had been applied relatively recently in order to seal up any gaps, and the building was otherwise well maintained with no obvious openings or cracks etc, thus reducing the possible ingress of bats. On this basis, the building was considered to have low probability for bat roost, therefore a bat activity survey was completed on the 18th July 2023, and also on the 21st August 2024. Building facades were monitored during both survey periods by 2No. personnel, with the exception of the rear façade which could not be gained access to, and no bat activity or emergence was recorded for the building as summarised below in Table 7, and a summary of the bat activity recorded call logs are presented in Appendix 1.

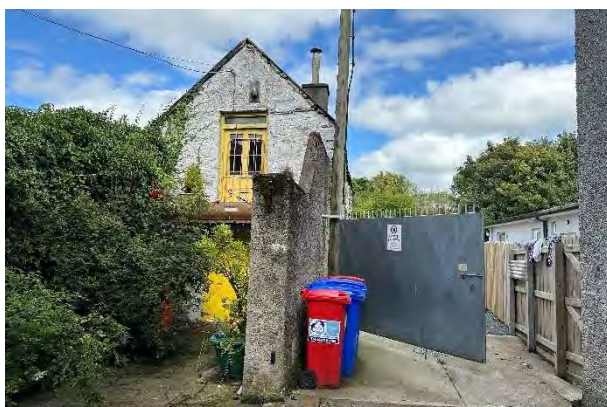
Photoplate No.12 – Front façade of Building No.46b.

Building No.46b comprises of a stone-built structure (see Photoplate No.12) with a number of PRF's identified externally. Open gaps were recorded along the stonework, and particularly between the top of the stonework and roof structure. In addition, gaps were also noted around the door frames. It is noted that the building is entirely affected by artificial flood lighting from all sides.

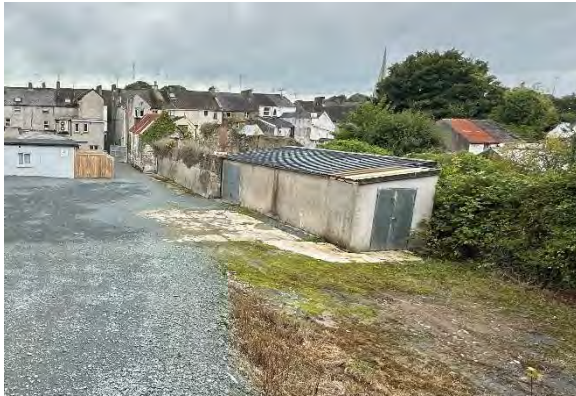
Photoplate No.13 – Front façade of Building No.46c.

Building No.46c was viewed from St. Davnet's Row and appears to be of modern construction with minimal potential for PRF's (see Photoplate No.13). The roof structure has a small portion of the facing cladding missing, however the roof is foam insulated with no visible openings (based on visibility using high powered binoculars). It is likely that this building will have negligible bat roost potential, however in the absence of access permission being gained, it should be noted that further recommendations have been made later within this report with respect to this building structure.

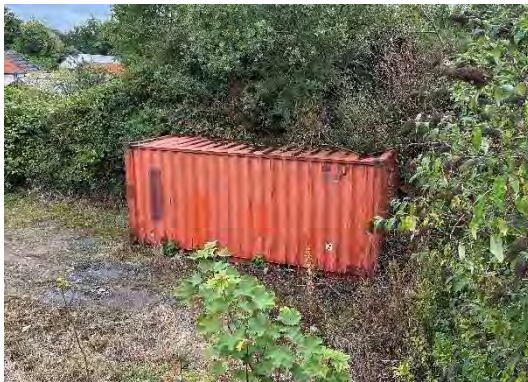
Photoplate No.14 –Building No.46d (shipping container)

Similar to Building No.46c, no permission was granted to inspect Building No.46d, nor to carry out bat activity surveys around the property. However, it is noted that Building No.46d comprises of a shipping container (see Photoplate No.14) and is thus considered to have negligible bat roost potential, given that the door appears to be in the locked position. Therefore, no bat activity surveys would be required for this structure.

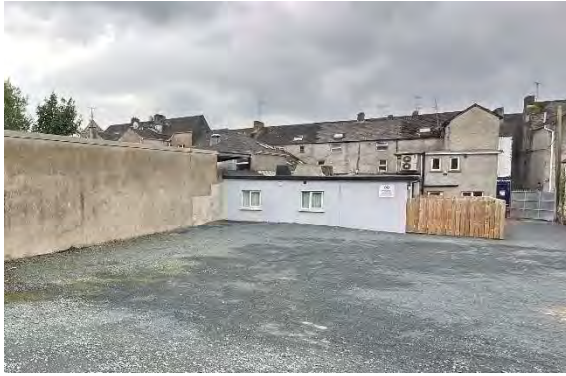
Photoplate No.15 – Building No.43a newly built / renovated

These buildings occupy the same yard area where permission was denied access to and comprise of recently renovated / constructed residential units (see Photoplate No.15). The buildings could only be viewed at a distance from St. Davnet's Row, however it is evident that the buildings have negligible bat roost potential, given that the building structures appear to be new. Therefore, no bat activity surveys would be required for this structure.

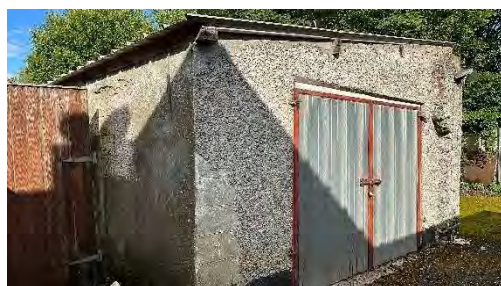
**Photoplate No.16 –Building No.41c (private garage)**

Building No.41c comprises of a private garage (see Photoplate No.16) which is in relatively good repair, however there were a number of small potentially usable PRF's, such as small gaps along the roof line, and within the blockwork to the rear. Overall, the bat roost potential was considered to be low, therefore a bat activity survey was carried out on the 20th July 2023, and subsequently on the 20th August 2024.

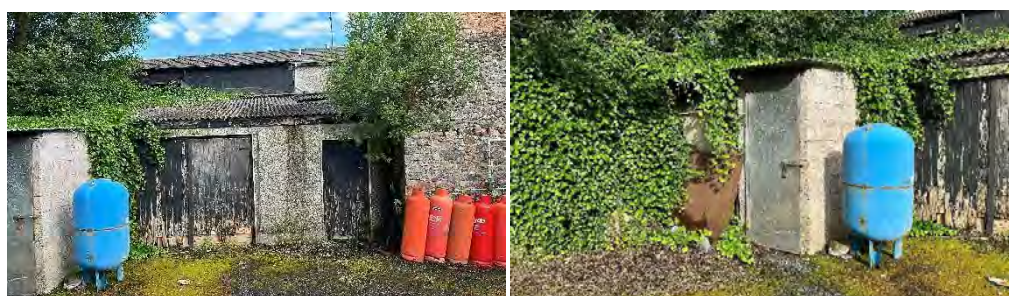
**Photoplate No.17 & 18 –Building No.38c / 37f, and Small outhouse (Building No.39c)**

Building No.39c comprises of a small blockwork outhouse with gas tank (Photoplate No.17), and was overgrown with ivy. Some gaps in the door were identified, along with some gaps noted between the blockwork and metal roofing. No access could be gained to inside the building structure, so internal inspections were not possible. The overall bat roost potential was considered to be low based on the PRF's recorded for the external facades. On this basis bat activity surveys were carried out during the same period as No.41c, and the results are summarised in Table 7.

Anecdotal information indicates that Building structures No.38c and 37f (Photoplate No.18) were subject to past vandalism and attempted arson and have been lying vacant since being secured. A number of PRF's were identified to include potentially small gaps in the roofing structure. In addition, ivy has overgrown the northern façade and may have caused ingress into the building structures, although this could not be determined given the limited access. Unfortunately, no access could be gained to inside the building, however, based on the external PRF's identified around the buildings, bat roost potential was considered to be low. Therefore, bat activity surveys were carried out during the same period as No.41c, and the results are summarised in Table 8.

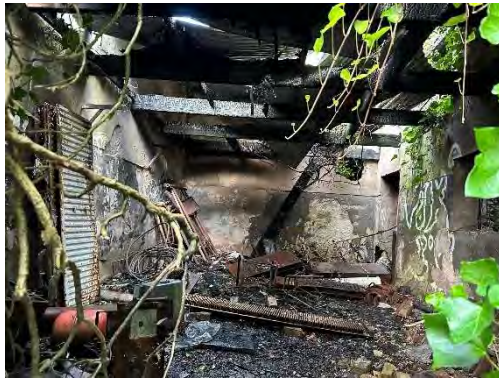
Photoplate No.19 –View inside Building No.40b (fire damaged)

Building No.40b comprises of the remains of a private shed, following extensive fire damage (see Photoplate No.19). As a result, the building is structurally unsafe, therefore no internal inspection could be carried out. Externally the building is very overgrown with ivy and was considered to have low to moderate potential for bat roost. However, when attempting a survey on the 19th July 2023, antisocial behaviour was observed which resulted in threats being issued to members of staff. The activity survey was subsequently abandoned. Another attempt to carry out an activity survey was made on the 25th August 2024, however this survey had to be abandoned following a similar encounter with antisocial behaviour.

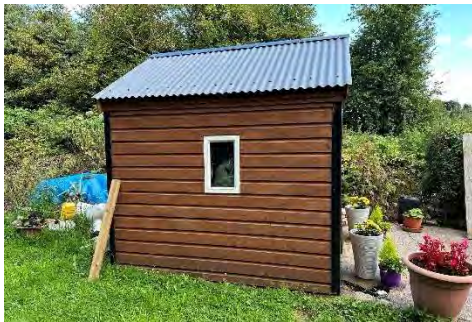
Photoplate No.20 –Garden shed (Building No.37g)

Building No.37g (2 of 2) comprises of a small wooden replacement shed structure which was installed recent to the site visit on the 18th July 2023 (see Photoplate No. 20). The structure has negligible bat roost potential, therefore no activity surveys were carried out.

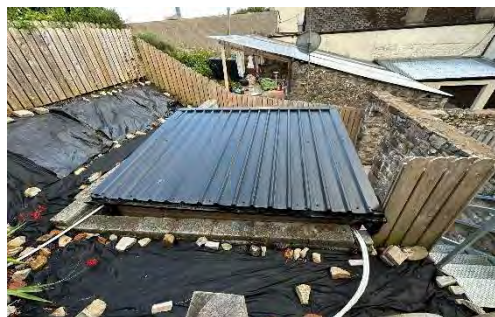
Photoplate No.21 –Garden shed (Building No.35b)

Similar to above, Building No.35b comprises of a newly built wooden garden shed, constructed within a small recess at ground level (see Photoplate No.21). The structure has negligible bat roost potential, therefore no activity surveys were carried out.

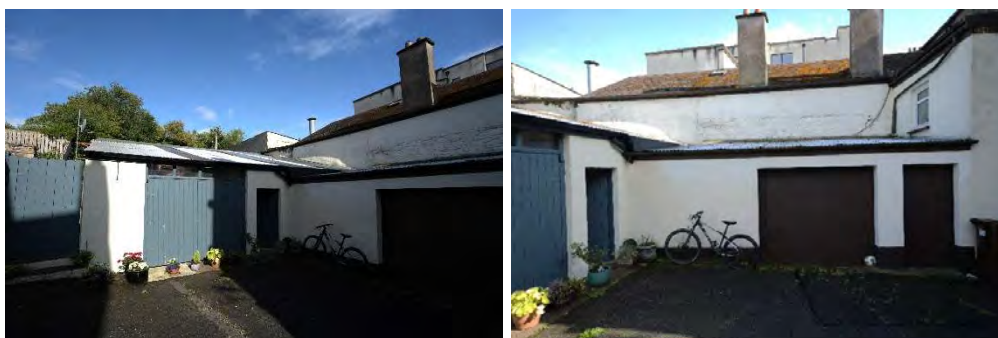
Photoplate No.22 & 23 – Building No.34a (left), Building No.33c (right)

Building Nos.34a & 33c directly adjoin onto each other (see Photoplate No.22 & 23) and are accessed by means of the same shared yard area. Building No.34a is used as a private garage, and Building No.33c effectively forms an extension to No.34 for storage. Both property owners were contacted on the 20th August 2024, and internal inspections were carried out within both building structures in the presence of the owners. No evidence of bat activity was recorded.

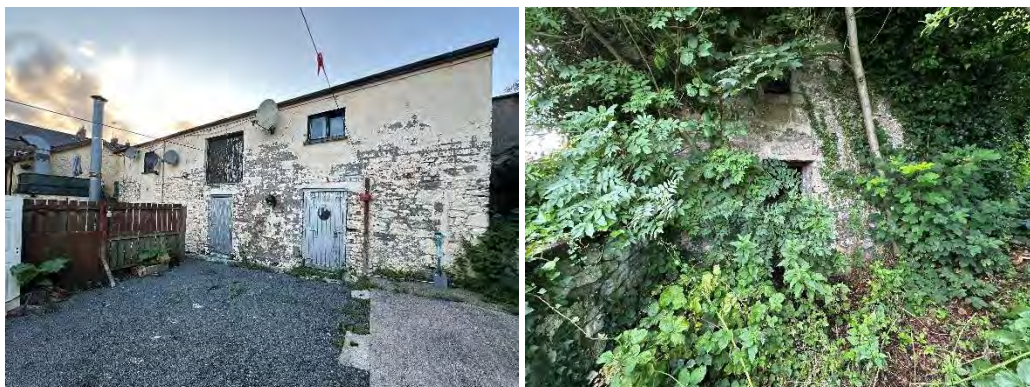
Photoplate No.24 & 25 – Building No.32b (left), Building No.32c (right)

Buildings No.32b and No.32c are located to the rear of the Shambles Bar and near Old Cross Square. Building No.32b was inspected externally in July of 2023, and again in August of 2024, and was found to have a number of small PRF's such as cracks in the wall structure and small gaps in the door frames (see Photoplate No.24). The overall bat roost potentially was considered to be low for Building No.32b, therefore a bat activity survey was carried out on the 19th July 2023, and the 14th September 2023 (at the same time as the survey for Building No.32c), however the rear of the building could not be accessed due to restrictions in gaining permission.

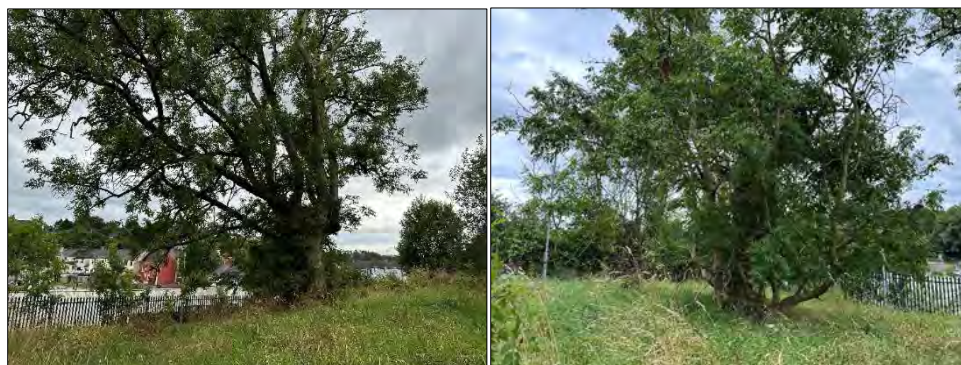
Photoplates 26 & 27 – Ash tree T29 (left) & T28 (right) with significant basal rot, scheduled for felling

Both trees exhibited open cracks and basal rot in places of deadwood, although both trees are in direct influence of artificial street lighting and flood lighting. Neither were considered to provide sufficient shelter and protection for regular usage as a bat roost, or to be able to support a large number of bats, and the appropriate conditions for light, temperature, humidity etc were not considered suitable for bat roosting. Based on the PRF's identified from visual inspection, the overall bat roost potential was considered to be low. As such a bat activity survey was carried out for both trees on the 26th August 2024, as summarised below in Table 14. The surveys were carried out by 2No. personnel at each tree from either side and using Elekon M2 Batlogger units.

The proposed development intends to retain all of the existing trees within the Old Infirmary Hill area, with the exception of two Ash trees within the southeastern portion of the site. A tree survey report was commissioned in August 2022 by Monaghan County Council, which indicated that the two prominent Ash trees were defective with excessive deadwood and were found to be hollow with basal rot. As such, the report recommended that both of these trees are felled. On this basis, the development proposals also include the removal of the two Ash trees (see Photoplate 26 & 26 below, labelled as T28 & T29 on the tree survey report) for the safety and protection of public amenity.

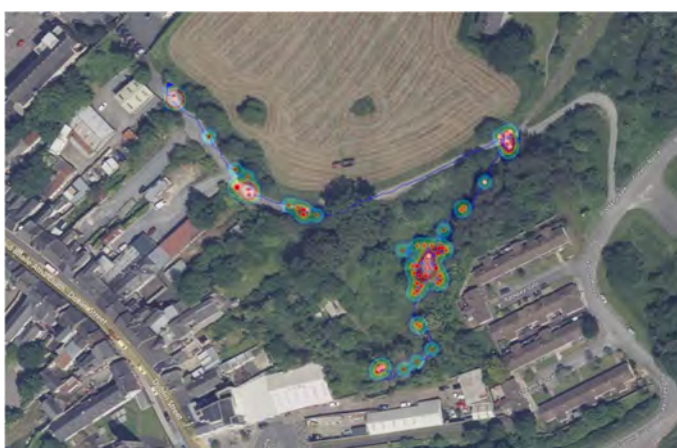
Figure 3. Transect route and heat map, 15th August 2023

Observations made during the transect surveys indicated that the greatest concentration of bat activity was found along the street lit public footpath between Old Cross Square and the intersection at St. Davnet's Row. Bats were clearly seen foraging around each of the street lights where insects are likely most abundant. In addition, commuting bats were observed coming from the mixed broadleaved and coniferous forested area to the east of the public footpath, and returning, indicating the possibility of potential bat roosts within the neighbouring forested area or buildings. Bat activity was also noted along St. Davnet's Row, where bats were observed to be foraging and commuting along the laneway at relatively low level, particularly within the northwest portion of the laneway. The results also demonstrated that the highest concentration of bat calls were found to be Common Pipistrelle

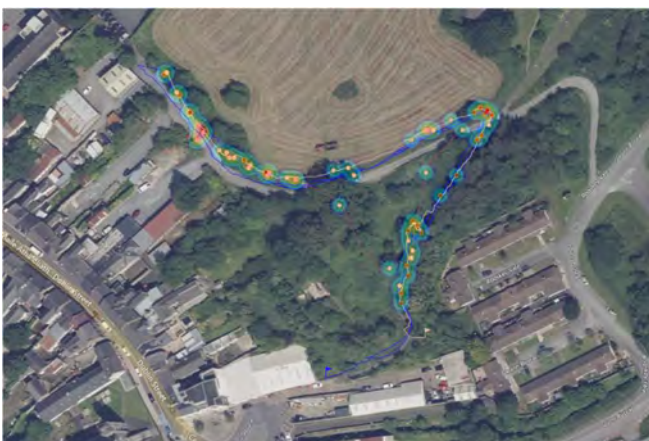
Figure 4. Transect route and heat map, 12th September 2023

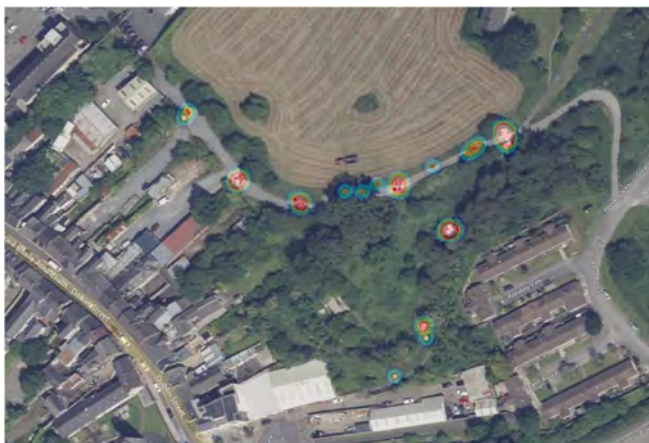
Figure 5. Transect route and heat map, 28th August 2024

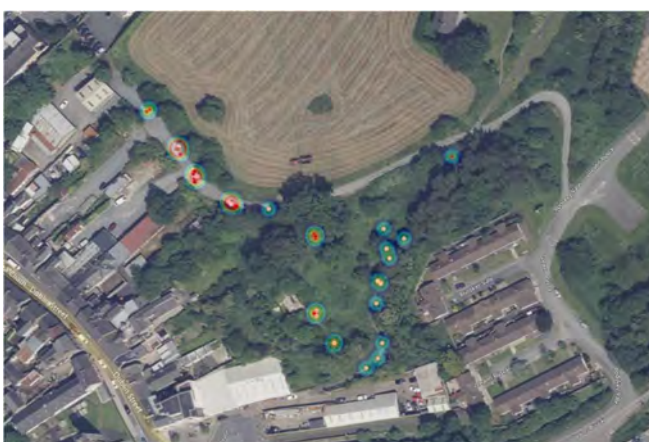
Figure 6. Transect route and heat map, 28th September 2024

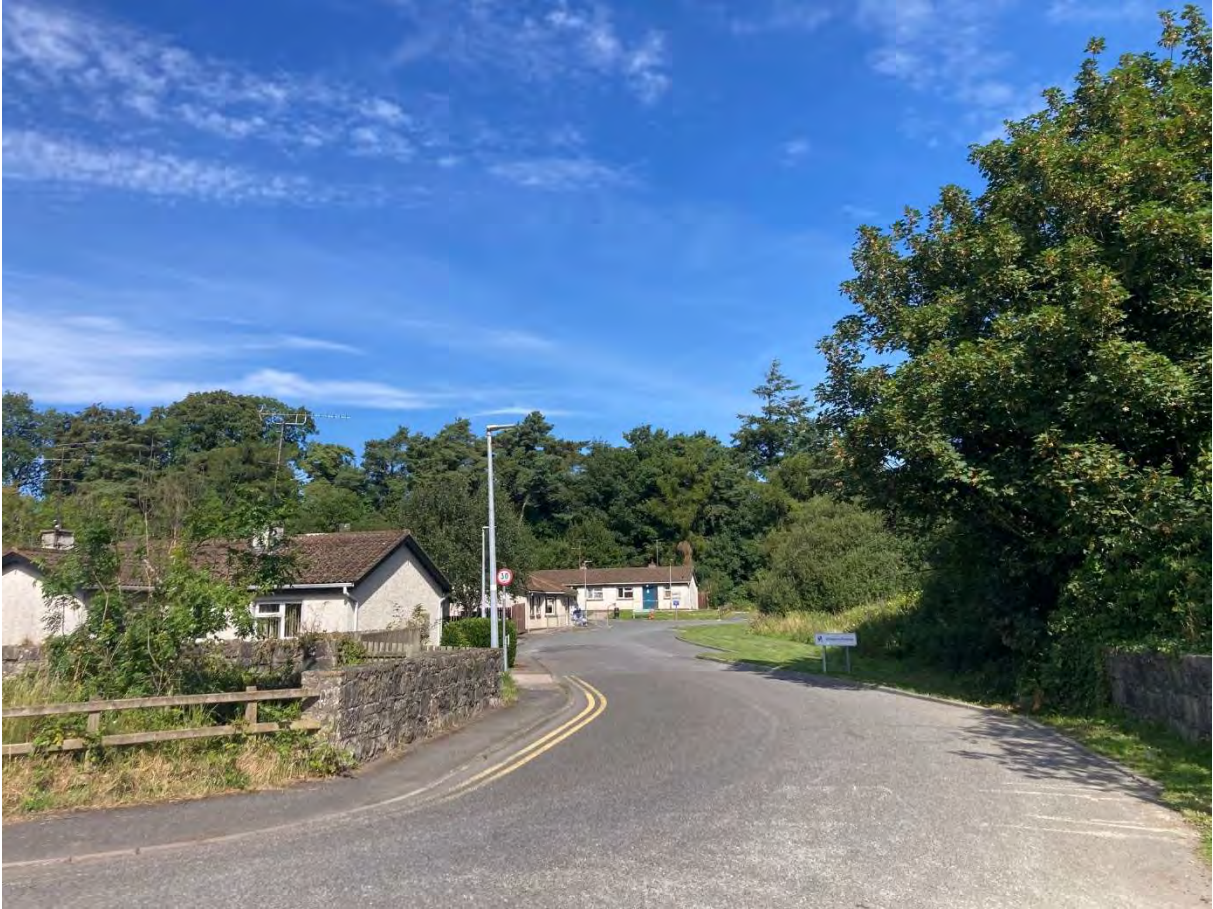
View of trees growing on the above site, taken from Rooskey Vale

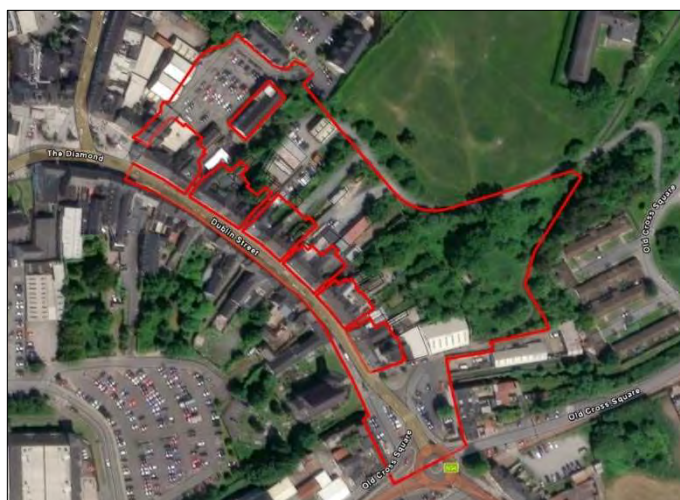
Figure 1- Proposed development area, lands to the rear of Dublin Street North

The proposed development area (herein termed the 'site') incorporates lands to the rear of Dublin Street North, Monaghan (see Figure 1), and comprises of a mix of urbanised areas, external residential amenity areas, commercial land, and derelict lands comprising of scrub and treelines along St. Davnet's Row and the Old Infirmary. Under the development proposals it is intended to regenerate the site by demolishing the existing buildings within the site, and constructing a new public access road, car parking area and event space, and also enabling the provision of future development plots for commercial and residential purposes.

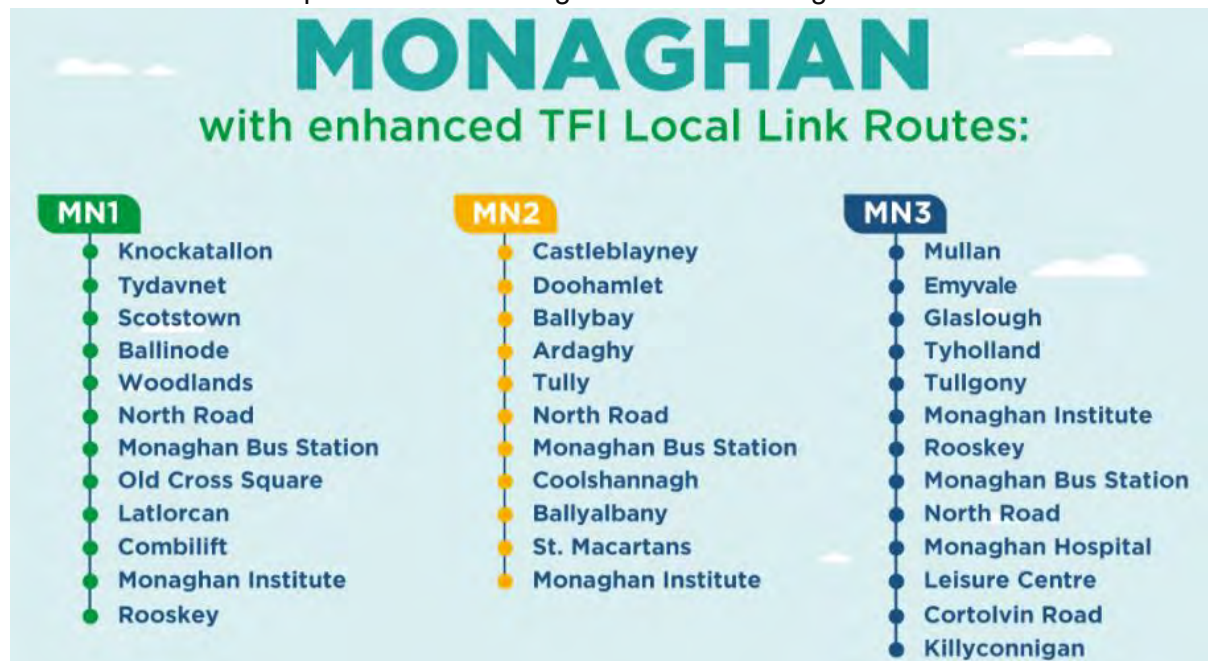
Figure 5 6: TFI Local Link Bus Routes

All 3 routes provide connectivity to Monaghan Bus Station to facilitate onward travel and provide connectivity to regional bus services.

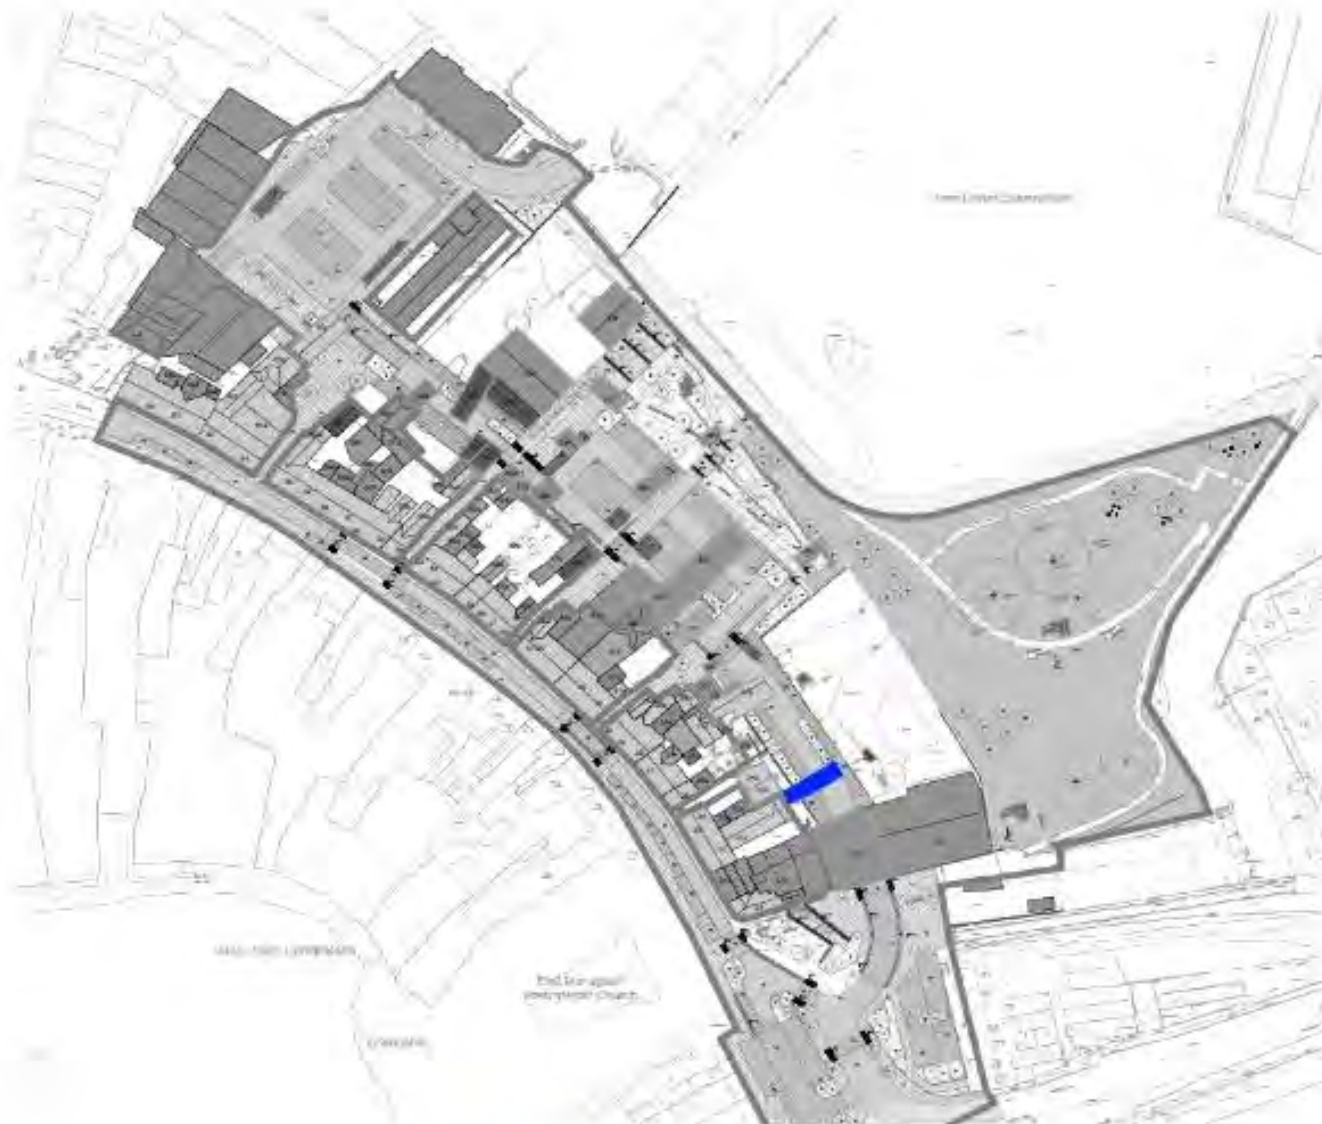
■ Location of Building

External: No ACMs identified

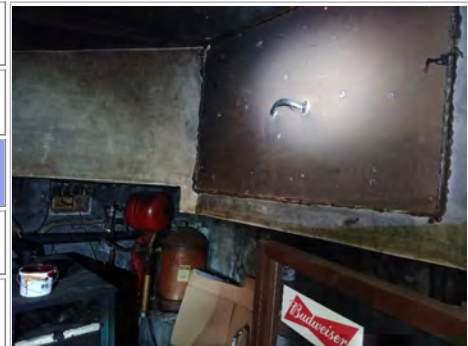
Photo No. 2 - No access - locked and no key available at time of survey

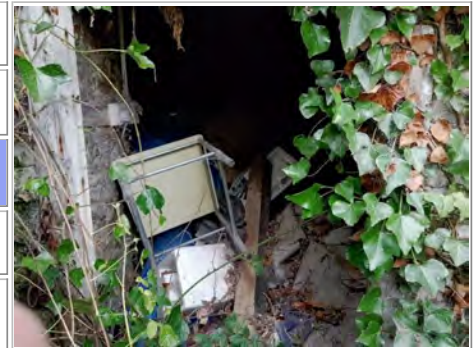
001 Store 1

Photo No. 1 - No access due to stored items

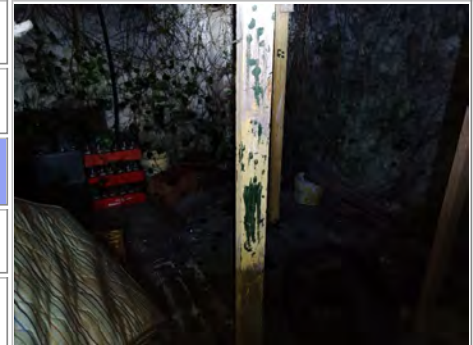
101 Store 2

Photo No. 2 - No access advised by owner wooden floors are unsafe to walk on

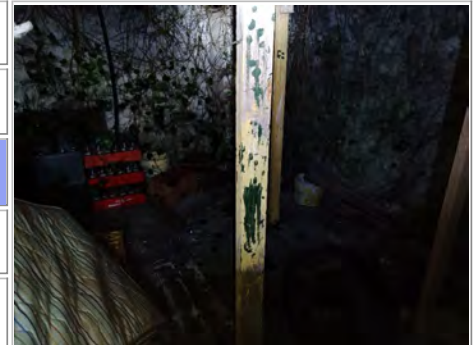
201 Store 3

Photo No. 3 - No access - no safe route to access ladder wooden floors unsafe

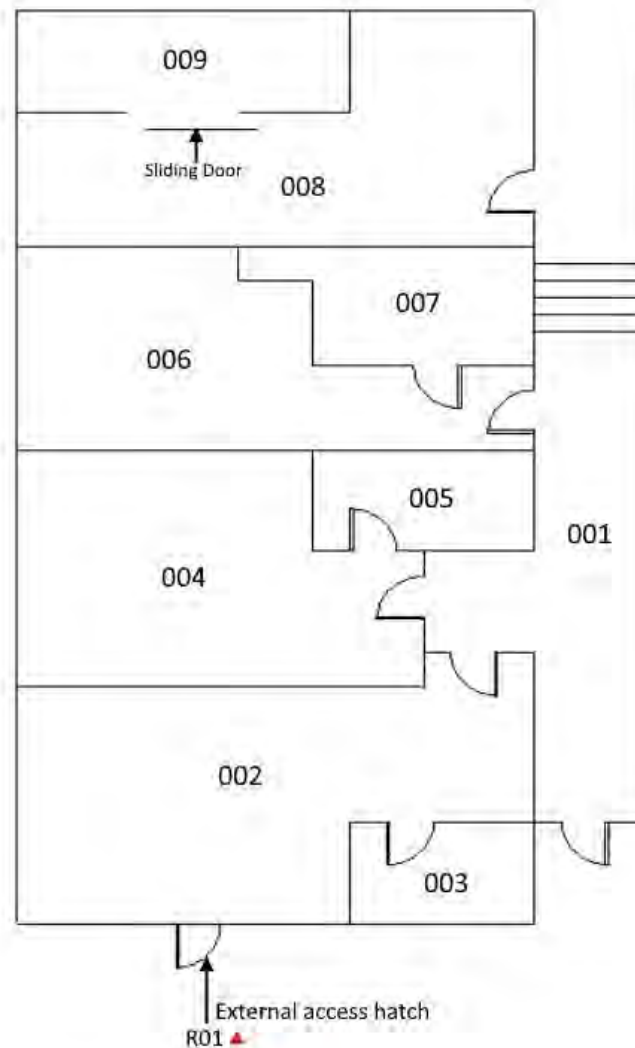
External: ▲

▲ Room contains identified or presumed ACM(s) (see register)

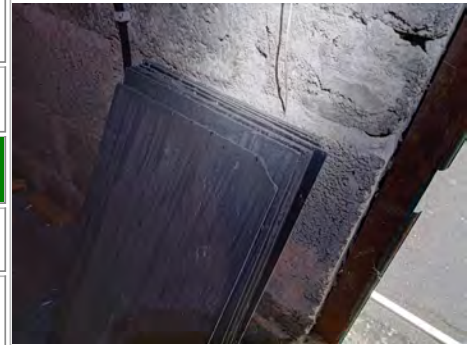
R01 Roof Void

Photo No. 1 - Roof tiles on right hand side of access hatch, leant against wall.

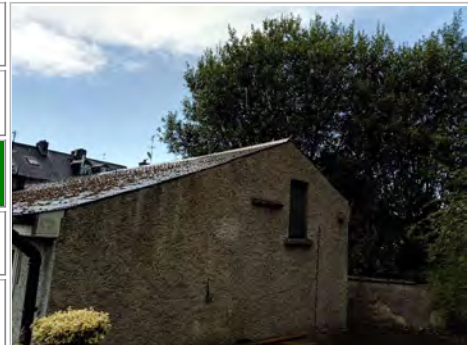
External

Photo No. 2 - Roof tiles

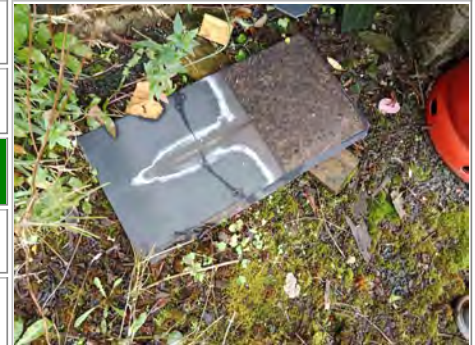
Photo No. 3 - Roof tile debris on ground beside entrance door

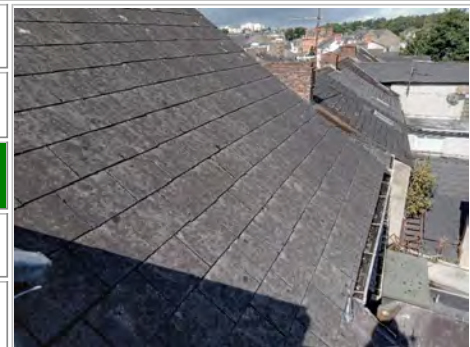
Photo No. 6 - Ridge capping tiles

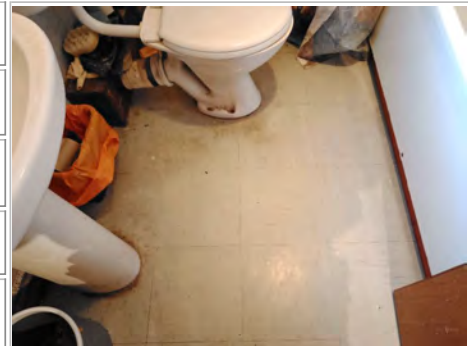
Photo No. 2 - Vinyl floor tiles (beige) on solid floor

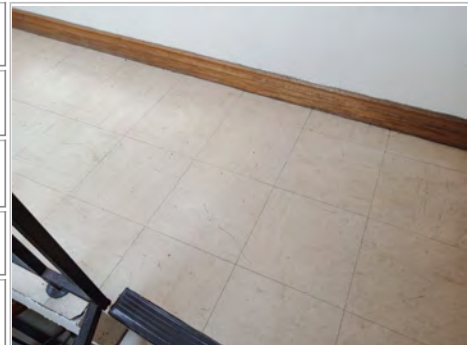
Photo No. 4 - Vinyl floor tiles (beige) on solid floor (as sample GU000230)

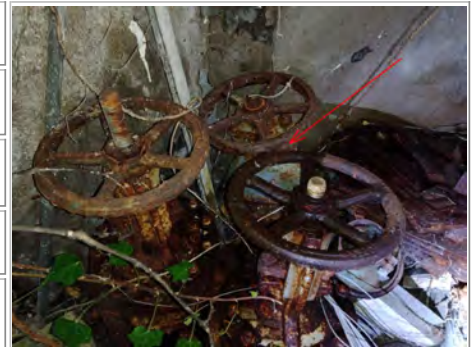
Photo No. 3 - Gaskets on valves not visible but presumed - beside entrance door (as sample GU000245)

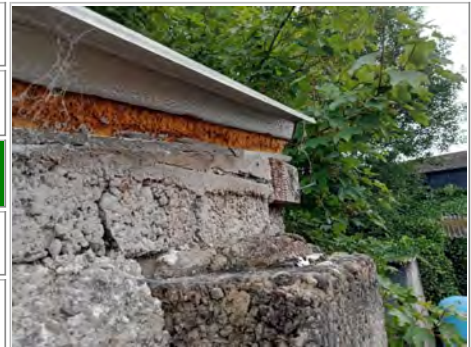
Photo No. 3 - Roof tile packer below modern corrugated metal roof - north side high elevation

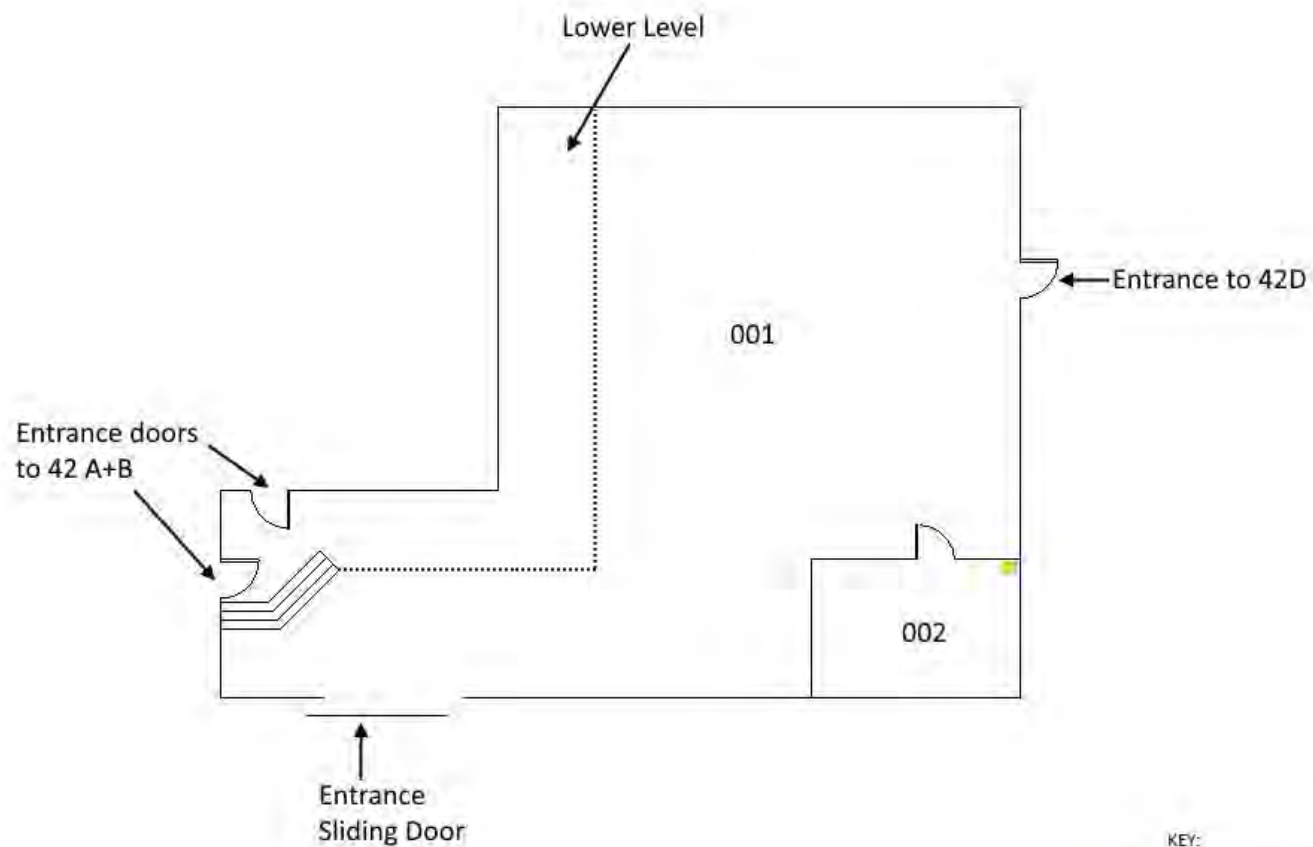
■ Location of Building

External: No ACMs identified

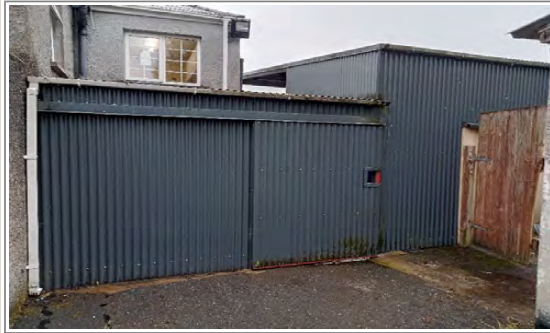
Photo No. 1 - No access - padlocked and no key available

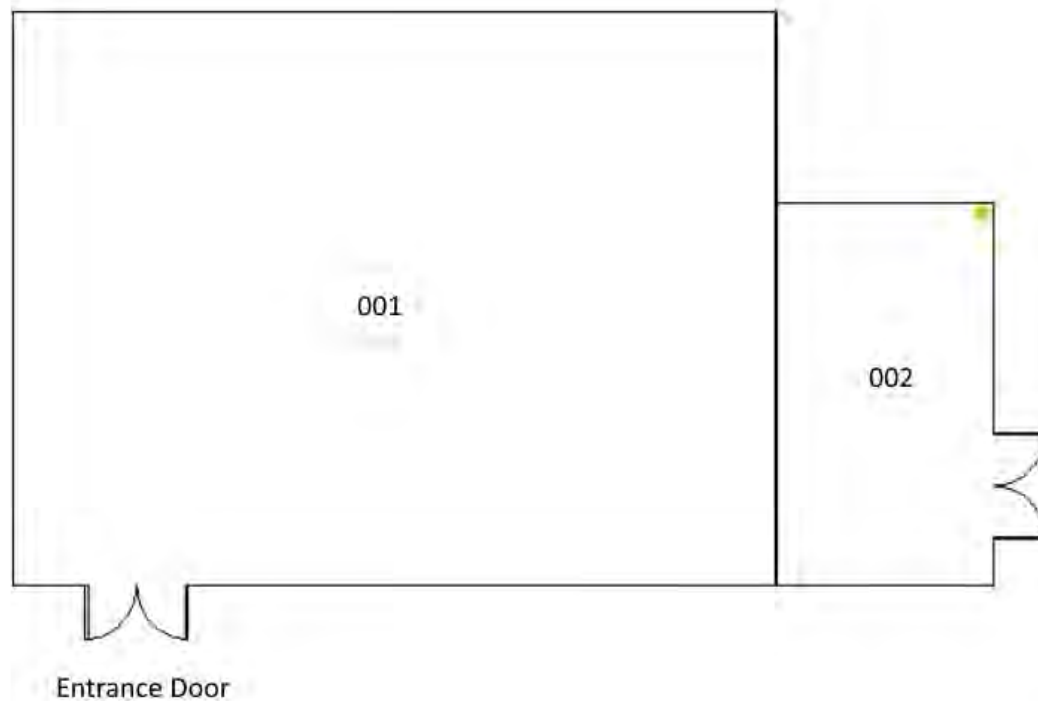
■ Location of Building

External: No ACMs identified

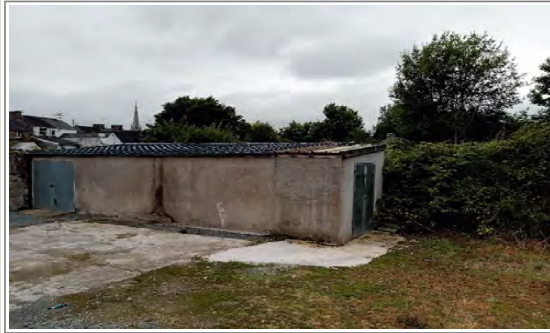
Photo No. 1 - No access as locked and no combination to padlock supplied

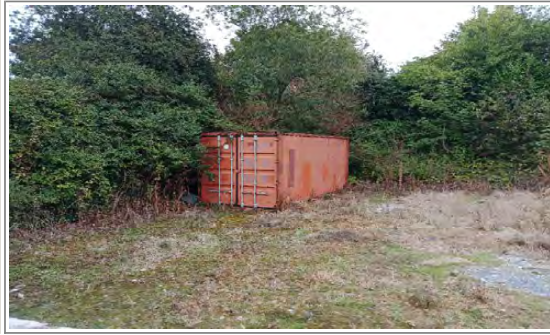
Photo No. 1 - No access to container unable to open

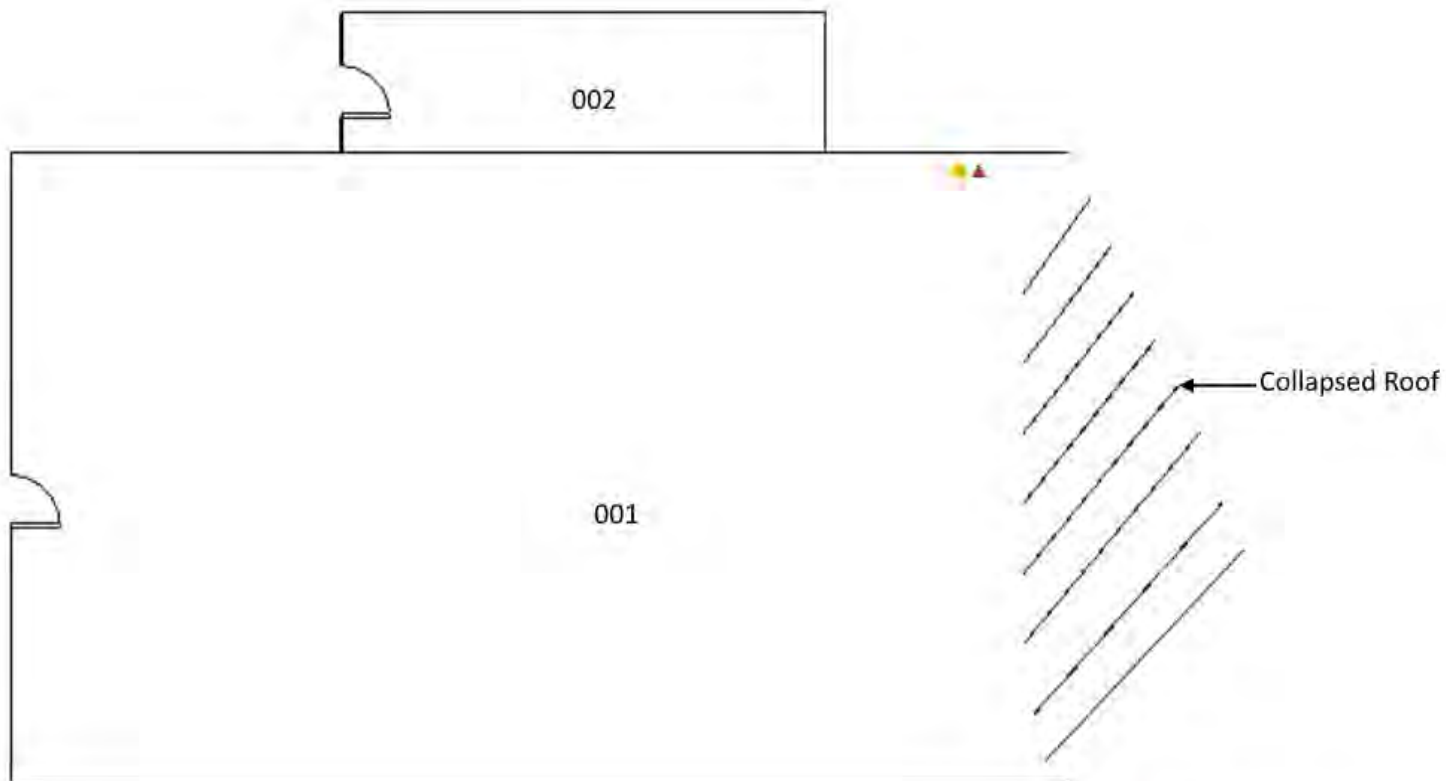
■ Location of Building

External: ●

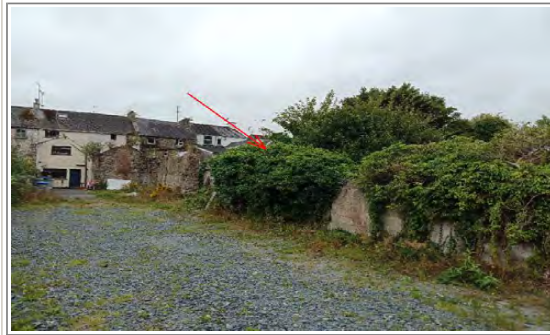
Photo No. 3 - Redundant roof tile against wall in south west corner

Manage - remove on commencement of any planned future works

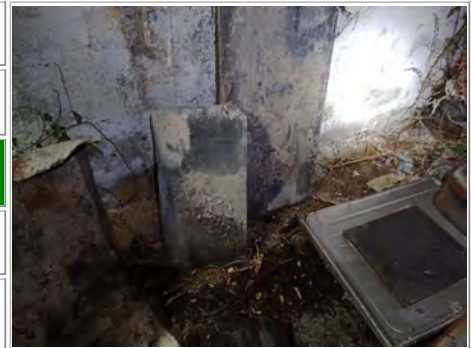
Photo No. 6 - Restricted access to entire east side of room due to badly collapsed roof

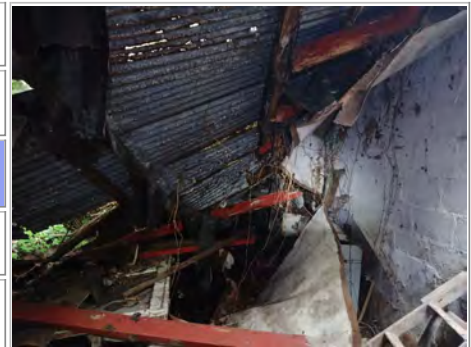
Photo No. 8 - Restricted access to area surrounding the property, thick undergrowth to north, east and west - access made through roof at south wall

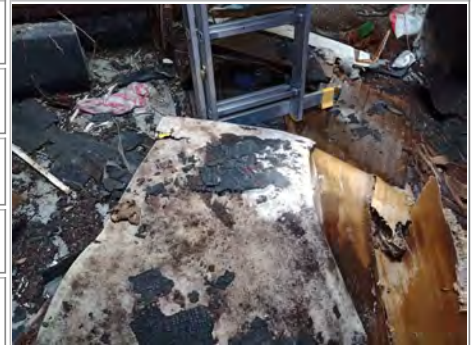
Photo No. 4 - Sink pad (thick) on redundant drainer on floor in south west corner

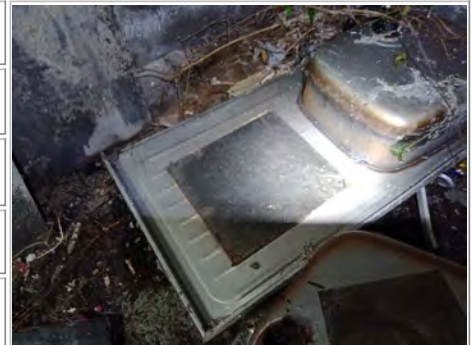
Photo No. 5 - Sink pads (thin) on smaller redundant sink and drainer on floor in south west corner
