1.0 INTRODUCTION

Layde Consulting was appointed by Carlin Planning Ltd to undertake a series of bat activity surveys and potential roost assessments for a proposed Regeneration Scheme within Monaghan town, extending to lands at the rear of Dublin Street North. This report summarises the key findings in relation to identified bat species within the study area and provides further recommendations as necessary.

1.1 Site Overview & Development Proposals

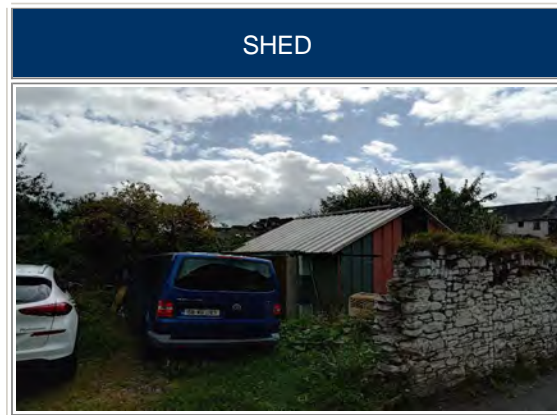
001 Store

Photo No. 1 - No access - owner not available

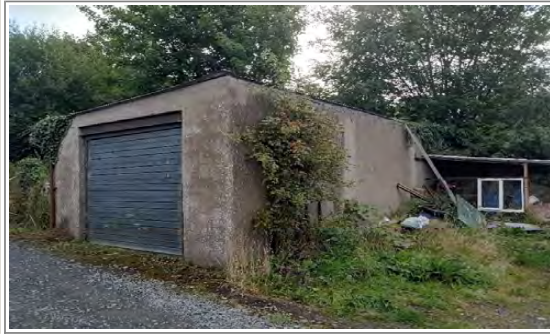
External

Photo No. 2 - Restricted access to rear / north side of property due to overgrowth

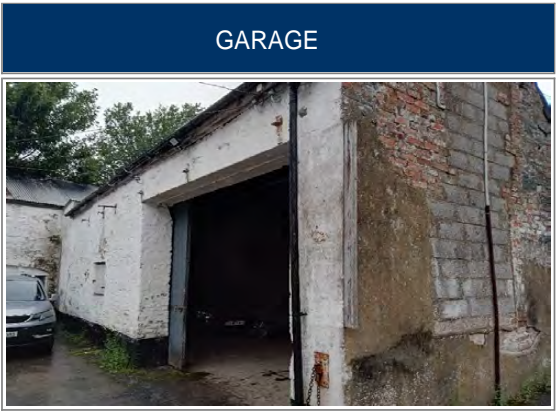
| 001 Garage | | | |

Photo No. 1 - Bitumen felt to underside of roof

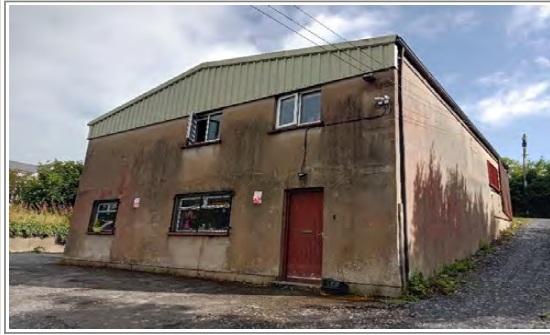
102 First Floor Rooms

Photo No. 3 - No access no key provided

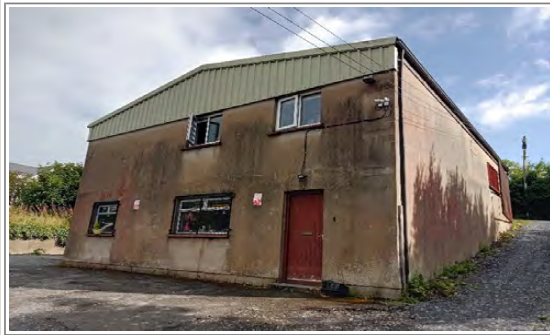
001 Hall

Photo No. 1 - Vinyl floor tiles (beige) on solid floor including area under stairs

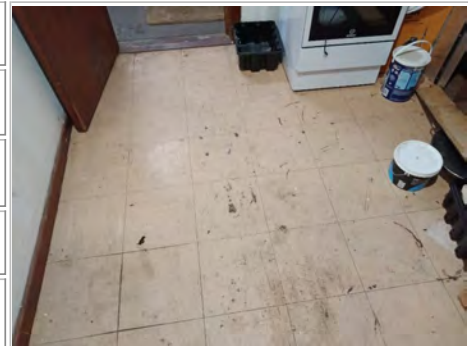
003 Garage

Photo No. 2 - Vinyl floor tiles (beige) on solid floor

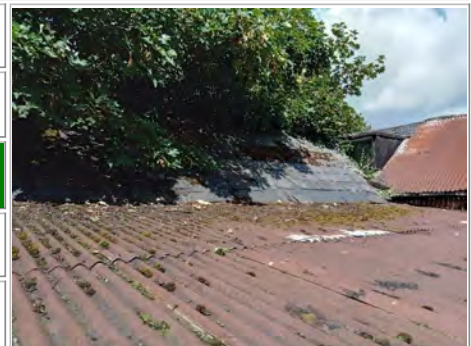
Photo No. 5 - Roof tile debris on ledge outside first floor door (as sample GU000227)

| Building Room Number | Room Use | Photo No. | Sample Reference Number | Position / Description | Quantity | Level of Identification | Product Type (1 - 3) | Asbestos Type (highest risk only) (1 - 3) | Extent of Damage Deterioration (0 - 3) | Surface Treatment (0 - 3) | Accessibility | Material Assessment | Priority Assessment | Recommended Action | Management Actions | Timescale For Completion | Date Of Next Review |
|---|---|---|---|---|---|---|---|---|--|---|---|---|---|---|---|---|---|
| | External | 5 | | Roof tile debris on ledge outside first floor door (as sample GU000227) | <1 m ² | Strongly Presumed | Asbestos Cement (1) | Chrysotile (1) | Good Condition (0) | Surface Sealed (1) | Very Low | Very Low | Very Low | D - Manage and Review | - | N/A | Aug 2025 |

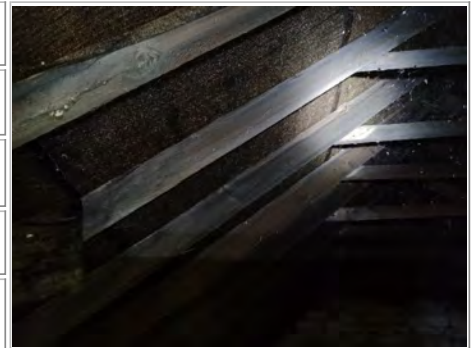
Photo No. 3 - Bitumen felt to underside of roof

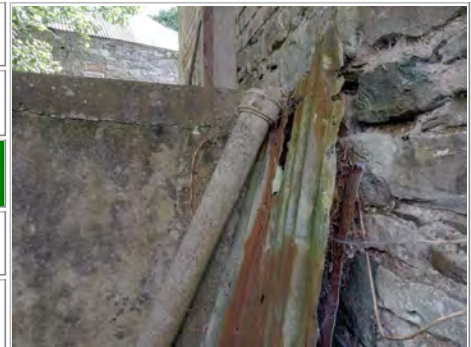
Photo No. 2 - Redundant cement downpipe resting on south wall of Store 1 (001) beside boundary wall

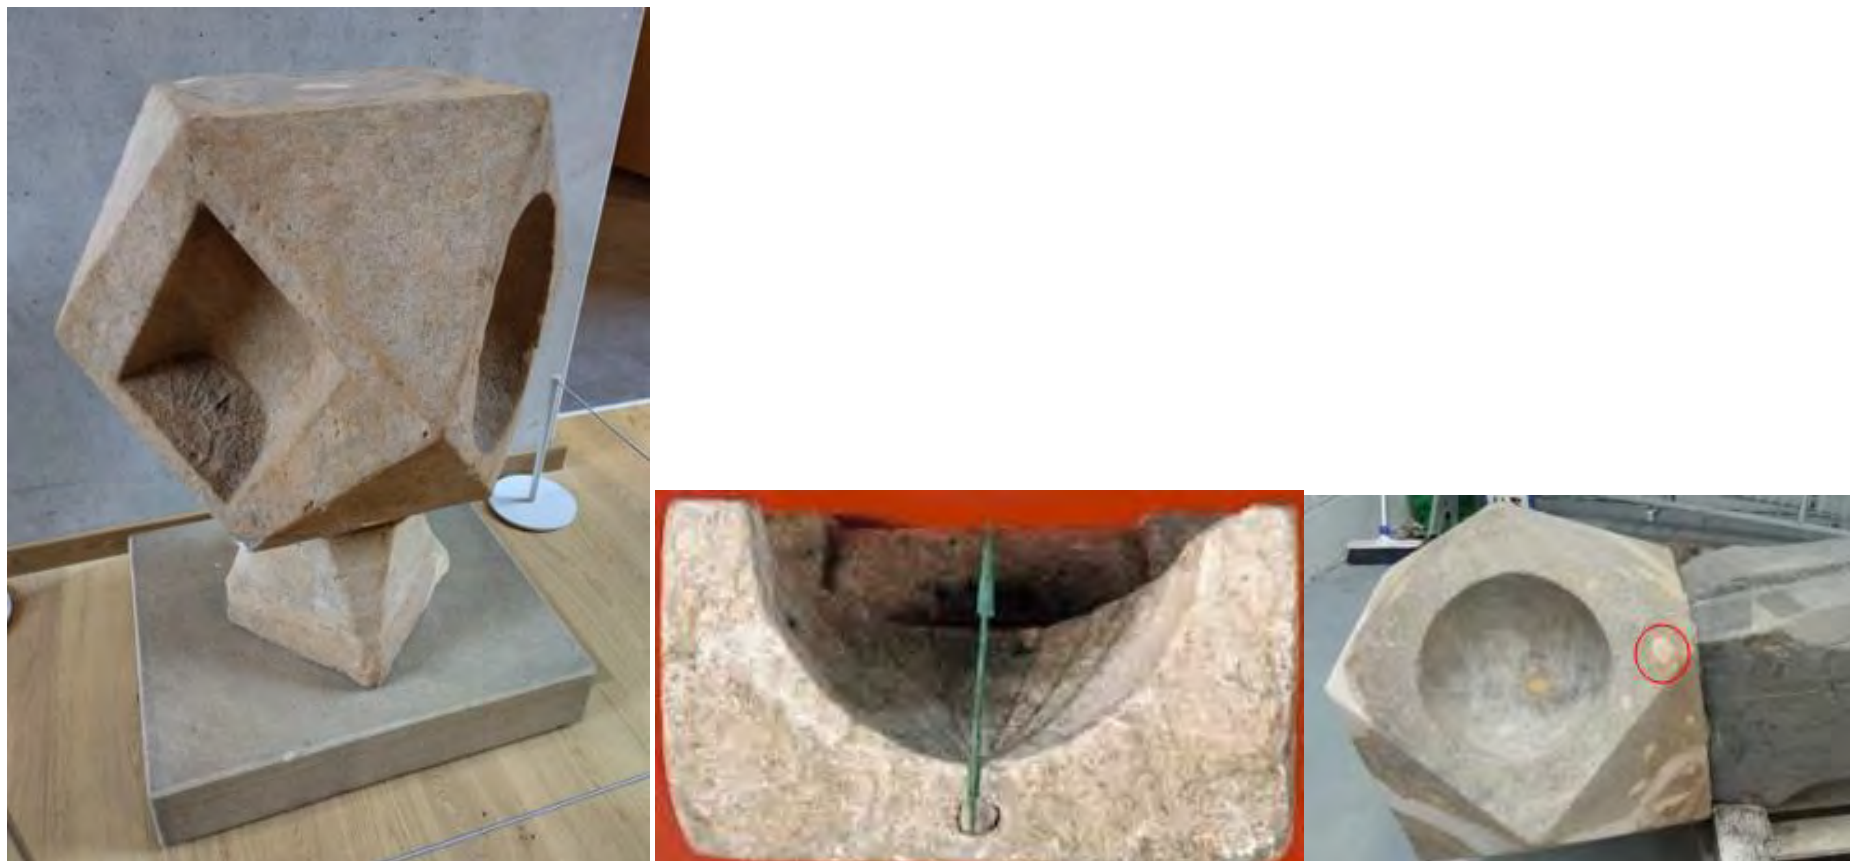
Figure 2 Sundial on display in Monaghan County Museum (left). This is described: Skillfully made stone structure, used to tell the time long before clocks and watches became the norm. Crafted from sandstone, this example is similar to sundials uniquely produced in Scotland in the early 17th century. This sundial and others in the region were either influenced or created by Scottish stonemasons that settled in the area. Look closely to find markings on the face of the stone that originally held gnomons. Gnomons are brass upright pieces that cast shadows allowing people to tell the time. Example of a gnomon in situ in sundial (middle) (image source sundials-ireland.com) and an original gnomon hole infilled on the Market Cross monument during conservation works in 2011

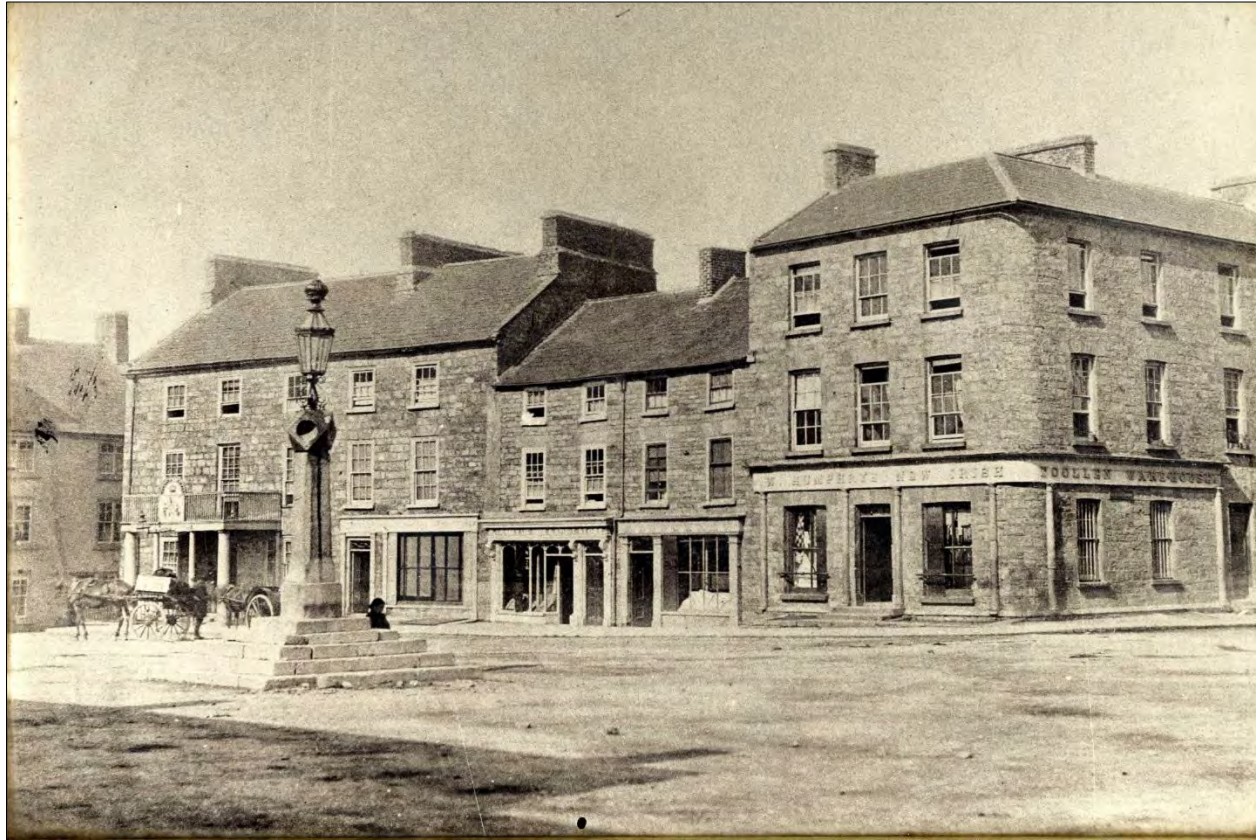
Figure 5 Photograph of the Diamond, Monaghan showing the Market Cross in active use as a gas lantern (Image Source: Livingston, H. 2000. *Francis Frith's Ireland*. Frith Book Company.). The lantern is documented as having been installed in 1870, and the monument painted, much to local dissatisfaction.

It is noted that by the later nineteenth century, c. 1870, the Market Cross was augmented and in use as a gas-powered lantern (**Figure 5**). These direct changes are evidence in the cut chasing on the face of the shaft to accommodate the gas pipework. Furthermore, during conservation works by Nolan⁵ (2011) the gauging out of the upper portion of the sundial to accommodate the lantern was evident (**Figure 6**).

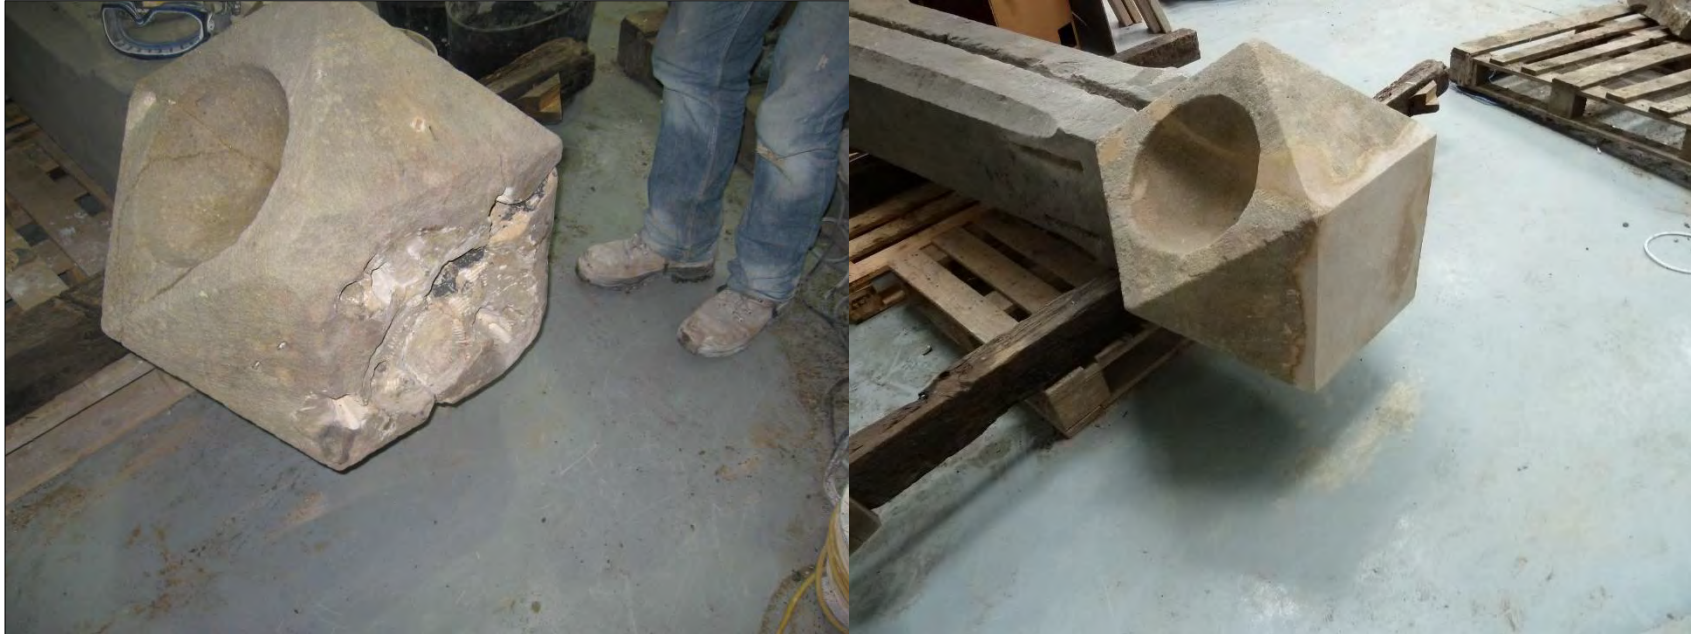
Figure 6 Evidence of gauging out of the sandstone sundial (left) to accommodate a gas lantern in the later nineteenth century. This was repaired (infilled) (right) and the sundial corrected to its original upright functional position atop the shaft, as part of 2011 conservation works. (Image source: D. Nolan, 2011)⁶

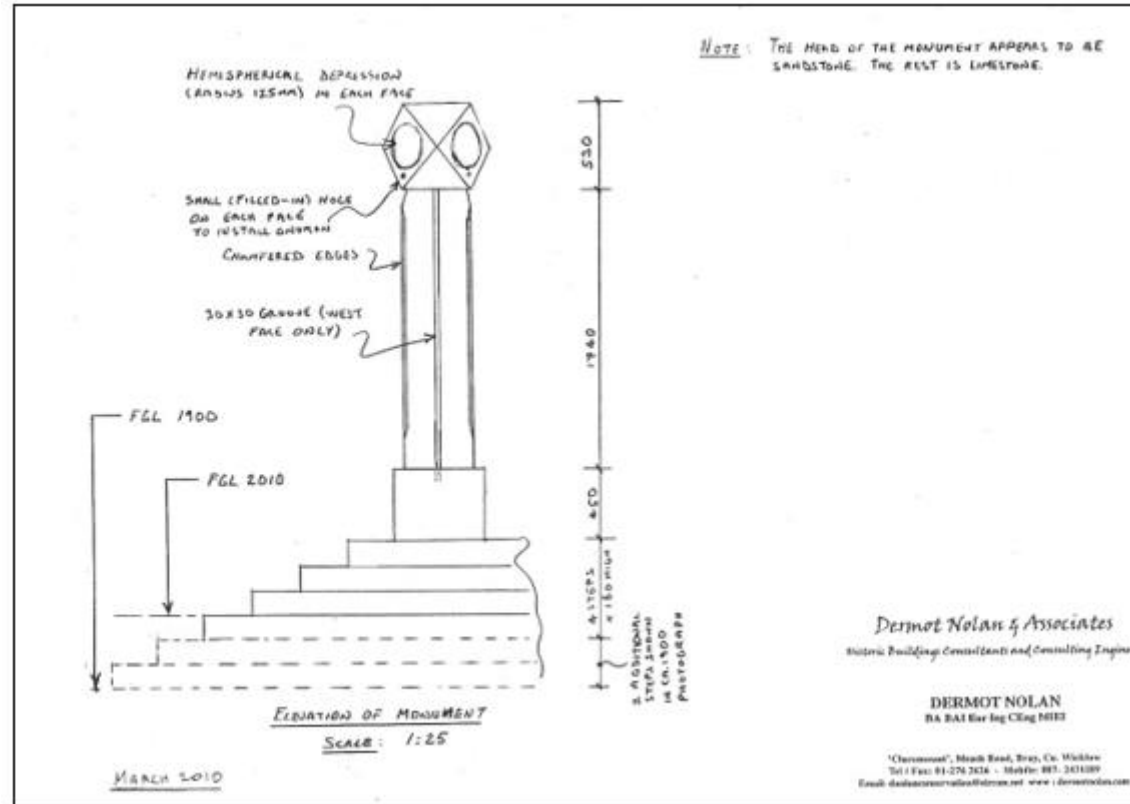
Figure 18 Market Cross Drawing before relocation to present-day position (D. Nolan, 2010)

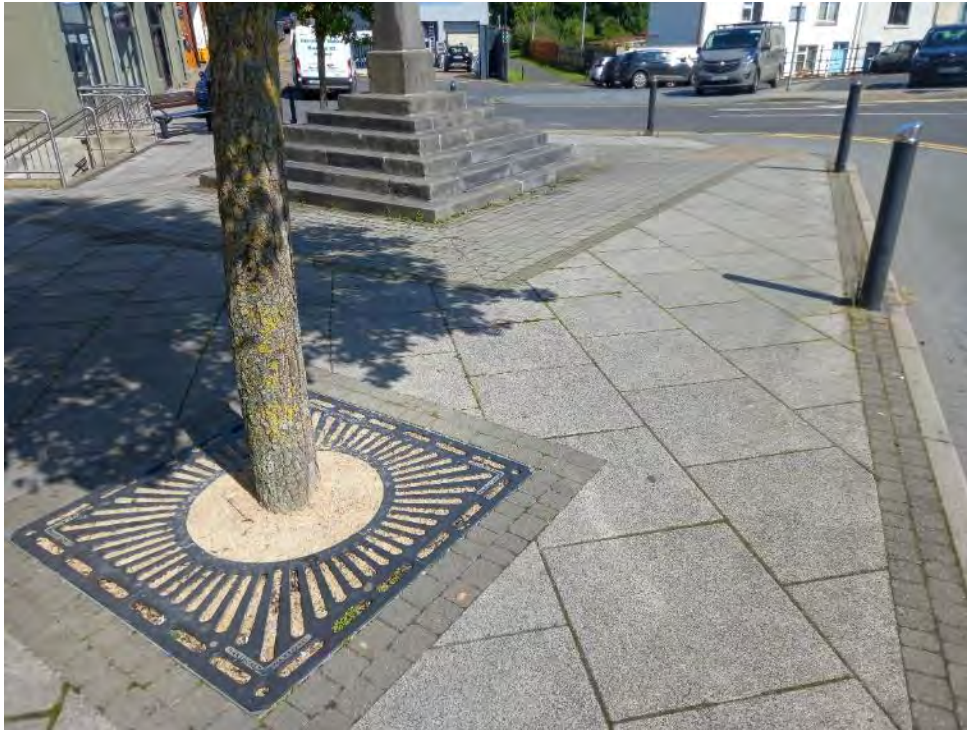
Landscaping and surface treatment at Market Cross today

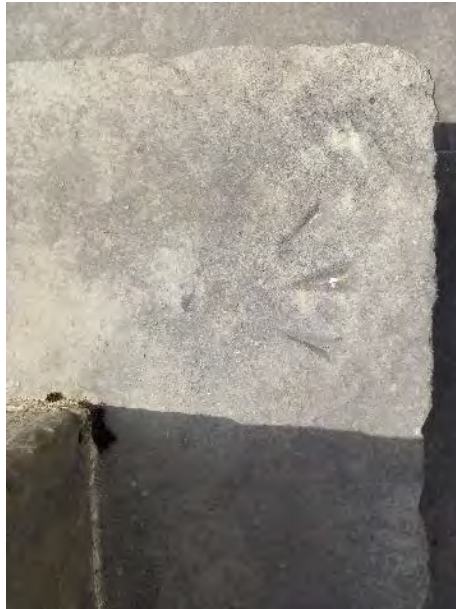
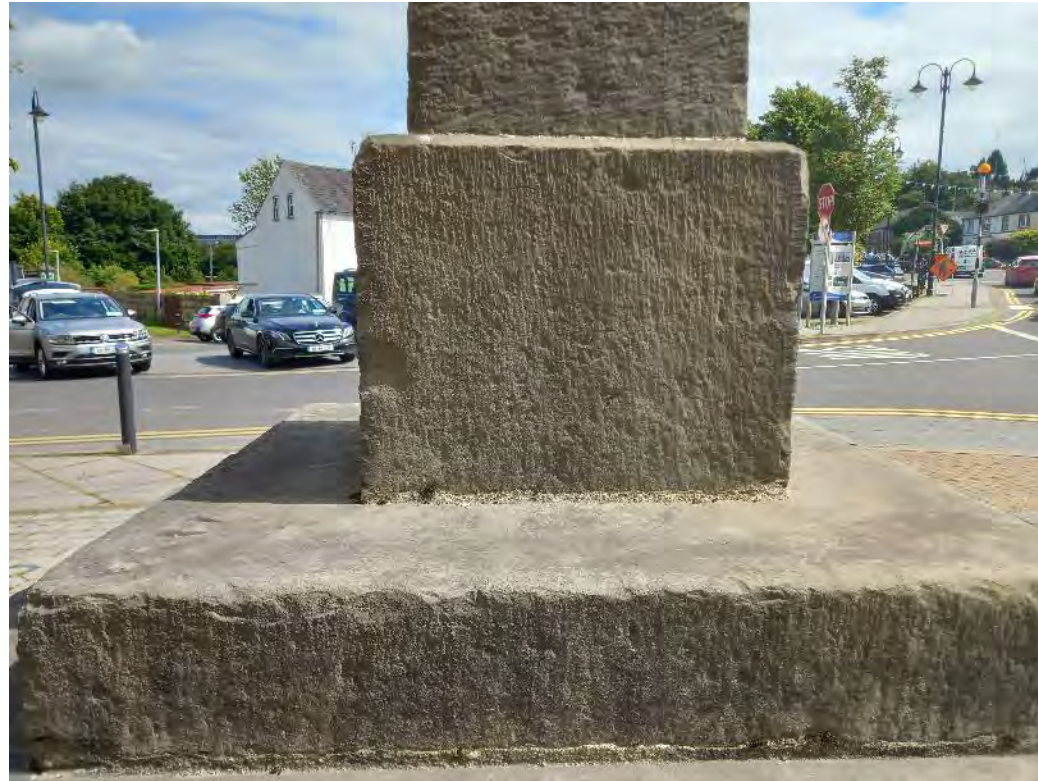
OS Benchmark on first step surface (left. Detail of first limestone step (right)

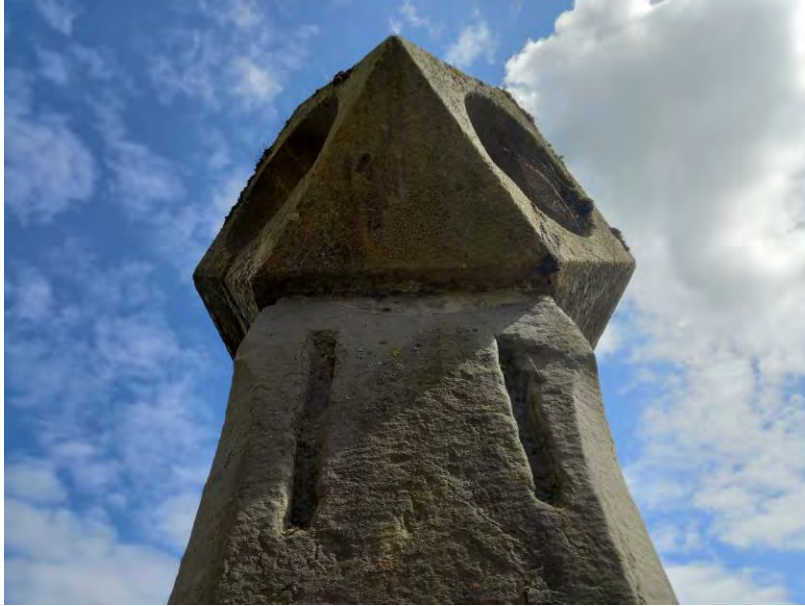
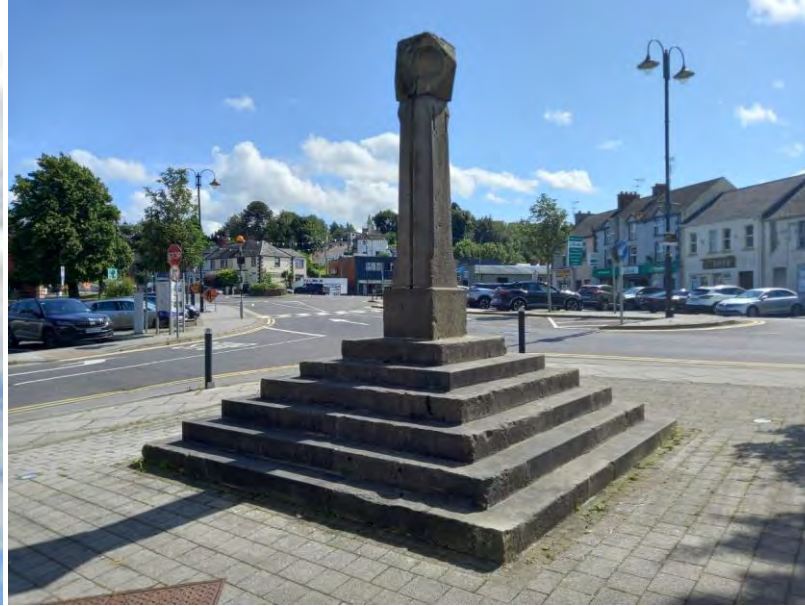
Detail of later augmentation for gas lantern and/or public notice mount (left) and chasing for gas pipework (right)

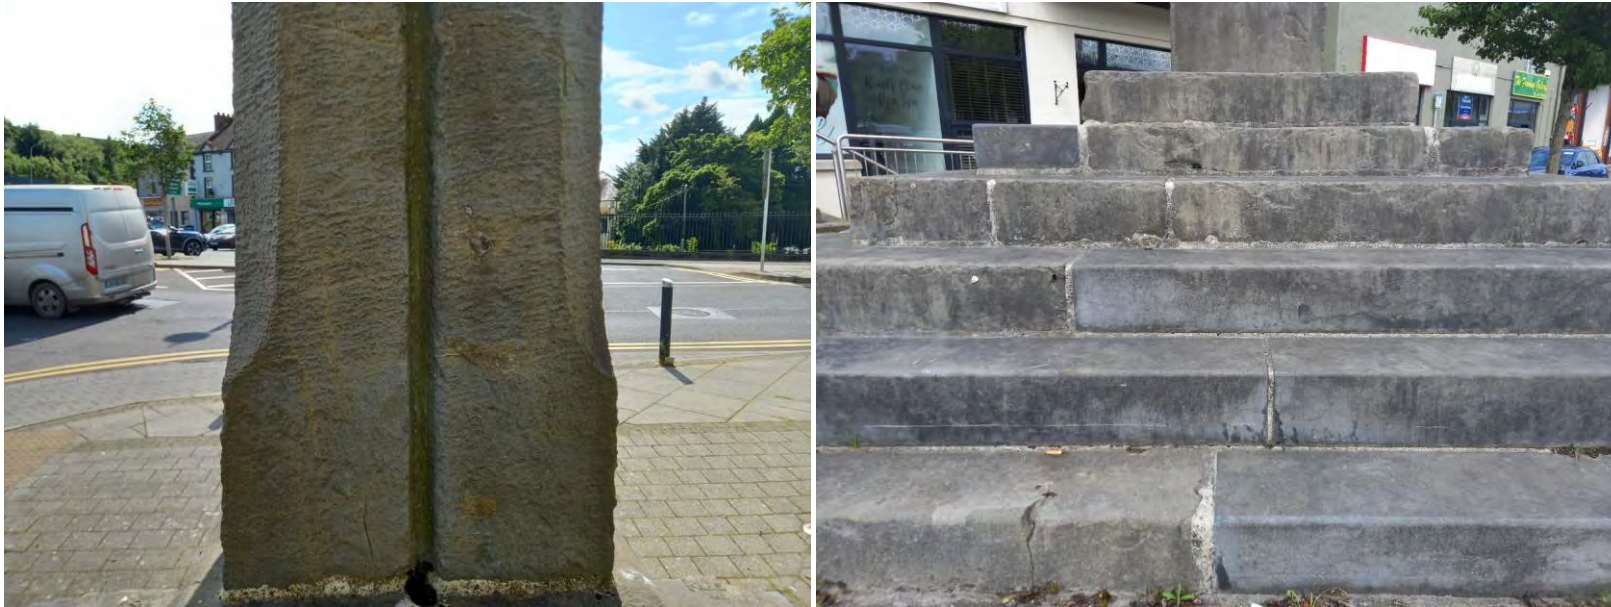
Detail of cut chasing for gas pipework (left) and limestone step conservation and replacement works undertaken in 2011 (right)

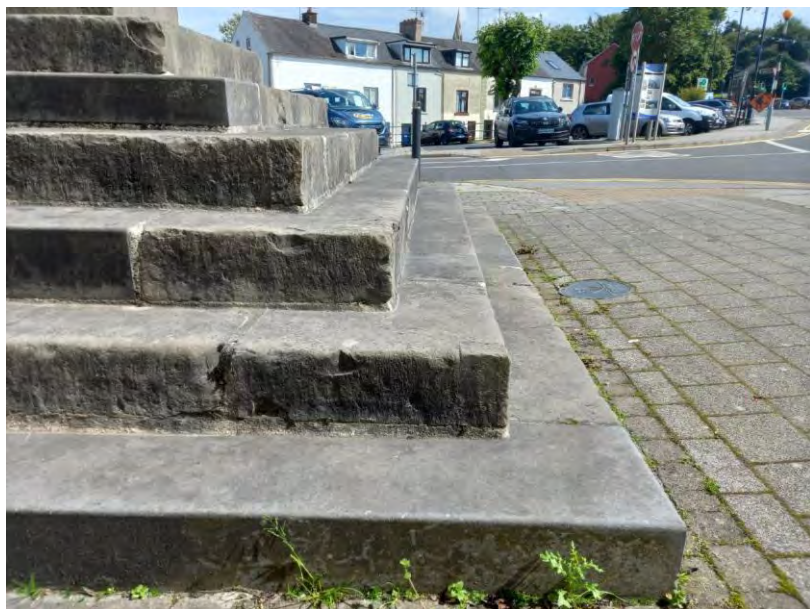
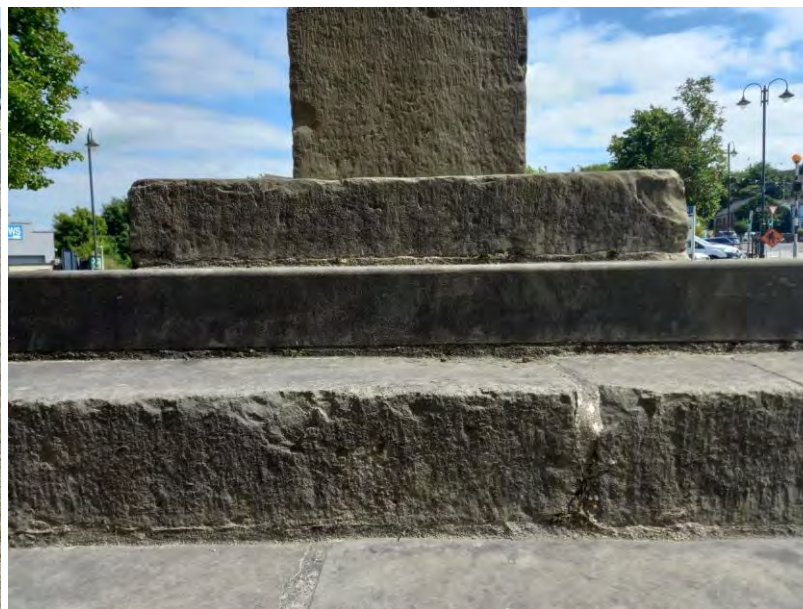
Detail of limestone step repairs and replacement conservation works (undertaken 2011)

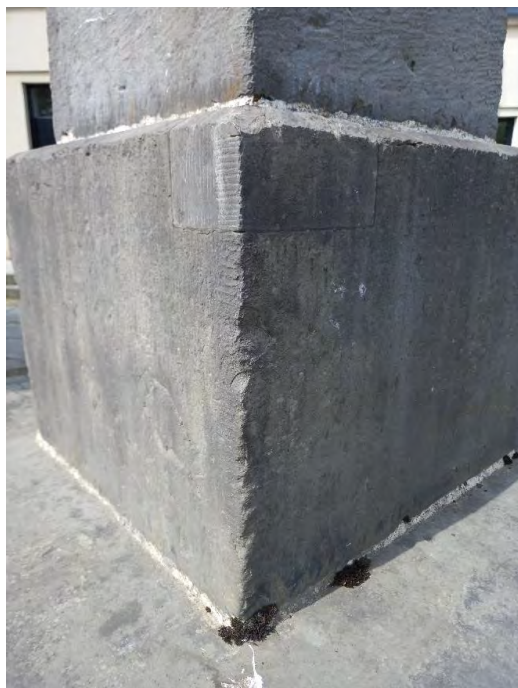
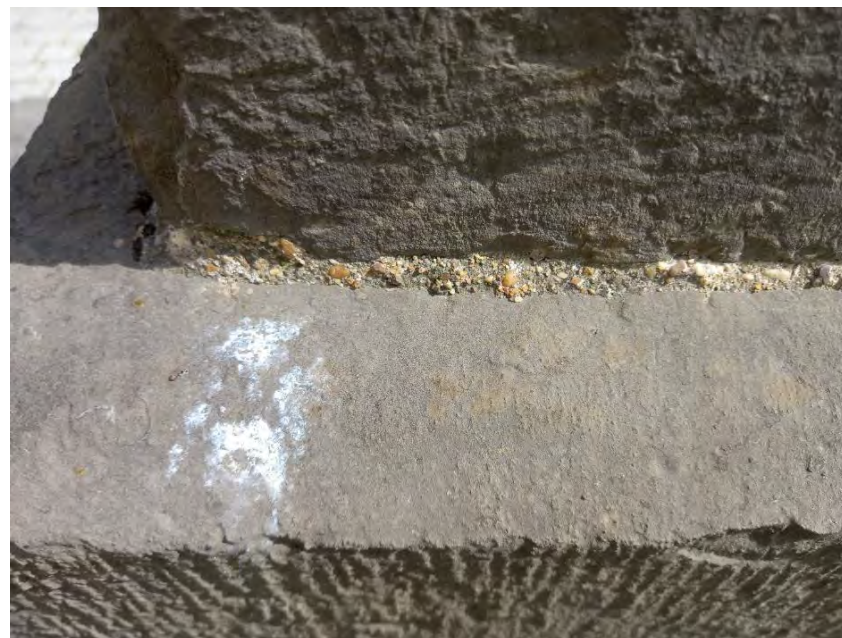
Detail of plinth repair works (left) and mortar detail (right) undertaken 2011

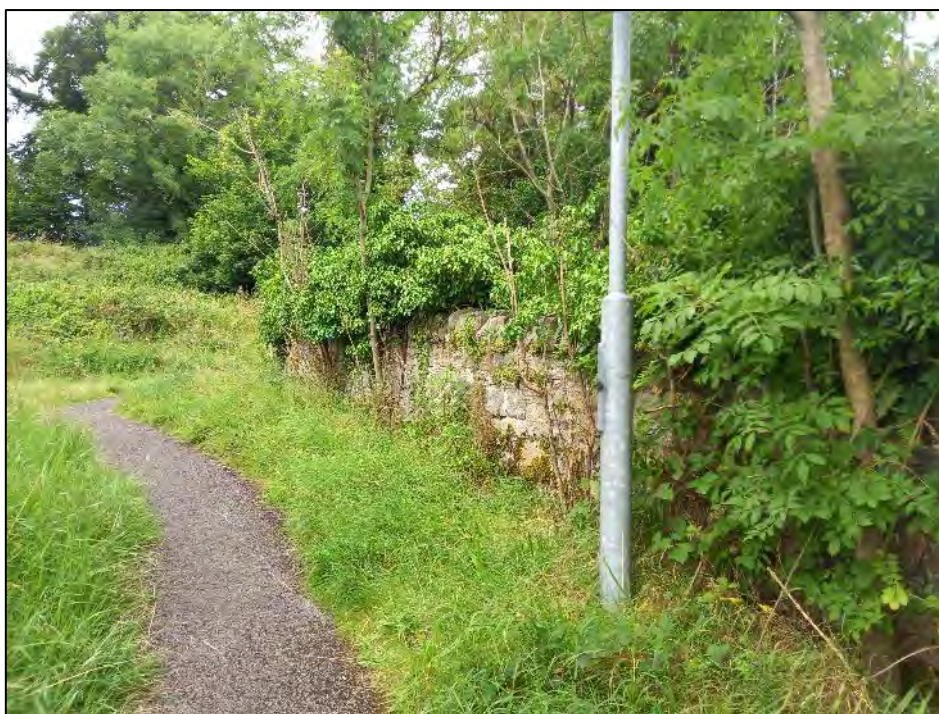
Plate 13.15: View of boundary walling with red brick gate pier, F01, at central (east) boundary of the Old Infirmary site

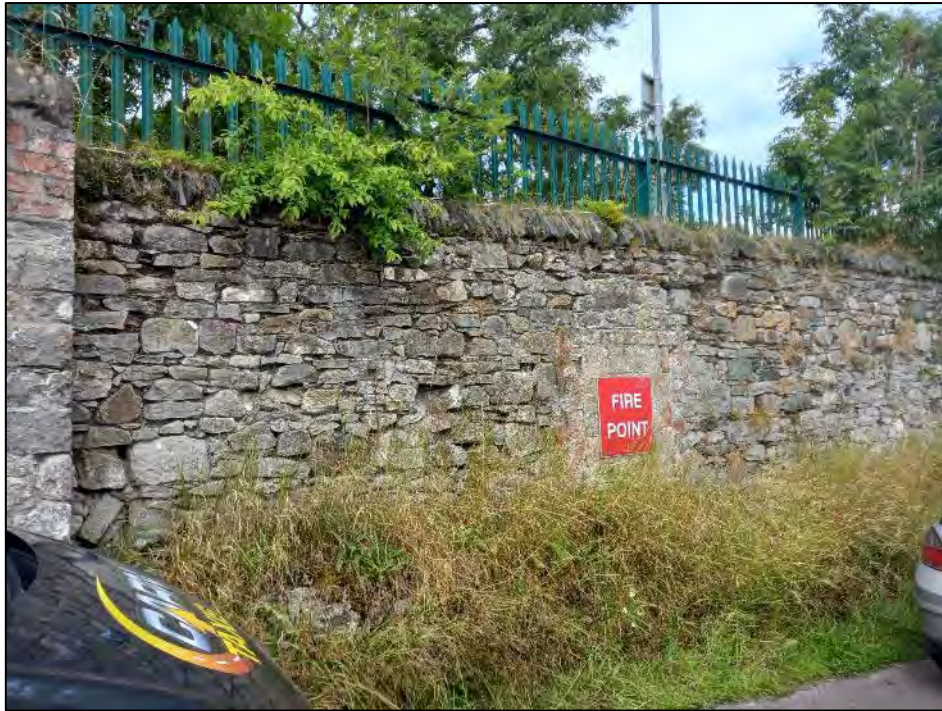
Plate 13.16: View towards north at southern boundary wall to Old Infirmary site, F02, external elevation

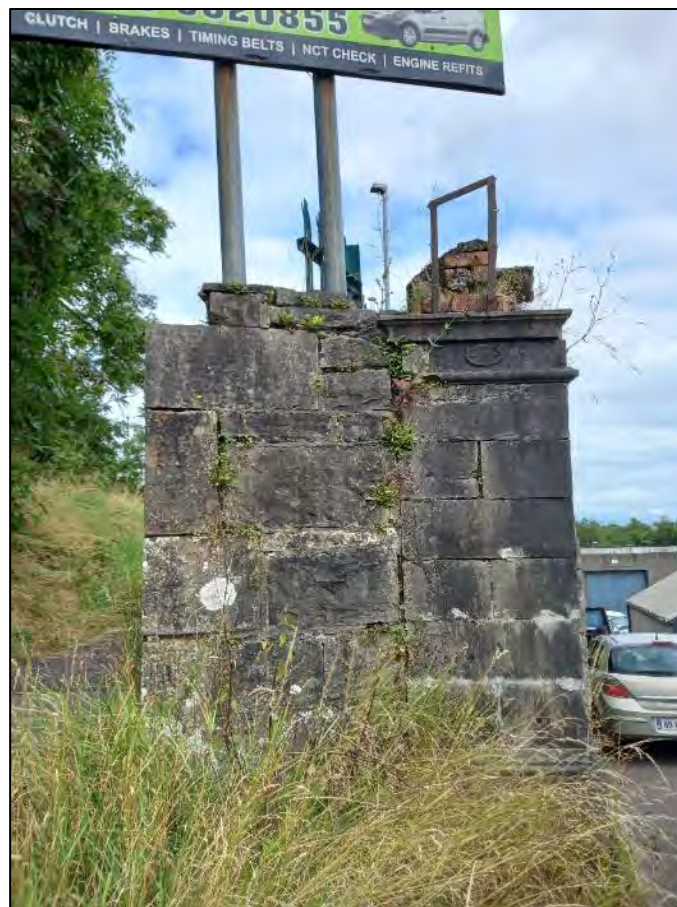
Plate 13.17: View towards cut stone gate pier at main entrance of Old Infirmary site, F03

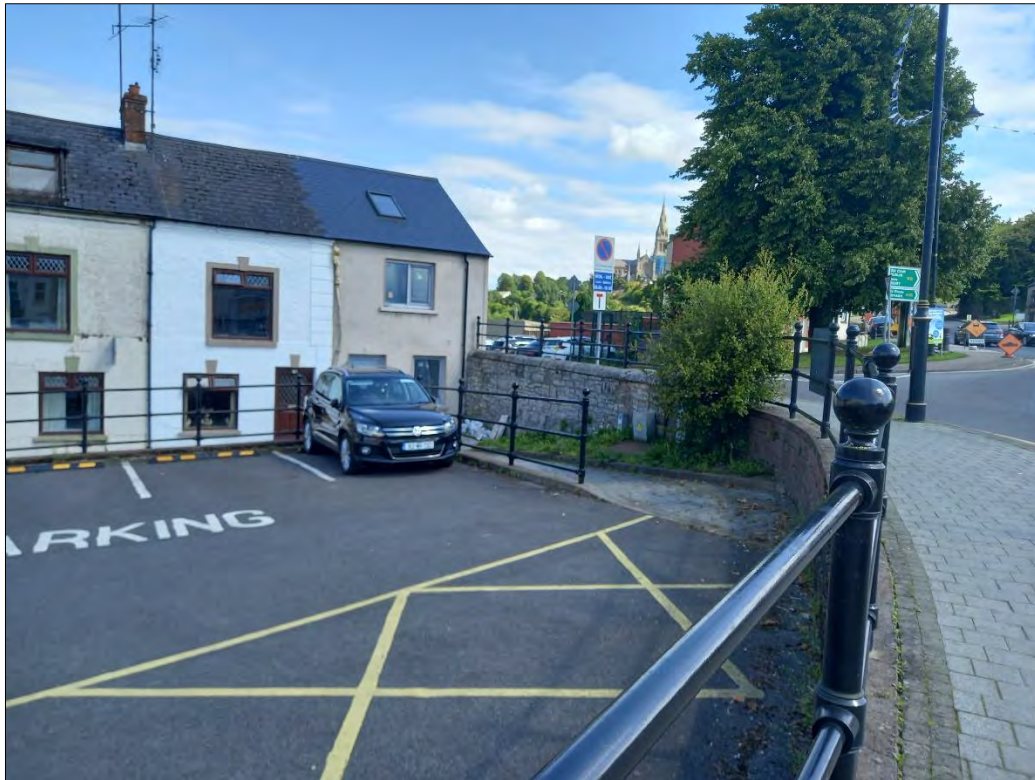
Plate 13.18: View towards portion of upstanding masonry canal walling (F06) abutting end of terrace house in Old Cross Square. The surviving canal tunnel NIAH 41303165 is located at the roadside opposite (hidden behind tree)

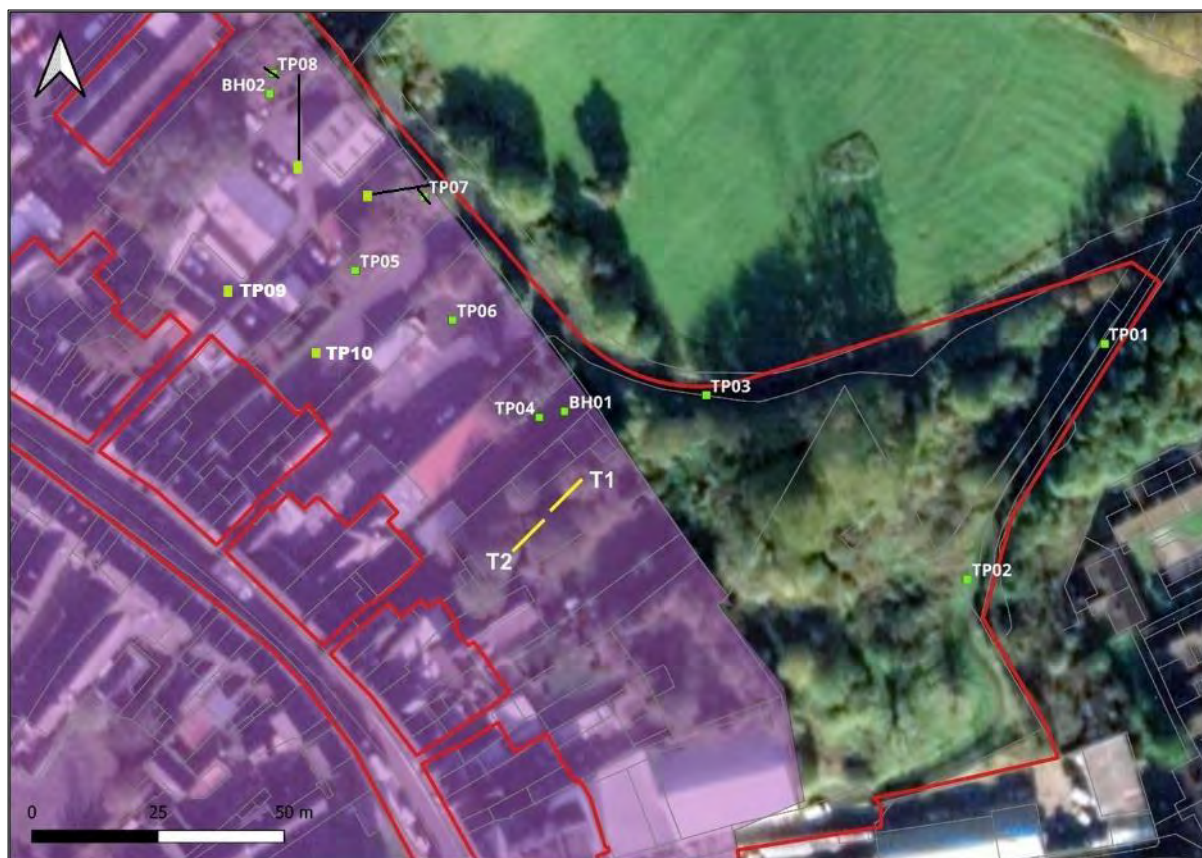
Figure 14: Location of archaeological test trenches (yellow) and GI test pits (green) within development area (red line). The ZoN of historic town (M0009-060---) is shaded purple

A programme of archaeological monitoring and test trenching was carried out under licence no. 24E0606 over a period of five days from 8 to 14 August. Testing was carried out at various locations within the boundaries of the proposed development site with two 8m long archaeological test trenches (Trench 1 and 2) excavated within a vacant greenfield plot to the rear of No. 46 Dublin Street. In addition, 10 no. geological test pits (TP 1- 10) were archaeologically monitored (**Figure 14, Table 3** and **4**). The archaeological test trenches were excavated by a 3 tonne 360° mechanical excavator, fitted with a 1.4m wide toothless grading bucket, which operated under constant archaeological supervision by the licensee. TP 1 - 4, 6, 7 and 9 were excavated by a 3 tonne 360° mechanical excavator, fitted with a 0.3m wide toothless grading bucket. TP 5, 8 and 10 were excavated using a 13 tonne mechanical excavator, fitted with a 0.9m wide toothless grading bucket. All excavations were carried out under constant archaeological supervision by the licensee.

Table 3: Archaeological test trench details. See **Figure 14** for trench locations

Table 4: SI test pit details. See **Figure 14** for locations

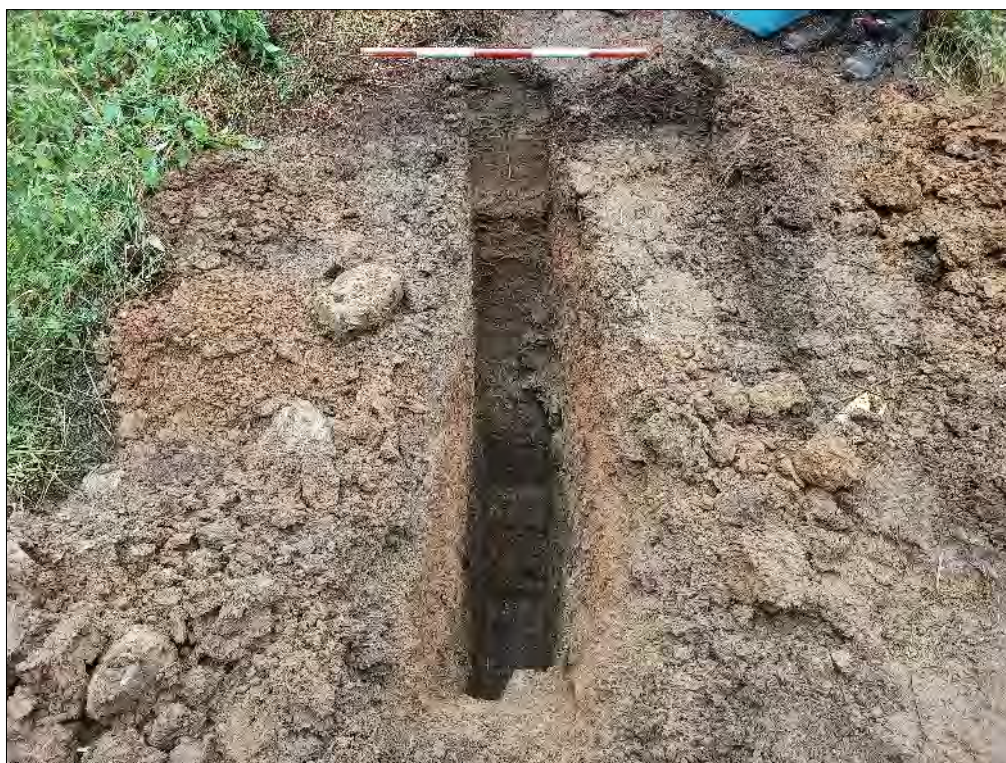
Plate 1: TP1 looking southwest

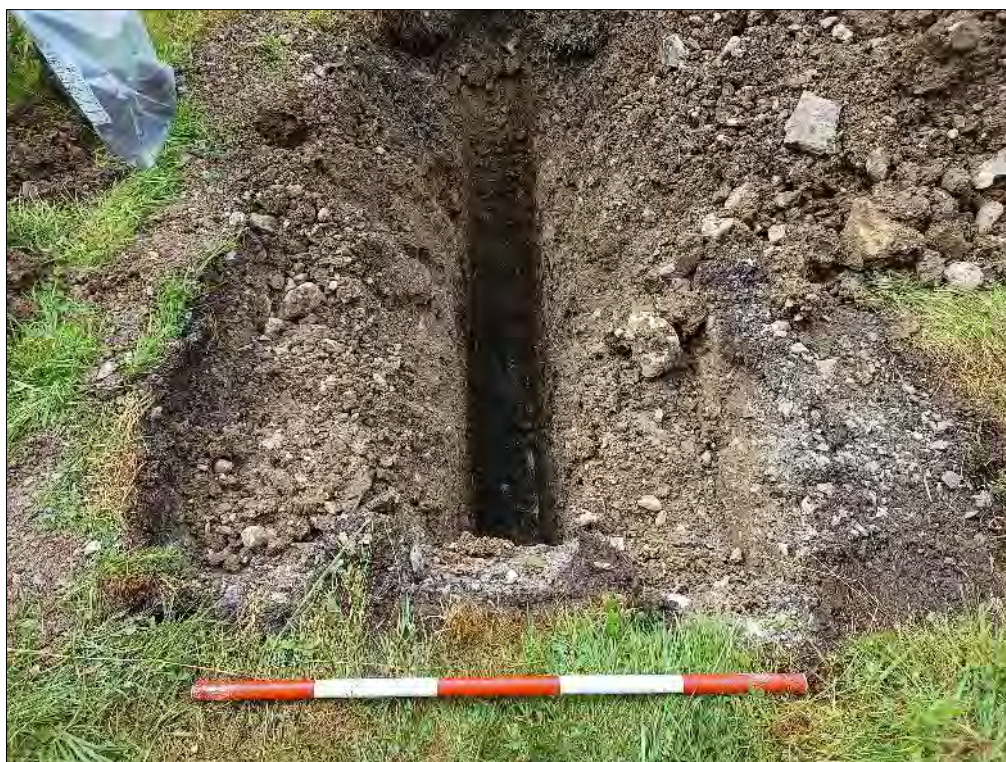
Plate 2: TP2 looking west

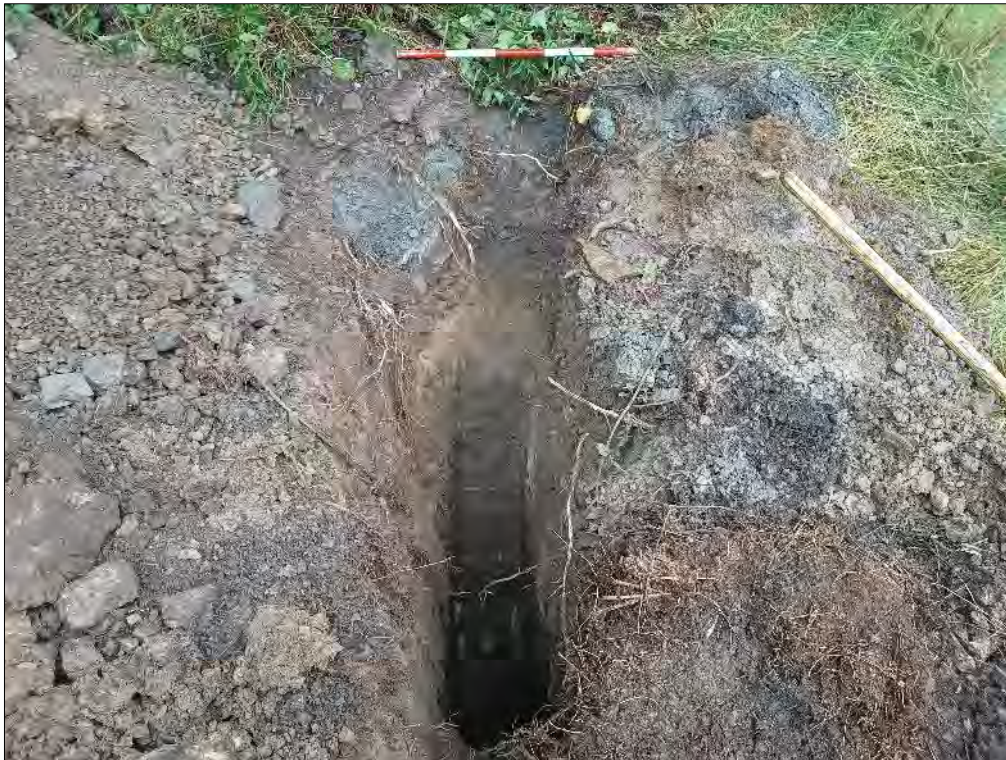
Plate 3: TP3 looking west

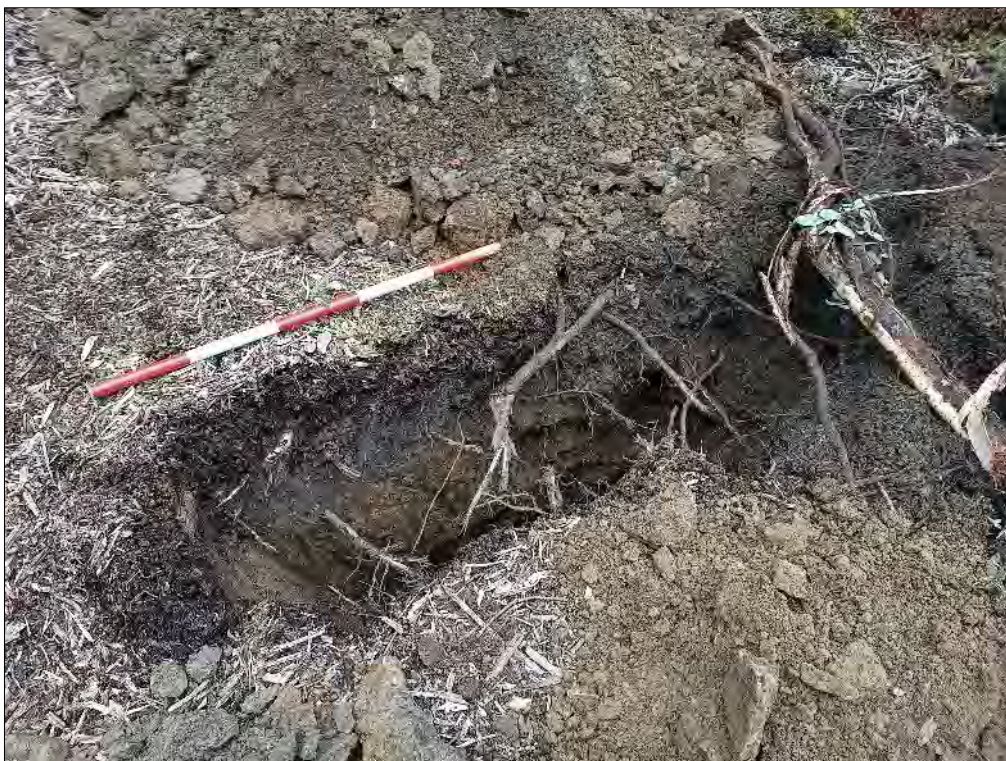
Plate 4: TP4 looking south

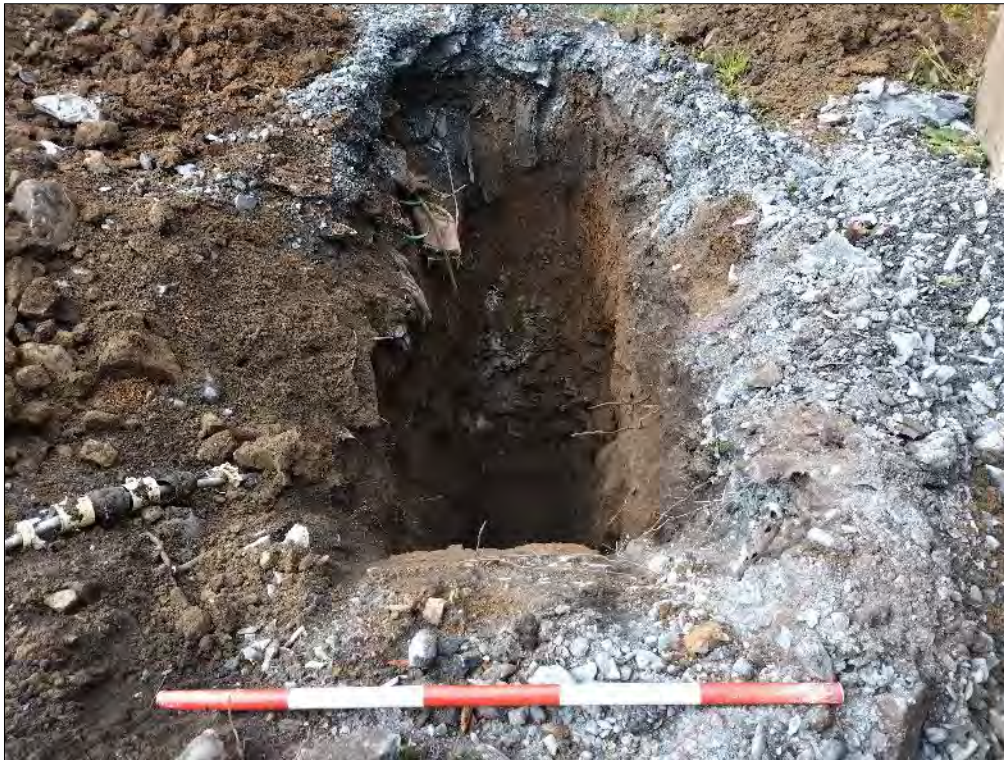
Plate 5: TP5 looking southwest

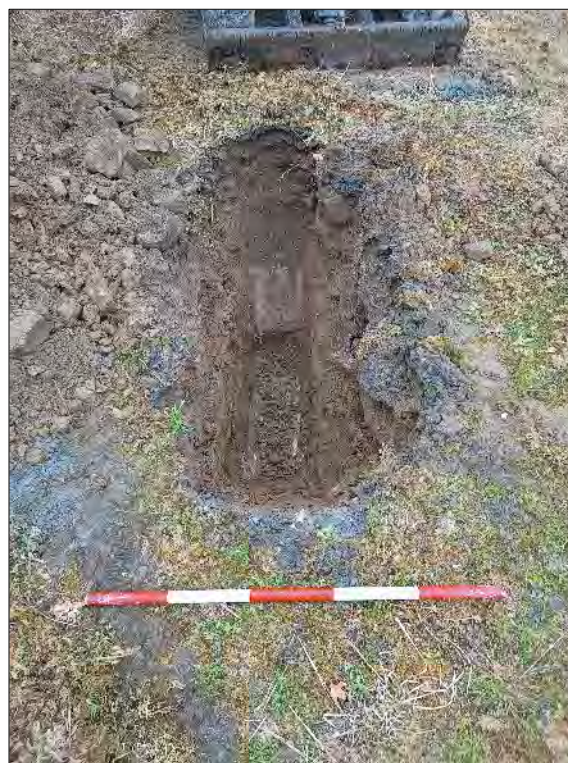
Plate 6: TP6 looking northeast

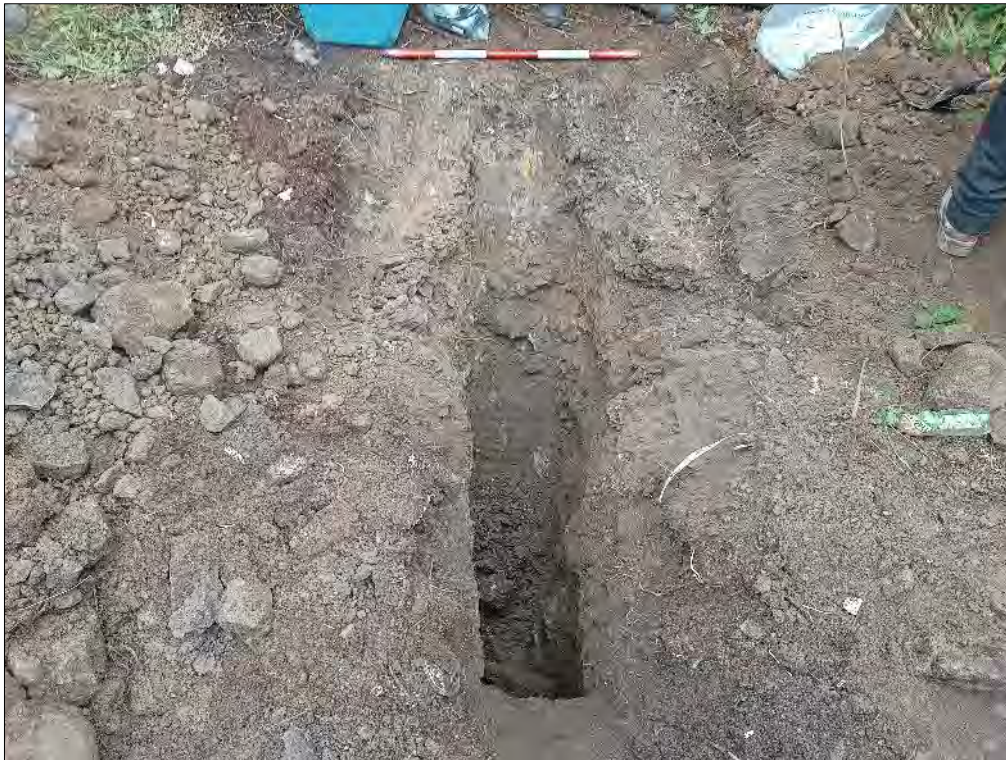
Plate 7: TP7 looking southeast
