1.0 INTRODUCTION

Layde Consulting was appointed by Carlin Planning Ltd to undertake a series of bat activity surveys and potential roost assessments for a proposed Regeneration Scheme within Monaghan town, extending to lands at the rear of Dublin Street North. This report summarises the key findings in relation to identified bat species within the study area and provides further recommendations as necessary.

1.1 Site Overview & Development Proposals

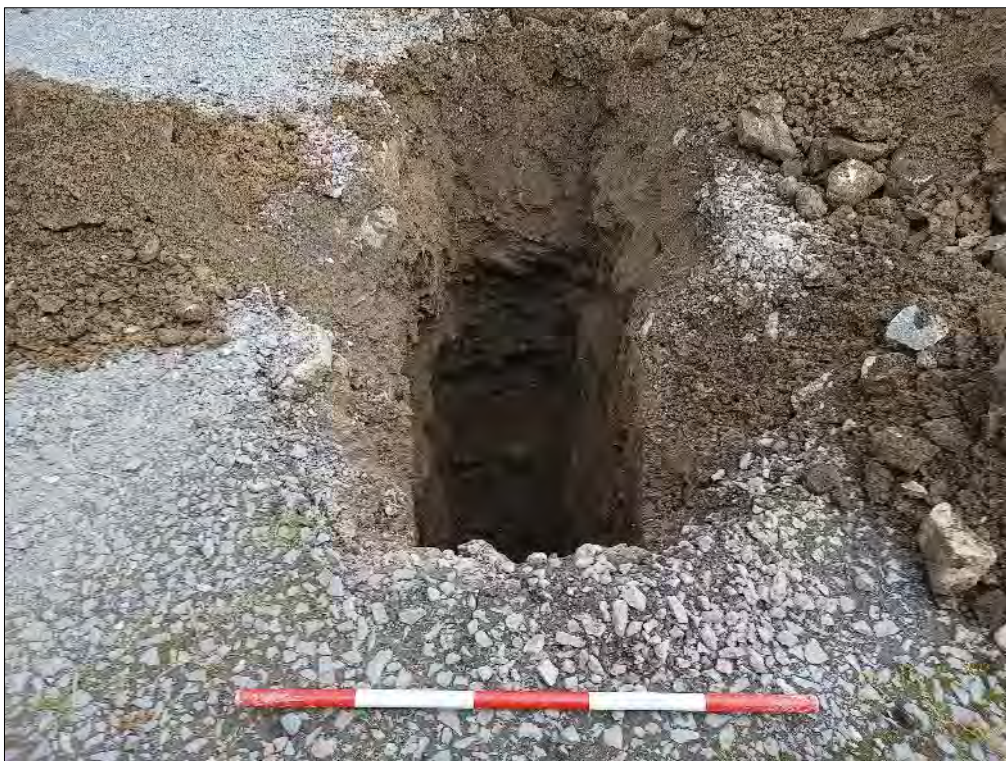
Plate 8: TP8 looking southeast

| Description | Trench located in rear plot/backlands 0 – 0.15m: Hardcore fill 0.15 – 1.5m: Mid brown gritty clay mixed with frequent modern refuse (textile, concrete, red brick) 1.5 – 2.0m: Light brownish yellow silty sand (natural subsoil) 2.0 – 3.0m: Light greyish brown clay with frequent stones and boulders (0.10-0.30m diam.) Plate 8 |

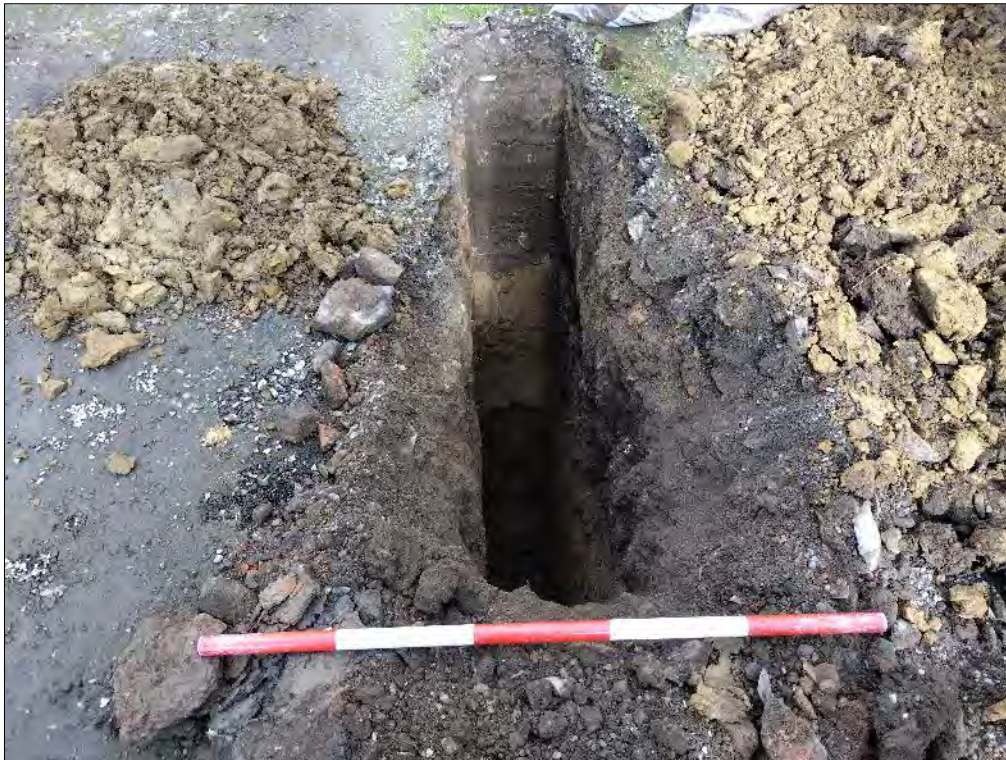
Plate 9: TP9 looking northwest

| Description | Trench located in rear plot/backlands 0 – 0.15m: Hardcore fill 0.15m – 1.0m: Dark brown silty clay mixed with fragments of red brick 1.0 – 2.5m: Light brown clayey silt with occasional large pebbles Plate 9 |

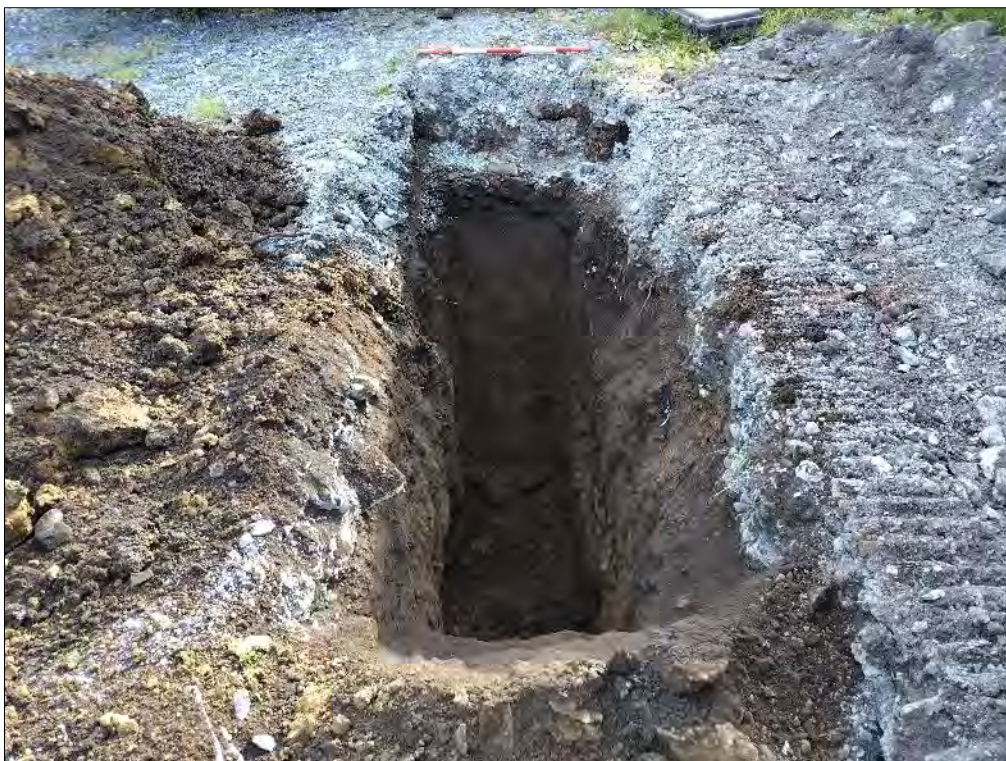
Plate 10: TP10 looking southwest

| Description | Trench located in rear plot/backlands 0 – 0.15m: Hardcore fill 0.15 – 1.4m: Dark brown garden soil with moderate inclusions of red brick and modern ceramics 1.4 – 2.80m: Light brownish yellow silty sand (natural subsoil) 2.80 – 3.0m: Light brownish greyish brown stony clay. Plate 10 |

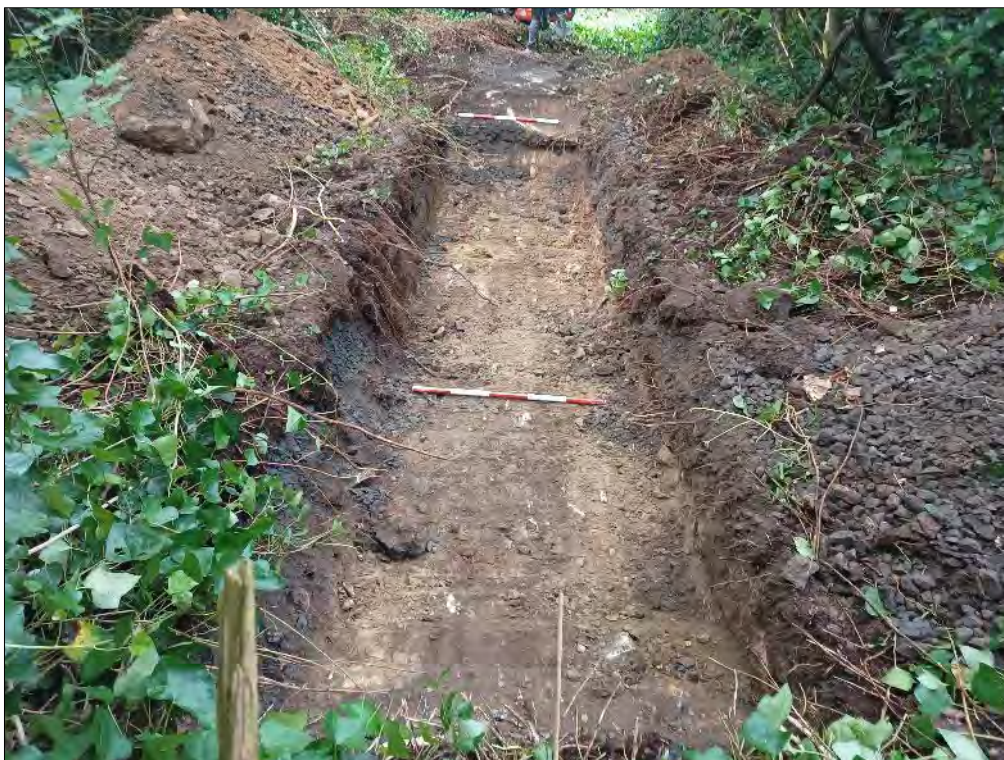
Plate 11: TR1 looking southwest

| Description | Located within vacant greenfield plot overgrown with shrubs and small trees. Excavated through a 0.20m thick layer of overburden comprising leaf mould, rubble and refuse. The overburden overlaid a 0.25m thick layer of fine gravel which had been laid down on a 0.10-0.20m thick layer of dark brown gritty garden soil (loam) with moderate inclusions of red and yellow brick fragments and coal. This deposit directly overlay the natural subsoil, a light brownish yellow silty sand with moderate stone inclusions. A slab of concrete, perhaps formerly used as a garden path, was noted at the southwest end of TR2. Plate 11 |

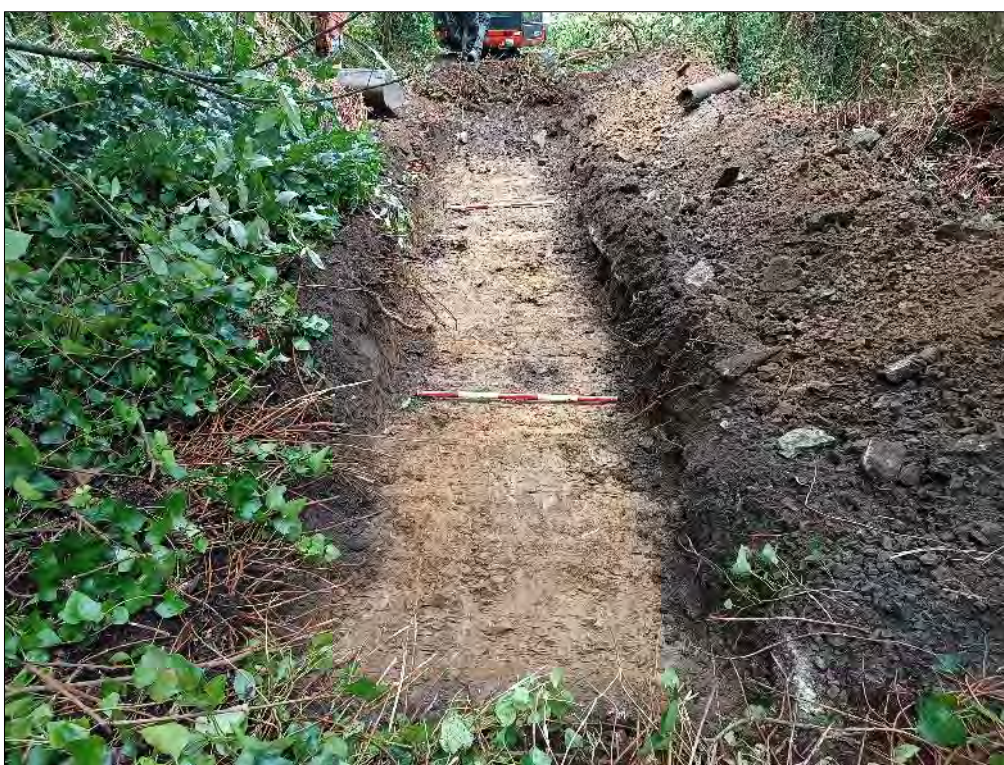
Plate 12: TR2 looking southwest

| Description | <p>Located within vacant greenfield plot overgrown with shrubs and small trees. Excavated through a 0.40m – 0.60m thick layer of overburden comprising leaf mould and dark brown garden soil (loam) mixed with large quantities of stone and gravel with inclusions of modern red brick fragments and glass. This deposit directly overlay the natural subsoil, a light brownish yellow silty sand with moderate stone inclusions. A concrete pipe covered with a slab of concrete, perhaps formerly functioning as a garden path, was noted along the western edge of TR2.</p> <p>Plate 12</p> |

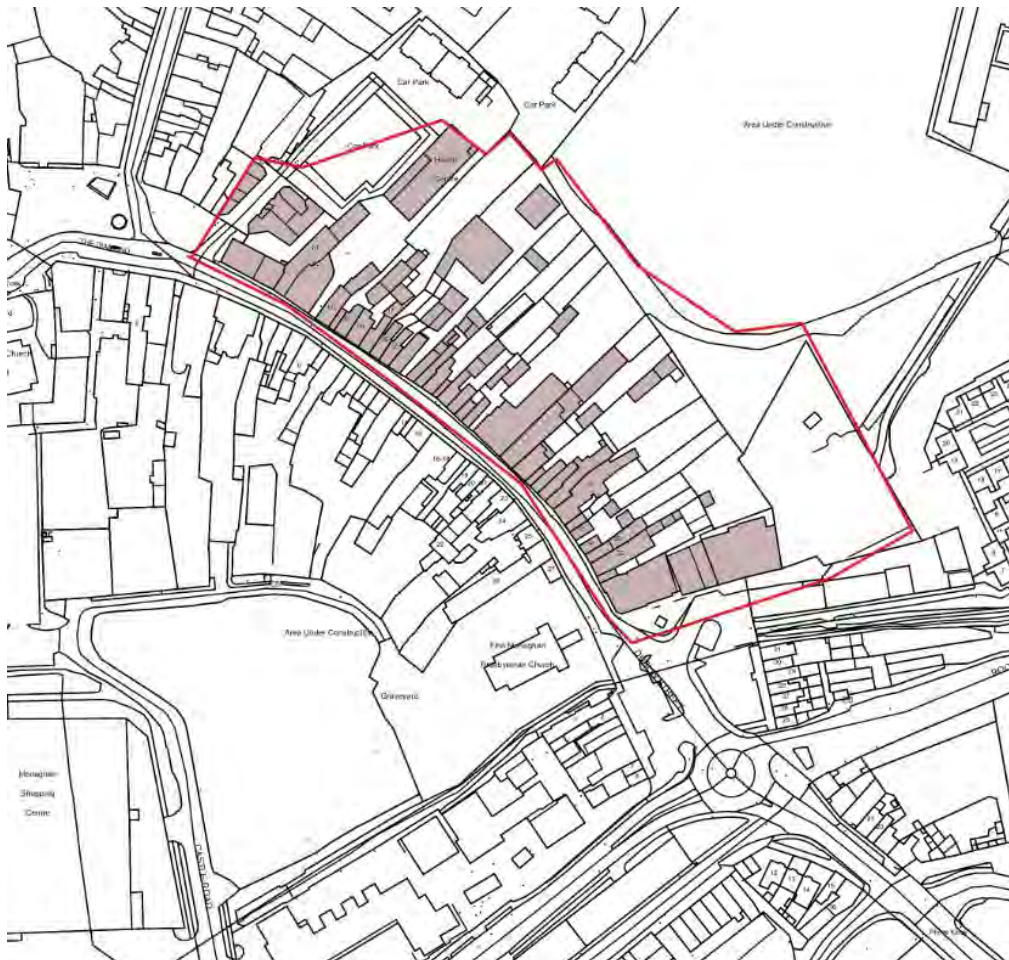
Area of analysis outlined with buildings highlighted

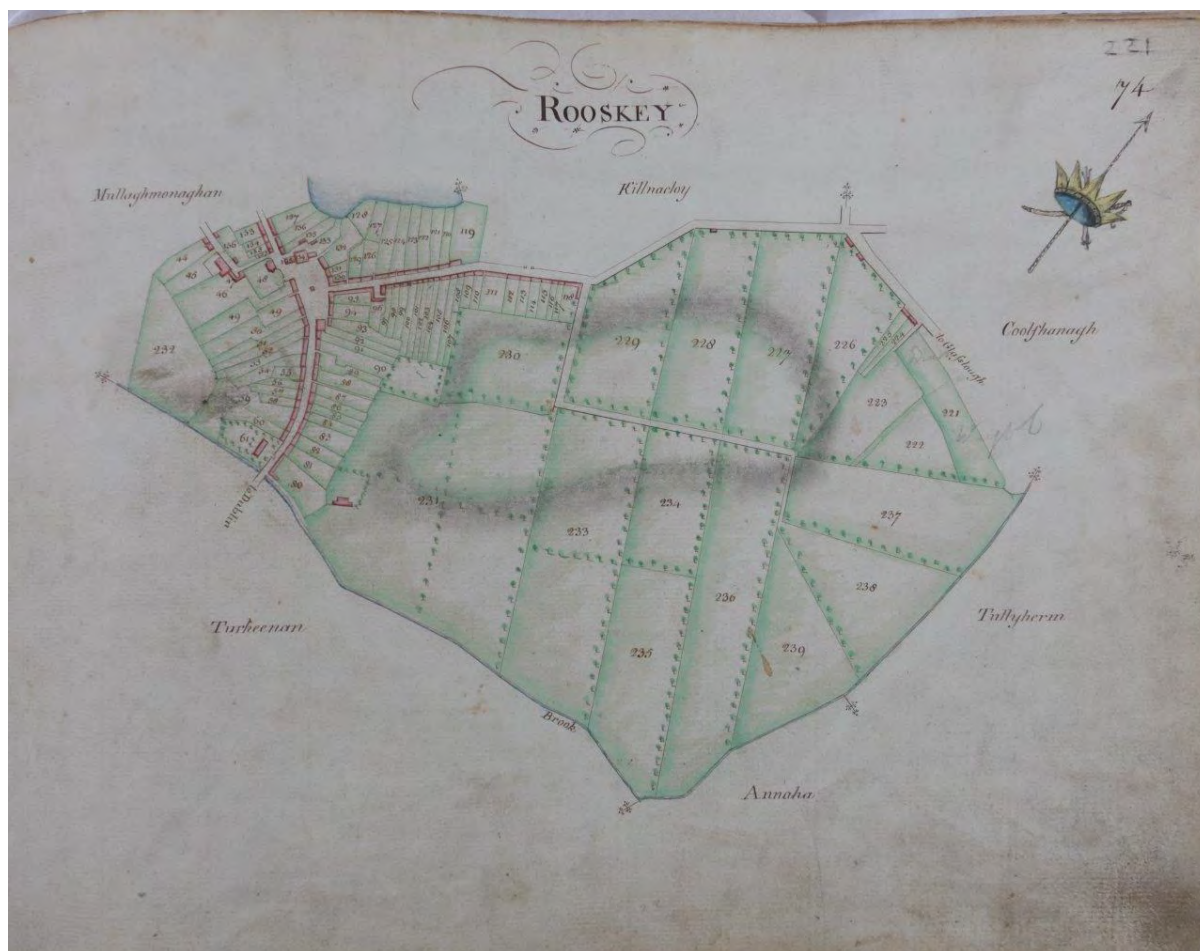
Cleremont Estate Map, c.1791

Currently known as the Rossmore Estate, the townland of Rooskey is within what was the Cleremont Estate at the end of the eighteenth century. It can be seen that there are thirteen plots identified to the north (right) side of Dublin Street. If any outbuildings were present, they are not noted on the map. The buildings appear long, presenting a wide façade to the street and are shown without any returns.

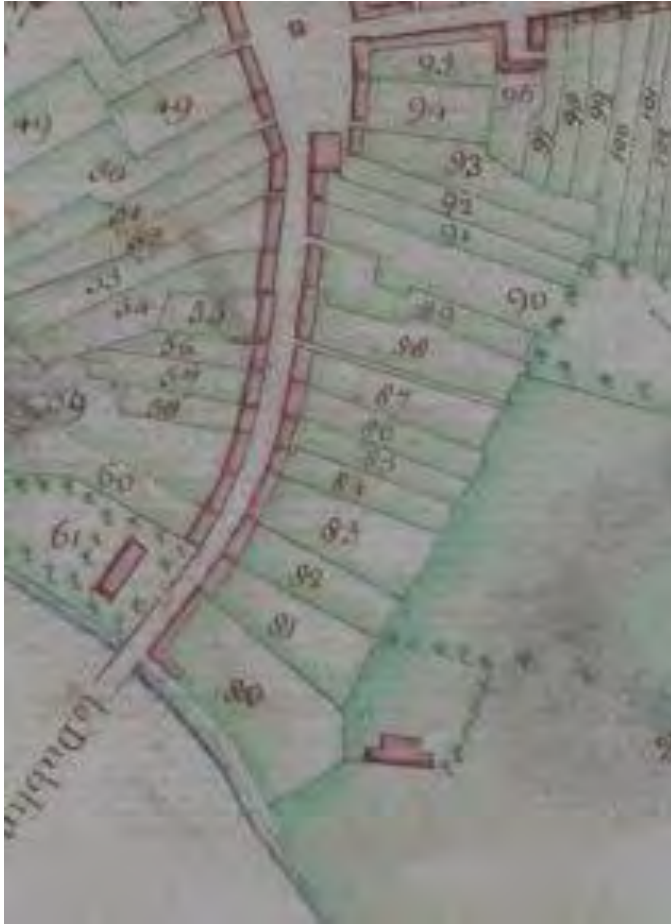
Clermont Estate map c.1791 detail of Dublin Street

On closer inspection, it can be seen that there are only two entries through the buildings; currently there are five. To the lower right of the map the footprint of the now demolished Asylum infirmary can be seen.

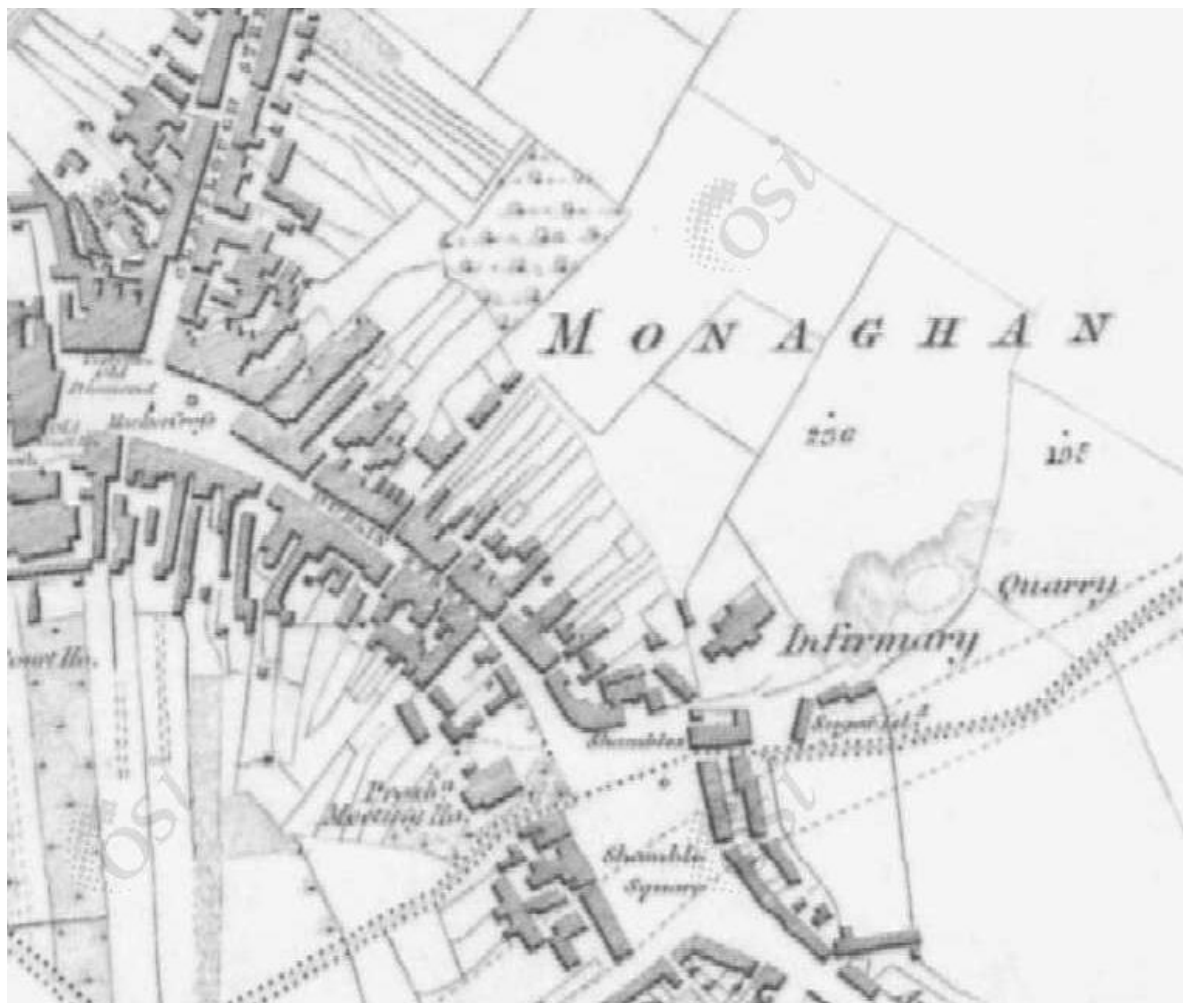
OS First Edition c. 1836

The OS First edition shows all five entries together with footprints and outbuildings similar to the current situation. This is quite different in building form and plot size to the 1791 map. A date plaque showing WM 1810 is set into no. 49 suggesting the building dates from then. The Shambles terrace is present at the south end of the street and the Square is known as Shambles Square. At this time the Old Town Cross is located in the Diamond at the north of the street.

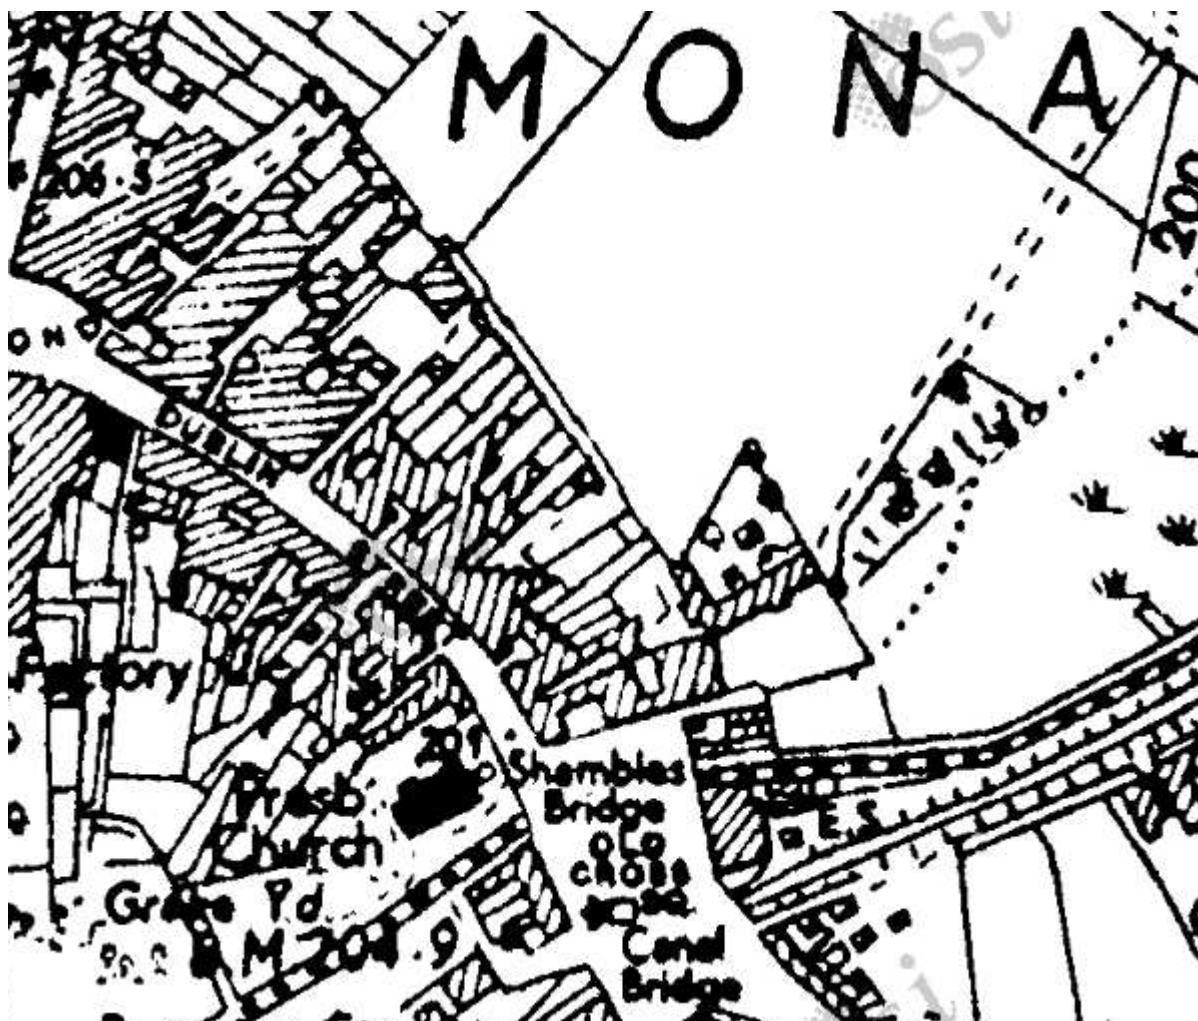
OS Last Edition c.1951

This edition shows a plan similar to the OS Second Edition but is less legible, and less reliable for detail.

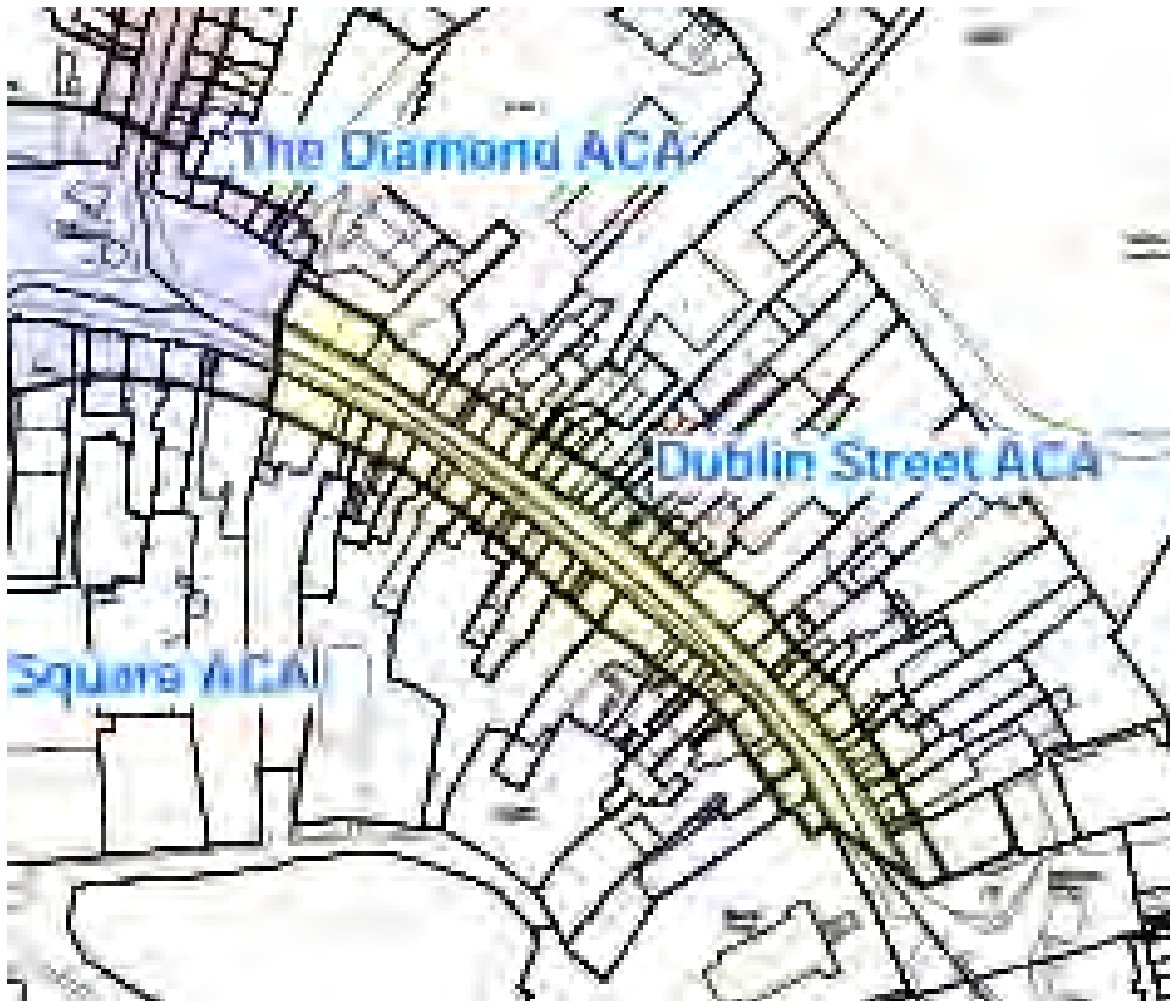
Dublin Street Architectural Conservation Area

There are several Architectural Conservation Areas (ACAs) in the town, and Dublin Street is a dedicated ACA. The boundary of the area takes in the main buildings fronting the street only, without including returns and outbuildings.

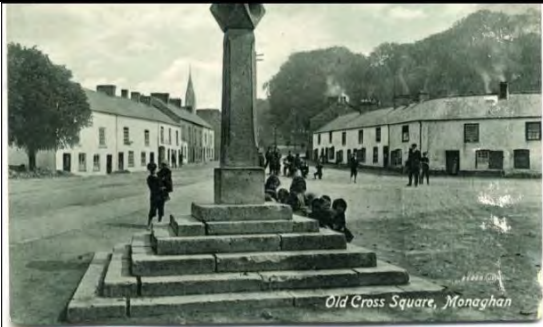
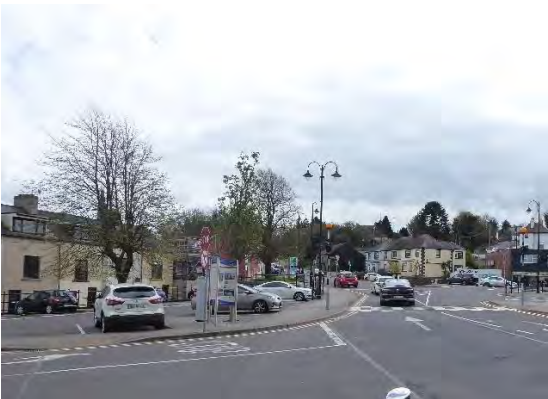
| Image 1 | <p>Postcard of Old Cross Square c.1900⁵</p> |
| Image 2 | <p>Present day Old Cross Square</p> |
| Description | <p>The Market Cross is notably not cross shaped, it is apparently a sundial. It is scheduled for inclusion in the next revision of the RMP and is described therein as follows:</p> <p><i>The cross is first recorded in 1714 (McKenna 1920, 1, 80-3) and it is described as 'Market Cross' in italic lettering on the 1834 edition of the OS 6-inch map at the centre of the Diamond where it had stood with the stocks beside it. Around 1875 the Rossmore Memorial, a neo-gothic memorial fountain, was erected in its stead and the Market cross was discarded. This caused great controversy at the time, when Nationalists rescued it and re-erected in the small square known as the Shambles and now called Old Cross Square. By the time Nationalists had a majority on the council in 1898 the heat had gone out of the issue, and the cross remains in Old Cross Square (McKenna 1920 1, 80-3). It is depicted on the 1907 edition of the OS 6-inch map as being in the centre of the square but this location must have caused traffic problems and it is now at the N side of the square. However, in setting up the cross here the head was attached upside down so that it no longer functions as a sun-dial (McMahon and Walsh 1982, 16).</i></p> <p><i>Six limestone steps lead to the rectangular base (dims 0.56m x 0.56m; H 0.446m) which supports a tapering limestone shaft (dims at base 0.44m x 0.43m; H 1.72m) with chamfered edges and curved stops. The head is a polygonal stone with four hemispherical hollows on different facets, each of which was originally aligned on a cardinal point. A gnomon or pointer would cast a shadow on lines in a particular cup depending on the time of day and season of the year. Even the N-facing cup provided readings on long summer's evenings. (ibid.)⁶</i></p> |

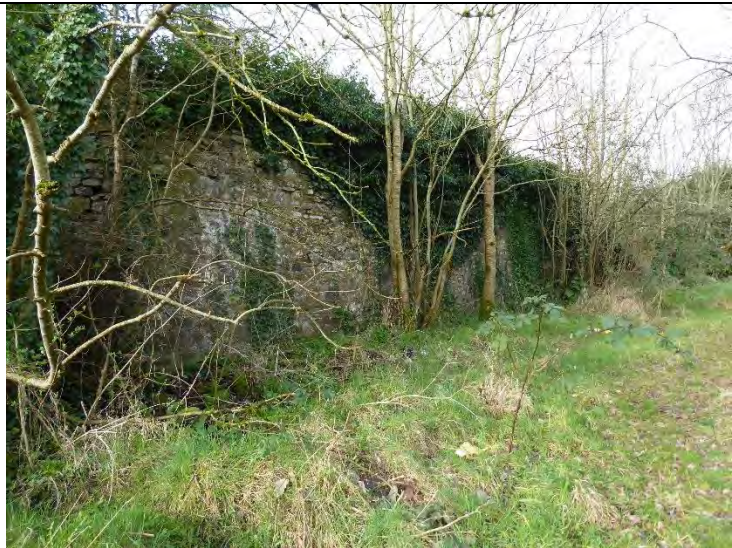
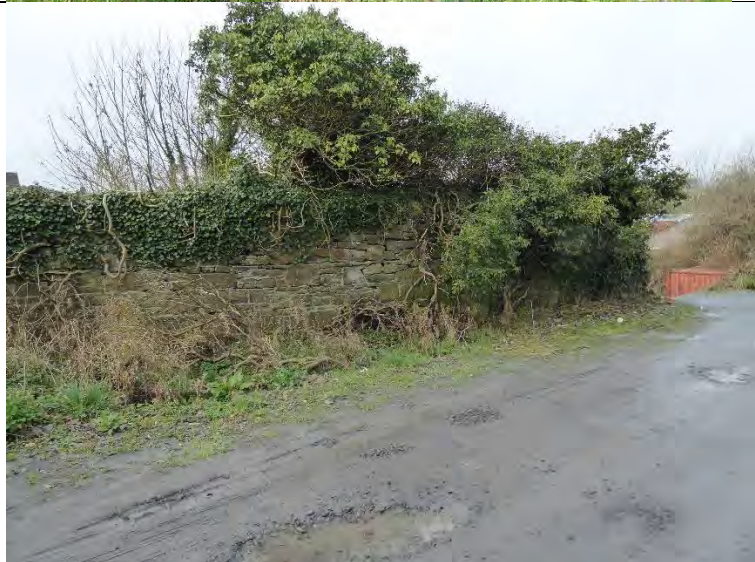
| Description | Tall coursed rubble boundary wall with coping to top. Colonised by vegetation to a greater or lesser extent along its length. Follows the line of the historic boundary between the Dublin Street plots and the hill behind. Does not follow the boundary line of 1791 but follows the line present on the OS First Edition in 1836. Was associated with the now demolished Asylum infirmary and its gate lodge; the wall turns the corner at Old Cross Square and a break line where the return was demolished is evident. | |

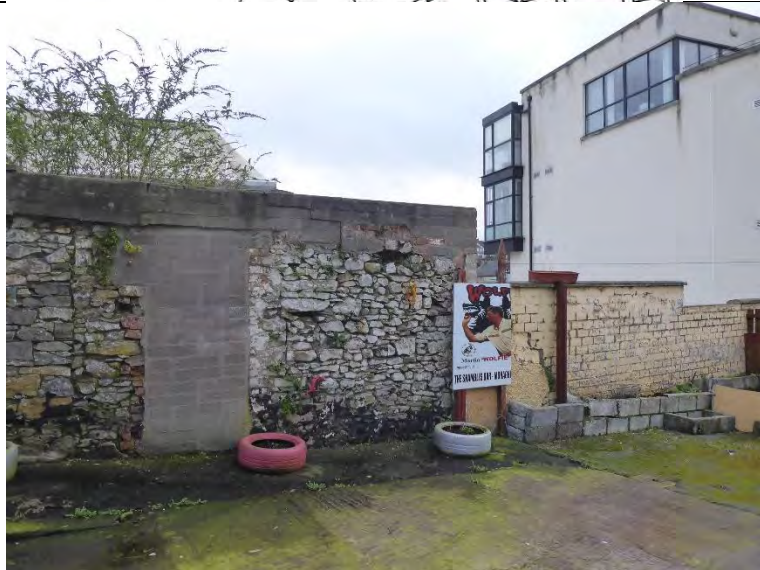
| Description | Stone boundary wall of varying rubble sizes, painted in some areas and modified with concrete block in others. Follows the line present on the OS First Edition in 1836 | | | | | |
