advice series

# energy efficiency

IN TRADITIONAL BUILDINGS

Comhshaol, Oidhreachta agus Rialtas Áitiúil  
Environment, Heritage and Local Government

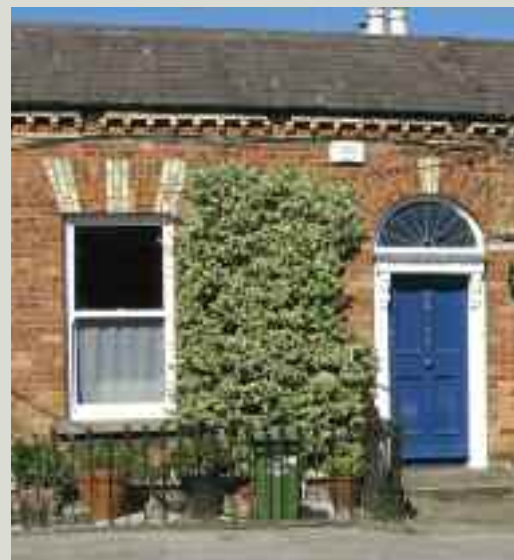
*A typical brick-fronted, nineteenth-century house with solid masonry walls, single-glazed sash windows and slate roof*

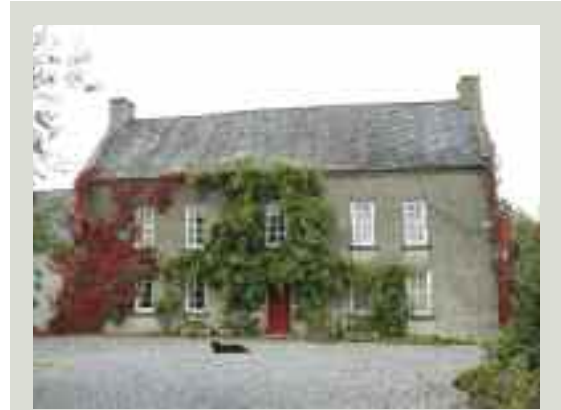
*A typical traditional farmhouse, built of stone and finished in lime render, with a slate roof and timber windows*

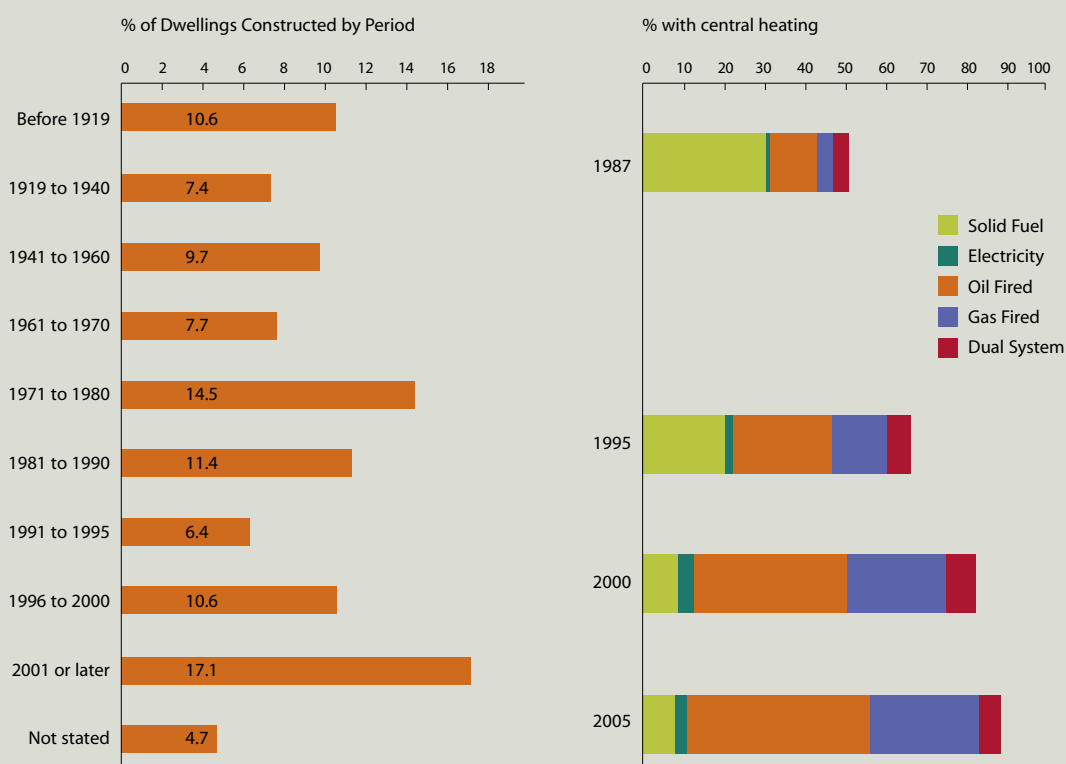
*Age of the Irish housing stock: According to 2006 figures, approximately 18% of the housing stock dates from before 1940*

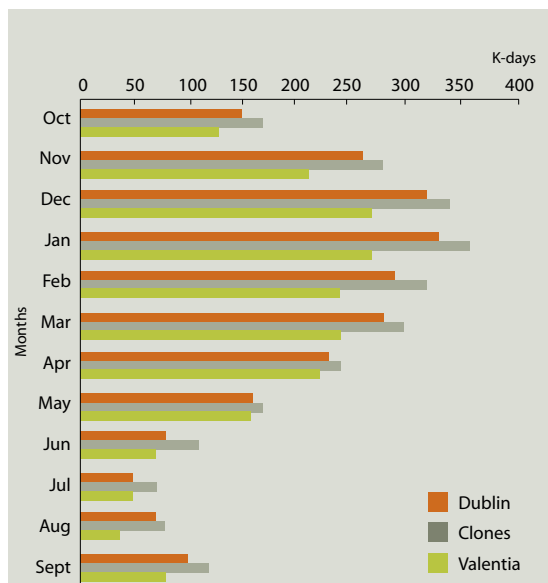
#### Monthly values for heating degree days

*Degree days (or Accumulated Temperature Difference) are calculated by multiplying the number of degrees below a base temperature (in Ireland 15.5°C) on any given day by the number of days in a single year that the difference occurs. The base temperature of 15.5°C assumes an internal design temperature of 18.5°C for an unheated space with a temperature difference between exterior and interior of 3°C (Source: Green Design, Sustainable Building for Ireland)*

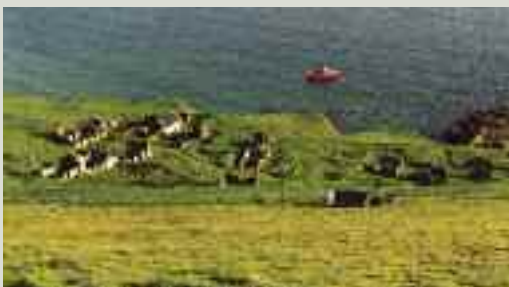
Houses on Great Blasket Island in lee of the hill with their gables turned towards the direction of the prevailing wind

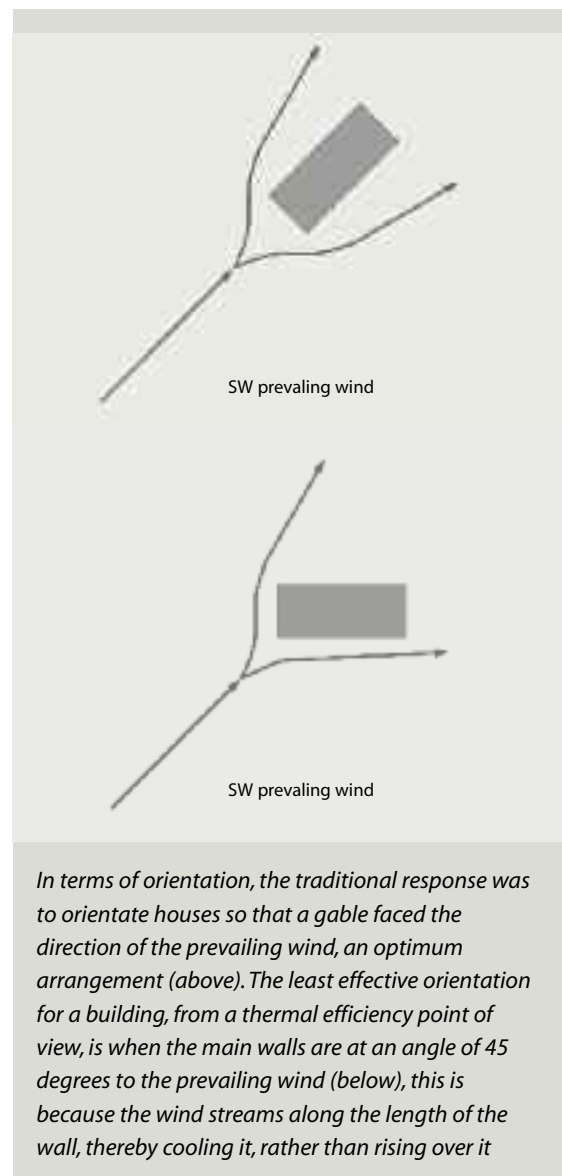
*In terms of orientation, the traditional response was to orientate houses so that a gable faced the direction of the prevailing wind, an optimum arrangement (above). The least effective orientation for a building, from a thermal efficiency point of view, is when the main walls are at an angle of 45 degrees to the prevailing wind (below), this is because the wind streams along the length of the wall, thereby cooling it, rather than rising over it*

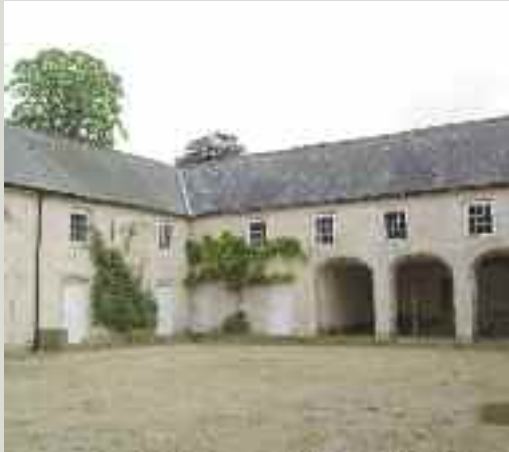
*Traditional farm complexes were arranged so that the buildings provided shelter, not only to each other, but also to the outdoor working areas*

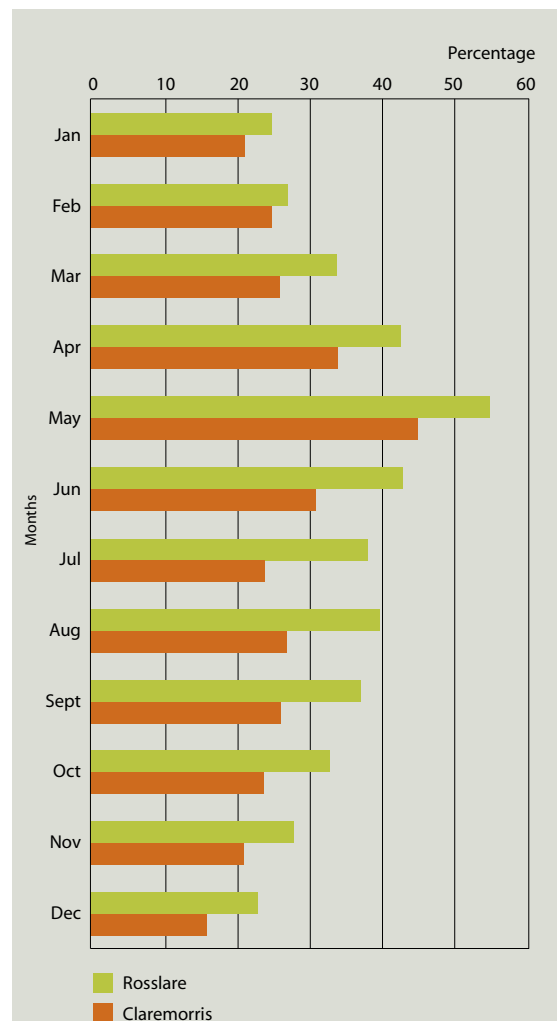
*Sunshine graph: the amount of available sunlight varies throughout the country (Source: Green Design: Sustainable Building for Ireland)*

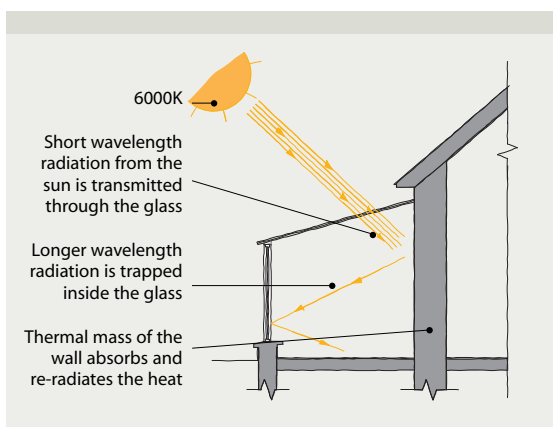
*Solar gain: the 'greenhouse' effect. Traditionally, conservatories and greenhouses were built to maximise the advantages of the heat from the sun; sunlight entering through the glass warmed the air inside allowing for the cultivation of exotic flowers and fruits. The conservatory also provided a room for entertaining which was a place of transition between the house and garden*

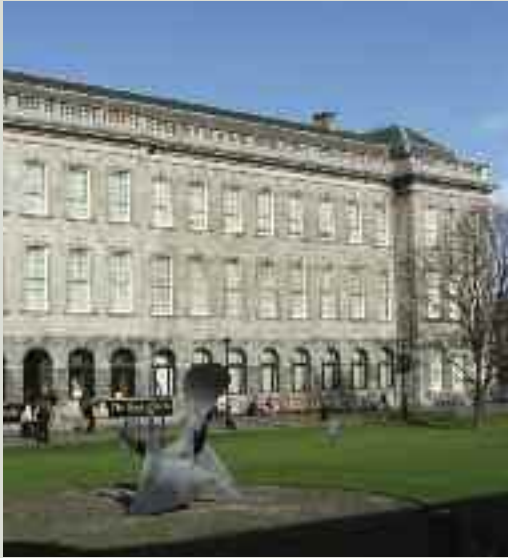
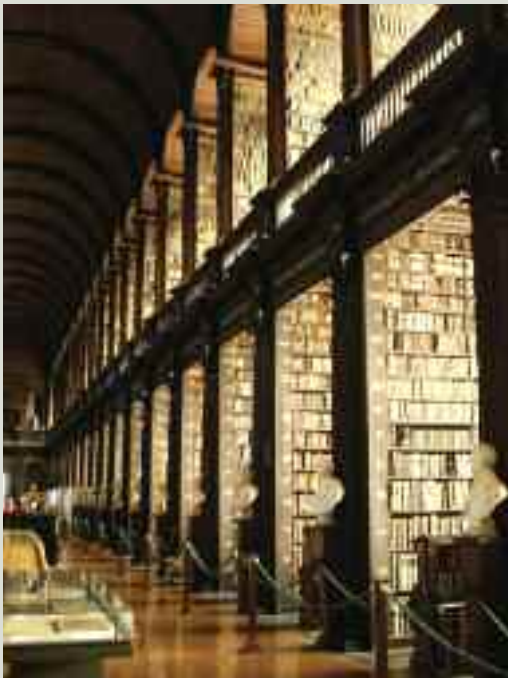
*Trinity College Library, Dublin. There were never fireplaces in the library, to avoid the risk of fire breaking out. Sunlight streams in through large single-glazed south-facing windows, maximising solar gain. Appropriate steps should be taken to protect light-sensitive historic furnishings and contents from damage caused by both ultra-violet light and visible sunlight*

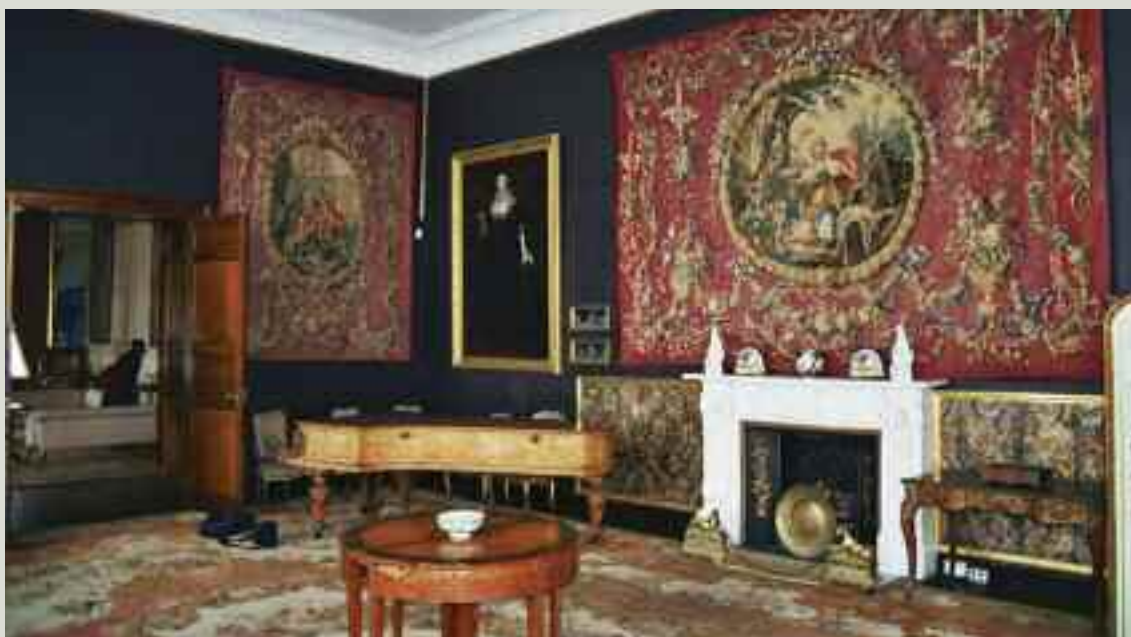
Leather linings and tapestries line the walls of this room and improve the thermal comfort of the occupants

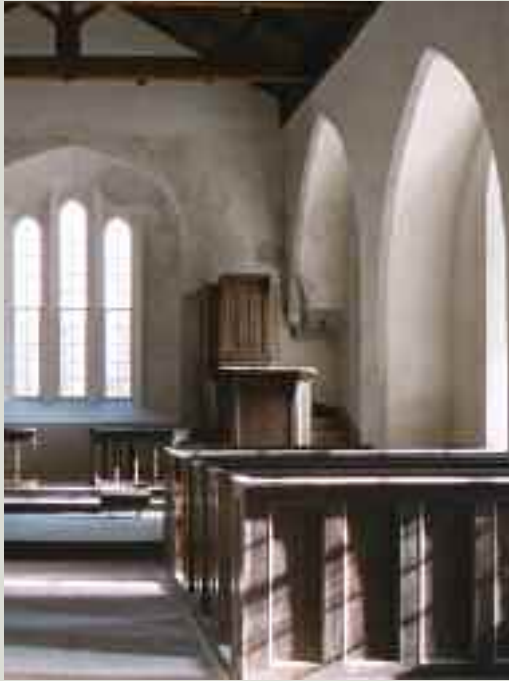
*Box pews were the traditional way of keeping church-goers warm in an unheated, or poorly heated, church. The timber floor to each pew provided a warm surface underfoot, while the 'box' protected its occupants from draughts*

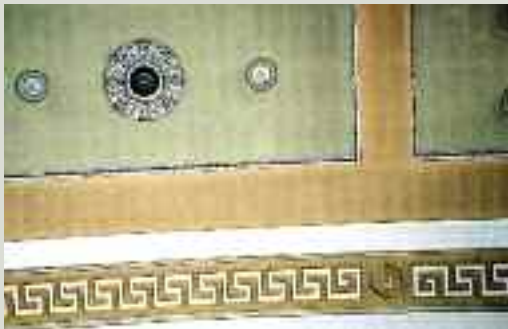
*This plastered ceiling has no insulation above it. Discolouration can be seen on the plasterwork between the timber joists located above, as the timber is slower to transfer heat to the cold roof space than the plaster alone. Dust particles in the warm air passing through the plaster remain trapped on the surface causing the discolouration*

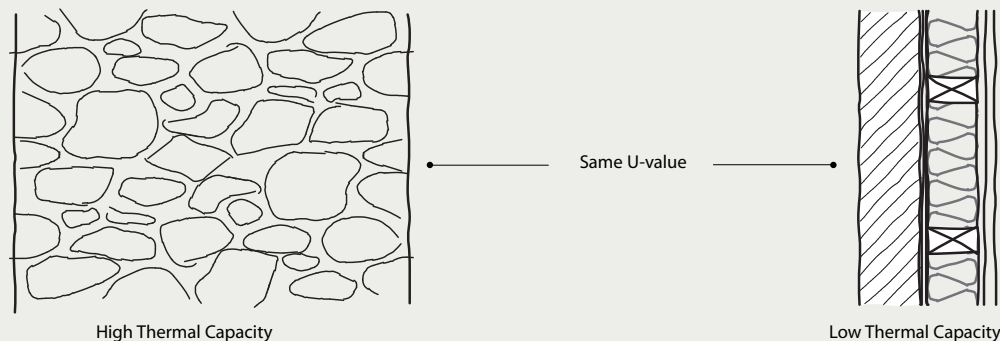
Two different wall constructions (above) with similar U-values may have very different thermal masses

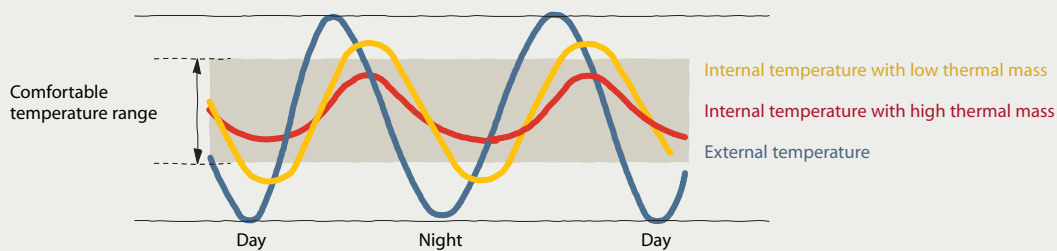
A graph (above) showing the temperature changes within buildings with high thermal mass (red line) and with low thermal mass (yellow line). As can be seen by the red line, less extreme changes of temperature are experienced inside the building with the higher thermal mass

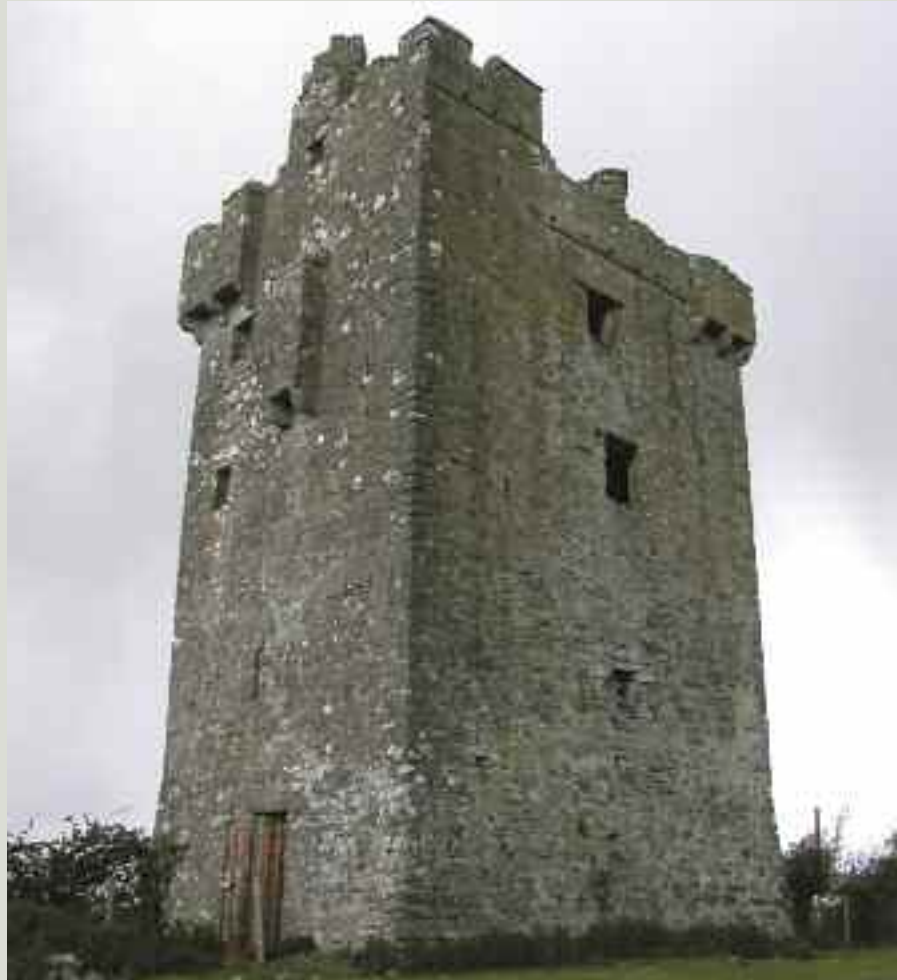
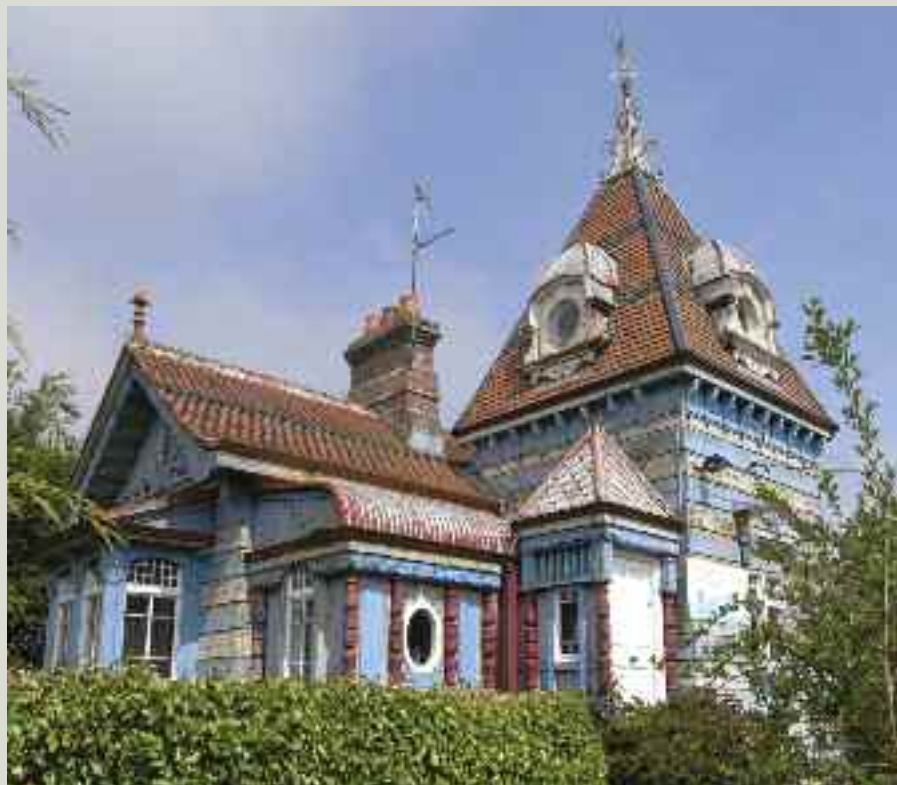
*A medieval tower house with thick stone walls and a high thermal mass (above) and an unusual lightweight timber building with low thermal mass (below)*

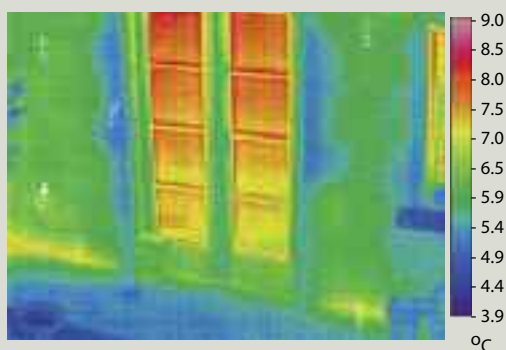
*A thermographic image of a double-glazed door at semi-basement level in a nineteenth-century terraced house; note how the yellow patches at the base of the wall, which are damper, indicate that these areas are emitting heat at a higher rate than the rest of the wall*

Thermal imaging can be used to identify potential problems with a building's fabric. When looking at traditional buildings, thermal imaging might be used to identify areas of dampness and to locate thinner depths of wall, cracking and voids. Expertise is required both in deciding how and when to take IR images and later in interpreting the information. For example, objects which have high or low emissivity such as metal do not give an accurate temperature reading. Weather conditions, orientation and the time of day when the image was taken all have the potential to affect the reading. The information gathered from thermal images can be properly assessed only in conjunction with data gathered as part of a comprehensive condition survey.

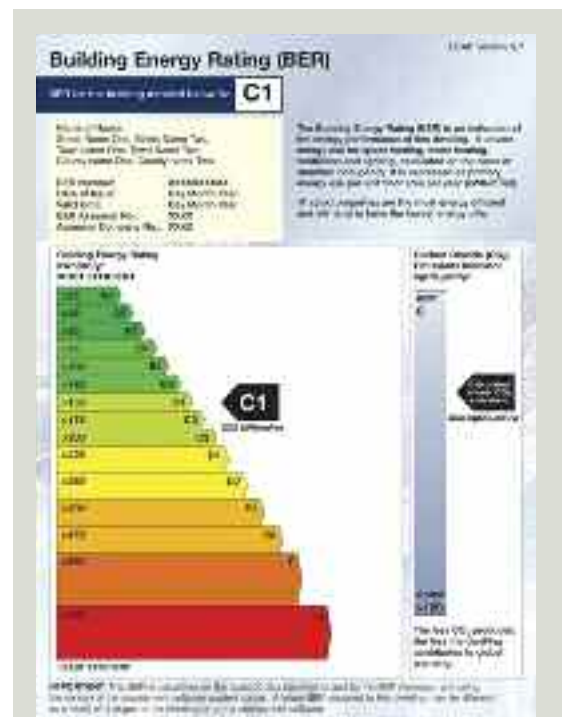
Sample Building Energy Rating Certificate for dwellings. The most energy efficient rating is 'A1' (green) down to the least efficient is 'G' (red)

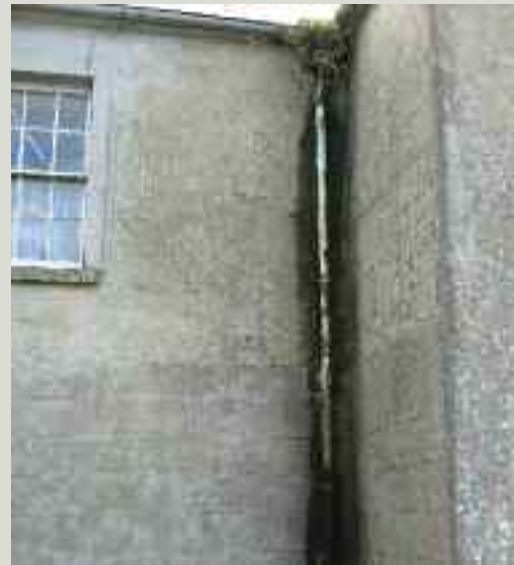
*The importance of maintaining rainwater goods in good working order cannot be over-emphasised. Not only will the water running down this wall cause rotting of the building fabric and damage to the interior in the short to medium term; the dampness in the wall will also cause it to transmit heat more quickly from the inside of the building making it colder and less thermally efficient*

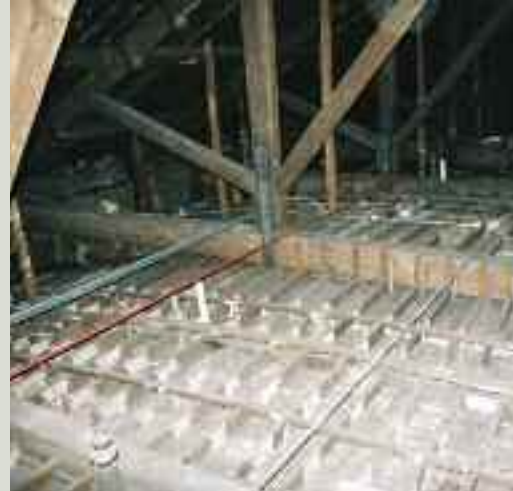
*A large roof space with no insulation above the ceiling; while the heat rising from the building interior may benefit the timber and other building materials in the roof space, a lot of energy is wasted in this way*

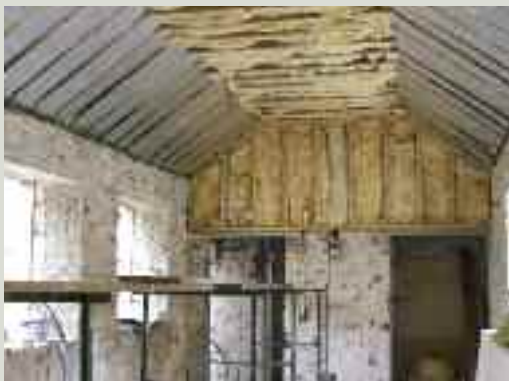
*As part of the complete refurbishment of this building, the opportunity was taken to insulate the roof. Rigid insulation has been fitted between the rafters in the sloping sides with quilted insulation fitted between the ceiling joists across the top*

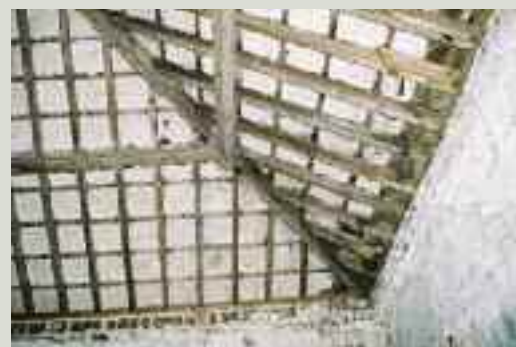
*A roof with largely intact lime mortar parging applied to the underside of the slates. Parging has an insulation value in itself and helps to reduce air-blown water infiltration*

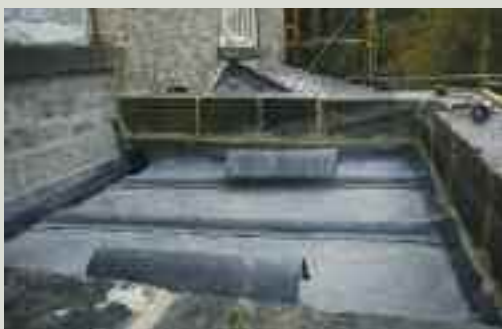
*A recently re-covered lead flat roof. These modern lead roof vents were introduced as, previously, poor ventilation had caused moisture to build up within the roof space leading to timber decay*

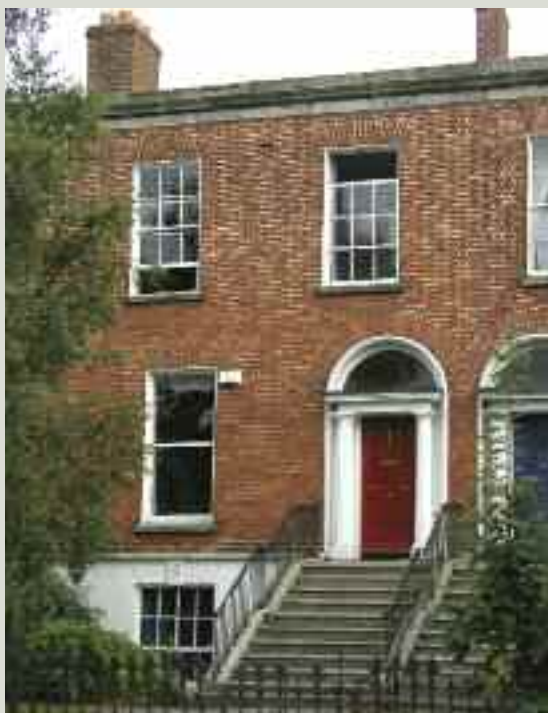
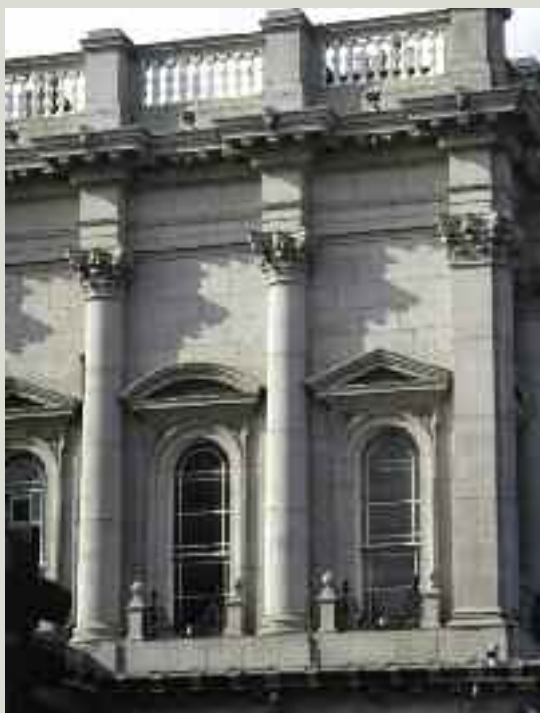
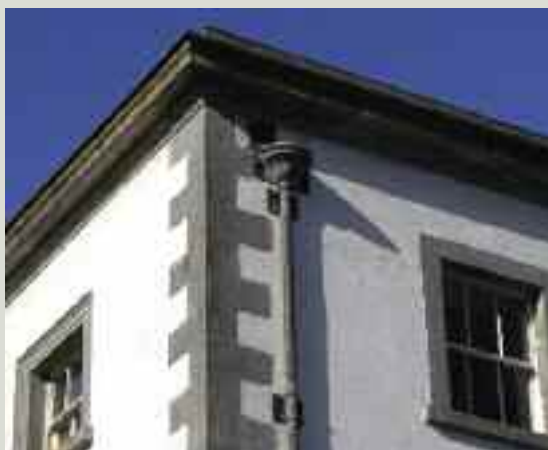
*The wealth of architectural detail and the quality and craftsmanship of materials used in historic buildings make them unsuitable candidates for external insulation. Even where the exterior of a traditional building is relatively plain, the alteration of the character and the need to replace window sills, remodel eaves details and the like would make the installation of external insulation inappropriate in many cases*

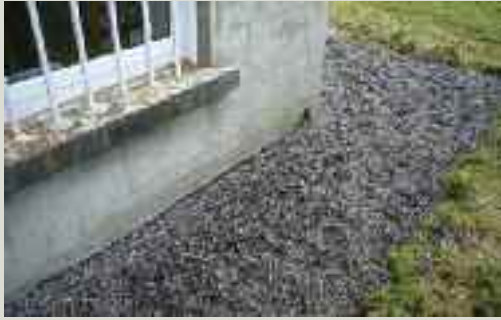
*Where there are persistent problems with damp, it is important to ensure that the external ground level is lower than the internal floor level and, if necessary, consider installing a French drain below ground level with a gravel finish. Water percolates through the gravel finish to a perforated drain below, following which it drains to a soakaway at a distance from the building. The rendered wall finish will generally require repair following the lowering of the ground level. The installation of a French drain around buildings in sites of archaeological potential, such as churchyards, will require careful prior assessment and consultation with the relevant authorities*

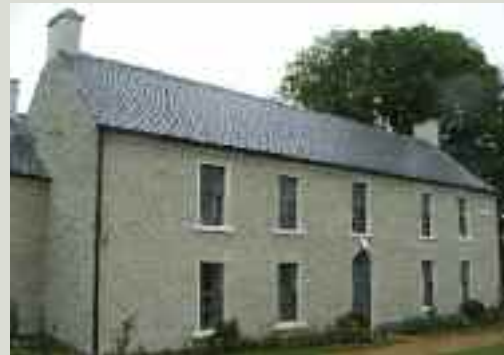
*A lime-rendered façade, in good condition, improves the insulating value of a wall and prevents damp penetration to the inside of the building*

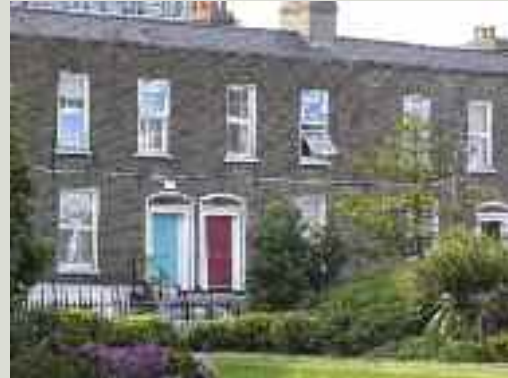
*Terraced houses with replacement uPVC-framed windows. These windows are unsympathetic to the character of the houses; opening outward instead of sliding up and down, they disrupt the streetscape; the modern glass creates jarring reflections; while the thick frames contrast poorly with the elegant timber sections of the original sash windows*

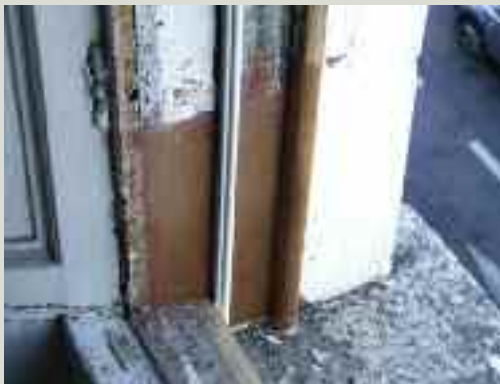
*A repaired window frame with a replaced style and new parting bead. The timber sash frames have been temporarily removed*

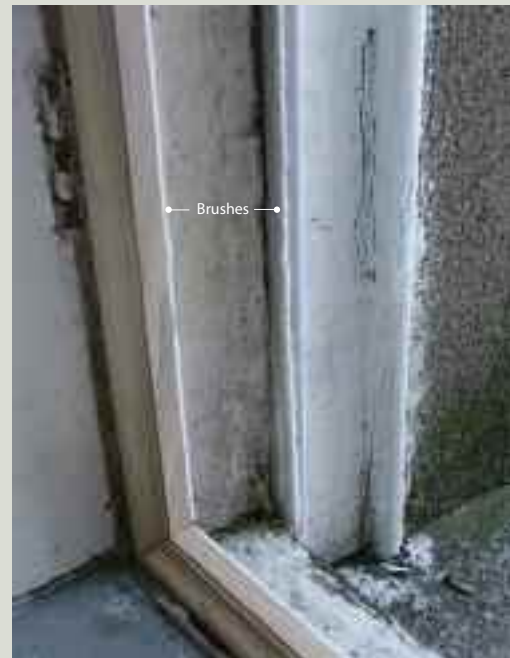
*Draught-proofed window frame: brushes are visible on the staff and parting beads, both of which have had to be replaced in order to draught proof. For the brushes to work properly it is important that they are not painted over*

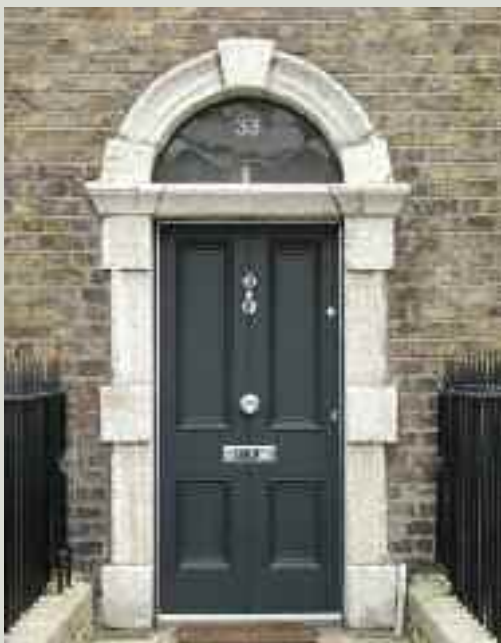
*Aluminium draught strips can be seen to all sides of this door. The metal part of these strips, unfortunately visible, can be painted (although it is difficult to achieve successfully) but it is important that the flexible sealant strip is not*

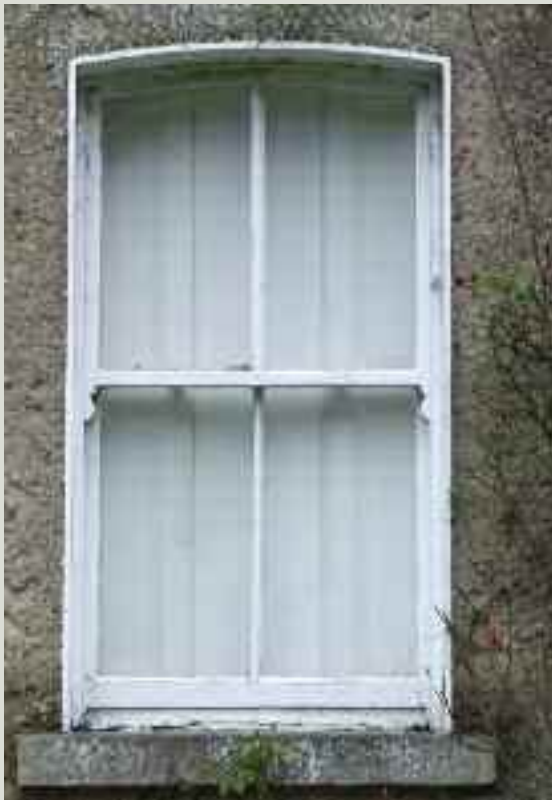
*Working timber shutters: the interior of the shutter boxes could be lined and sealed to reduce air leakage. Any new linings should not prevent the shutters from folding back into the shutter box when not in use*

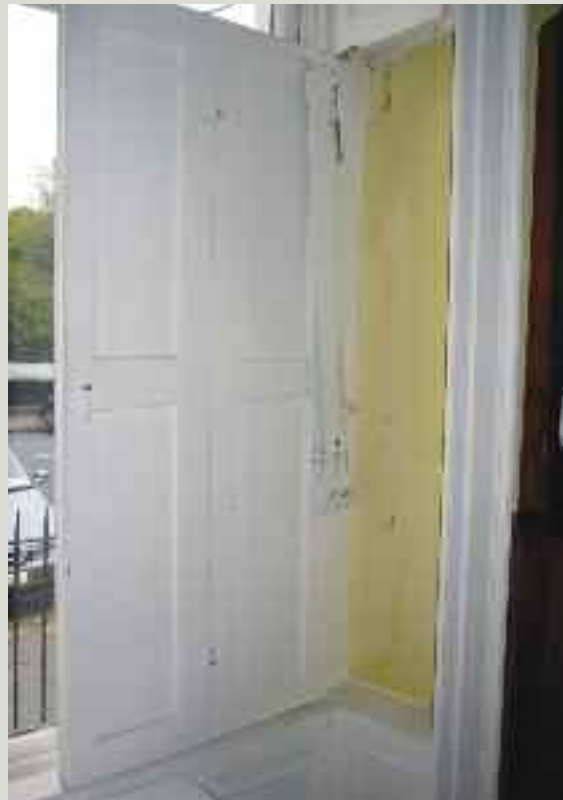
*A well-sealed shutter lining*

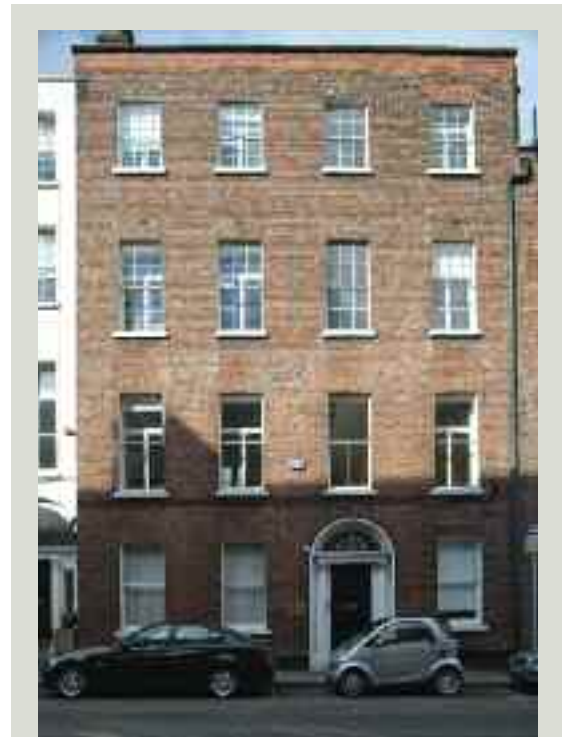
*Inappropriate timber-framed secondary glazing with frame proportions that do not match those of the original window, creating a discordant appearance*

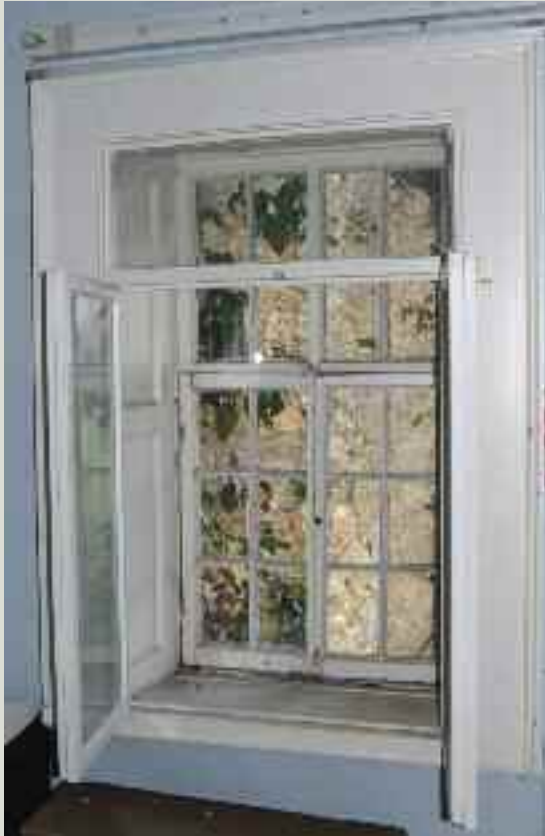
*An Edwardian window with 1950s secondary glazing. The secondary glazing is chunky and does not match the original window profile and blocks light from the room. The position of the frame within the opening prevents the shutters from being used*

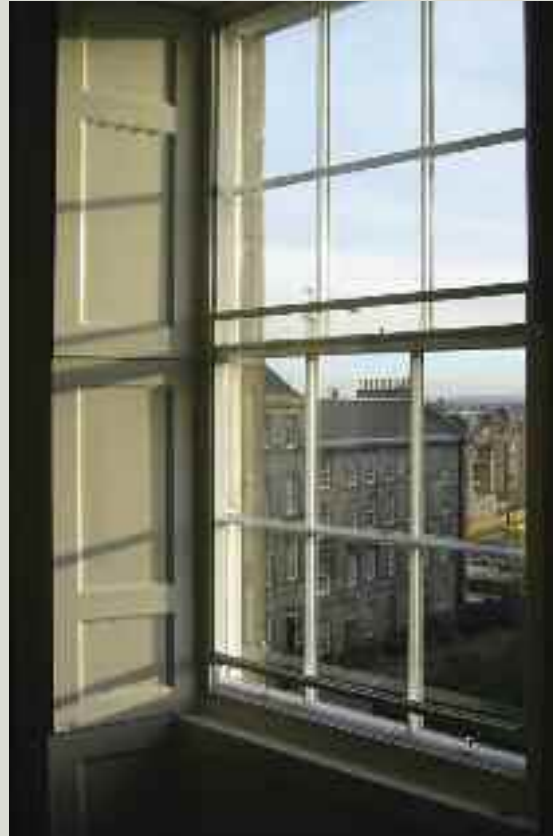
*Carefully designed bespoke secondary glazing installed as part of Changeworks' Energy Heritage project (Image © Changeworks)*

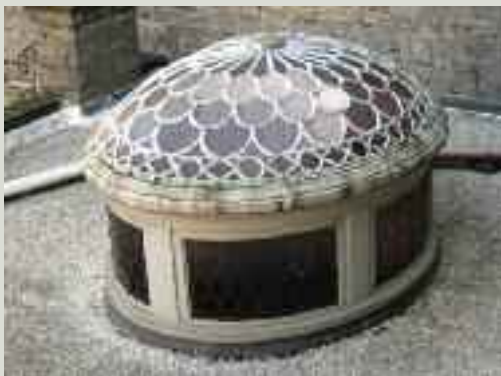
*Historic skylights and lanterns, such as this fine example, should be well-maintained but are rarely suitable for thermal upgrading*

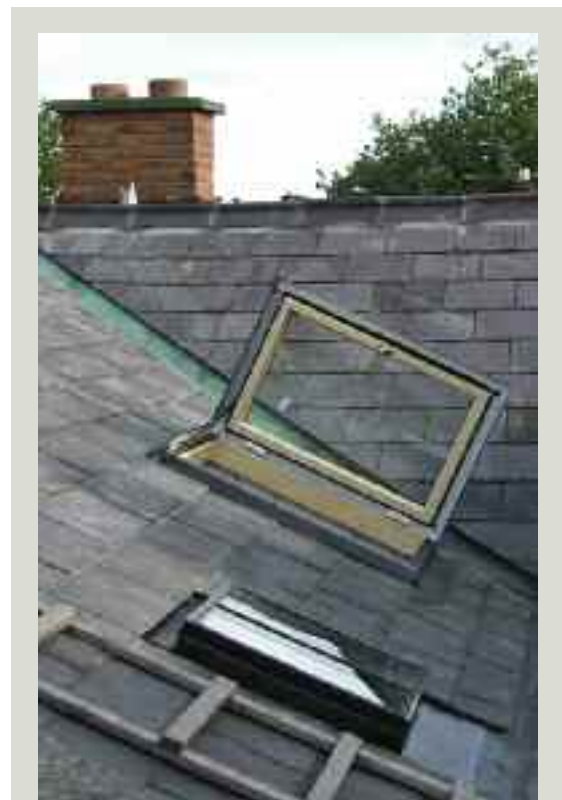
*This modern double-glazed skylight allows access to a concealed valley gutter for maintenance inspections and cannot be seen from ground level. It also lets additional natural light into the attic space below*

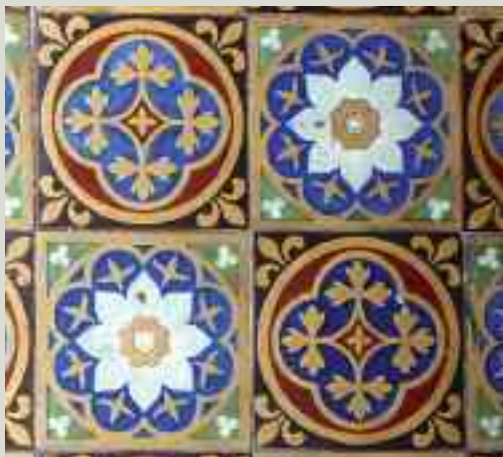
*Decorative and high quality floors are difficult to upgrade and require careful analysis of the time, cost and, above all, the potential damage that could be caused to the historic finish in exchange for improved thermal performance. Fine floor finishes such as these tiles should not be lifted*

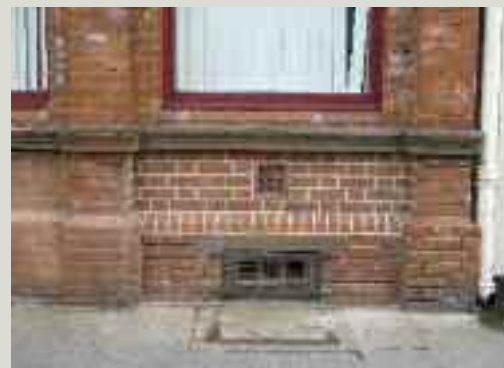
*A floor vent to ventilate the ground floor was built into the wall between the cellar and ground floor windows as part of the original design*

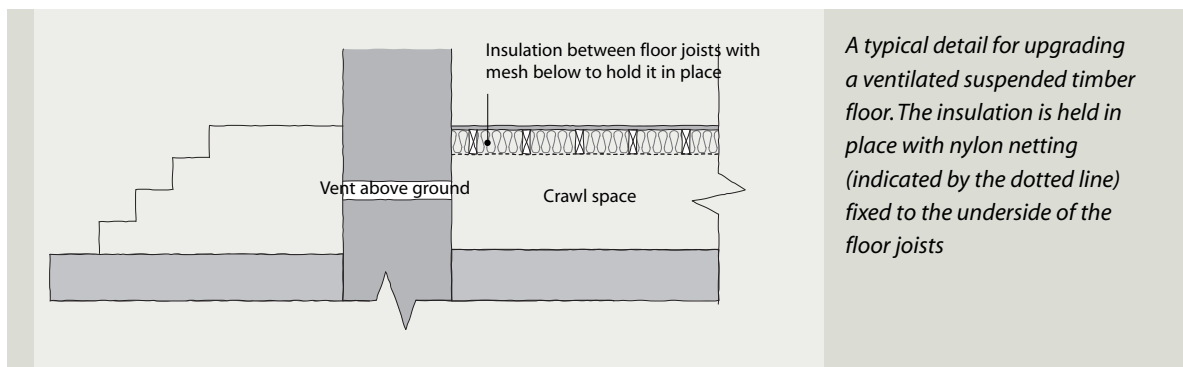
*A typical detail for upgrading a ventilated suspended timber floor. The insulation is held in place with nylon netting (indicated by the dotted line) fixed to the underside of the floor joists*

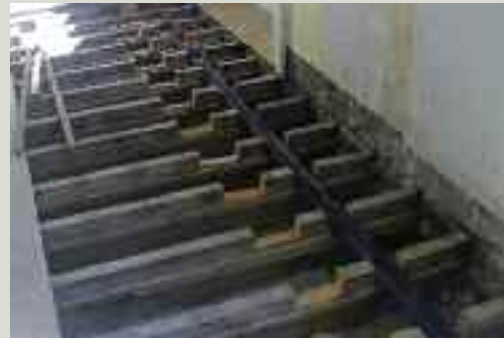
*Existing holes in floors or notches in joists can be reused to accommodate new runs of services. New holes or notches should not be created to avoid further weakening of the joists which has occurred in this example. Where there is existing pugging within the floor space, it should preferably be left in place*

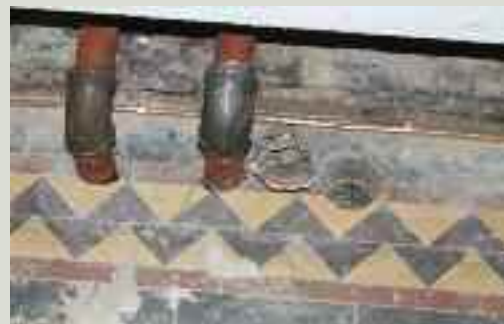
*New and redundant holes in floors should be made good, fire-sealed where appropriate, and finished to match the existing floor. Where new service runs would interfere with the fabric of a protected structure, planning permission may be required*

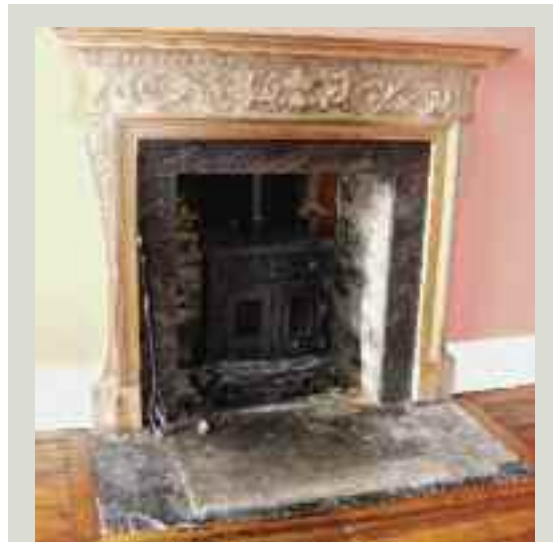
*Wood-burning stoves can be efficient but in a traditional building they should generally only be fitted into non-decorative fireplaces. Historic grates and fire surrounds should not be damaged or removed in order to fit a stove*

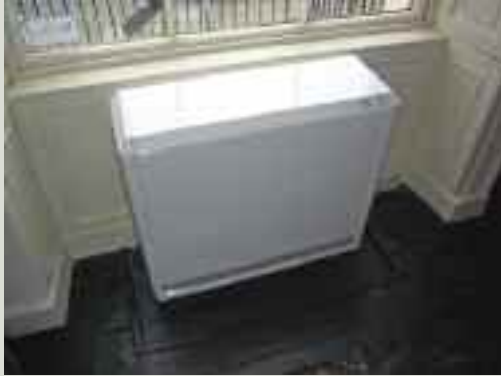
*A storage heater fitted in a Georgian house. The low height of the storage heater allows for operation of the shutters at night and does not block the window*

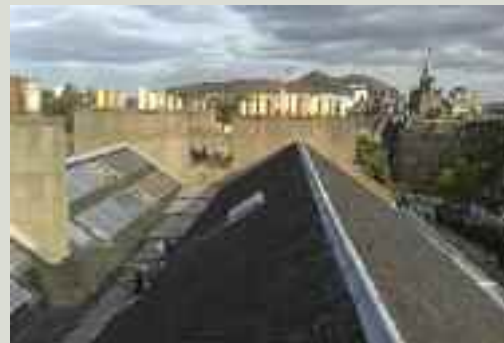
*A roof valley may be an appropriate place to locate solar thermal or photovoltaic panels provided that the orientation of the roof is appropriate. This image shows solar panels installed in hidden roof valley as part of Changeworks' Renewable Heritage project (Image © Changeworks)*

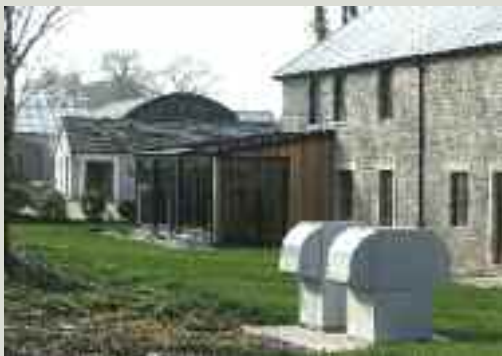
*Air-to-water heat exchangers: a heating system provided to a converted stable building. The grey metal casing will be camouflaged by future planting*

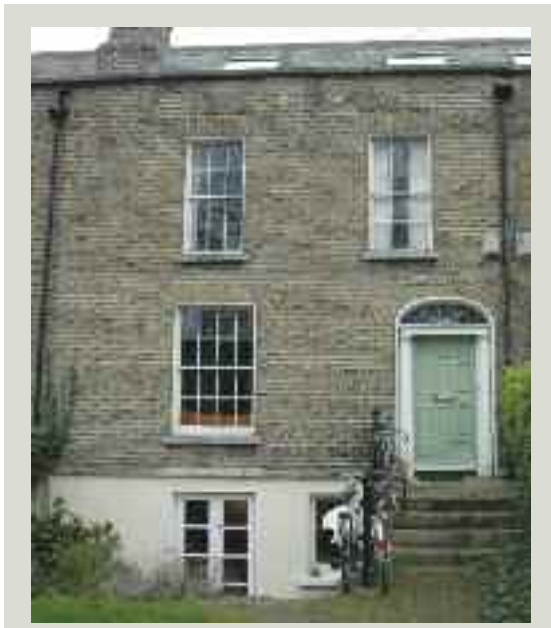
*The brick façade from 1821 was later repointed using a sand and cement mortar. While the removal of this pointing and its replacement with a vapour-permeable lime-based mortar would benefit the building, it is likely that the process of removal of the pointing would cause unacceptable damage to the brickwork*

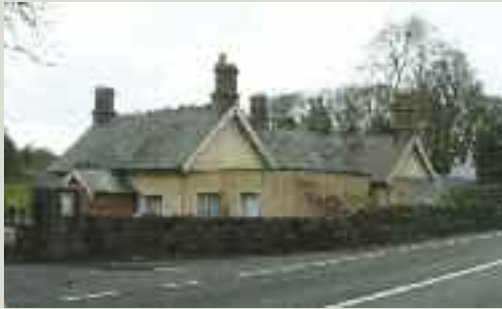
*Cottages prior to refurbishment*

Poorly built modern extensions to the cottages were replaced with modern, highly insulated extensions with window openings primarily facing east and west. Sun rooms were added on the south side of the houses, providing pleasant living spaces and contributing to the solar gain of the buildings in their entirety. As the cottages are semi-detached, the new extensions to north and south leave only one exposed original wall in each cottage. The ground floor was excavated and a new, insulated floor laid while the roof was insulated as part of the re-slatting works. Historic leaded single-glazed windows have been retained and repaired. As a result of the repairs these windows have a snug fit and have not required draught proofing. Where existing, original shutters were brought back into use. New timber double-glazed windows, some with shutters, have been provided elsewhere. External render was replaced in a lime-based render which matches the original. A French drain was provided around the building to help reduce the moisture content at the base of the external walls.

New gas-fired condensing boilers have been provided and serve underfloor heating and radiators. Each house has three heating zones with separate thermostats. All radiators have been fitted with thermostatic radiator valves. Wood-burning stoves have been fitted in the living room fireplaces and these chimneys are therefore still in use.

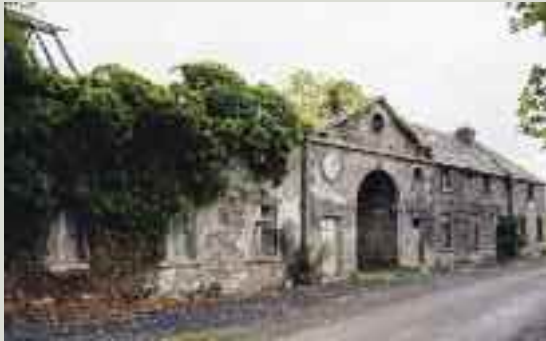
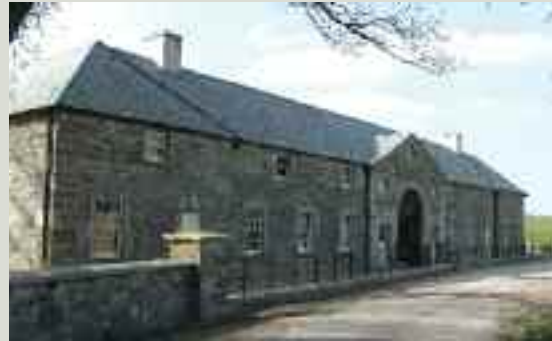
*Before and after images of restored stable yard*

The complex has been subdivided into a group of ten houses. As part of the restoration of the courtyard, the building was re-roofed, with high levels of insulation provided. New windows were installed in both single and double-glazed arrangements. Where existing windows survived, these were repaired and fitted with single glazing. The design of all the new windows was based on evidence of pre-existing four-pane windows. These new windows are double-glazed casement windows. The solid rubble limestone walls were repointed with a lime mortar in order to ensure high levels of breathability while a new insulated floor slab was laid with an injected DPC being provided at low level to the original walls. New, well-insulated extensions complying with the building regulations were provided to four of the houses. This has internalised part of the north wall of the complex, making that wall warm and dry.

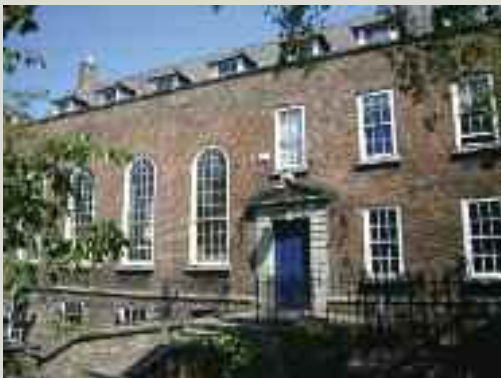
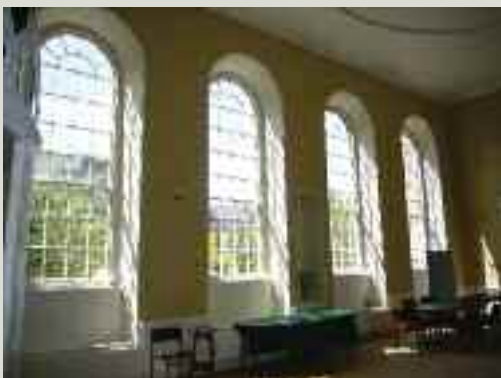
*Tall, south-facing windows allow the main hall to be flooded with light and maximise solar gain*

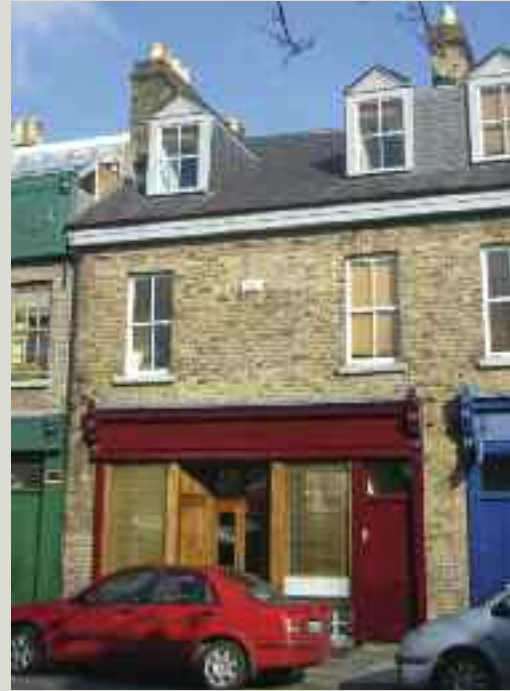
*Although this traditionally built building is not a protected structure, it has been refurbished in accordance with best conservation practice*

At the time of its redevelopment in 2000, the basement floors were replaced with a concrete slab having an insulated screed containing a piped underfloor heating system. Floors throughout the remainder of the building consist of timber joists with timber floorboards; new ceilings were added between the shop floor and the apartments above, insulated with mineral wool, primarily for fire separation purposes, but which also has advantages in terms of reducing noise transfer. The roof was re-slatted and provided with insulation to building regulation requirements. At attic level, mineral wool insulation was provided over the flat ceilings while insulation board was provided to the coved areas. The original walls of granite rubble and brick were left uninsulated.

The highly insulated extension on the north side was constructed of steel studs with insulation between, and with external insulation finished with a proprietary render to the exterior. New windows are timber framed with double-glazed units. The original windows were repaired but not draught proofed. No shutters were provided. An earlier aluminium shopfront was removed and replaced with a new timber-framed double-glazed shopfront.
