advice series

# energy efficiency

IN TRADITIONAL BUILDINGS

Comhshaol, Oidhreachta agus Rialtas Áitiúil  
Environment, Heritage and Local Government

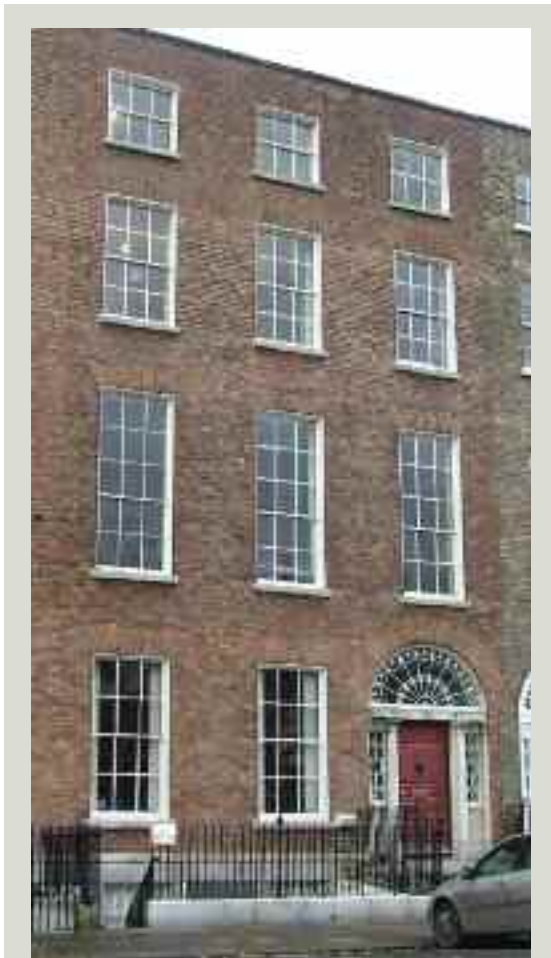
*A well-maintained Georgian house with its original timber-framed sash windows*

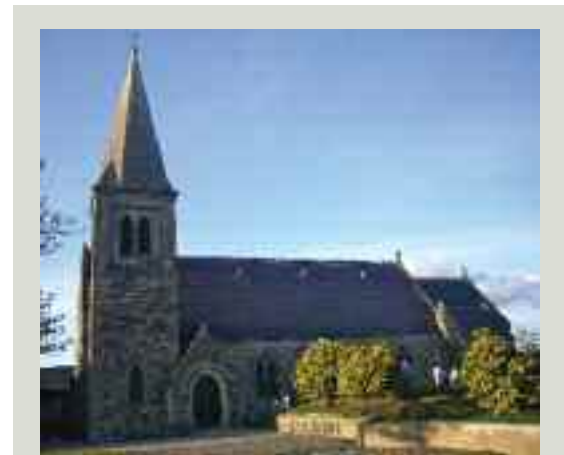
*A nineteenth-century church with spire. The roof has been re-slatted and insulated and the walls re-pointed*

The roof was re-slatted with new Bangor Blue slate. While re-slating the roof the opportunity was taken to add a layer of insulation using a very thin layer of reflective material between the slates and the ceiling boards. This resulted in a slightly raised roof which was accommodated with secret valleys at the barge and raised gutters, supported by new stone insets. Walls were repointed in a lime-based mortar to reduce damp and internal lime plaster was repaired where necessary. All lighting was replaced with low energy metal halide lamps; with tungsten halogen lamps confined to the sanctuary area to allow for manipulation of the lighting levels.

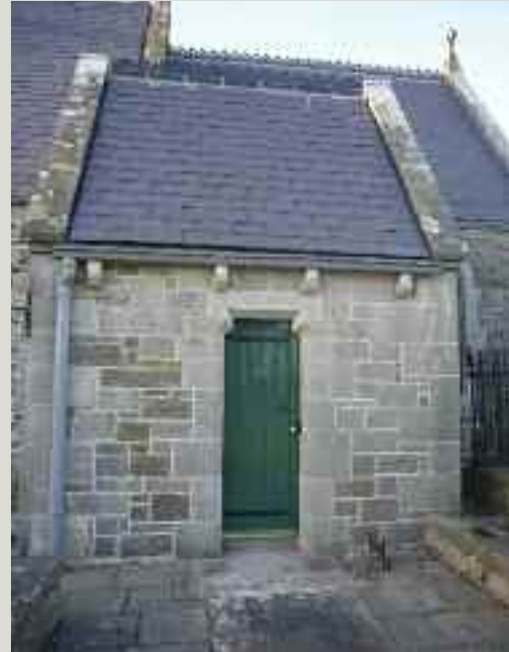
*A special detail was used to deal with the small additional height that resulted from adding insulation to the roof build-up; stone blocks were added under the reinstated cast-iron gutter*

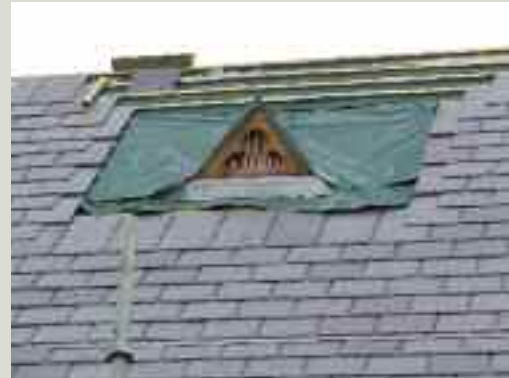
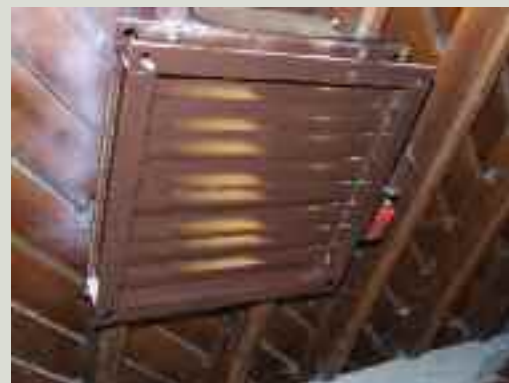
*While re-slating, the opportunity was taken to put the original ceiling vents back into working order. The vents are mechanically controlled to allow the users to alter the amount of ventilation as required*

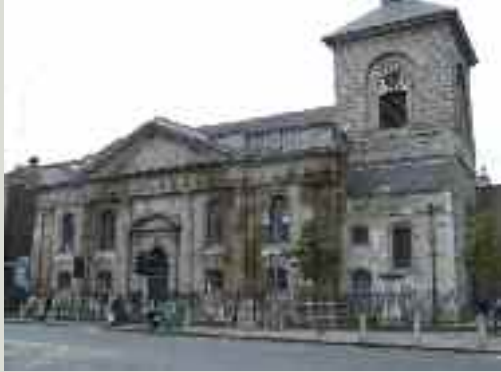
*The church following restoration*

This church is intensively used both during the week and at weekends. A programme of works was undertaken a number of years ago to refurbish the building for its current use. The building had suffered from serious damp ingress over time and required works to the roof, rainwater goods and stone façades. As part of these building works, an extension was added to the rear of the building and underfloor heating was provided. Mineral wool insulation was provided over the main ceiling. The existing single-glazed timber framed windows were repaired and refurbished but not draught proofed.

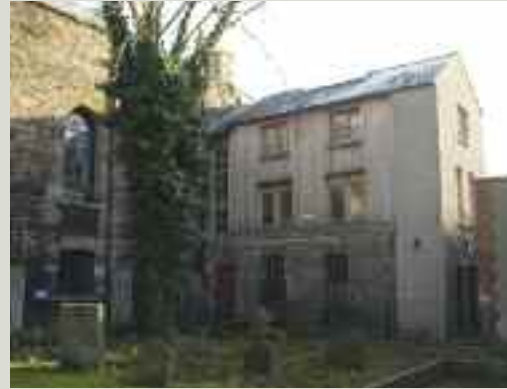
*This new extension to the rear of the church provides necessary office accommodation and comprises two storeys built on top of the ruins of the original vestry*
