Arboriculture (Tree and Hedgerow Survey) Report

N2 Monaghan Town to Emyvale, County Monaghan Proposed Pavement and Minor Improvement Scheme

TREE AND HEDGEROW SURVEY AND REPORT

N2 MONAGHAN TO EMYVALE ROAD

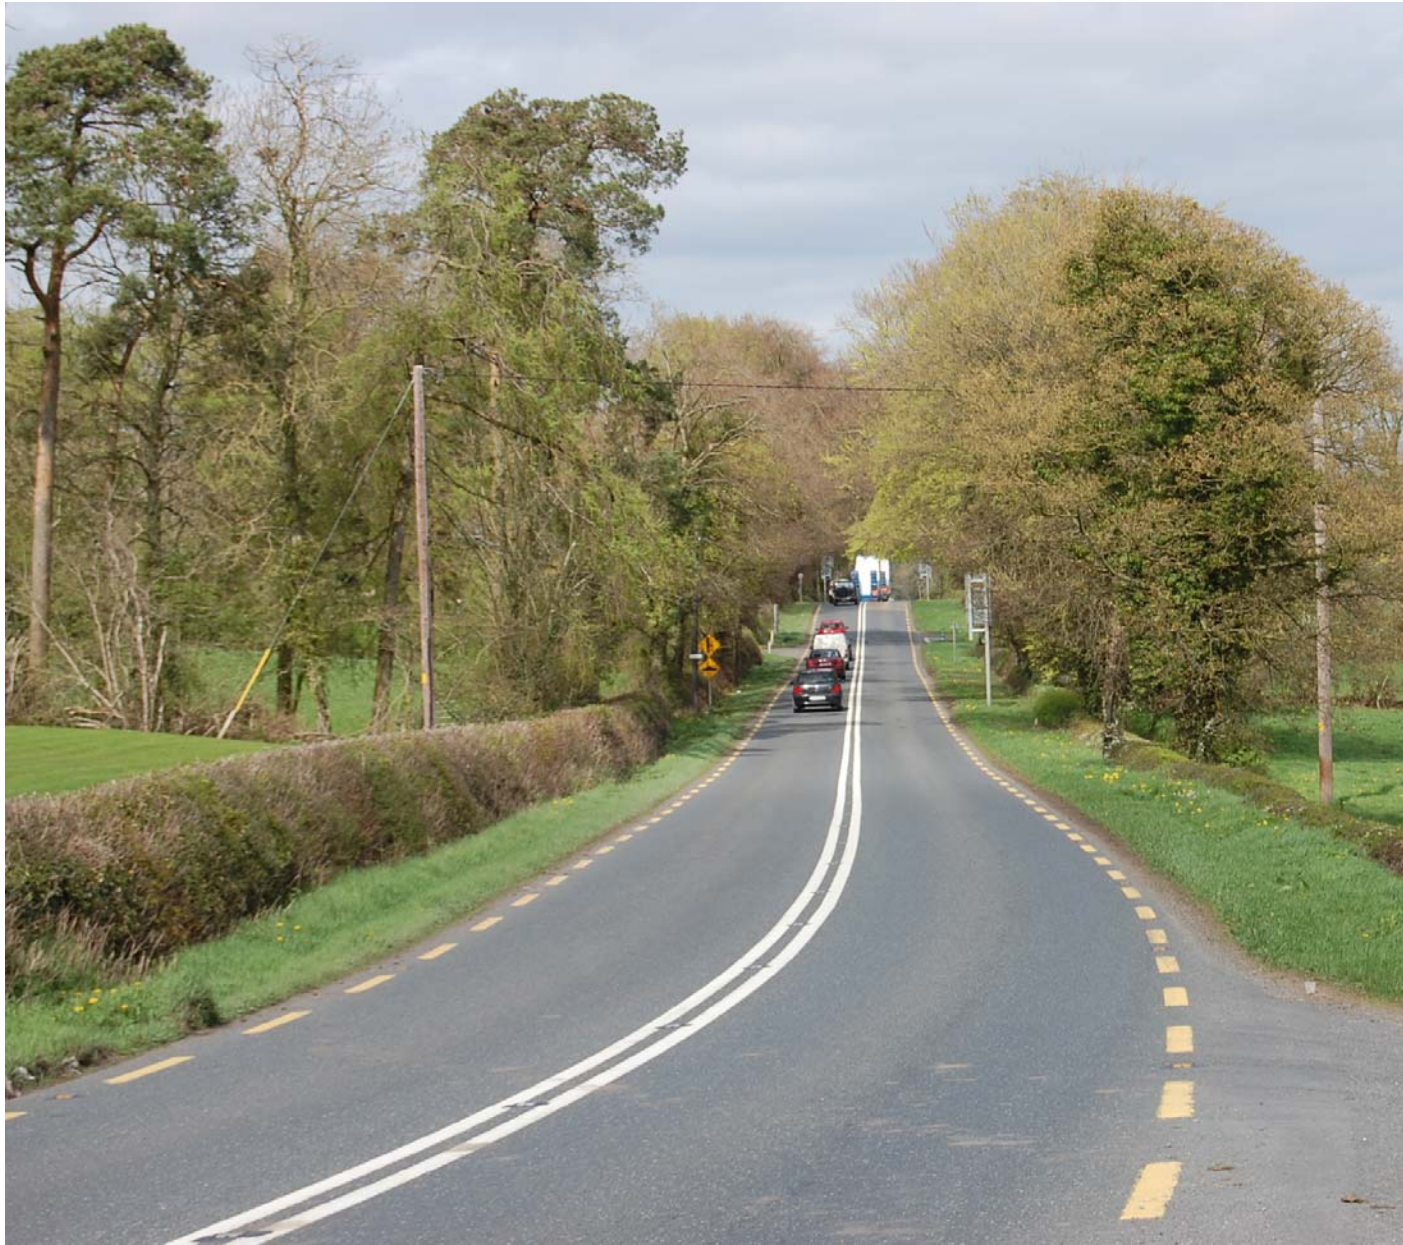
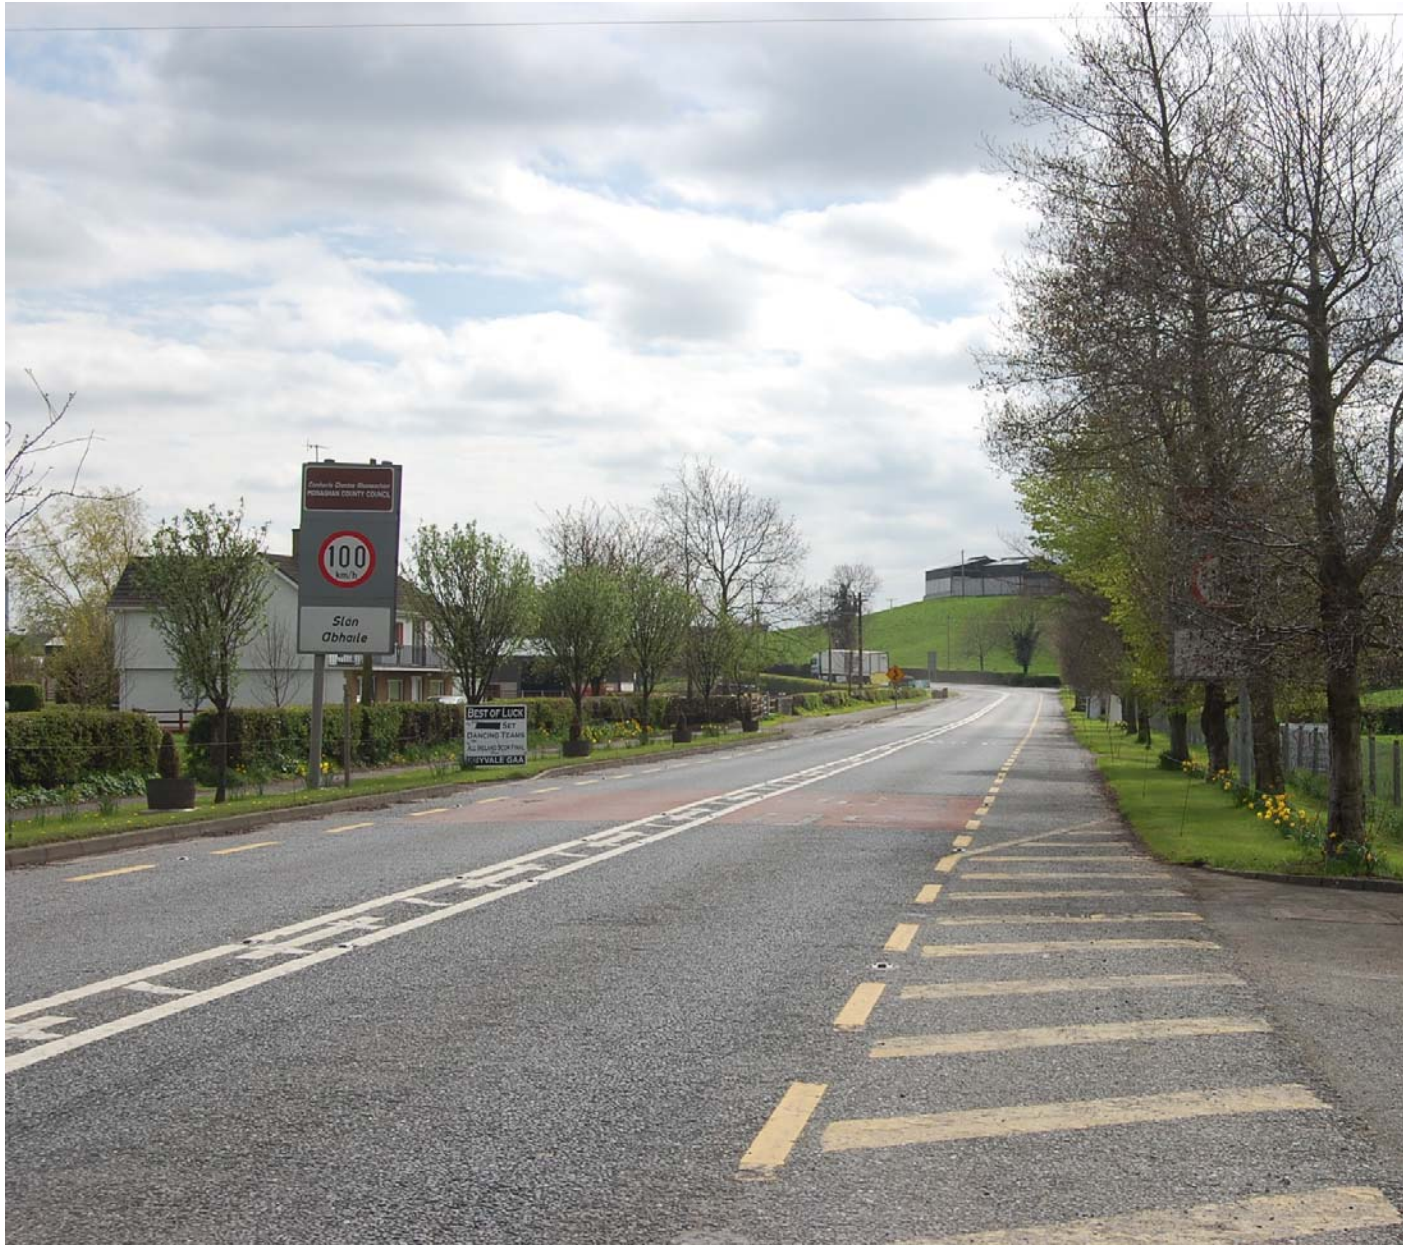
Two views of trees growing on the above site, taken from the N2 .

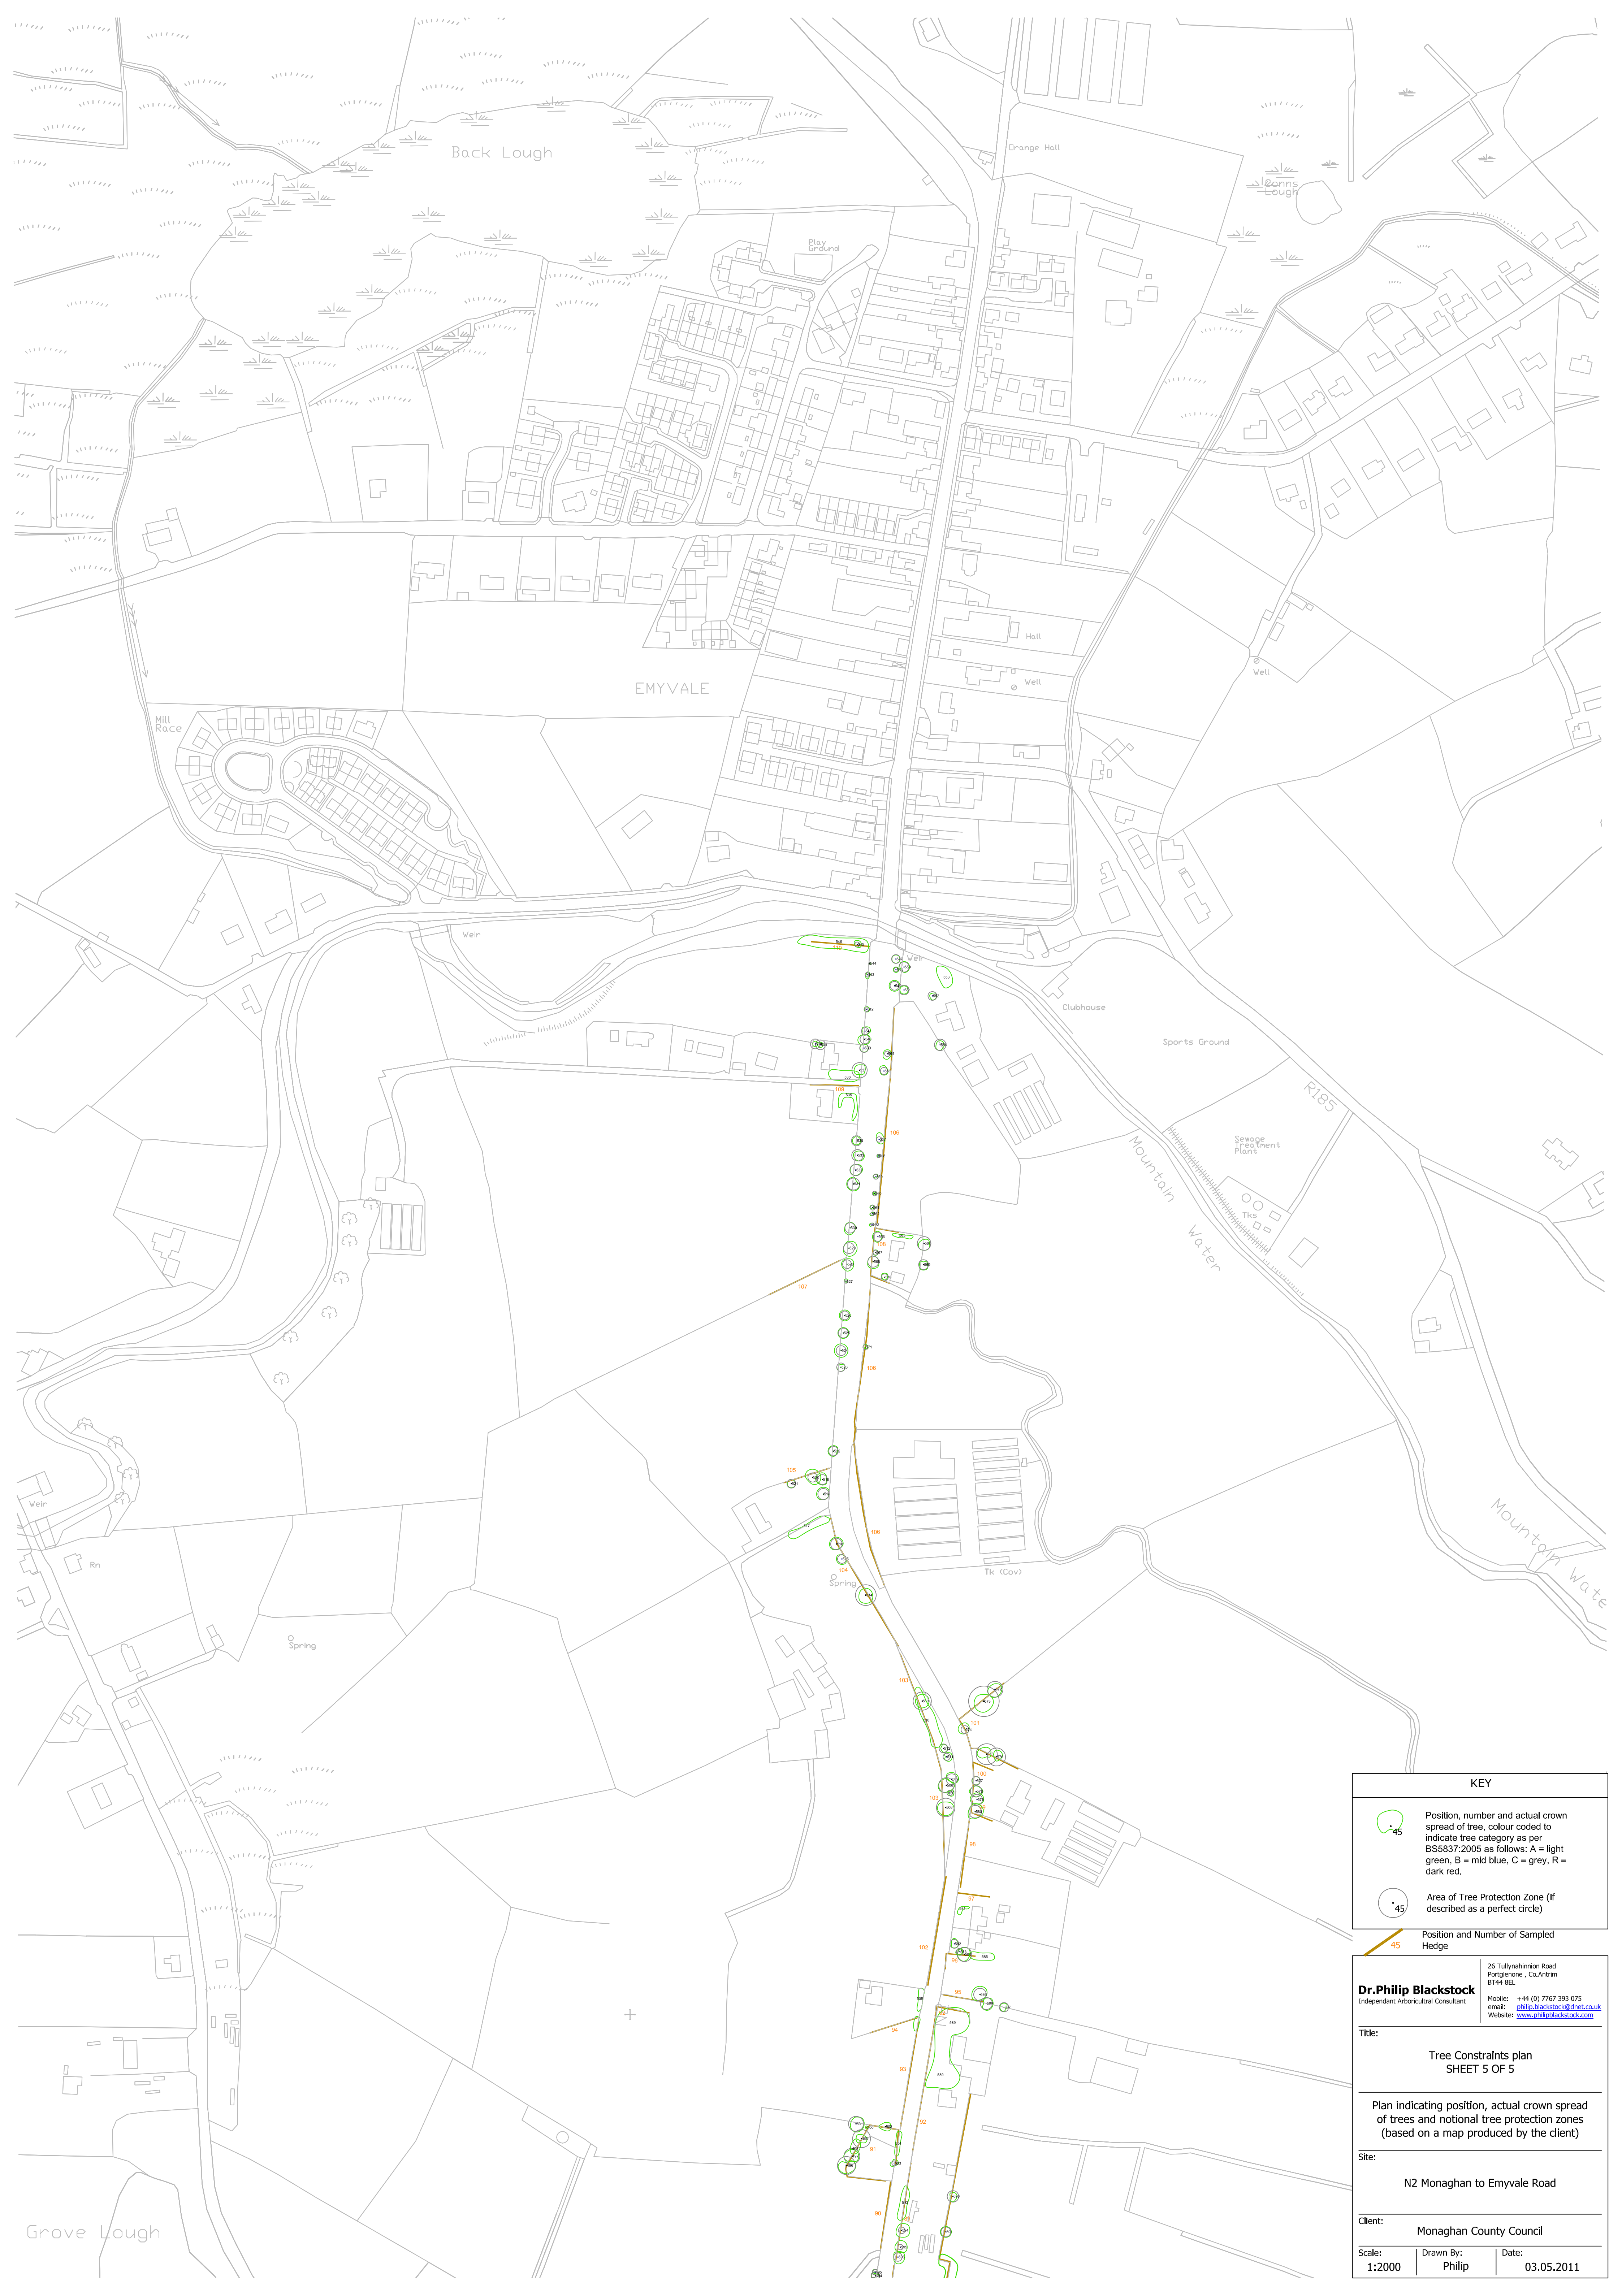
Drawing 5 of 5*

- Position, number and actual crown spread of tree, colour coded to indicate tree category as per BS5837:2005 as follows: A = light green, B = mid blue, C = grey, R = dark red.
- Area of Tree Protection Zone (if described as a perfect circle)
- Position and Number of Sampled Hedge
